City of Oak Harbor  
City Council Agenda Bill

Bill No. 5. c. i.  
Date: January 15, 2019  
Subject: Clean Water Facility Update

# Clean Water Facility Project

# Monthly Report

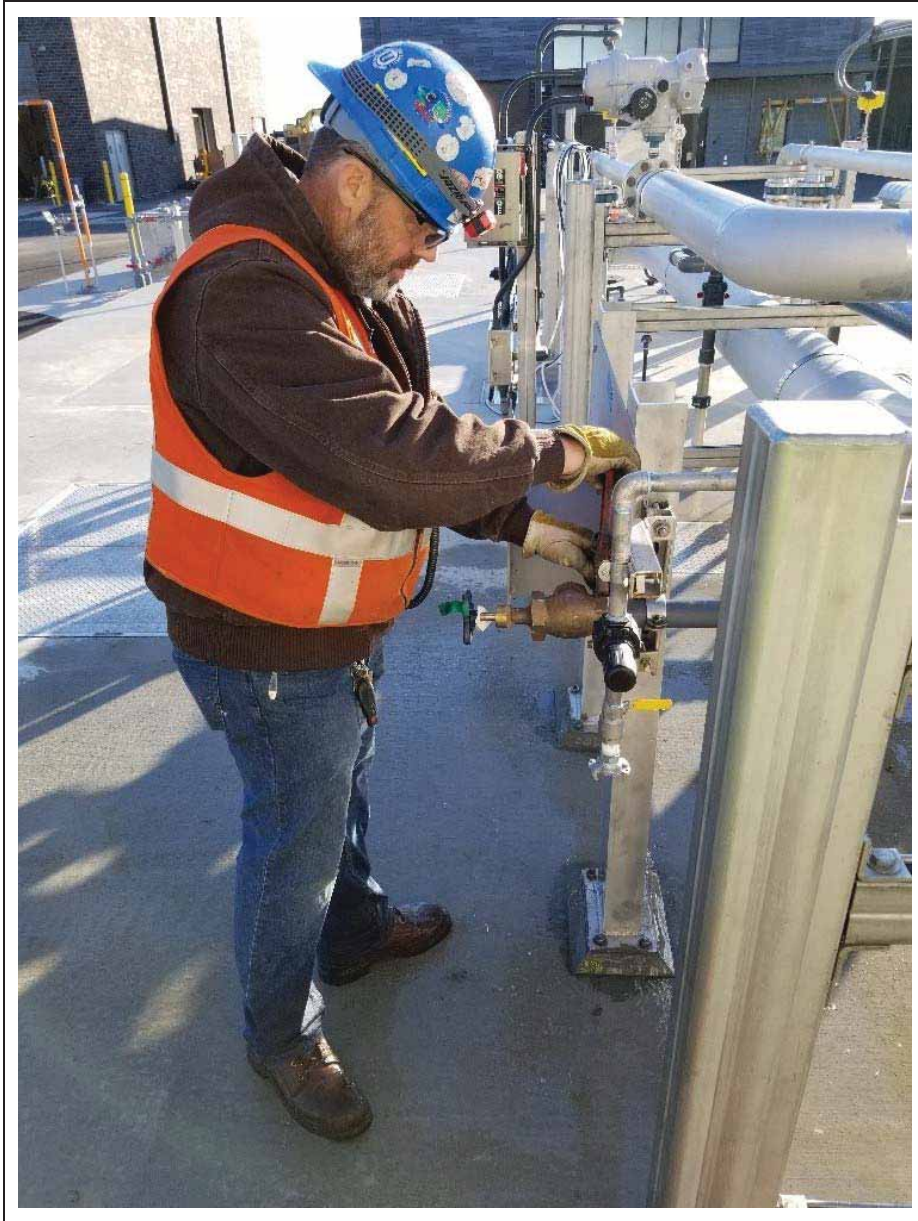
Photo #3

Area 33 RAS Tanks  
(looking south) on  
Monday, December 3<sup>rd</sup>.

A pipefitter for University  
Mechanical is repairing a  
globe valve.

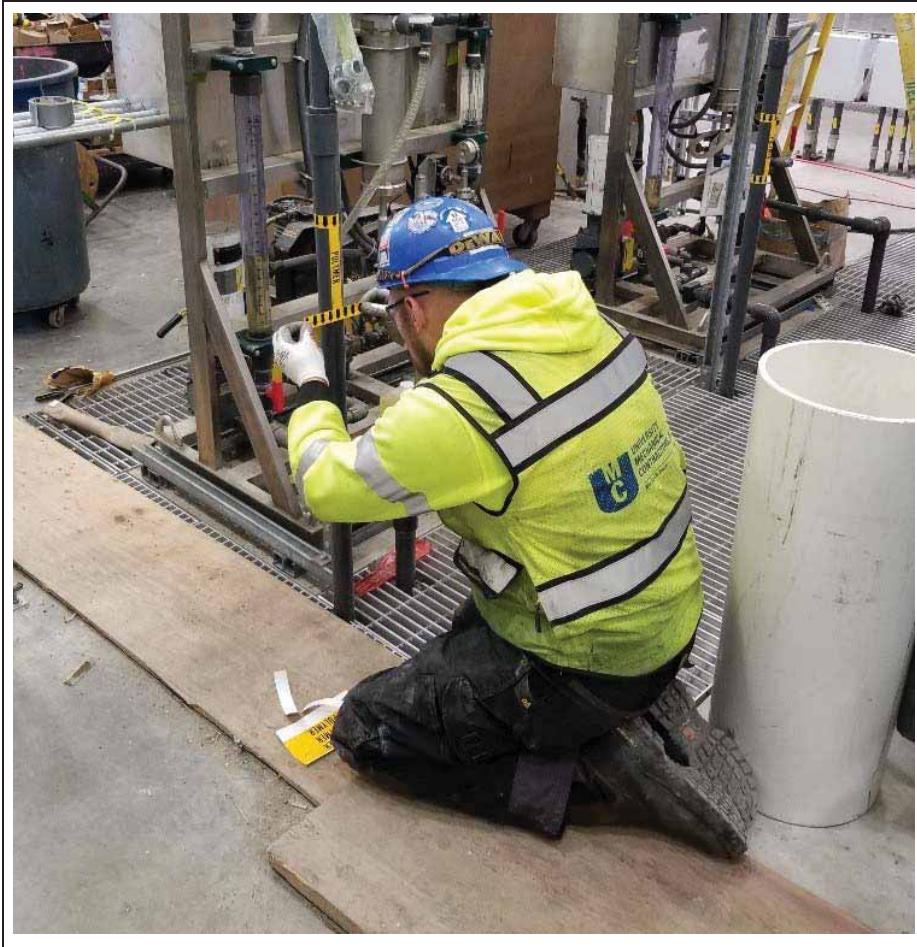
Photo #4

Area 50 Biosolids (looking southwest) on Monday, December 3<sup>rd</sup>.

A pipefitter for University Mechanical is labeling PVC pipe at a polymer blending unit.

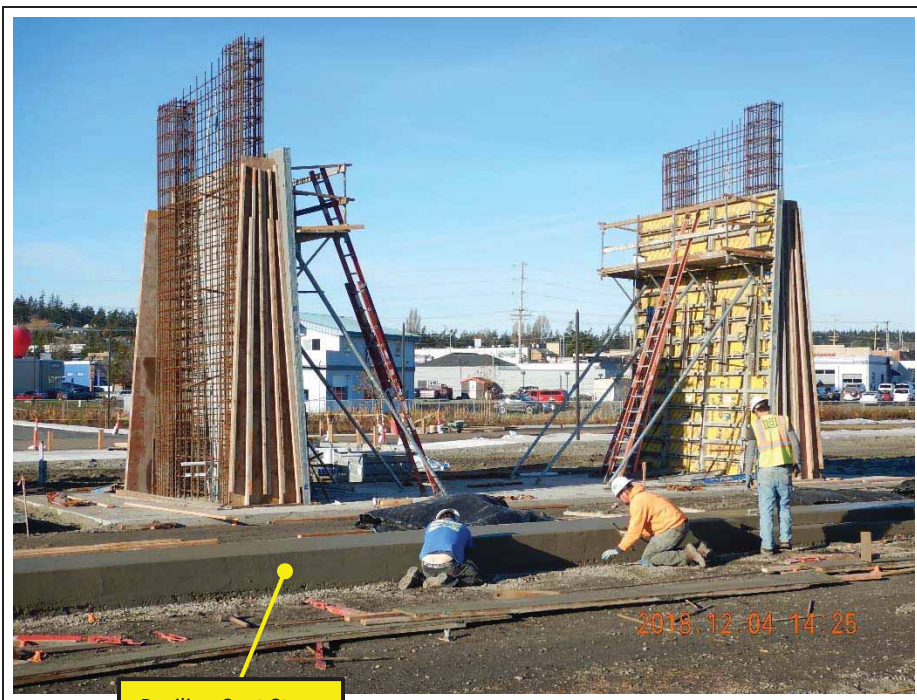
Photo #5

West end of Windjammer Park (looking northwest at the pavilion) on Tuesday, December 4<sup>th</sup>.

**GMPA No. 13 – Windjammer Park Improvements.** Work on this portion of GMPA No. 13 is approximately 55% complete (see Photo #1). Interwest Construction placed concrete for seat steps at the pavilion (see Photo #5) and placed concrete for a mow strip along the seat steps. Interwest Construction continued to build formwork and place concrete for sidewalks, walkways, and seat walls at the west and north ends of the park (see Photos #15, #34, and #49). Interwest Construction began placing concrete for a pedestrian walkway that runs in a north-south direction between Pioneer Way and Oak Harbor Bay (see Photos #20, #26, #30, and #43). Interwest Construction built forms and placed reinforcing steel and concrete for a planter box located adjacent to the west side of the west kitchen. Interwest Construction graded on-site earthen material east of the splash park and along the southwest border of Windjammer Park. Two pre-assembled stainless steel restrooms, known as Portland Loos, arrived on site during the week of December 10<sup>th</sup> (see Photo #33). Interwest Construction installed utility piping and plumbing fixtures and placed concrete to facilitate installation of the Portland Loos (see Photo #65). Pacific Earth Works installed irrigation piping and topsoil at the southwest corner of the park (southwest of the traffic circle) and around two basketball courts. Pacific Earth Works began installing irrigation piping at an area just east of the west kitchen. Pacific Earth Works placed and graded top soil adjacent to the west side of a stormwater detention pond. Valley Electric continued to install conduit, conductors, fiberglass light posts, and precast concrete lamp bases throughout the park (see Photo #32). Valley Electric installed ground rods for the western most Portland Loos (see Photo #59) and installed electrical conduits within formwork for shear walls at the pavilion. P&L General Contractors began to install glulam beams and columns at the west kitchen (see Photos #55 and #57). P&L General Contractor's subcontractor, LangCo NW, built forms and placed reinforcing steel and concrete for seat walls at the west kitchen (see Photo #18) and at the east kitchen (see Photo #42). LangCo NW also placed concrete for portions of a 4-inch topping slab at both the west and east kitchens. LangCo NW and Morse Steel Services built formwork and placing reinforcing steel, respectively, for two shear walls for a pavilion (see Photo #14). LangCo NW placed concrete for the shear walls (see Photos #21, #37, and #58). Turnstone Construction finished placing and sculping concrete for faux rocks and logs at the splash park and at the shipwreck water feature. Turnstone Construction finished painting the rocks and logs to make them look more realistic (see Photos #16, #31, and #44). Turnstone Construction pressure washed the splash park.

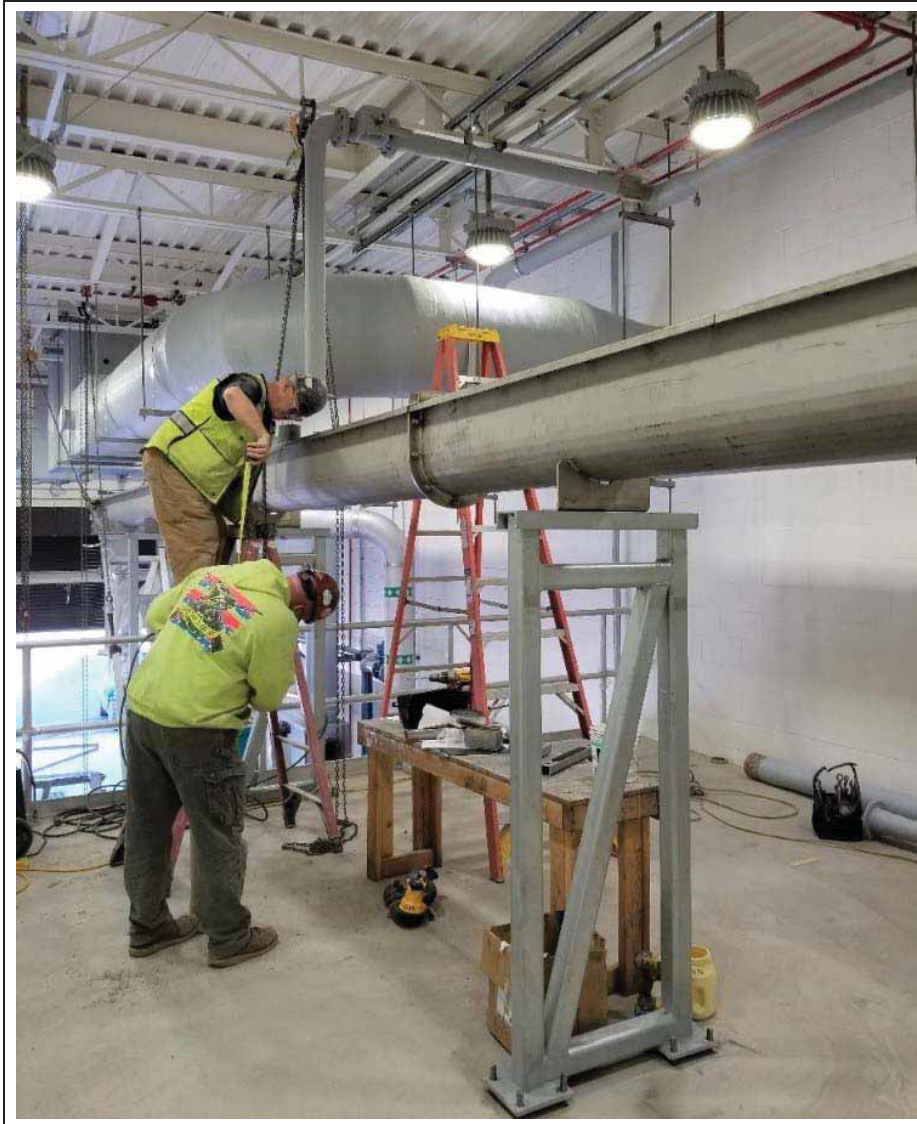
Photo #6

Area 50 Biosolids Building (looking north in the load out area) on Tuesday, December 4<sup>th</sup>.

Sheet metal workers for Delta Technology Corporation are preparing for the installation of a fiber reinforced plastic (FRP) foul air duct associated with a conveyor.

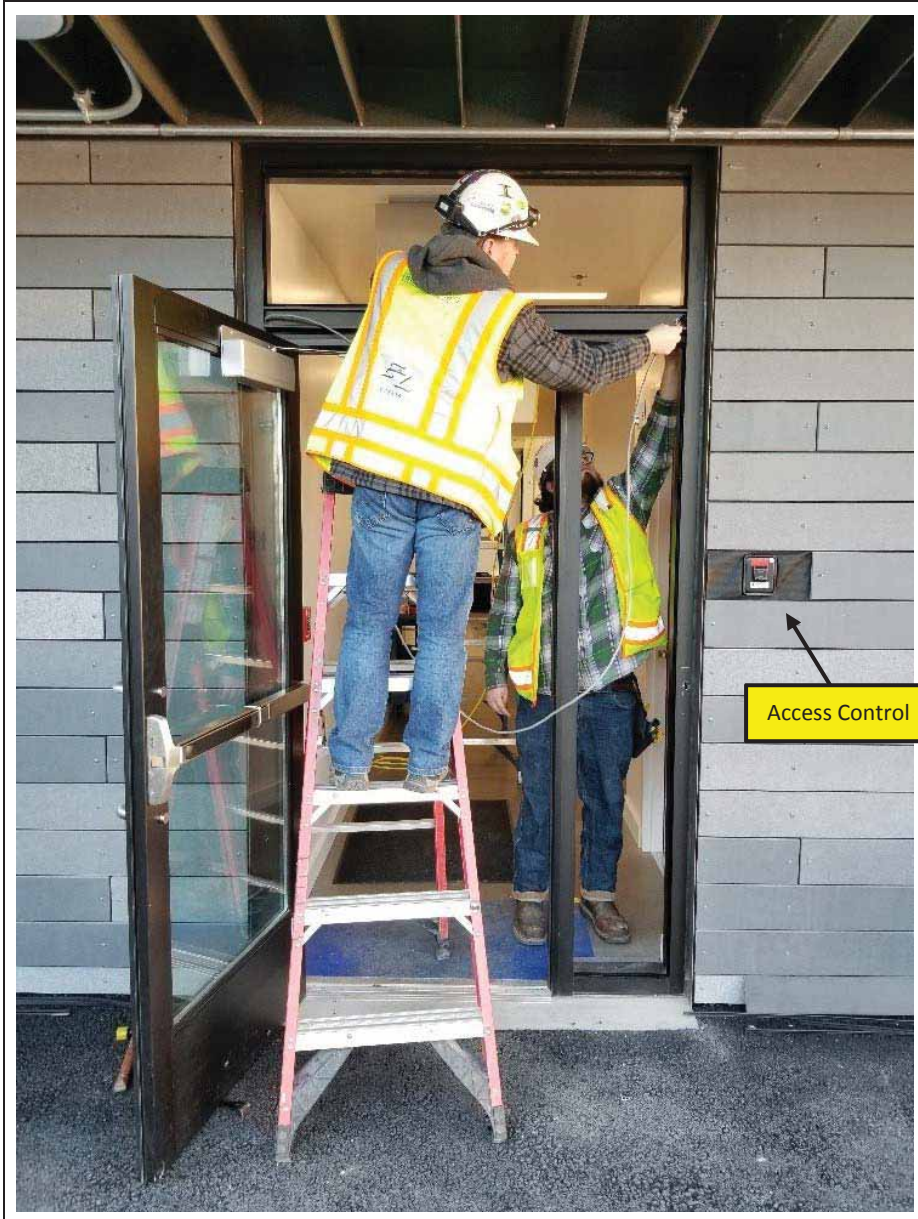
Photo #7

Area 01 Administration Building (looking west) on Tuesday, December 4<sup>th</sup>.

Electricians for EZ Interface are guiding conductors through a hole in a window frame. The conductors are part of a security and access control system.

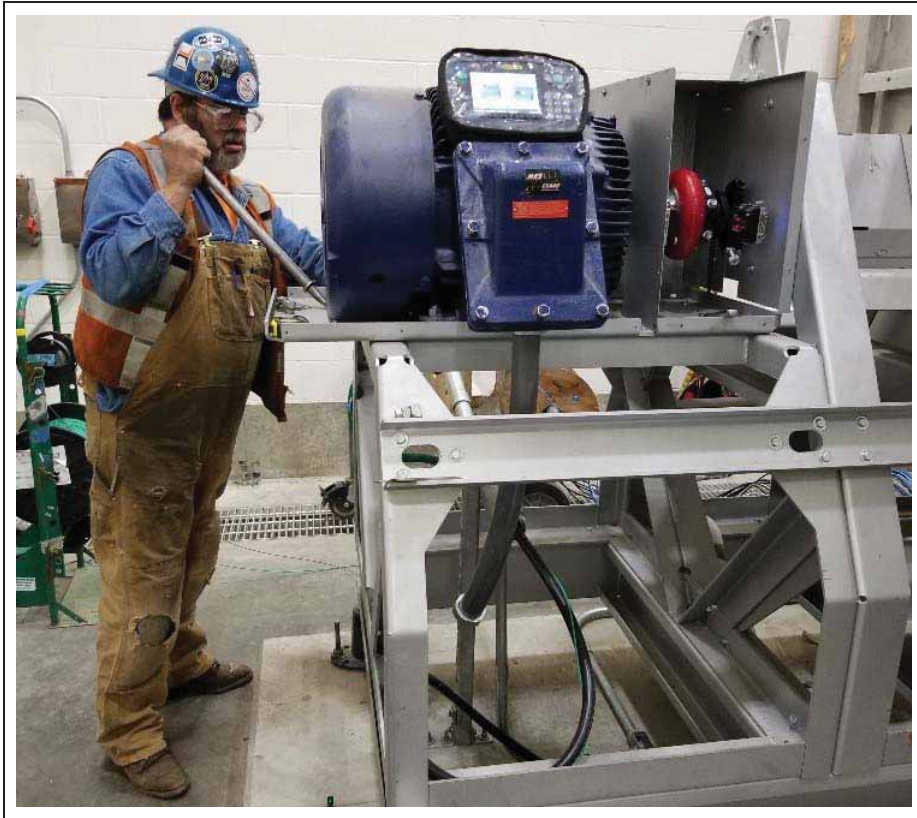
Photo #8

Area 50 Biosolids (looking east) on Wednesday, December 5<sup>th</sup>.

A millwright for University Mechanical is aligning a coupling for a hot gas fan.

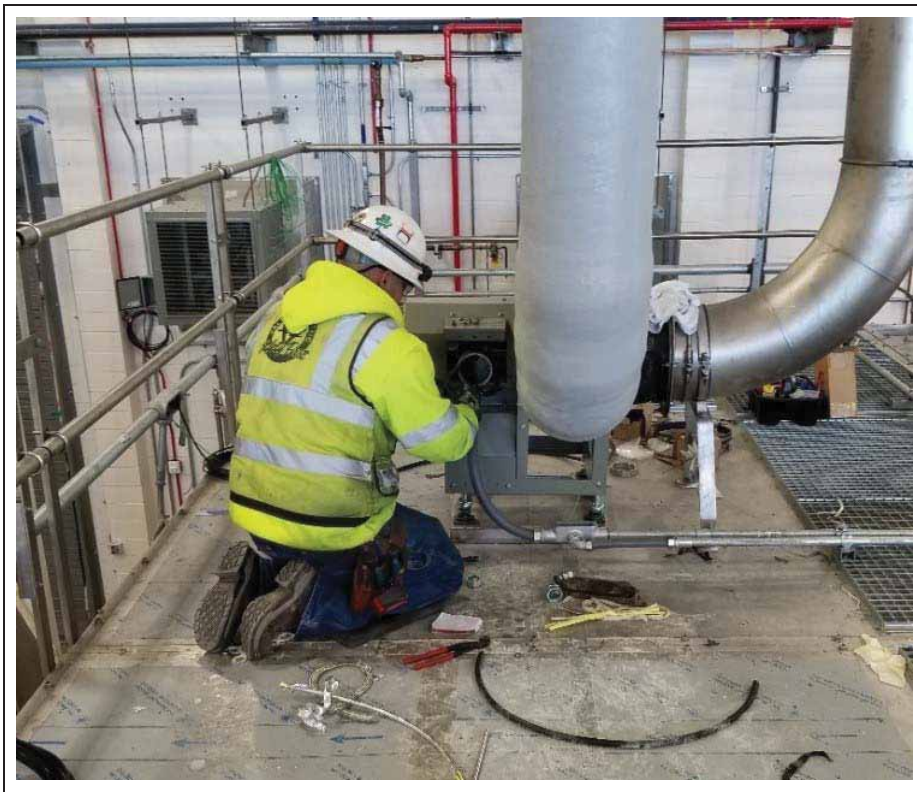
Photo #9

Area 50 Biosolids (looking north) on Wednesday, December 5<sup>th</sup>.

An electrician for Valley Electric is installing conduit and conductors for an exhaust fan that is located atop the biosolids dryer.

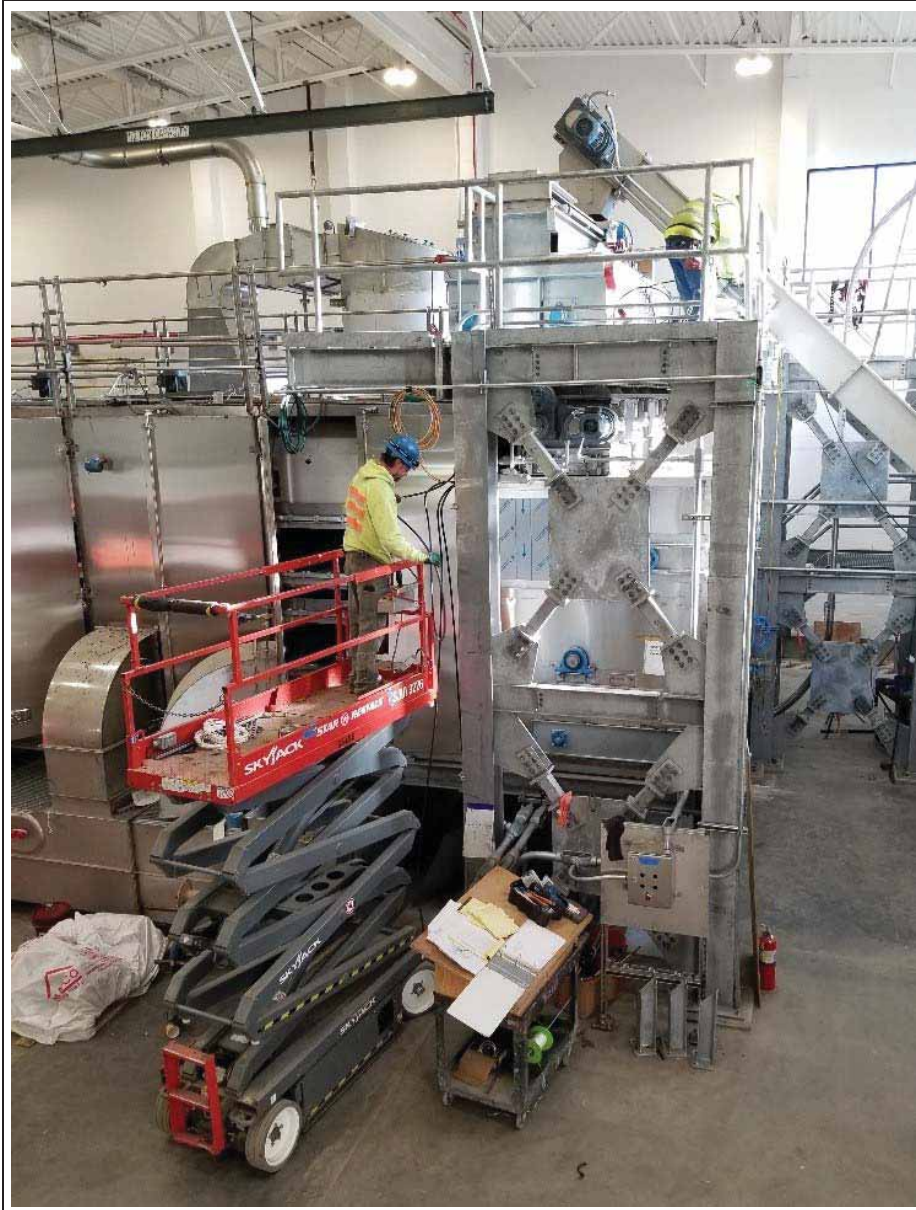
Photo #10

Area 50 Biosolids (looking east) on Wednesday, December 5<sup>th</sup>.

Electricians for Valley Electric are installing conduits and conductors associated with biosolids dryer equipment.

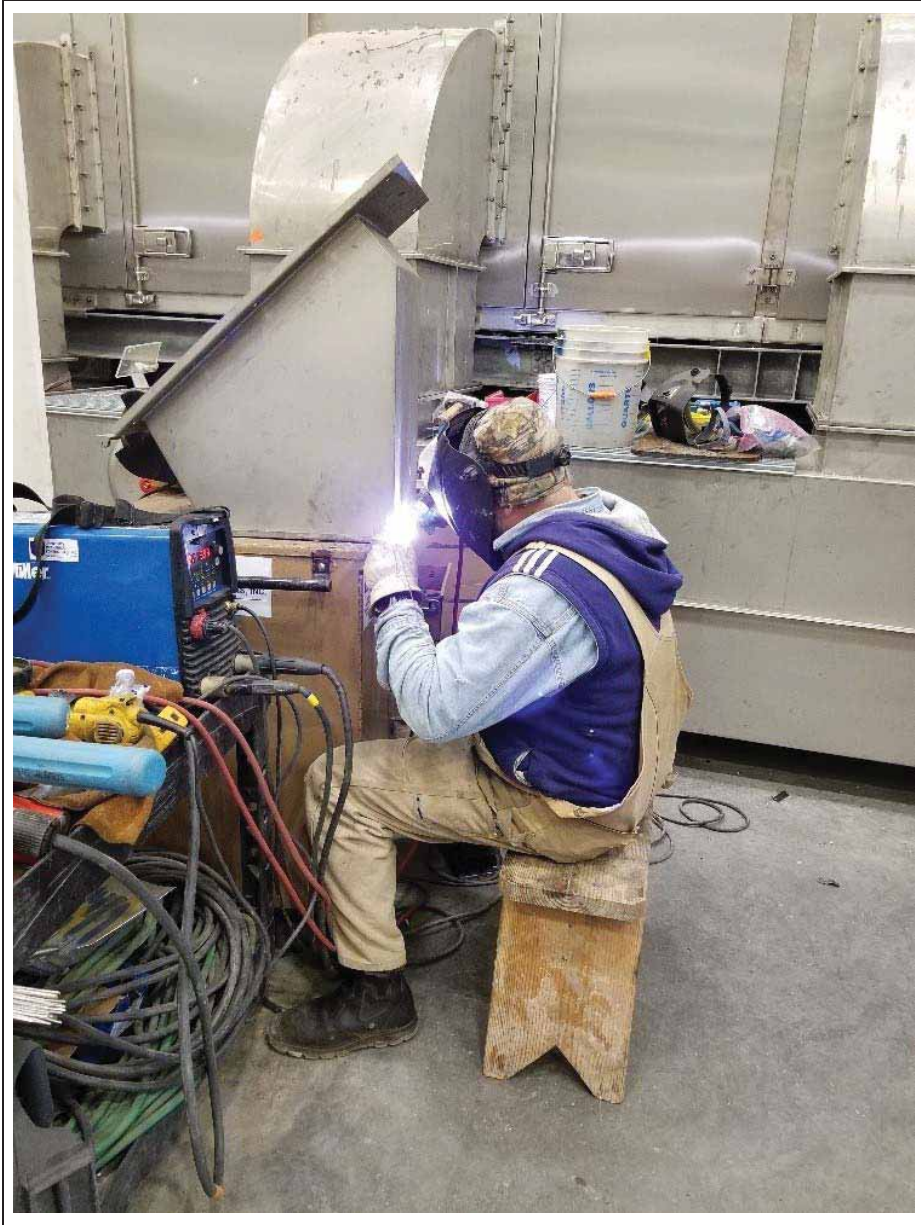
Photo #11

Area 50 Biosolids (looking east) on Wednesday, December 5<sup>th</sup>.

A pipefitter for University Mechanical is modifying (by means of welding) a section of stainless steel chute associated with a conveyor.

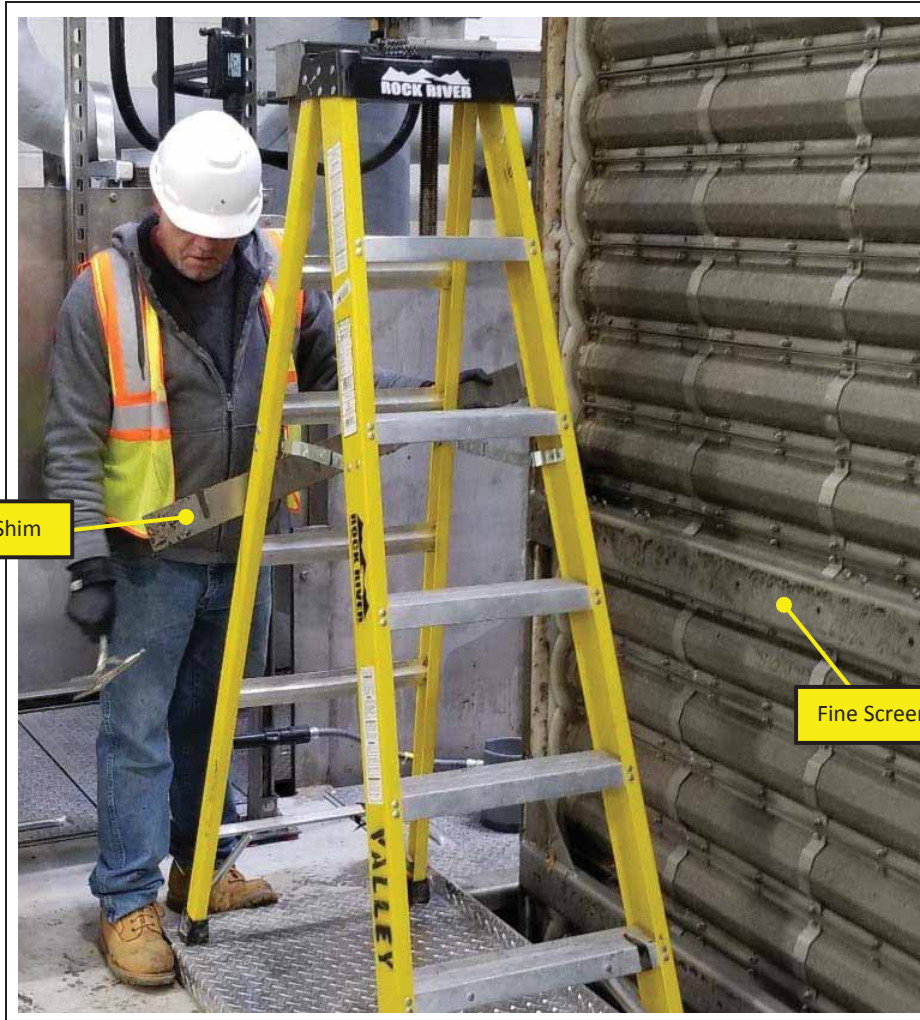
Photo #12

Area 20 Headworks Building (looking northeast at a fine screen) on Wednesday, December 5<sup>th</sup>.

A customer service manager for Headworks International, Bryon Phillipe, is holding a shim that he removed from a fine screen, which reduced friction and the resulting amperage draw.

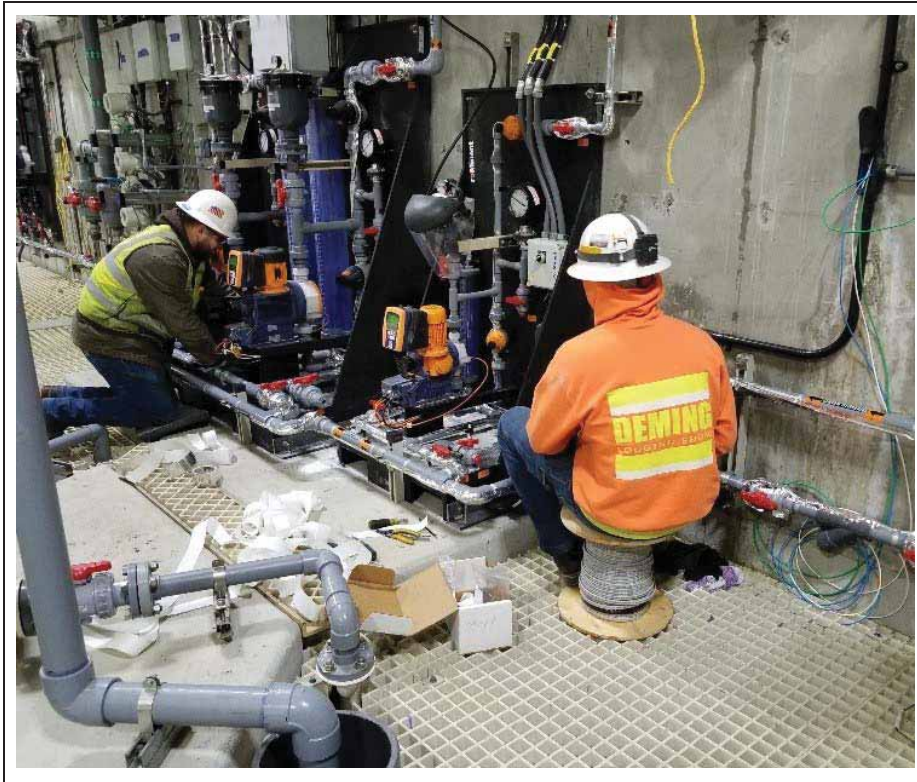
Photo #13

Area 37 Chemical Facilities (looking northwest) on Wednesday, December 5<sup>th</sup>.

Two electricians for Valley Electric are installing heat trace conductors and tape on PVC chemical piping.

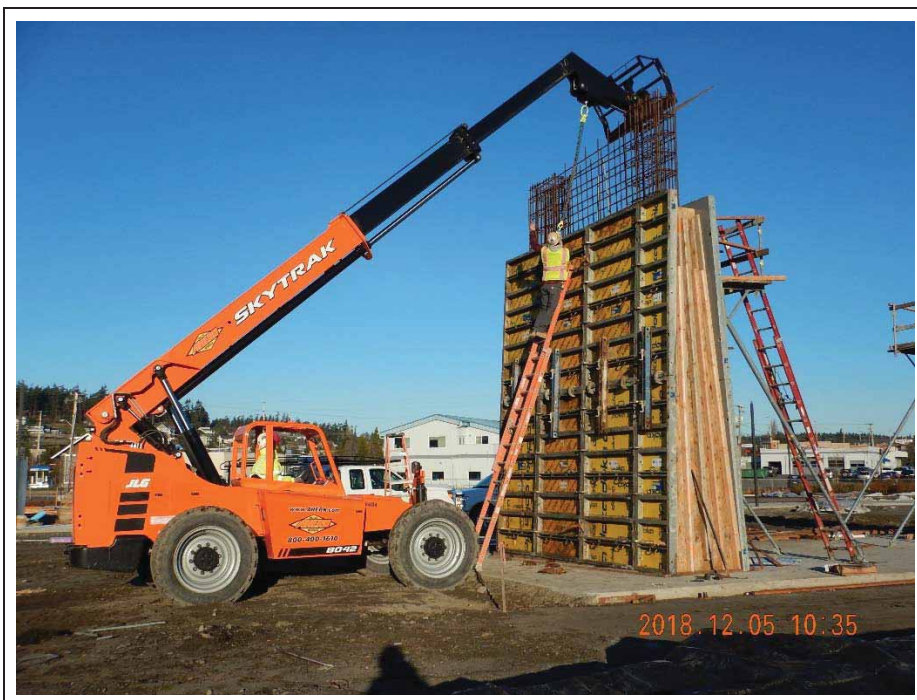
Photo #14

West end of Windjammer Park (looking northwest at a pavilion) on Wednesday, December 5<sup>th</sup>.

Carpenters for LangCo NW are installing formwork for one of two shear walls at the pavilion.

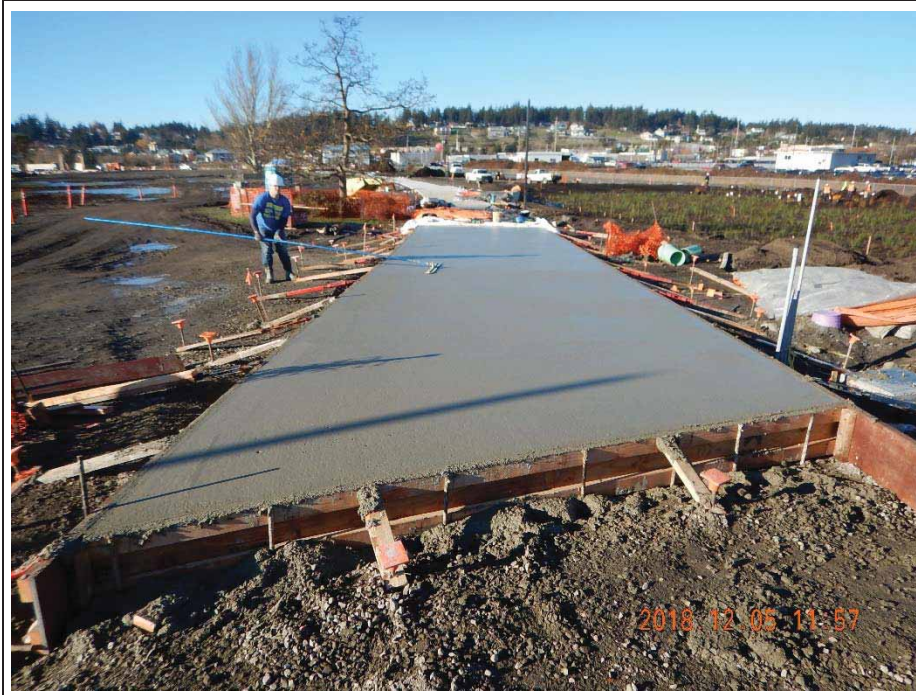
Photo #15

North end of Windjammer Park (looking west) on Wednesday, December 5<sup>th</sup>.

A carpenter for Interwest Construction is finishing concrete for a pedestrian walkway.

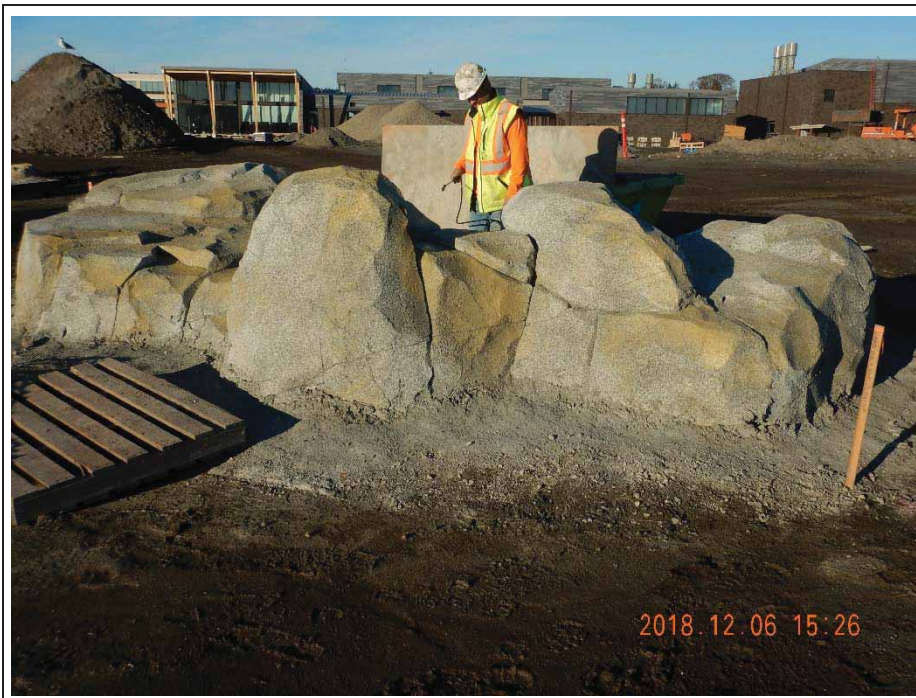
Photo #16

South end of Windjammer Park (looking north at the east side of the splash park) on Thursday, December 6<sup>th</sup>.

A laborer for Turnstone Construction is applying light brown paint to faux rocks.

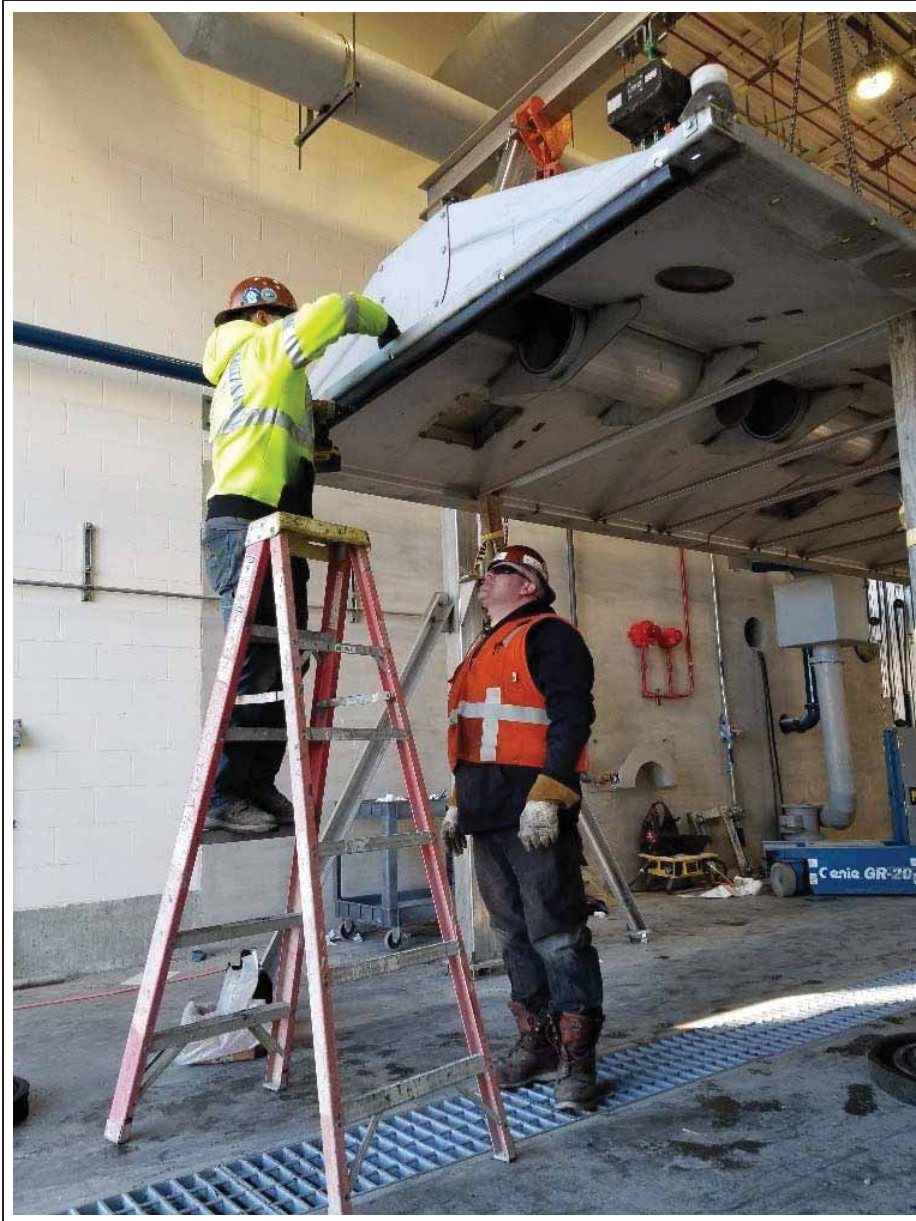
Photo #17

Area 50 Biosolids (looking southeast) on Thursday, December 6<sup>th</sup>.

Pipefitters for University Mechanical are installing a roll-off bin cover in the loadout area of the biosolids building.

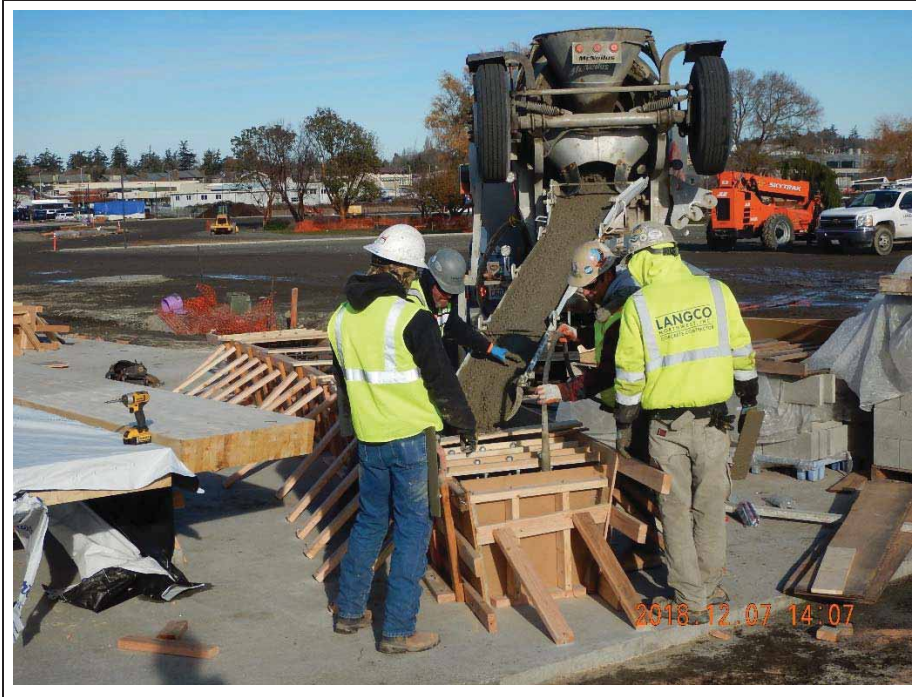
Photo #18

Southwest end of Windjammer Park (looking north at the west kitchen) on Friday, December 7<sup>th</sup>.

Carpenters for LangCo NW are placing concrete for a seat wall.

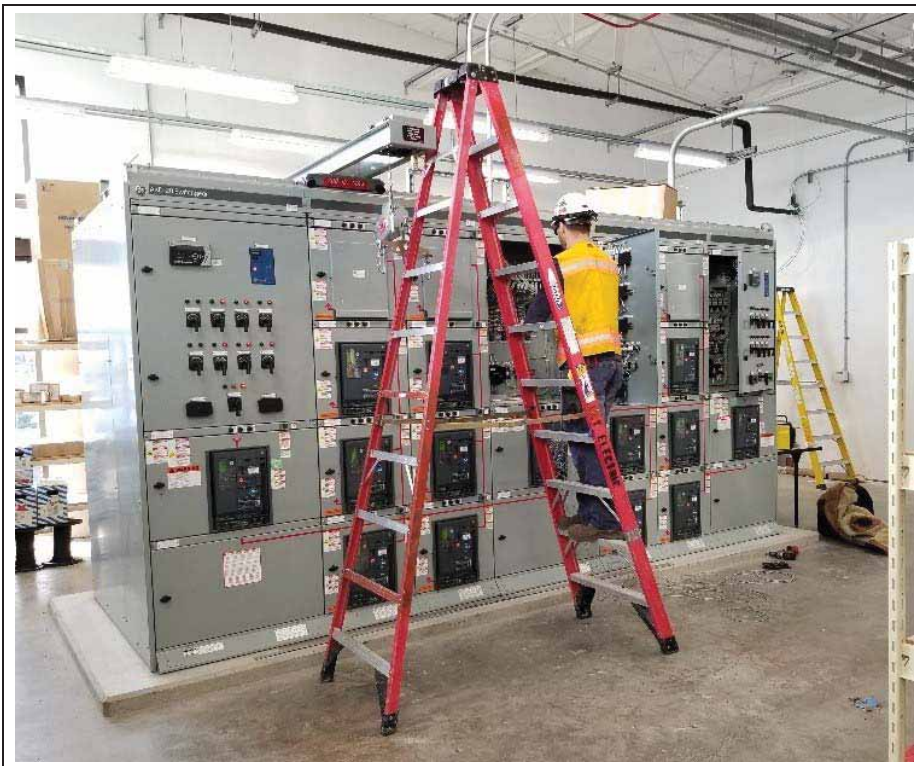
Photo #19

Area 70 Electrical Building (looking west at main switchgear) on Monday, December 10<sup>th</sup>.

An electrician for General Electric is installing an EIP communications gateway.

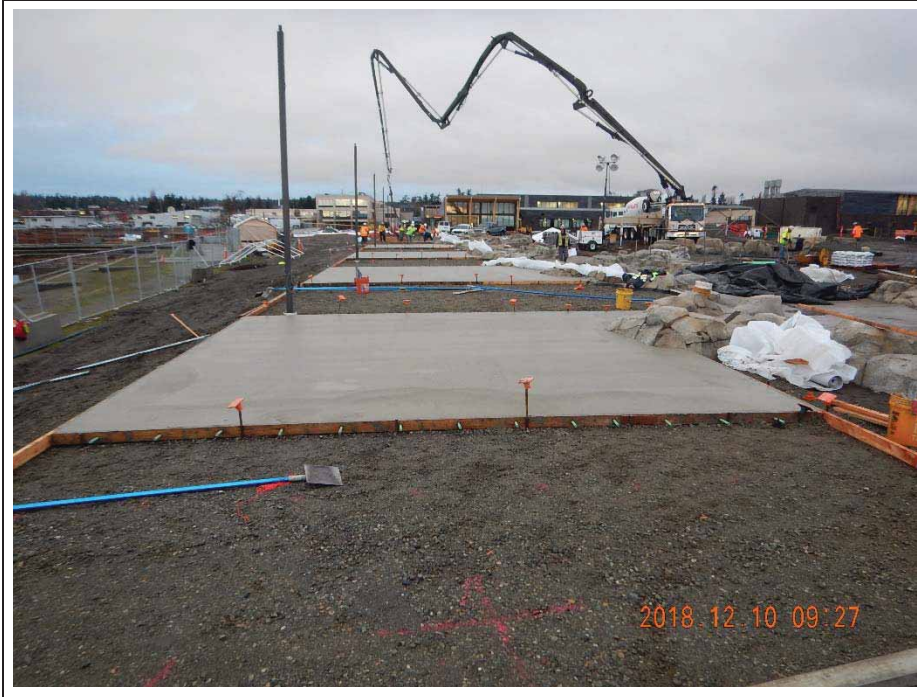
Photo #20

South end of Windjammer Park (looking north along the west side of the splash park) on Monday, December 10<sup>th</sup>.

Interwest Construction is utilizing a truck-mounted concrete pump and hydraulic actuated boom to place concrete for the main north-south pedestrian walkway between Pioneer Way and Oak Harbor Bay.

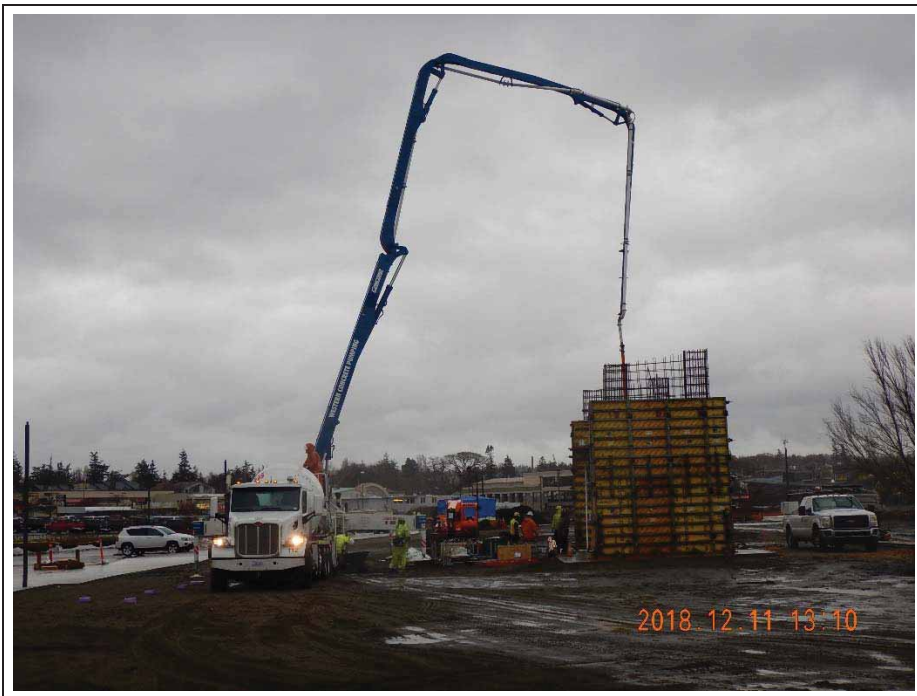
Photo #21

West end of Windjammer Park (looking north) on Tuesday, December 11<sup>th</sup>.

LangCo NW is utilizing a truck-mounted concrete pump and hydraulic actuated boom to place concrete for two shear walls associated with a pavilion.

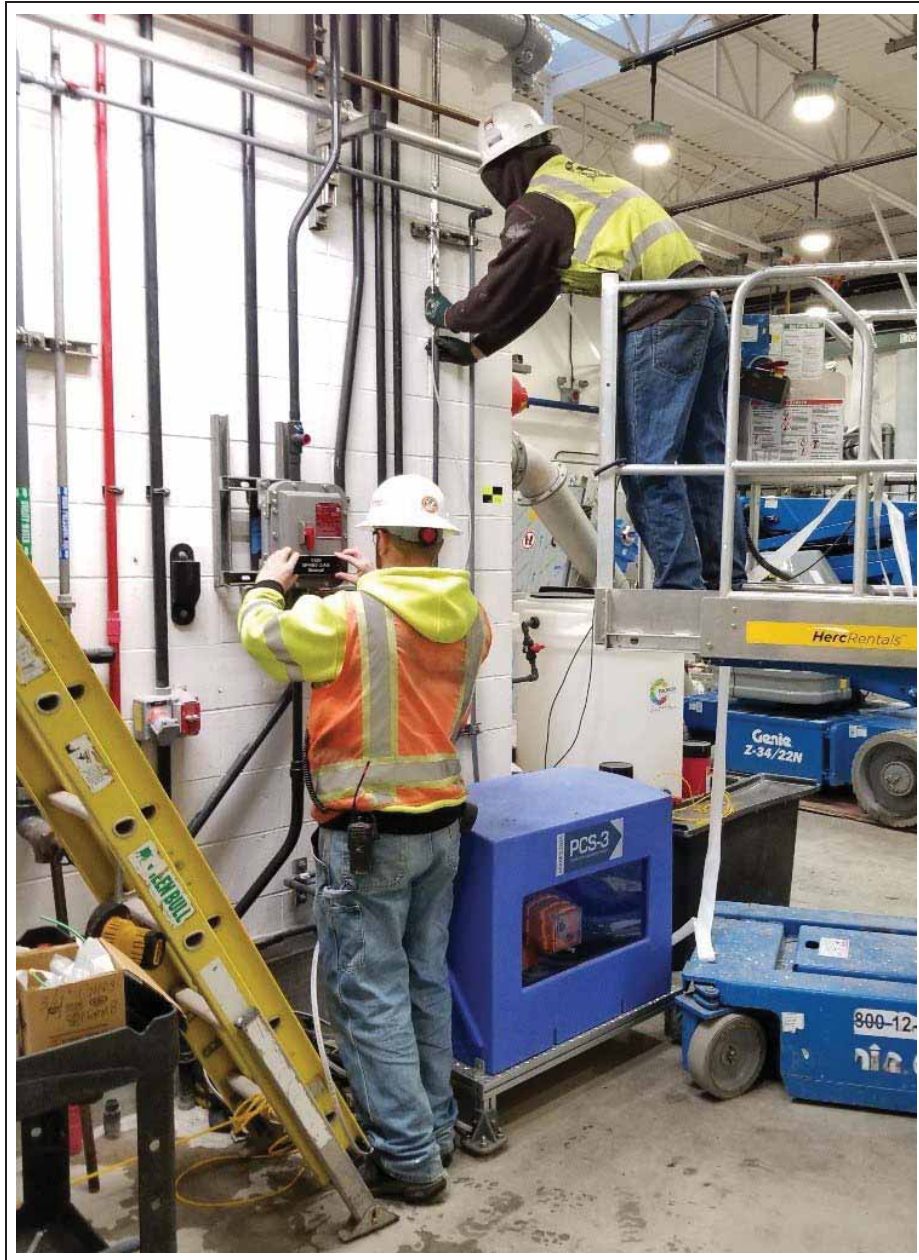
Photo #22

Area 20 Headworks Building (looking northwest) on Tuesday, December 11<sup>th</sup>.

Electricians for Valley Electric are attaching a label to an explosion-proof disconnect switch (left) and attaching heat trace conductors and tape to nutrient feed piping (top right).

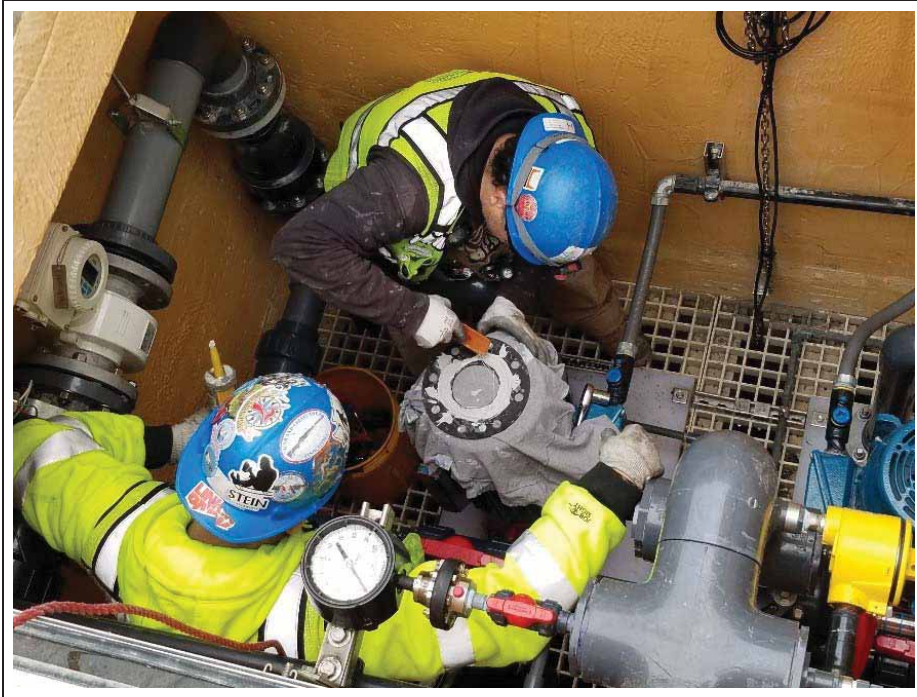
Photo #23

Pipefitters for University Mechanical are applying sealant to a gasket that is associated with a flow meter in a re-circulation chamber.

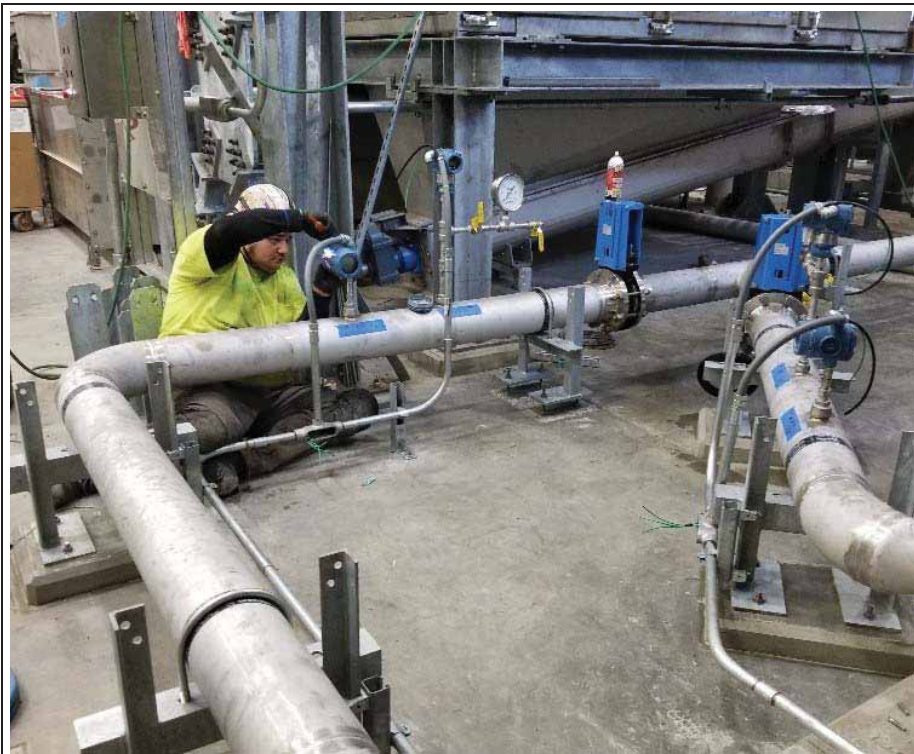
Photo #24

An electrician for Valley Electric is terminating conductors for a sensor that is part of a dewatered sludge piping system.

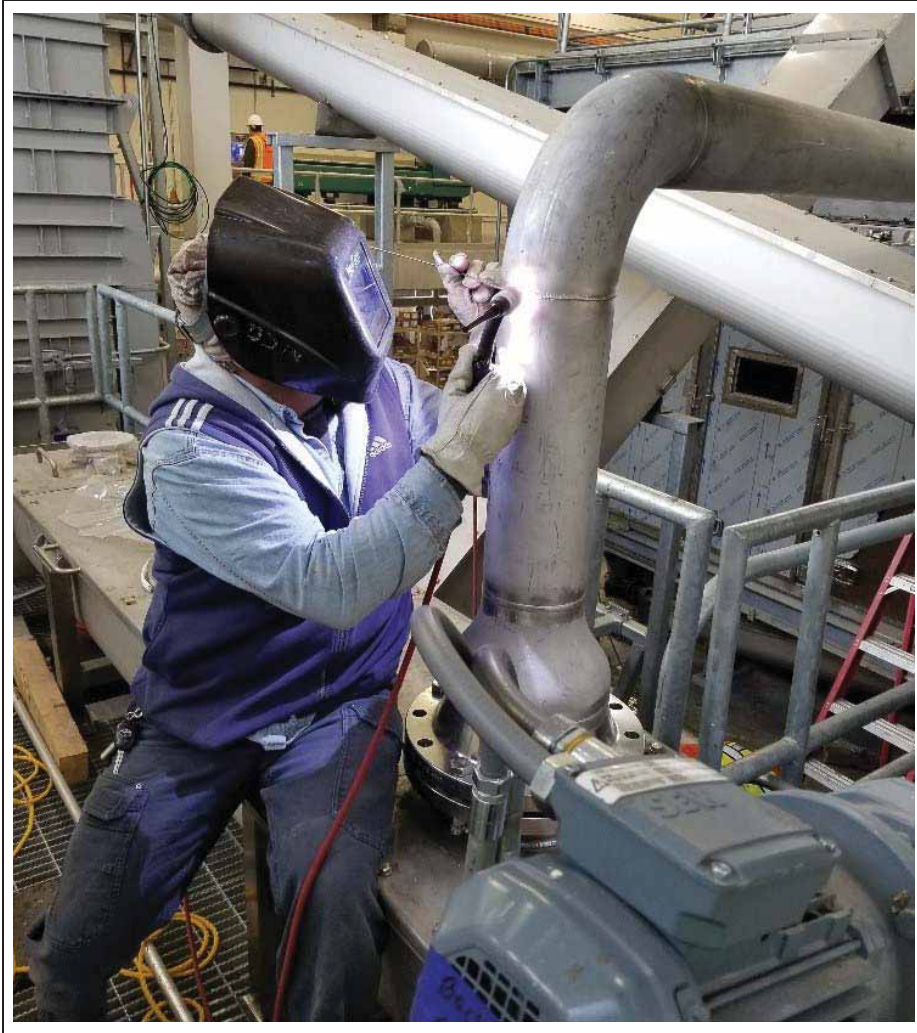
Photo #25

A pipefitter for University  
Mechanical is welding  
together two sections of  
stainless steel dewatered  
sludge piping.

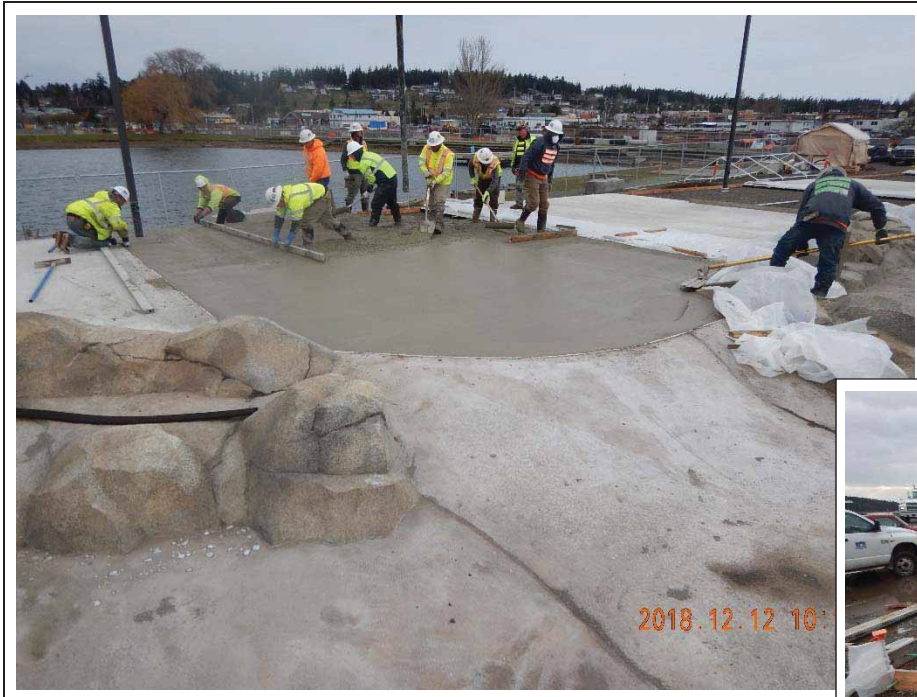
Photo #26

Interwest Construction continues to place concrete for walkways.

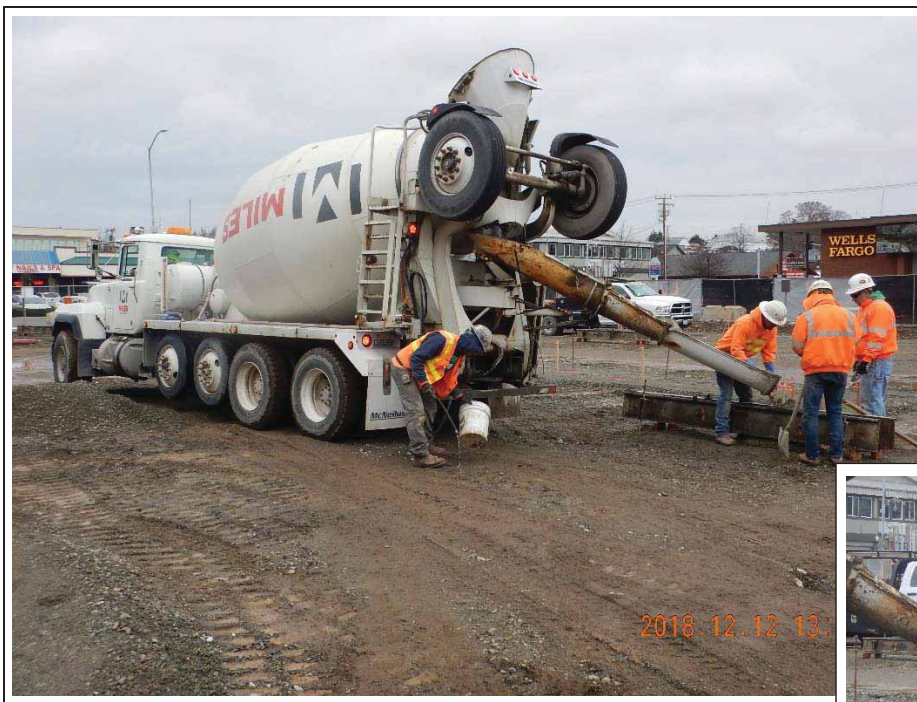
Photo #27

Area north of aeration blower building (looking northeast) on Wednesday, December 12<sup>th</sup>.

S&S Concrete, Inc., is placing concrete for curbs for a parking lot.
