City of Oak Harbor  
City Council Agenda Bill

Bill No. 5. c. i.  
Date: January 15, 2019  
Subject: Clean Water Facility Update

# Clean Water Facility Project

# Monthly Report

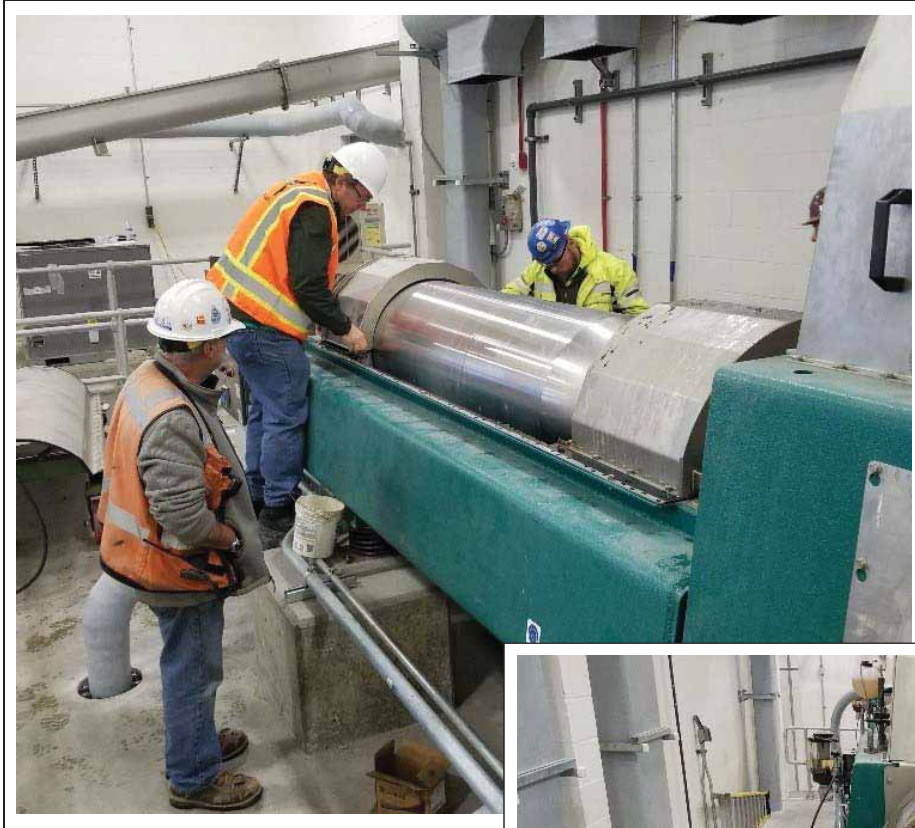
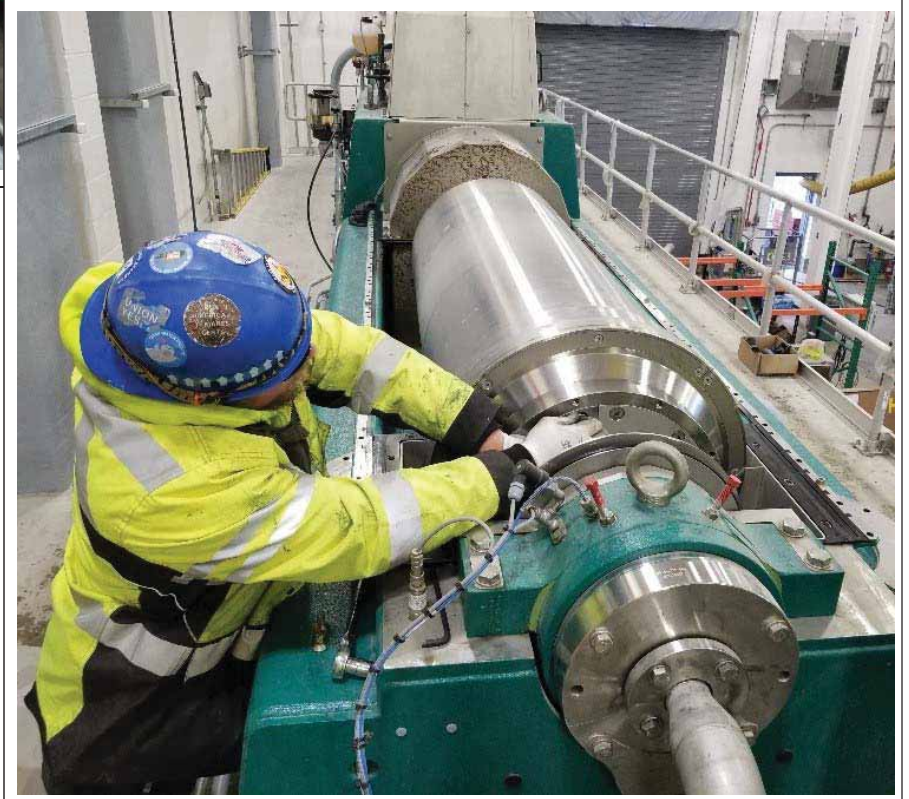
Photo #28

GEA representative Tom Potter (center) and a pipefitter for University Mechanical (right) are removing a cover at a centrifuge. A pipefitter (bottom photo) is exchanging a weir plate as a means of adjusting centrate discharge.

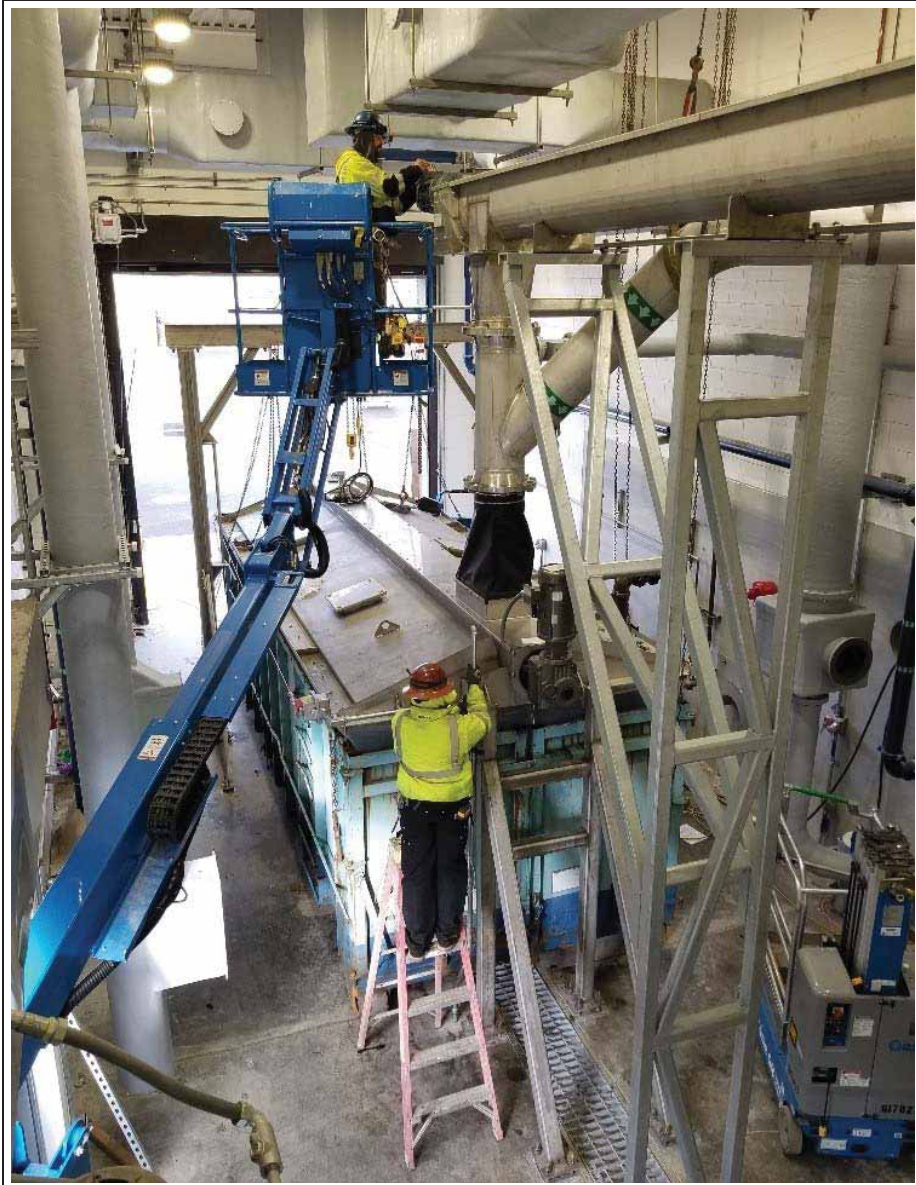
Photo #29

Electricians for Valley Electric are installing conduits and conductors for screw conveyor motors.

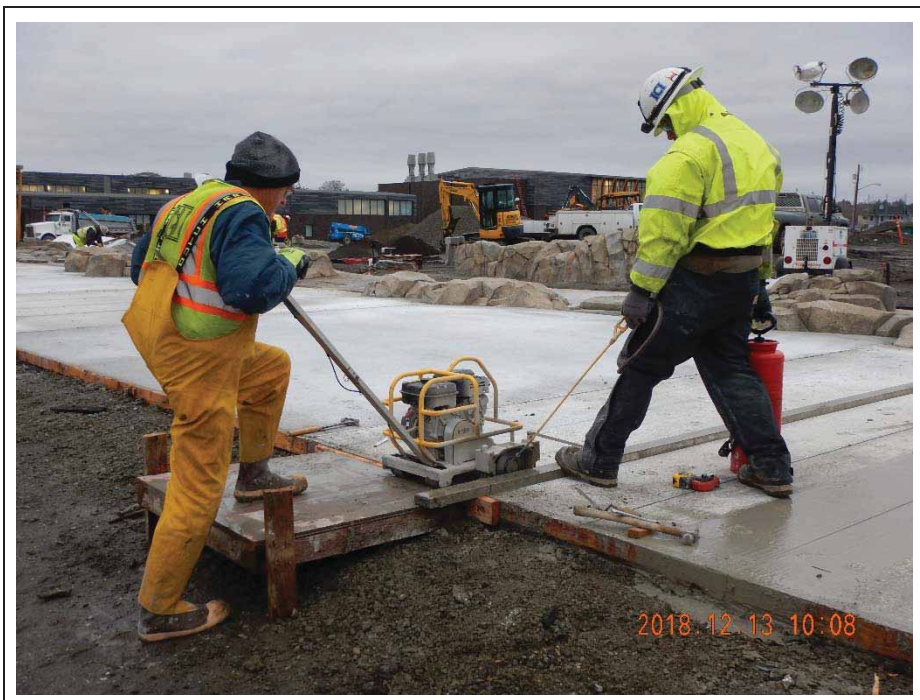
Photo #30

Carpenters for Interwest Construction are utilizing a gas-powered saw to cut contraction joints in a pedestrian walkway.

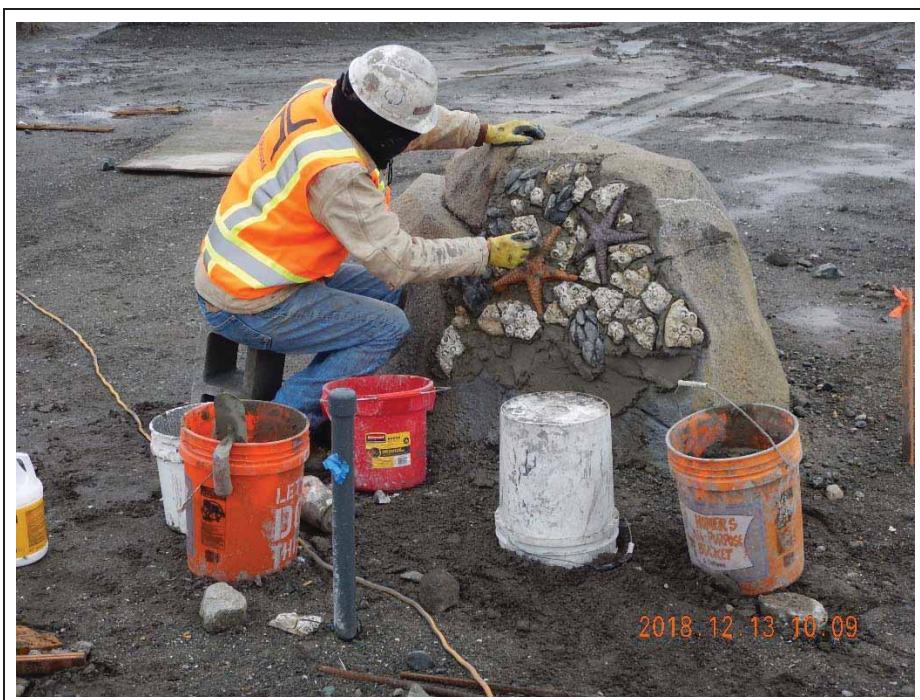
Photo #31

A carpenter for Turnstone Construction is attaching faux starfish and barnacles to a faux rock.

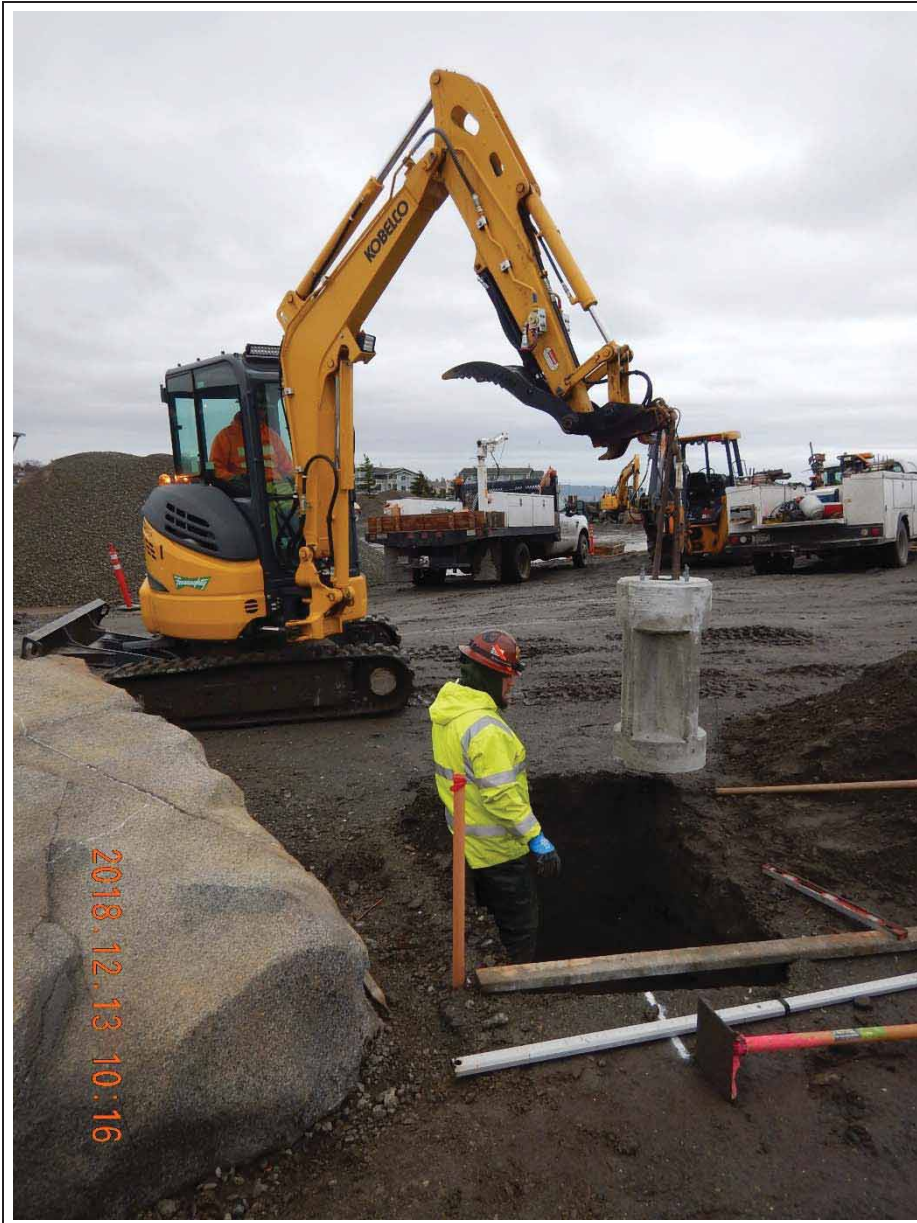
Photo #32

Electricians for Valley Electric are installing a precast concrete lamp base.

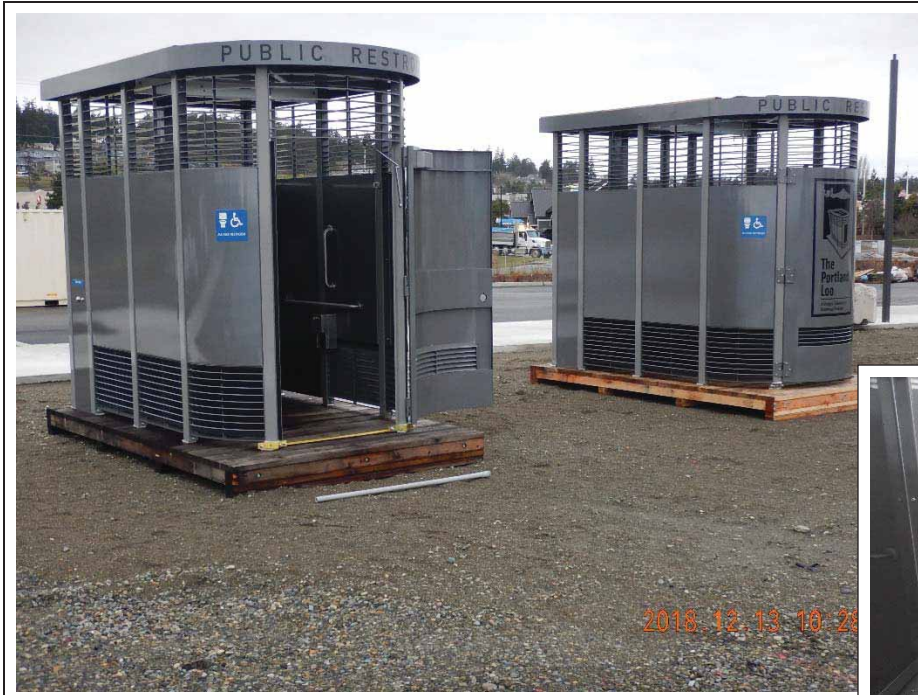
Photo #33

West end of Windjammer Park (looking northwest) on Thursday, December 13<sup>th</sup>.

Two Portland Loos arrived on site earlier this week.

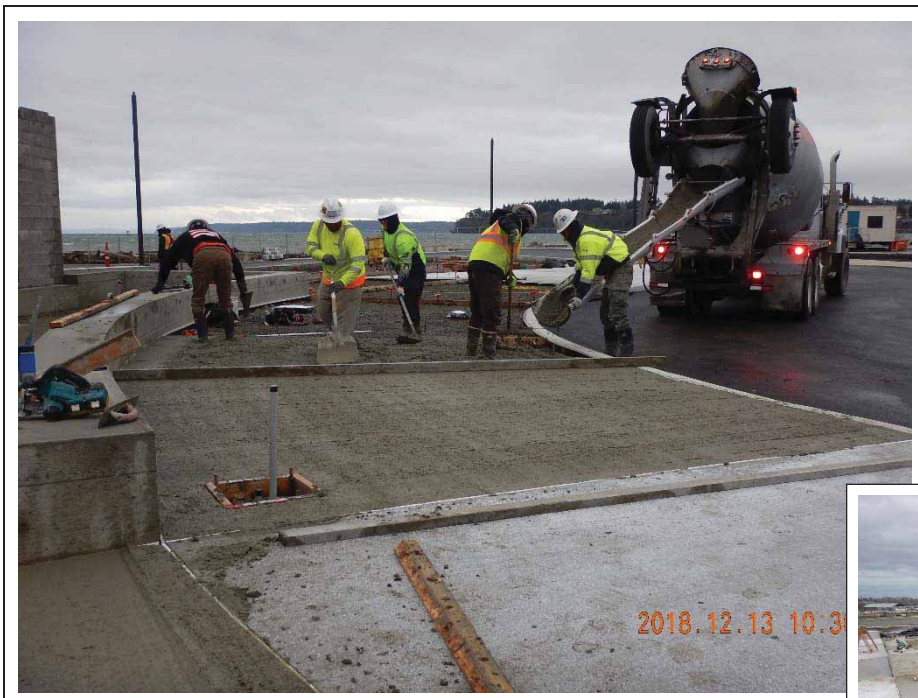
Photo #34

Southwest end of Windjammer Park (looking south and east near the west kitchen) on Thursday, December 13<sup>th</sup>.

Carpenters for Interwest Construction are placing concrete for a sidewalk adjacent to the west kitchen.

- Interwest Construction continued to place concrete for pedestrian walkways in Windjammer Park (see Photos #15, #20, #26, and #34).
- LangCo NW built concrete shear walls for a pavilion in Windjammer Park (see Photos #21, #37, and #58).

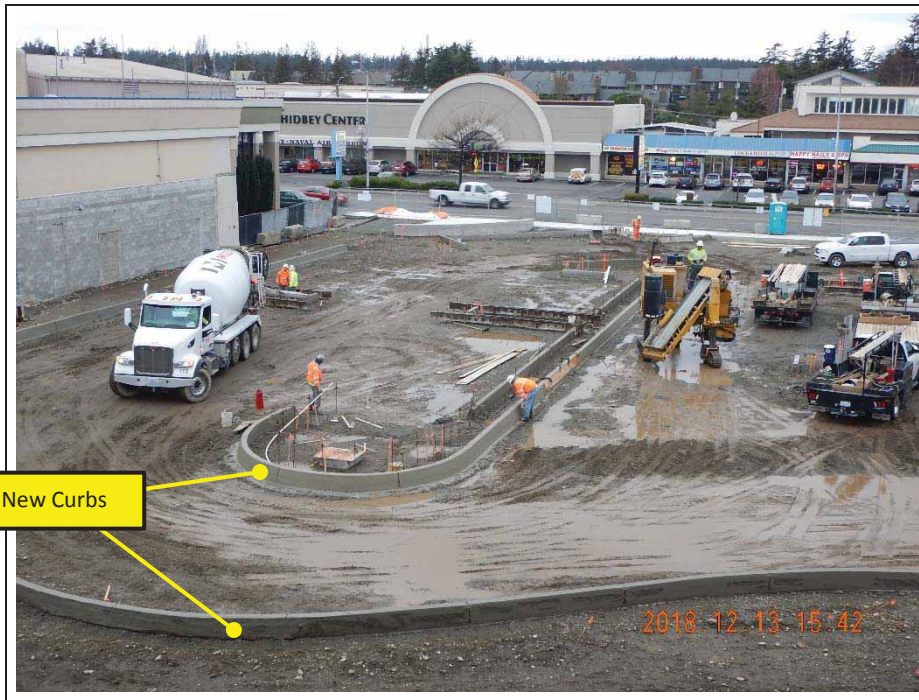
Photo #35

S&S Concrete Construction is building curbs for a parking lot.

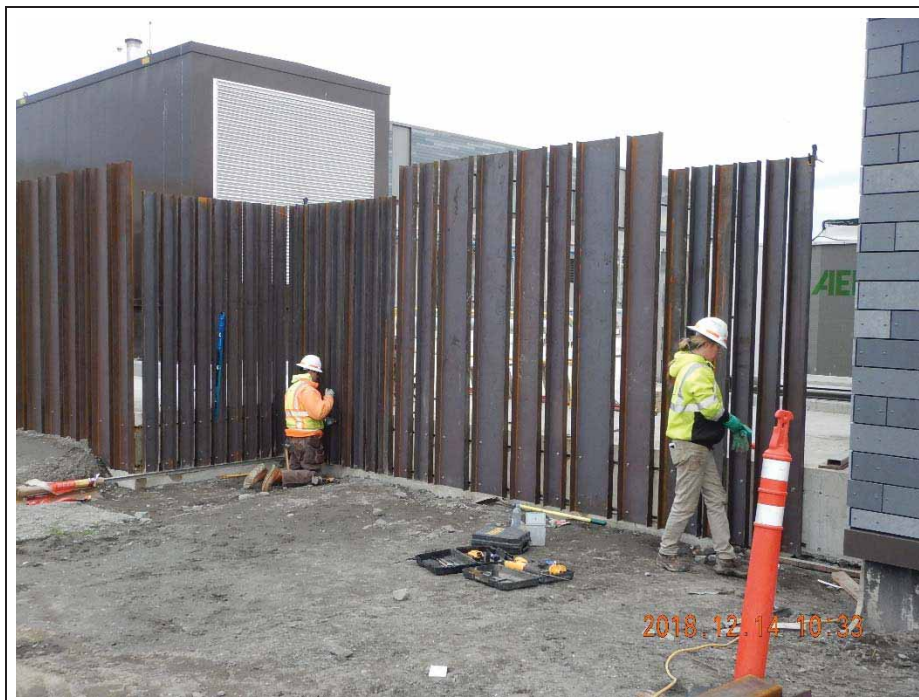
Photo #36

Area 70 Generator Yard north (looking northeast towards the engine generator) on Friday, December 14<sup>th</sup>.

Two carpenters for P&L General Contractors continue to install screen wall made of weathering steel.

P&L General Contractors finished installing a screen wall made of weathering steel along the west side of the generator yard (see Photo #36) and along the north and west sides of the odor control structure. Pacific Earth Works continued to place wetland enhancement plantings in a storm water detention pond located just west of the administration building. Turnstone Construction painted faux rocks and sprayed acid on concrete at a water feature located adjacent to the west and south sides of the interpretive center portion of the administration building (see Photo #45).

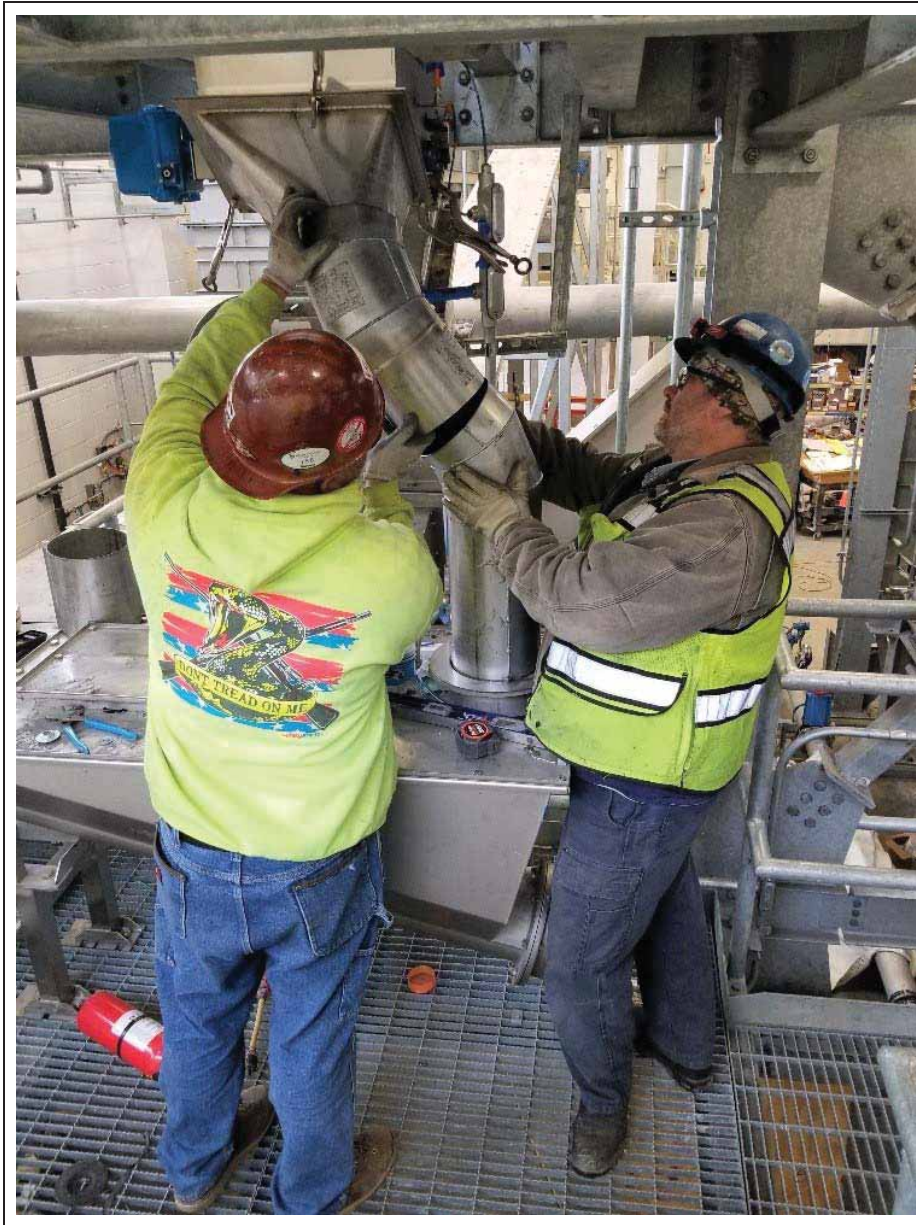
Photo #38

A sheet metal worker for Delta Technology Corporation (left) and a pipefitter for University Mechanical (right) are installing a chute between a diverter and a back mixer screw.

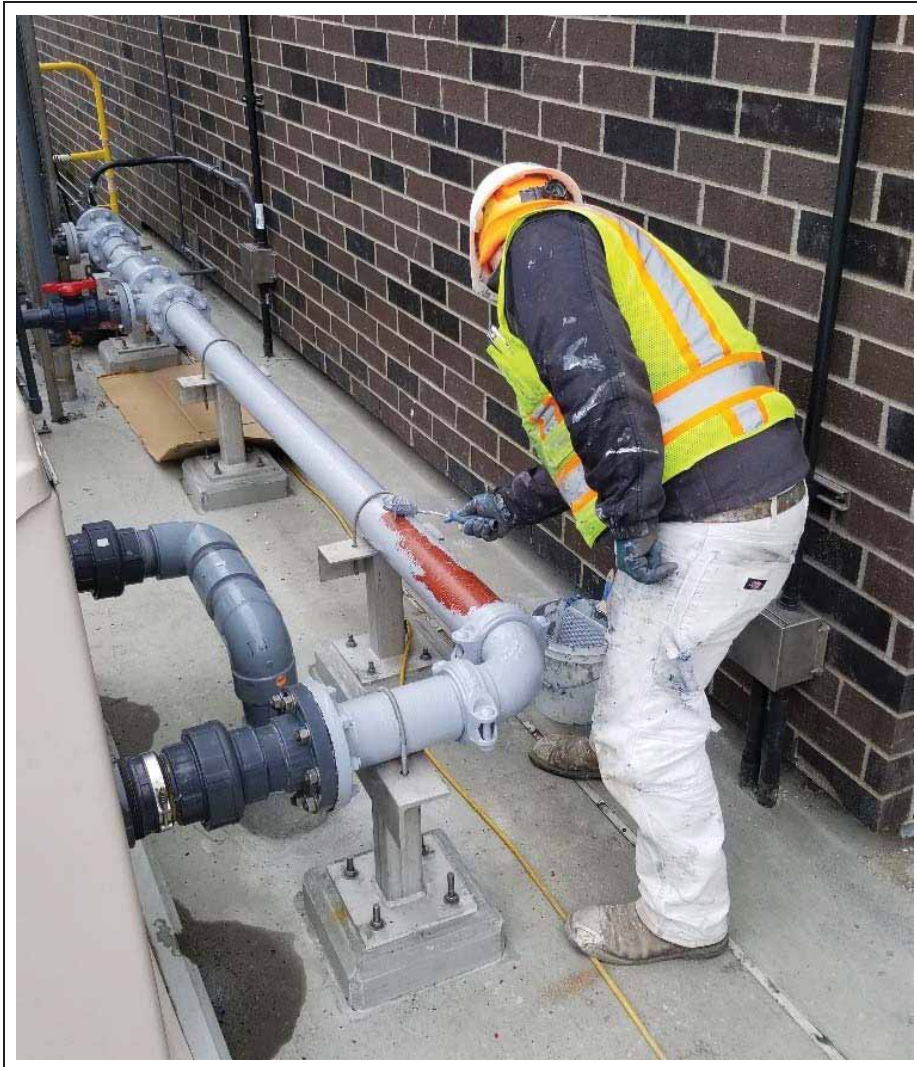
Photo #39

A painter for Penington  
Painting Company is  
painting utility water  
piping atop the odor  
control structure (next to  
the headworks building).

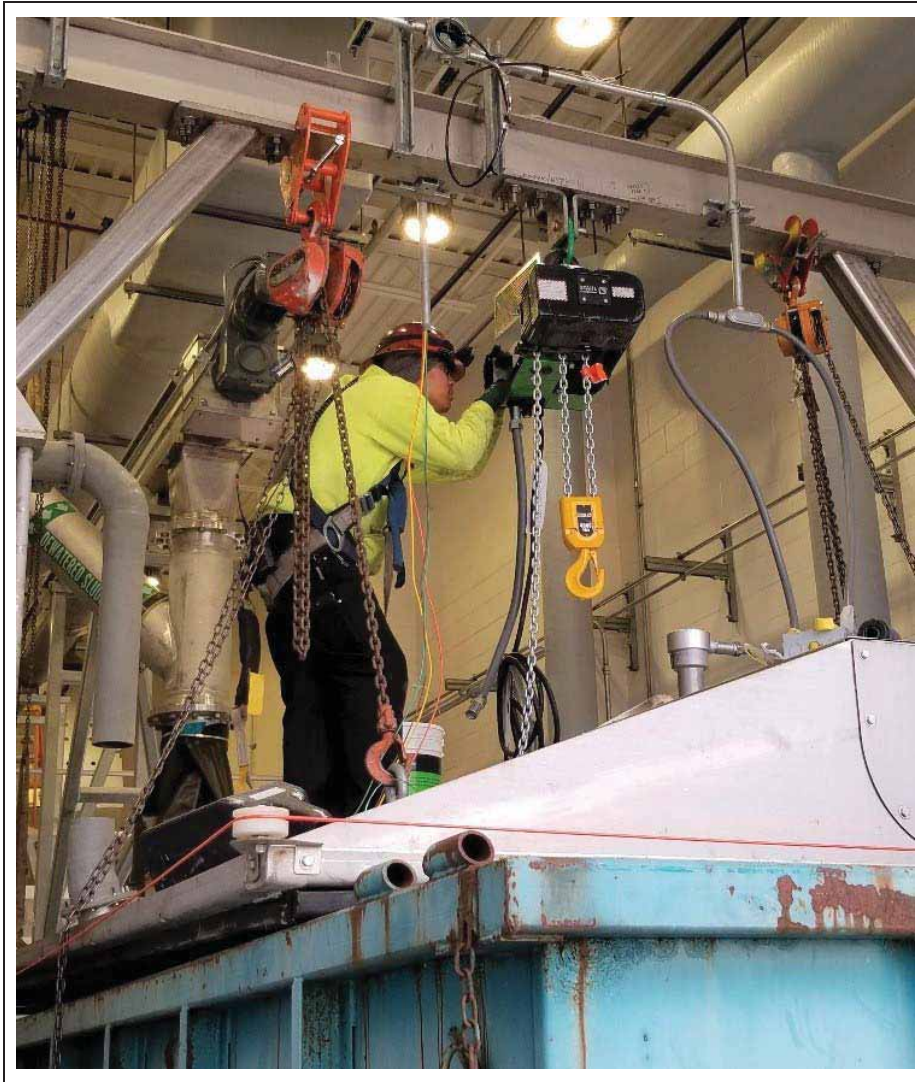
Photo #40

An electrician for Valley  
Electric is terminating  
conductors at a bin cover  
hoist.

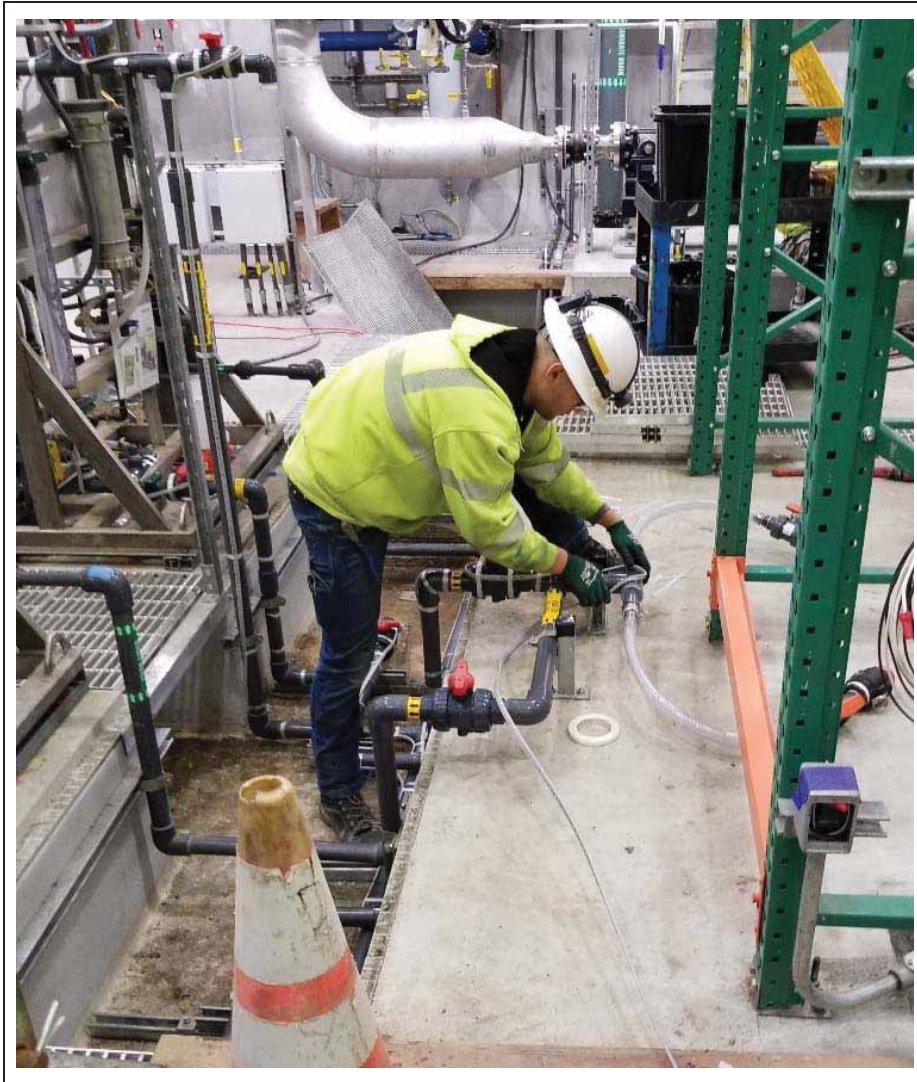
Photo #41

An electrician for Valley  
Electric is attaching heat  
trace conductors to  
polymer piping.

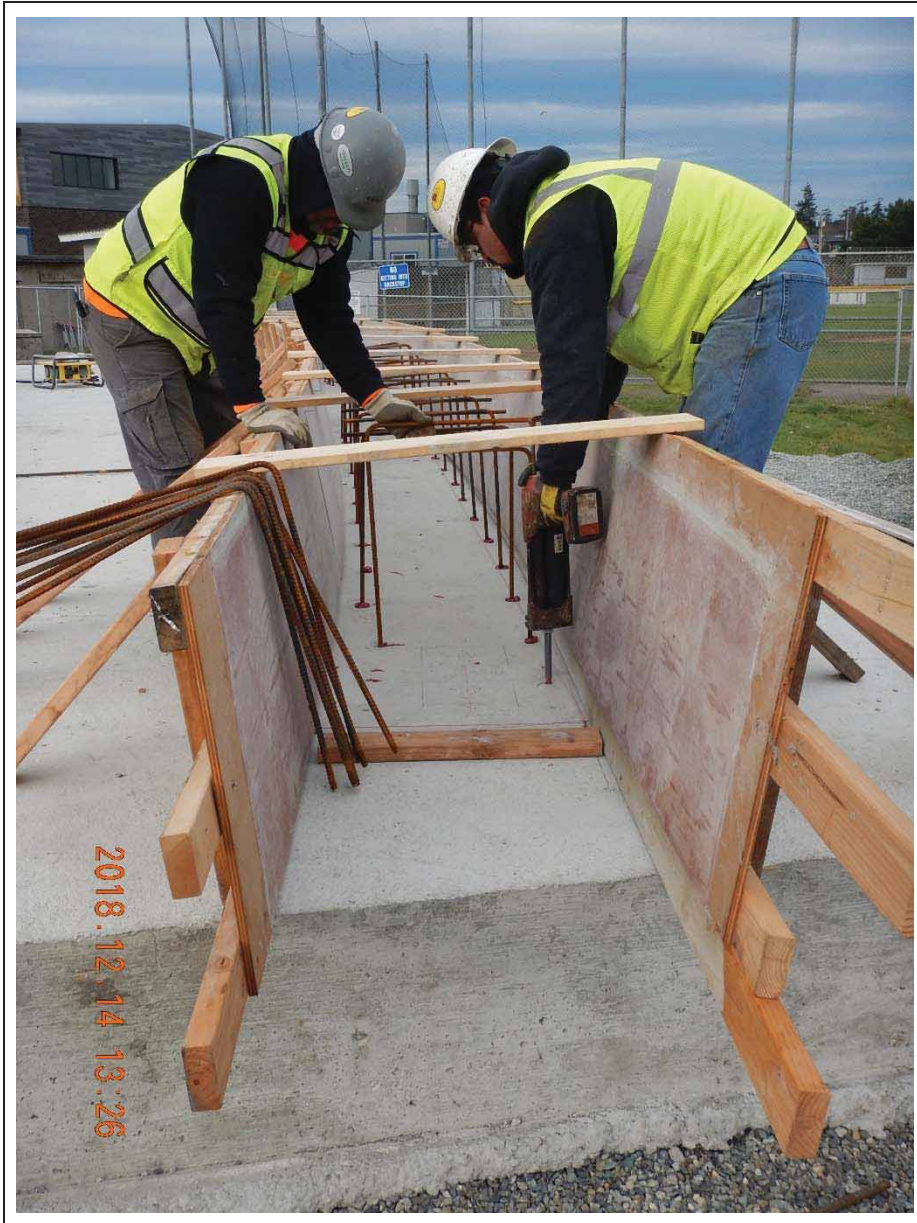
Photo #42

Two carpenters for LangCo NW are installing reinforcing steel for a seat wall by means of drilled holes and epoxy.

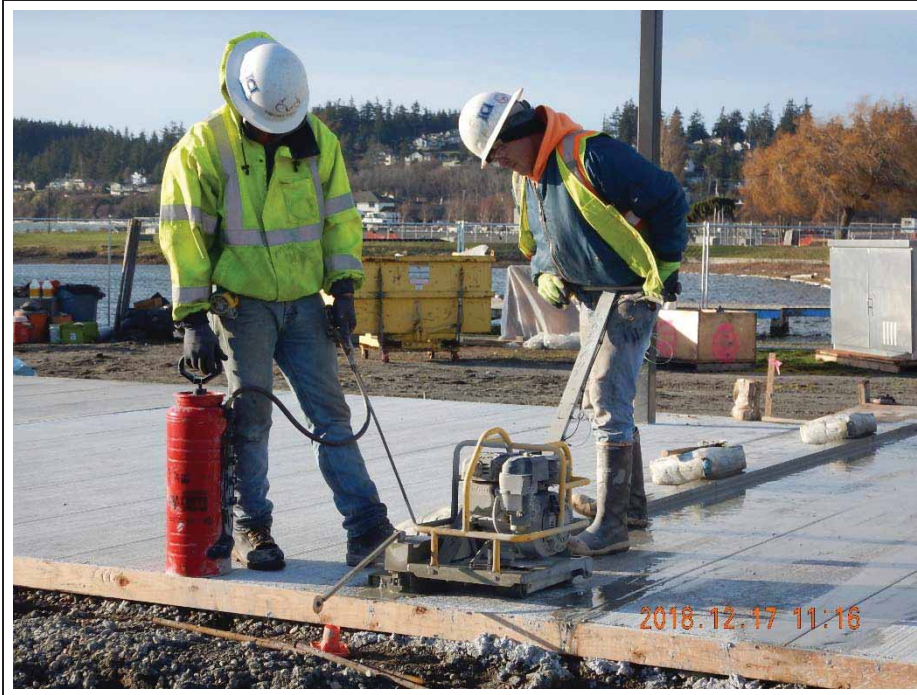
Photo #43

Carpenters for Interwest Construction are utilizing a gas-powered saw to cut contraction joints in a pedestrian walkway.

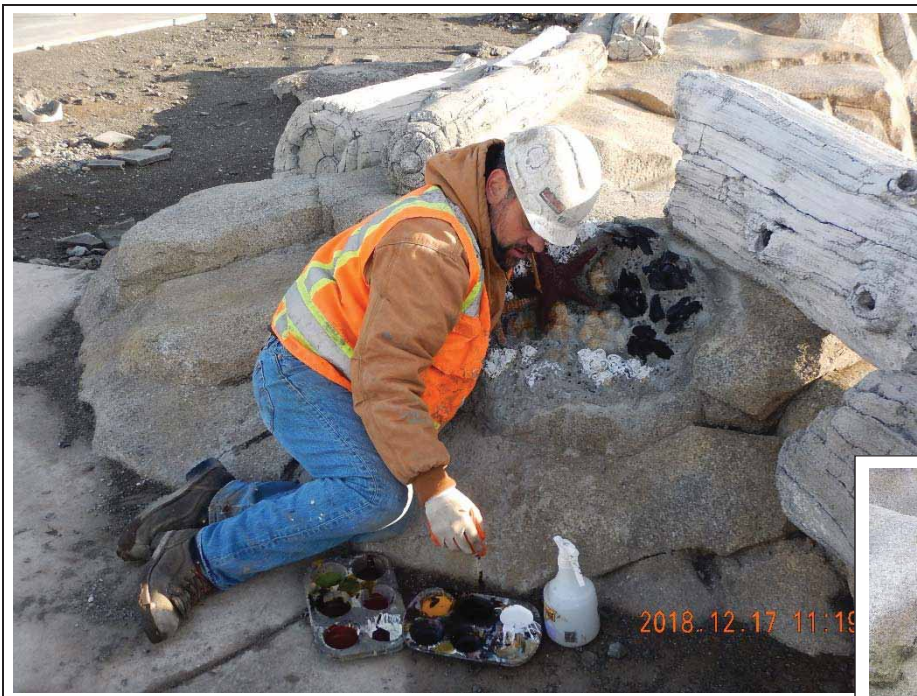
Photo #44

South end of Windjammer Park (looking east at the south end of a splash park) on Monday, December 17<sup>th</sup>.

A carpenter for Turnstone Construction is painting faux starfish and barnacles.

**GMPA No. 13 – Windjammer Park Improvements.** Work on this portion of GMPA No. 13 is approximately 55% complete (see Photo #1). Interwest Construction placed concrete for seat steps at the pavilion (see Photo #5) and placed concrete for a mow strip along the seat steps. Interwest Construction continued to build formwork and place concrete for sidewalks, walkways, and seat walls at the west and north ends of the park (see Photos #15, #34, and #49). Interwest Construction began placing concrete for a pedestrian walkway that runs in a north-south direction between Pioneer Way and Oak Harbor Bay (see Photos #20, #26, #30, and #43). Interwest Construction built forms and placed reinforcing steel and concrete for a planter box located adjacent to the west side of the west kitchen. Interwest Construction graded on-site earthen material east of the splash park and along the southwest border of Windjammer Park. Two pre-assembled stainless steel restrooms, known as Portland Loos, arrived on site during the week of December 10<sup>th</sup> (see Photo #33). Interwest Construction installed utility piping and plumbing fixtures and placed concrete to facilitate installation of the Portland Loos (see Photo #65). Pacific Earth Works installed irrigation piping and topsoil at the southwest corner of the park (southwest of the traffic circle) and around two basketball courts. Pacific Earth Works began installing irrigation piping at an area just east of the west kitchen. Pacific Earth Works placed and graded top soil adjacent to the west side of a stormwater detention pond. Valley Electric continued to install conduit, conductors, fiberglass light posts, and precast concrete lamp bases throughout the park (see Photo #32). Valley Electric installed ground rods for the western most Portland Loos (see Photo #59) and installed electrical conduits within formwork for shear walls at the pavilion. P&L General Contractors began to install glulam beams and columns at the west kitchen (see Photos #55 and #57). P&L General Contractor's subcontractor, LangCo NW, built forms and placed reinforcing steel and concrete for seat walls at the west kitchen (see Photo #18) and at the east kitchen (see Photo #42). LangCo NW also placed concrete for portions of a 4-inch topping slab at both the west and east kitchens. LangCo NW and Morse Steel Services built formwork and placing reinforcing steel, respectively, for two shear walls for a pavilion (see Photo #14). LangCo NW placed concrete for the shear walls (see Photos #21, #37, and #58). Turnstone Construction finished placing and sculping concrete for faux rocks and logs at the splash park and at the shipwreck water feature. Turnstone Construction finished painting the rocks and logs to make them look more realistic (see Photos #16, #31, and #44). Turnstone Construction pressure washed the splash park.

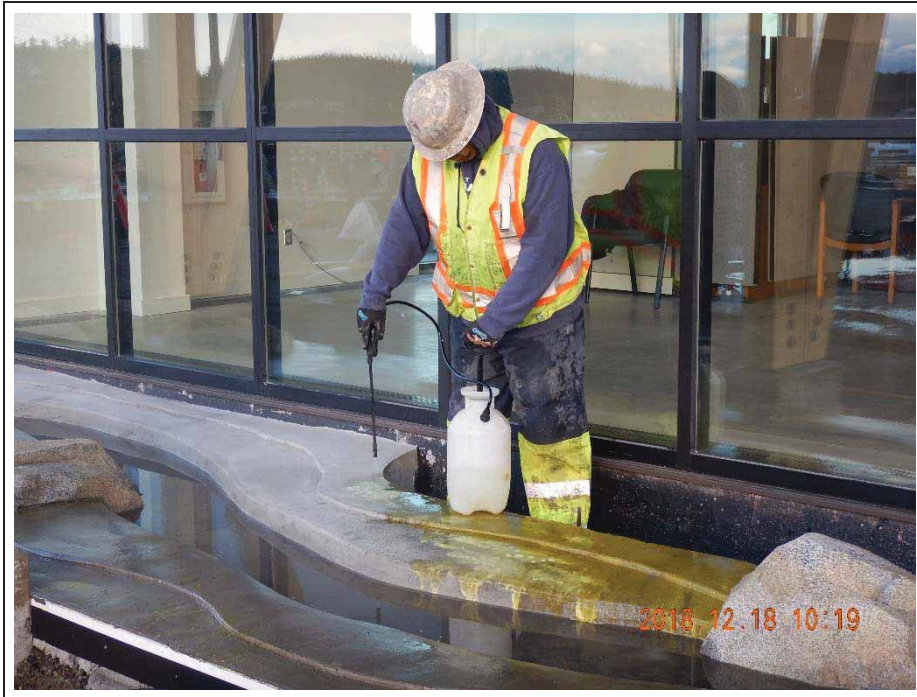
Photo #45

A carpenter for Turnstone Construction is spraying muriatic acid on a concrete water feature. The acid removes excess mortar and further exposes aggregate.

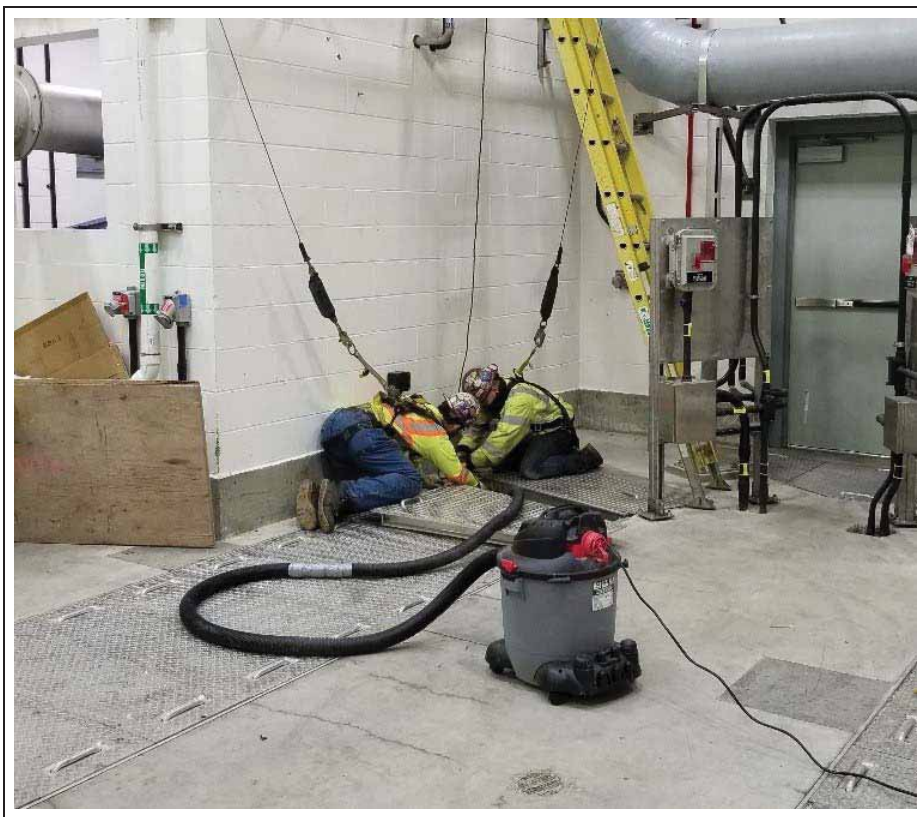
Photo #46

Two ironworkers for Steelkorr are installing aluminum tread plates atop a course screen channel.

**GMPA No. 11 – Superstructure Construction.** Work on this GMPA is approximately 98% complete. Valley Electric and its subcontractor, EZ Interface, continued to install a security and access control system (see Photo #7). EZ Interface installed a battery as part of an uninterrupted power supply for a network panel in the administration building. Pacific Glass was on site to disassemble door and window frames at locations where EZ Interface drilled holes through the frames to facilitate installation of the security and access control system. Honeywell and EC Electric continued to work on the HVAC system in the administration building. D&G Mechanical Insulation wrapped insulation around HVAC piping in the administration building (see Photo #61) and around HVAC ducts at an air handling unit located adjacent to the north side of the administration building. Painters for Penington Painting Company (Penington) painted utility water lines, roof joists, and a monorail beam in the headworks building. Penington painted utility water piping, UV piping, and other process piping in the secondary treatment building and atop the odor control structure (see Photo #39). Penington painted a hydropneumatic tank adjacent to the north side of the biosolids building and process piping in the biosolids building. Steelkorr continued to work on aluminum tread plates in the headworks building (see Photo #46).

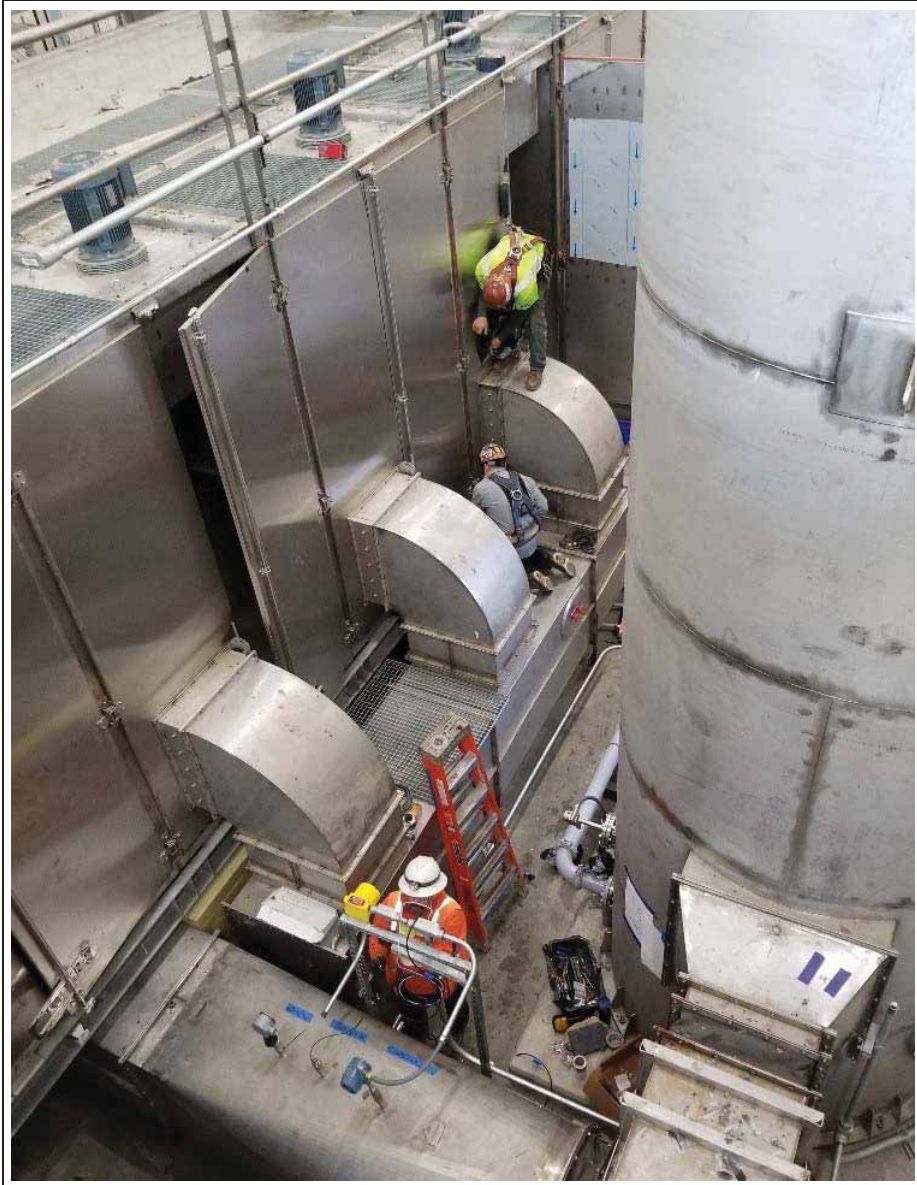
Photo #47

Two pipefitters for  
University Mechanical are  
removing protective film  
from the stainless steel  
dryer (top) and an  
electrician for Valley  
Electric (bottom) is  
terminating conductors for  
an instrument associated  
with an off-gas fan  
(bottom).

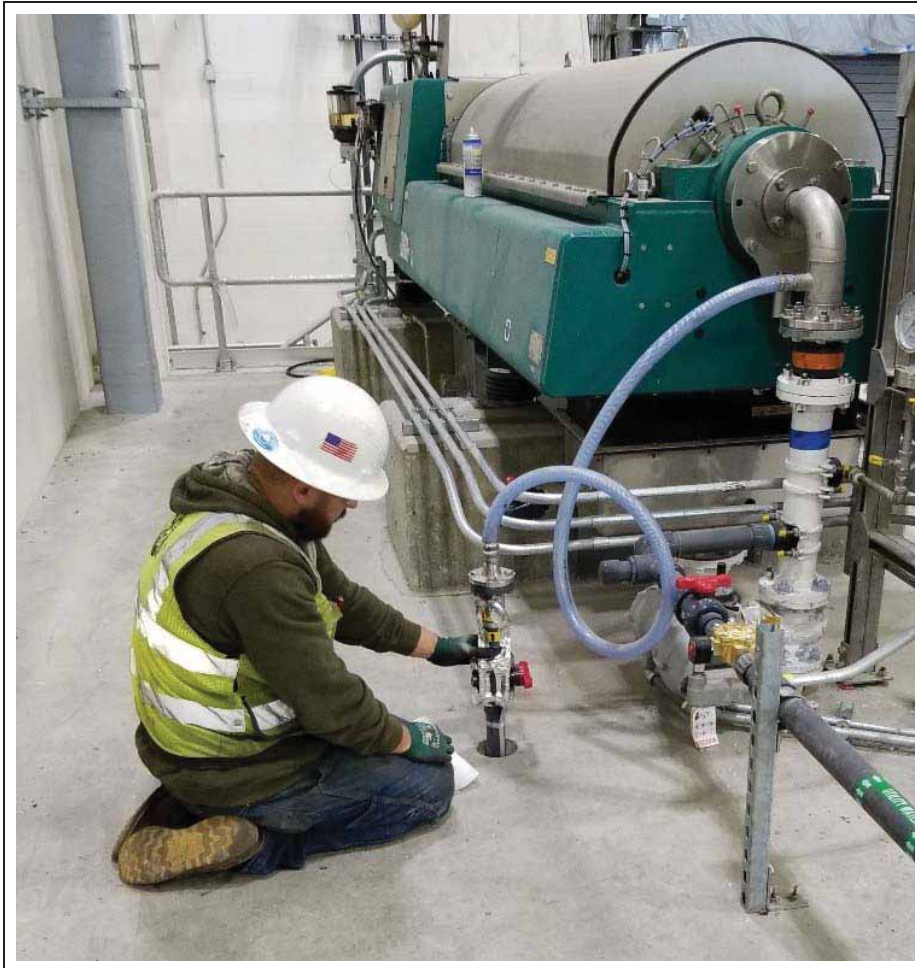
Photo #48

An electrician for Valley Electric is attaching heat tape to a polymer pipe.

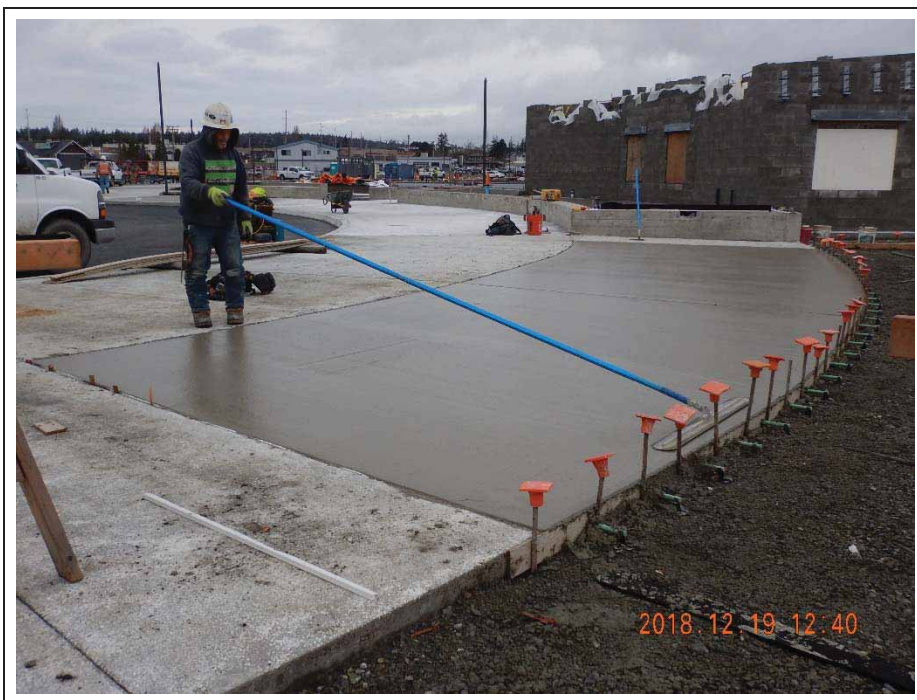
Photo #49

A carpenter for Interwest Construction is utilizing a Fresno trowel to finish concrete for a pedestrian walkway.

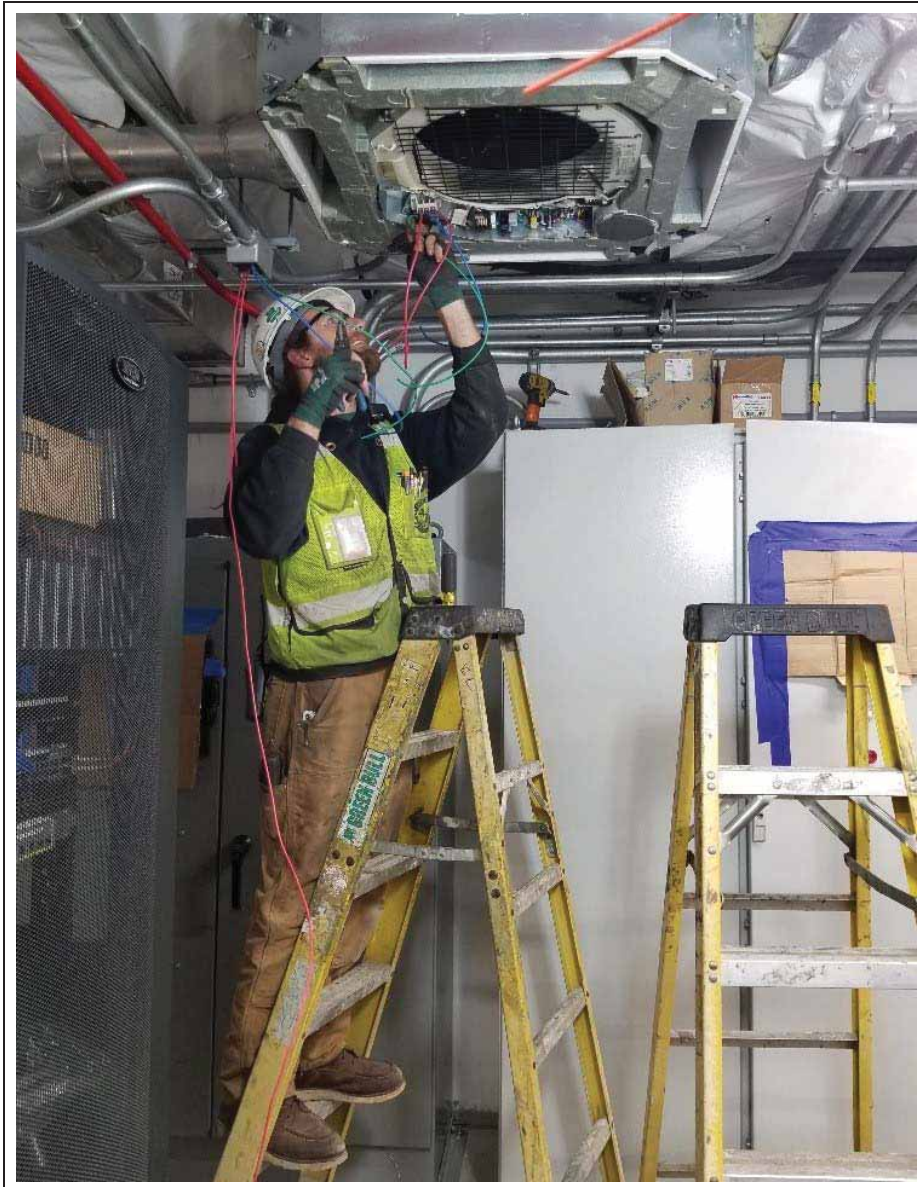
Photo #51

An electrician for Valley  
Electric is terminating  
conductors for an air-  
handling unit.

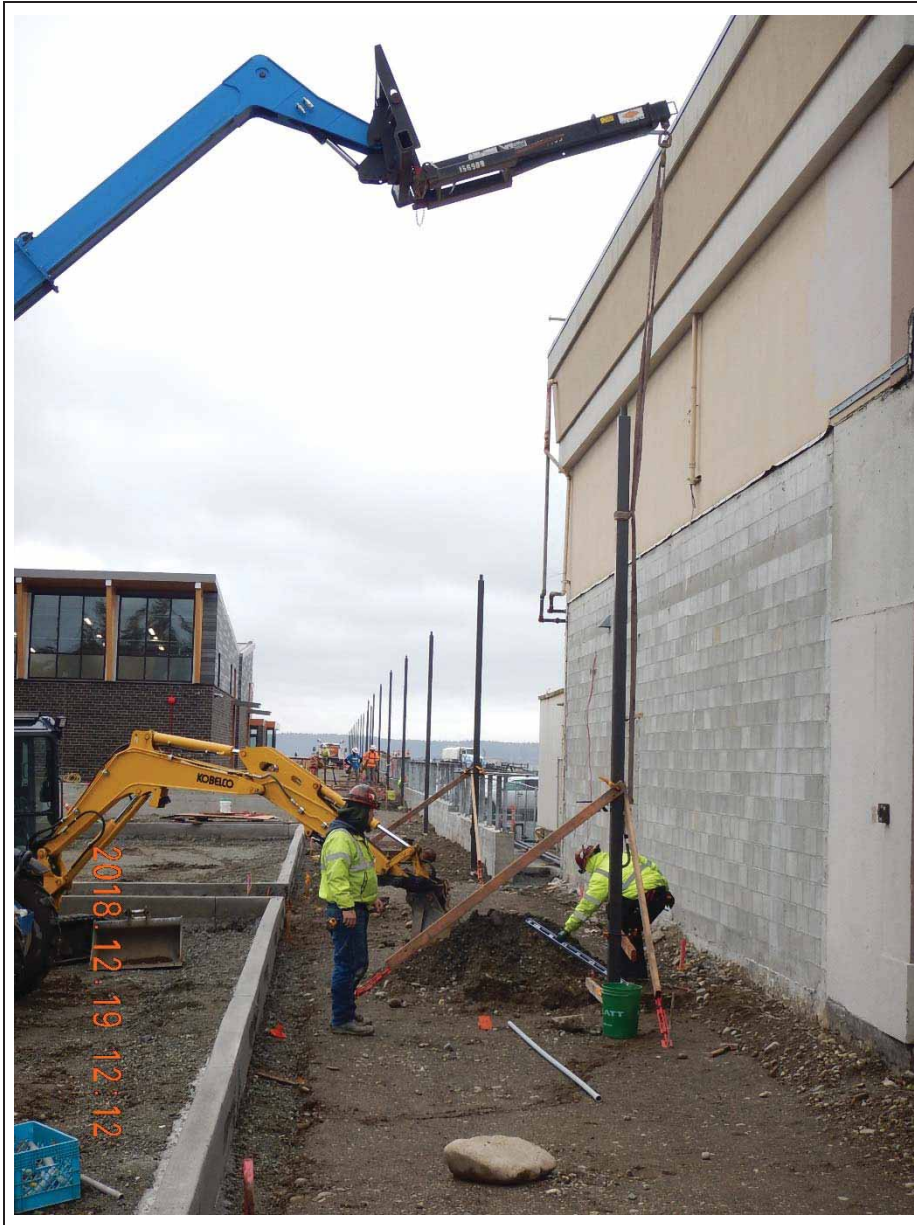
Photo #52

Electricians for Valley Electric are utilizing a telescoping lift to install a fiberglass light pole within a not-yet-constructed pedestrian walkway. The walkway runs in a north-south direction between Pioneer Way and Oak Harbor Bay. The east side of the People's Bank building is seen at right.
