City of Oak Harbor  
City Council Agenda Bill

Bill No. 5. c. i.  
Date: January 15, 2019  
Subject: Clean Water Facility Update

# Clean Water Facility Project

# Monthly Report

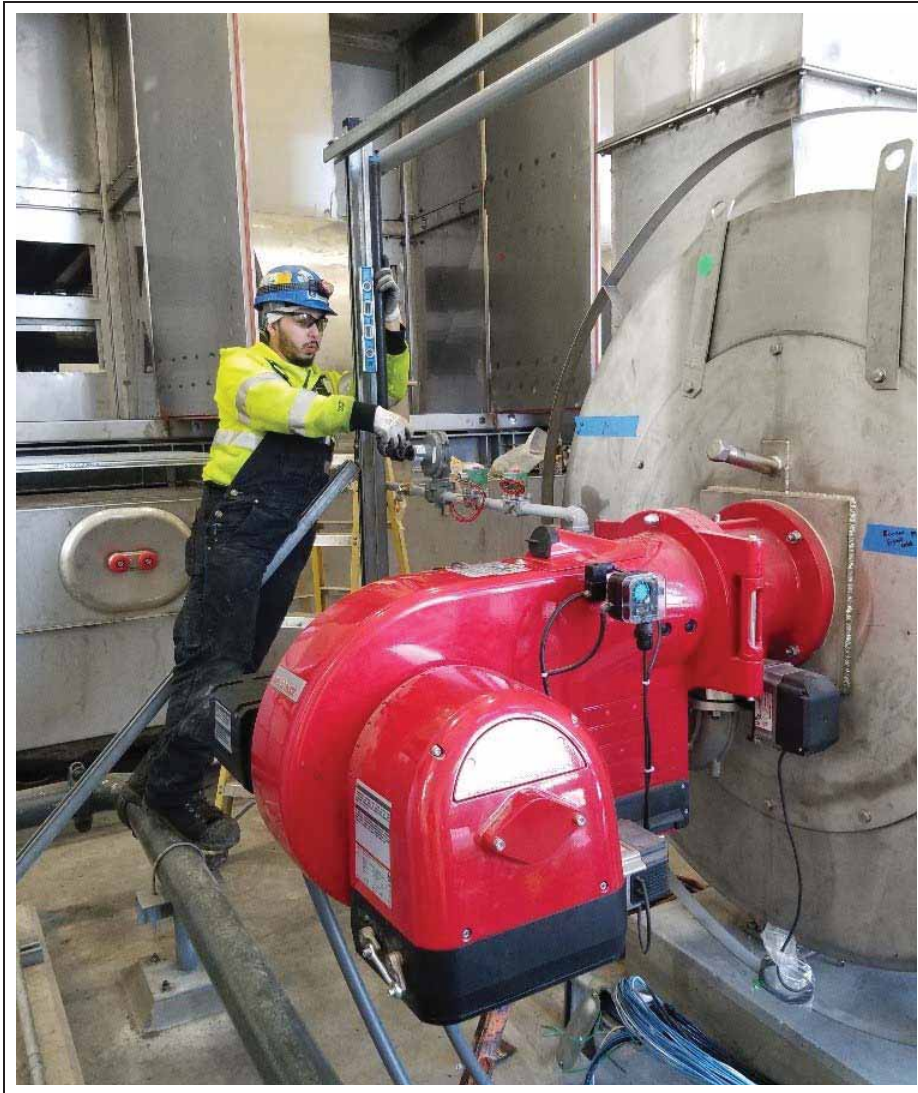
Photo #53

A pipefitter for University  
Mechanical is installing  
ventilation piping  
associated with a natural  
gas regulator at a burner  
plenum.

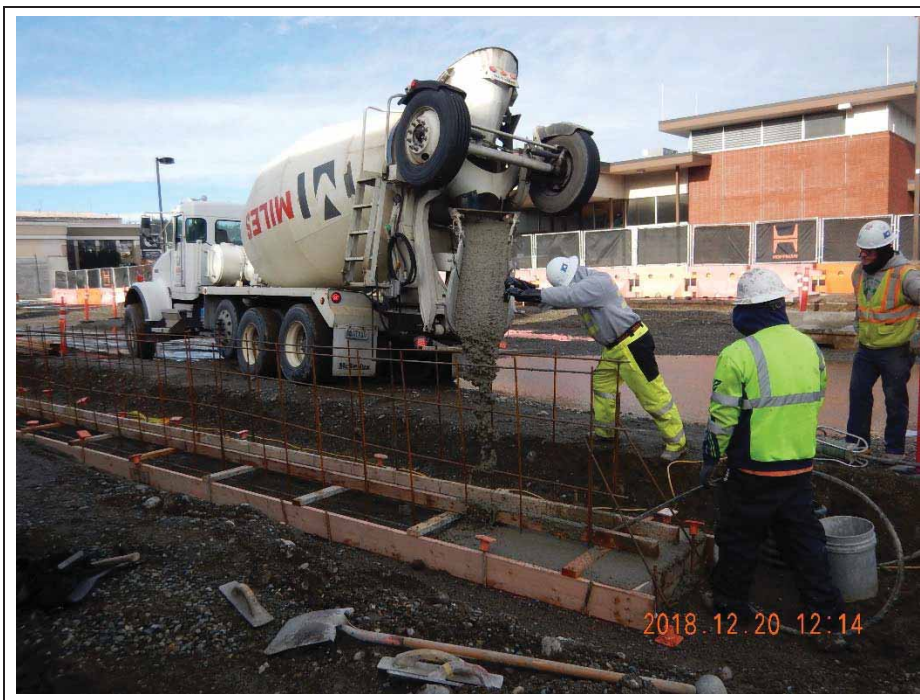
Photo #54

Carpenters for Interwest Construction are placing concrete for a seat wall footing.

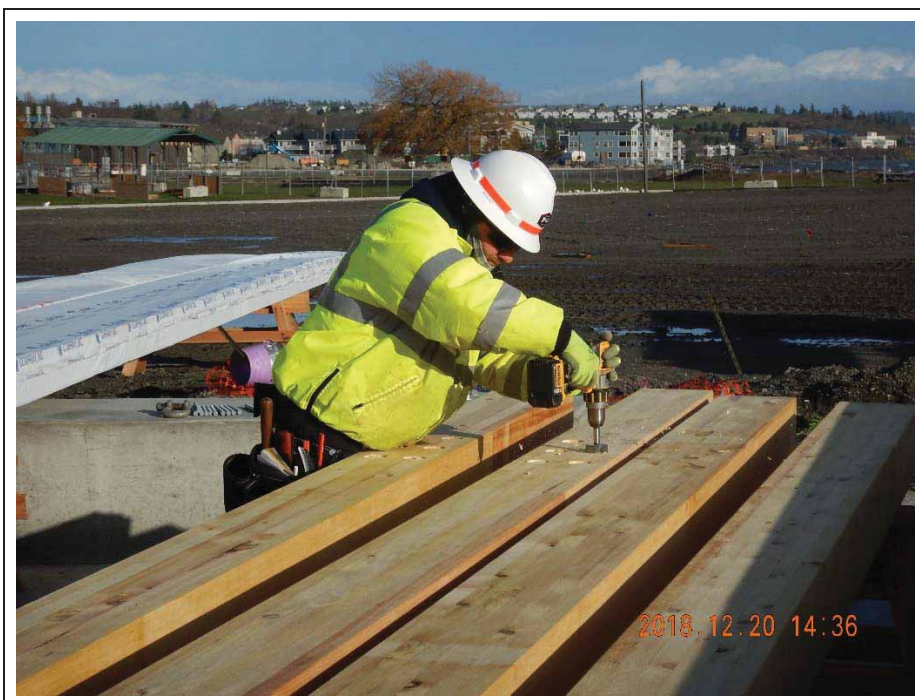
Photo #55

A carpenter for P&L General Contractors is utilizing a battery-powered drill with a special bit to facilitate countersinking bolts in a glulam column.

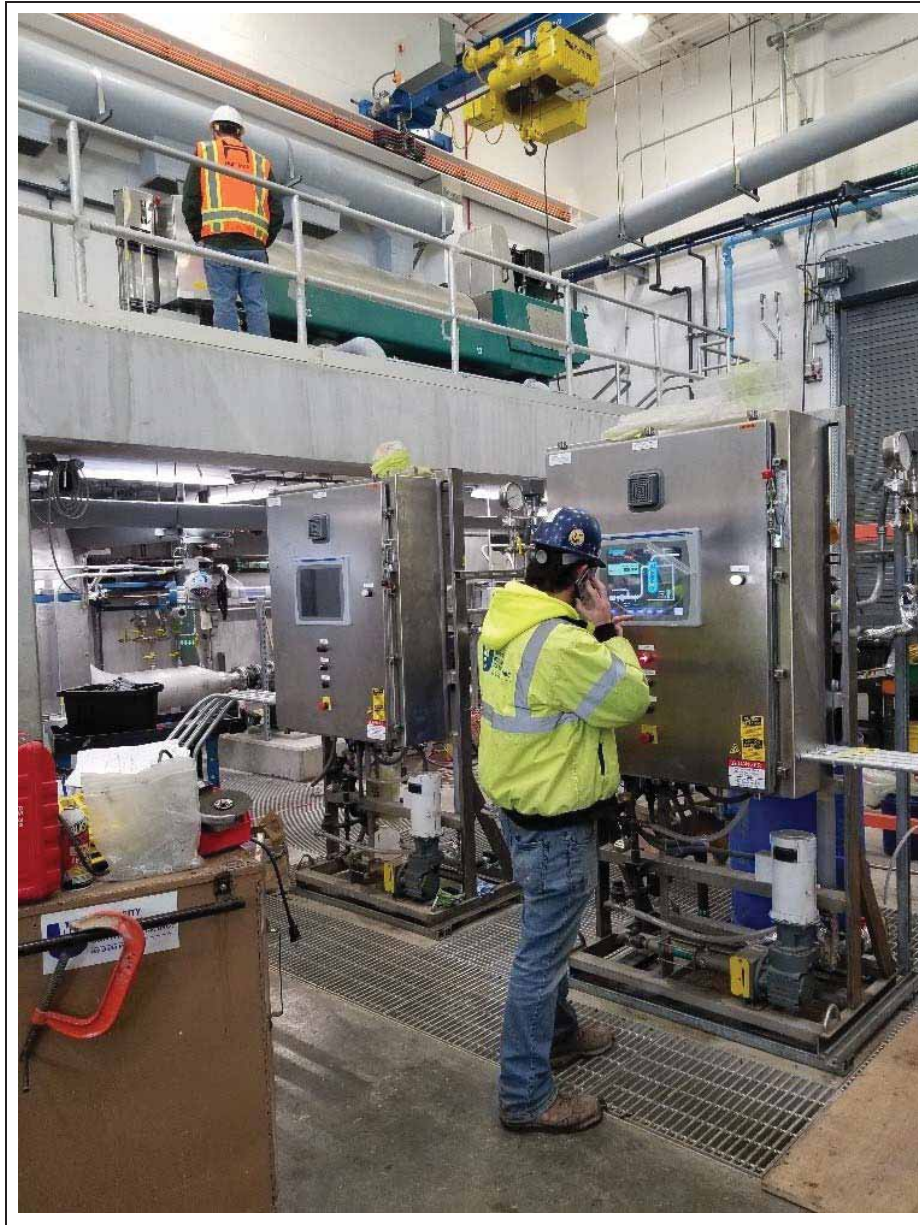
Photo #56

A representative of centrifuge manufacturer DEA, Tom Potter, (top in orange vest) and an engineer for University Mechanical, Joe Alvarez (bottom in yellow jacket) are utilizing control panels to operator a centrifuge and polymer dosing units, respectively.

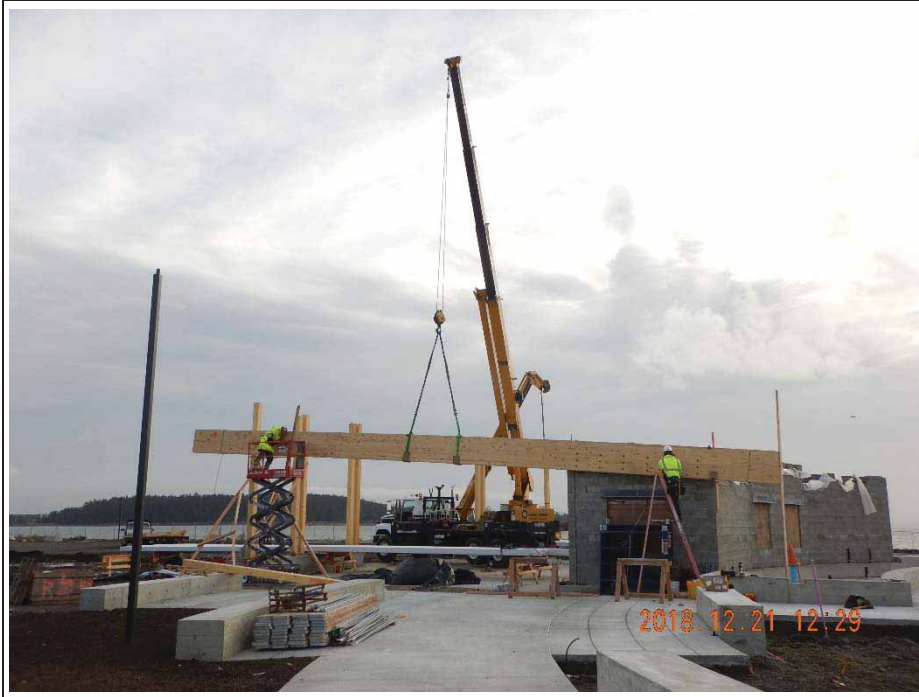
Photo #57

Carpenters for P&L General Contractors are utilizing a mobile crane to lift a glulam beam into place at the west kitchen.

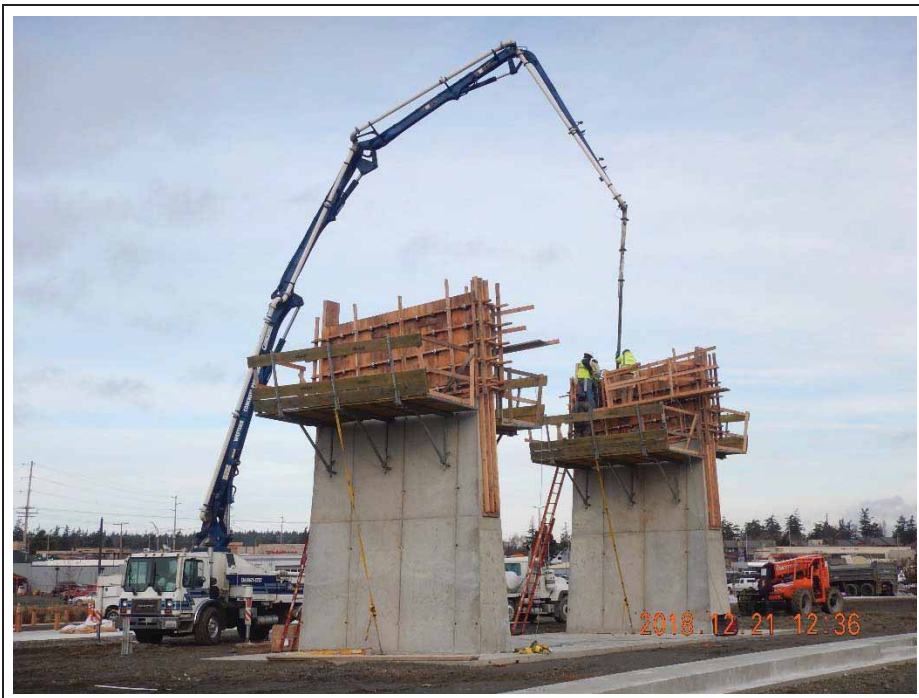
Photo #58

Carpenters for LangCo NW are utilizing a truck-mounted concrete pump to place concrete for the top portions of two shear walls.

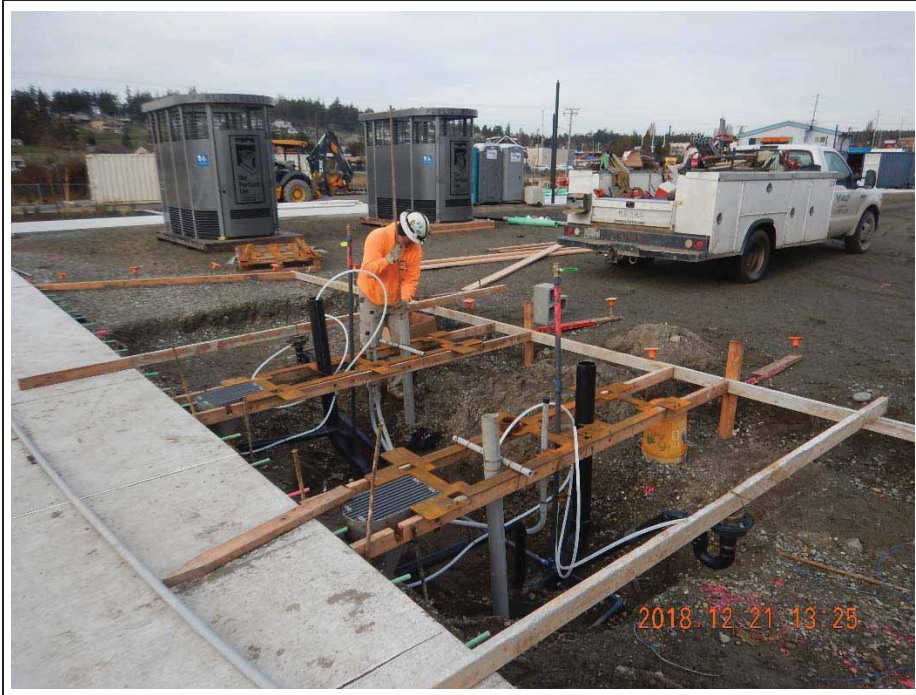
Photo #59

An electrician is installing a  $\frac{3}{4}$ -inch diameter, 10-foot-long bare copper ground rod.

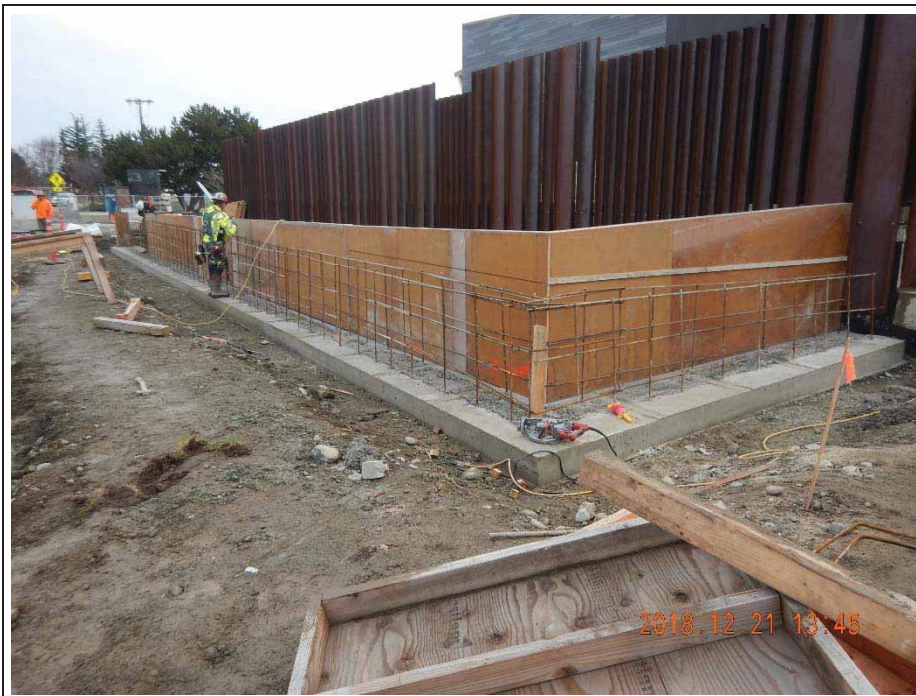
Photo #60

Carpenters for Interwest Construction are placing reinforcing steel and formwork for a seat wall.

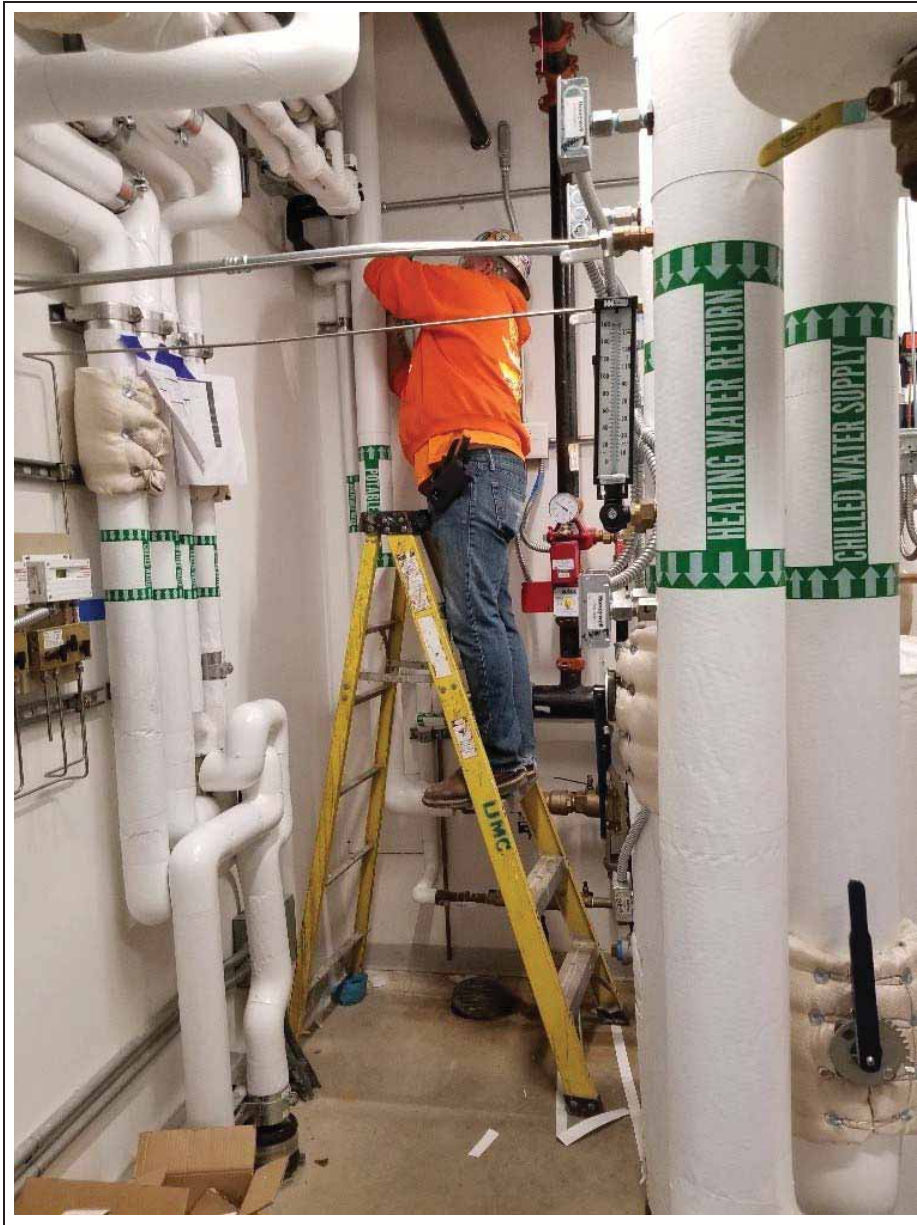
Photo #61

A worker for D&G Insulation is wrapping a potable water pipe with insulation.

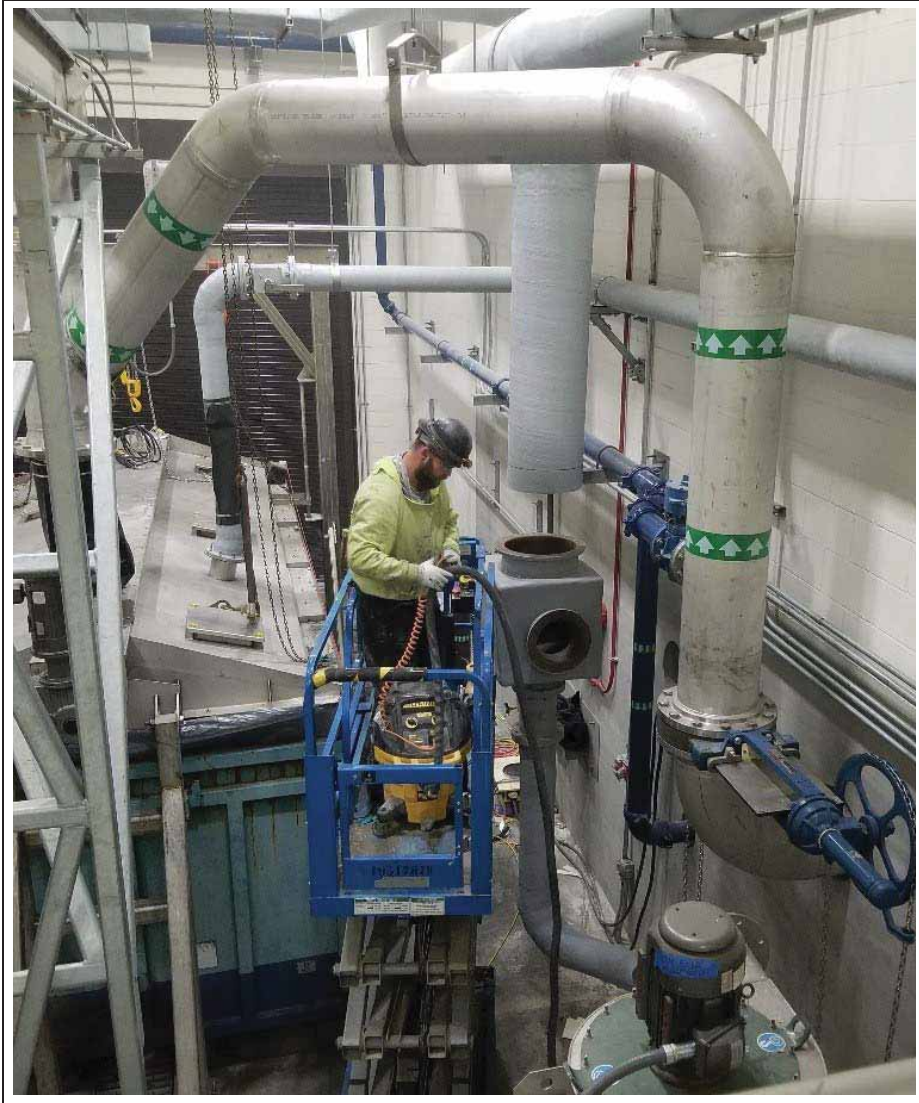
Photo #62

A sheet metal worker for Delta Technology Corporation is installing foul air ductwork for a dust collection system.

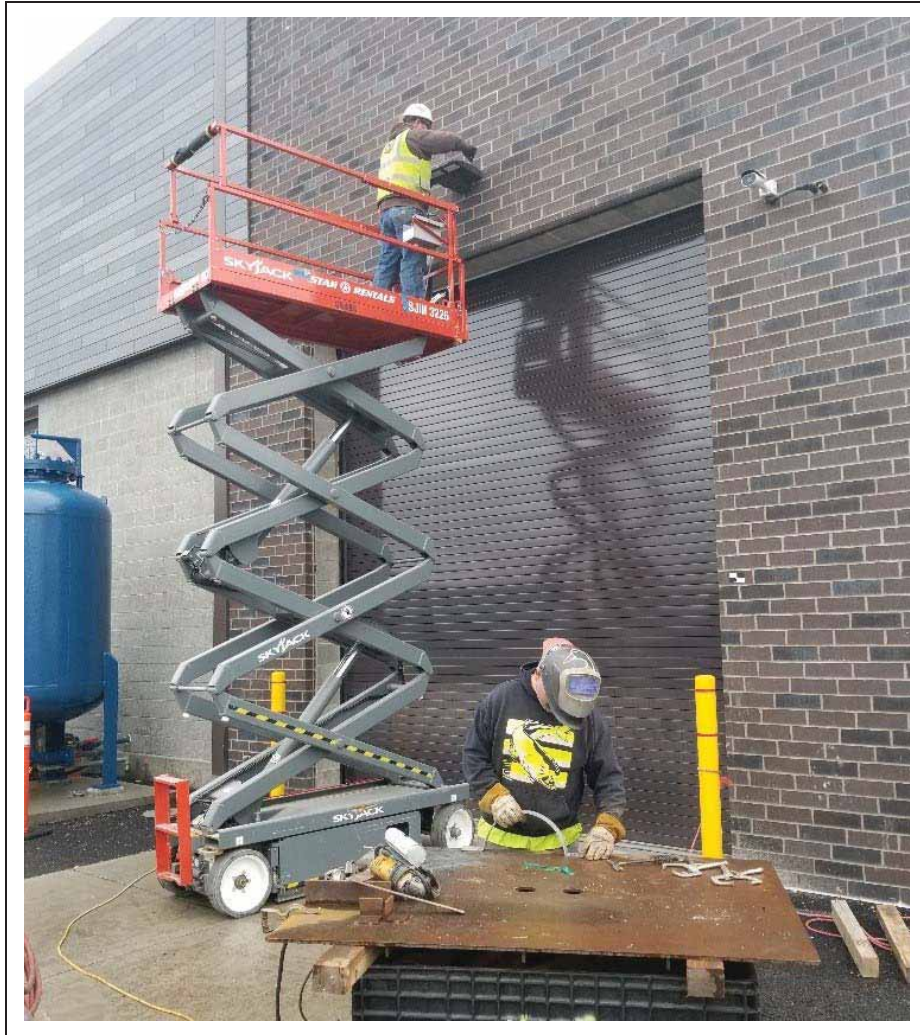
Photo #63

An electrician for Valley  
Electric (top) is installing a  
luminaire above a rollup  
door at the load out area.

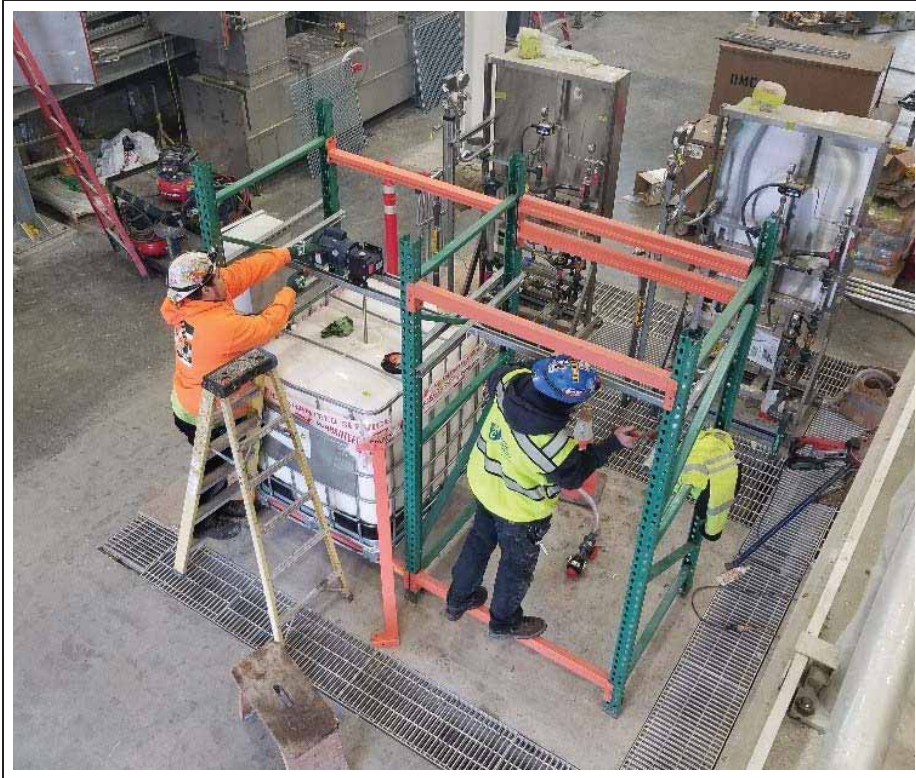
Photo #64

An electrician for Valley Electric (left) and a pipefitter for University Mechanical (right) are working on a polymer tote mixer motor and a polymer tote rack, respectively.

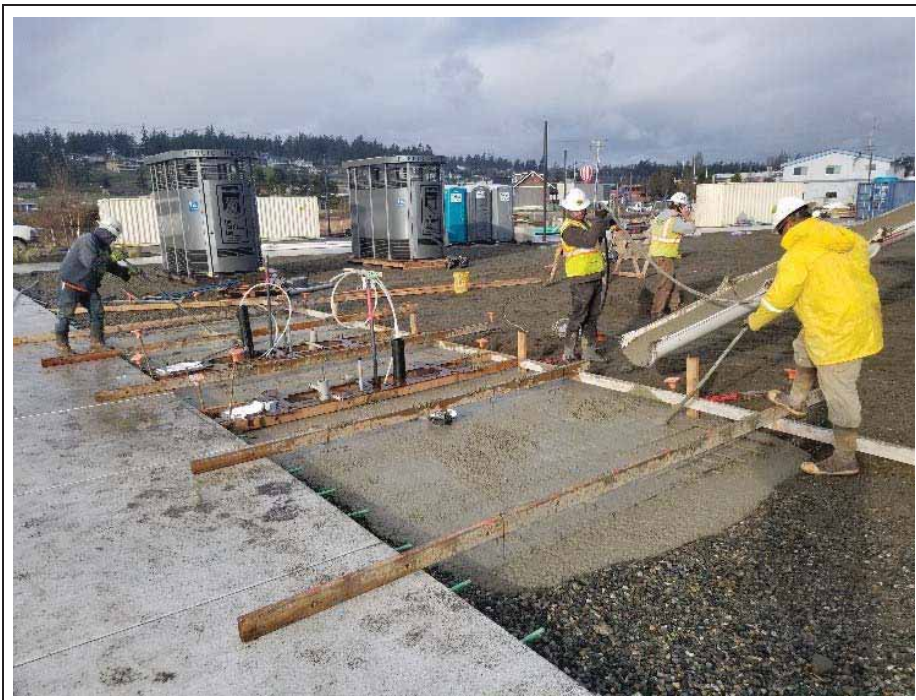
Photo #65

Carpenters for Interwest Construction are placing concrete for a foundation for two Portland Loos (seen in background at left).

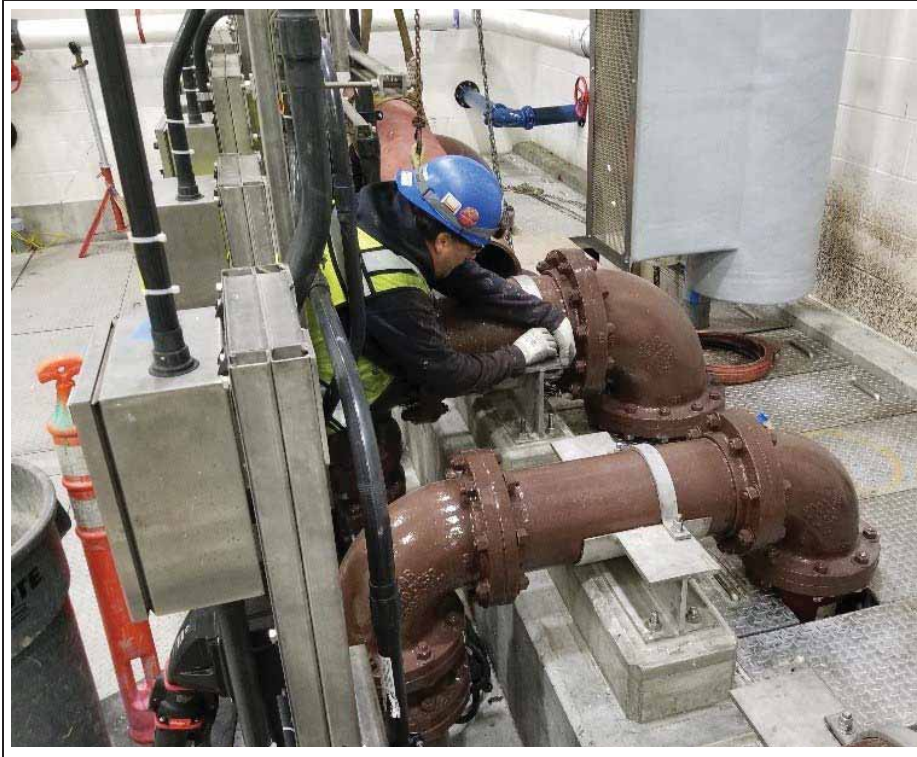
Photo #66

A pipefitter for University Mechanical is installing a pipe strap around a ductile-iron raw sewage discharge pipe.

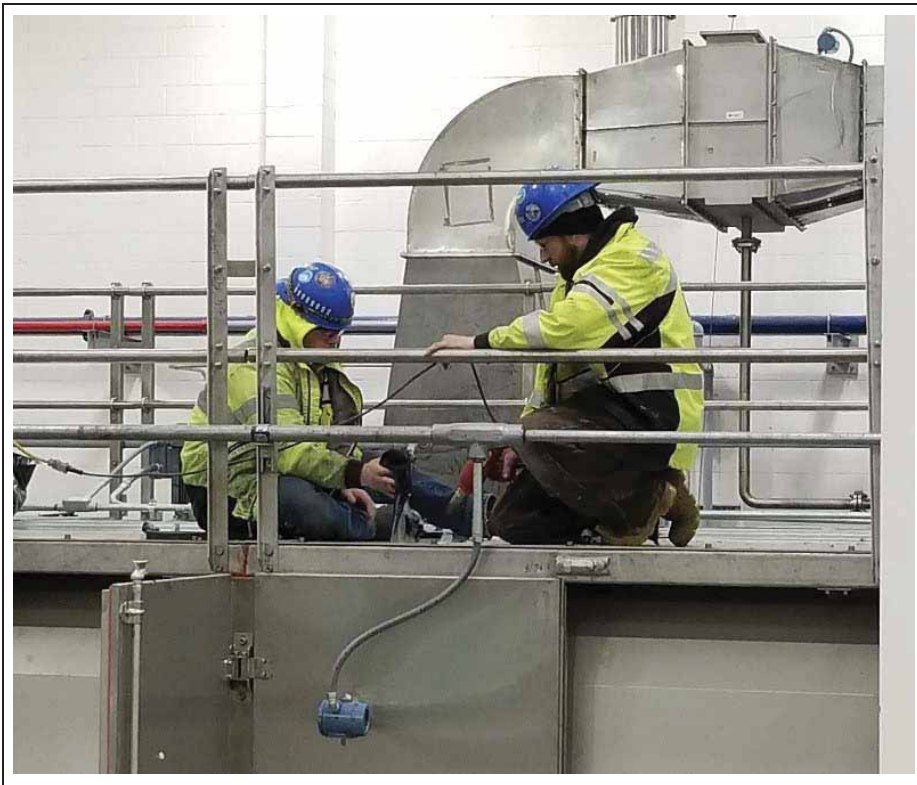
Photo #67

Area 50 Biosolids Building (looking east) on Friday, December 28<sup>th</sup>.
