City of Oak Harbor  
City Council Agenda Bill

Bill No. 5. c. ii.  
Date: October 16, 2018  
Subject: Clean Water Facility Update

# Clean Water Facility Project

**MONTHLY PROGRESS REPORT**

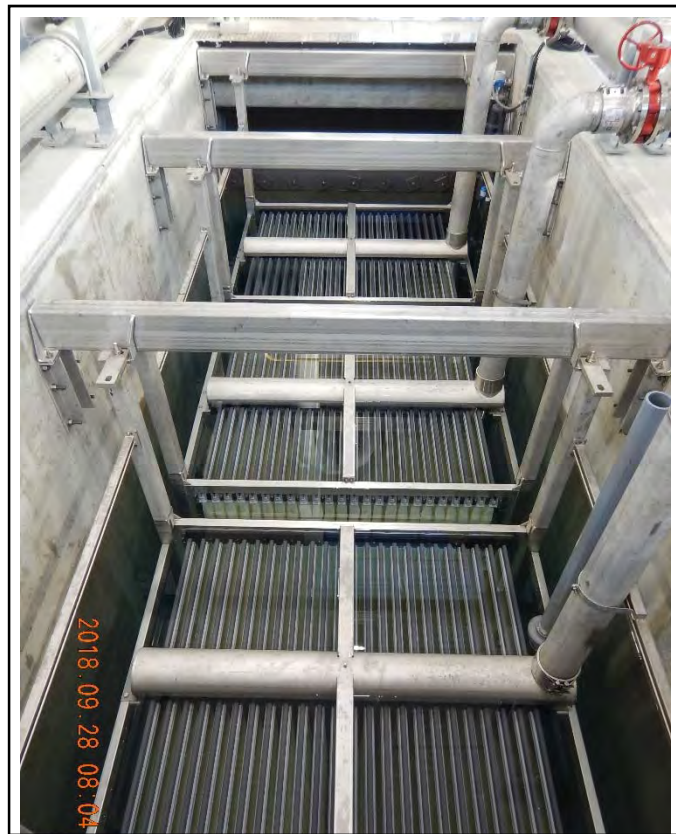
Membrane Cassettes submerged in Potable Water

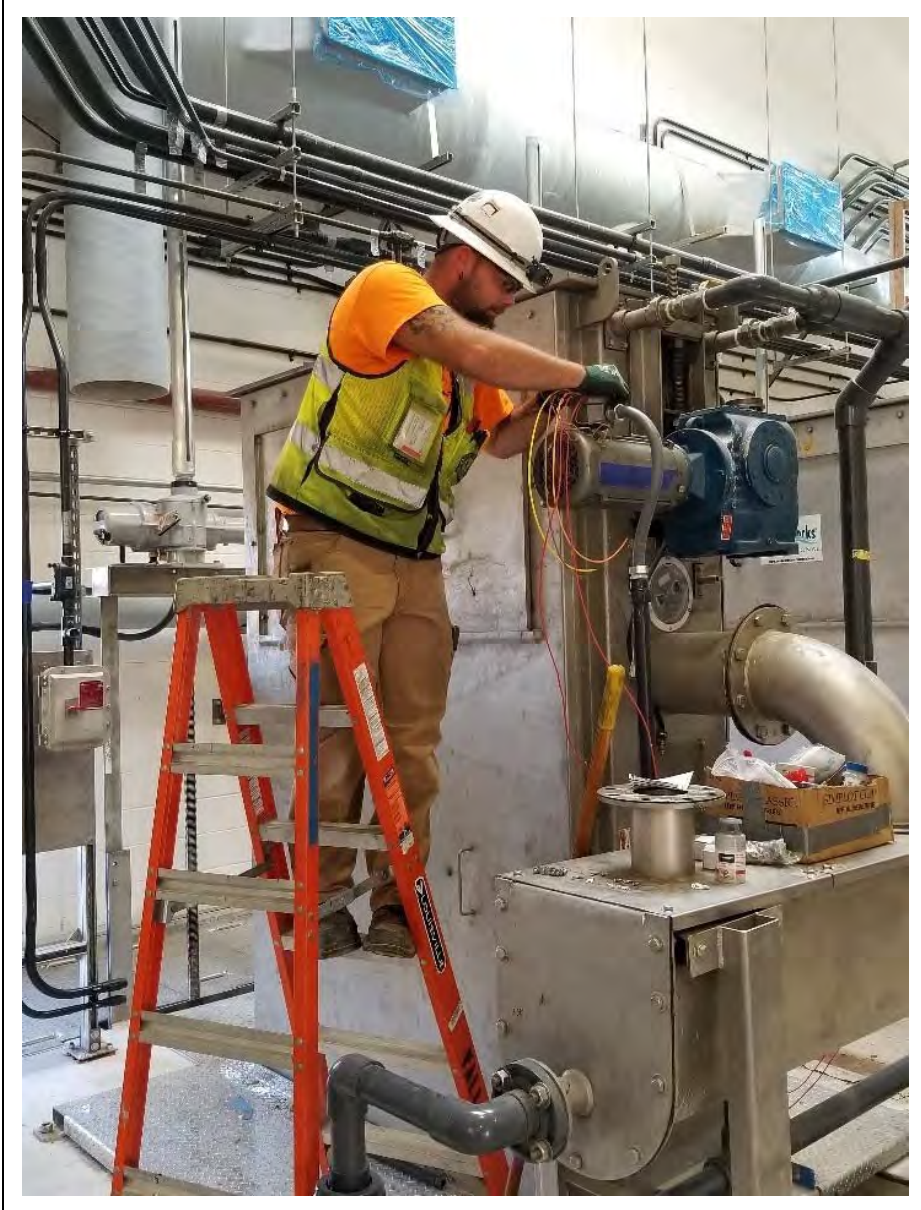
Photo #3

Area 20 Headworks  
(looking northeast) on  
Tuesday, September 4<sup>th</sup>.

An electrician for Valley  
Electric is terminating  
conductors at an electric  
motor for a fine screen.

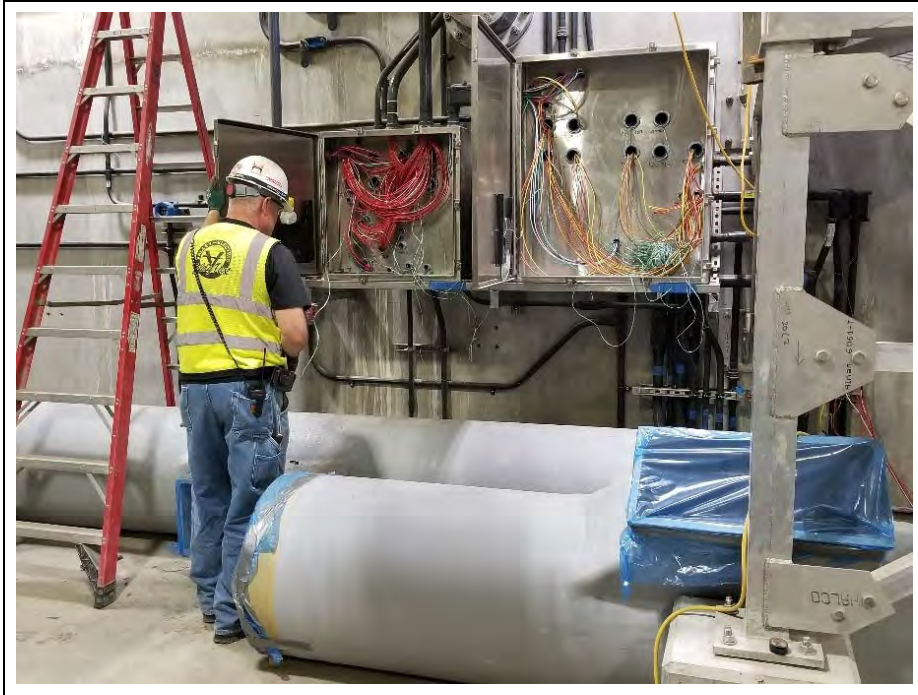
Photo #4

Area 20 Headworks (looking east) in the gallery below the headworks building on Tuesday, September 4<sup>th</sup>.

An electrician for Valley Electric is pulling conductors through junction boxes.

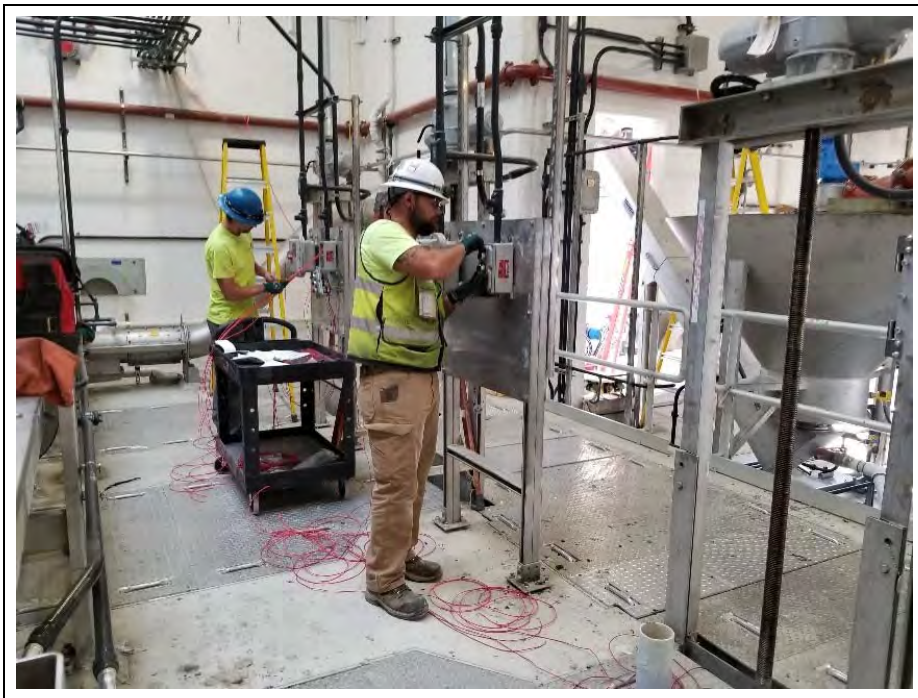
Photo #5

Area 20 Headworks (looking east) on Wednesday, September 5<sup>th</sup>.

Electricians for Valley Electric are installing local control panels for slide gate operators. The slide gates are located on the discharge side of the fine screen channels.

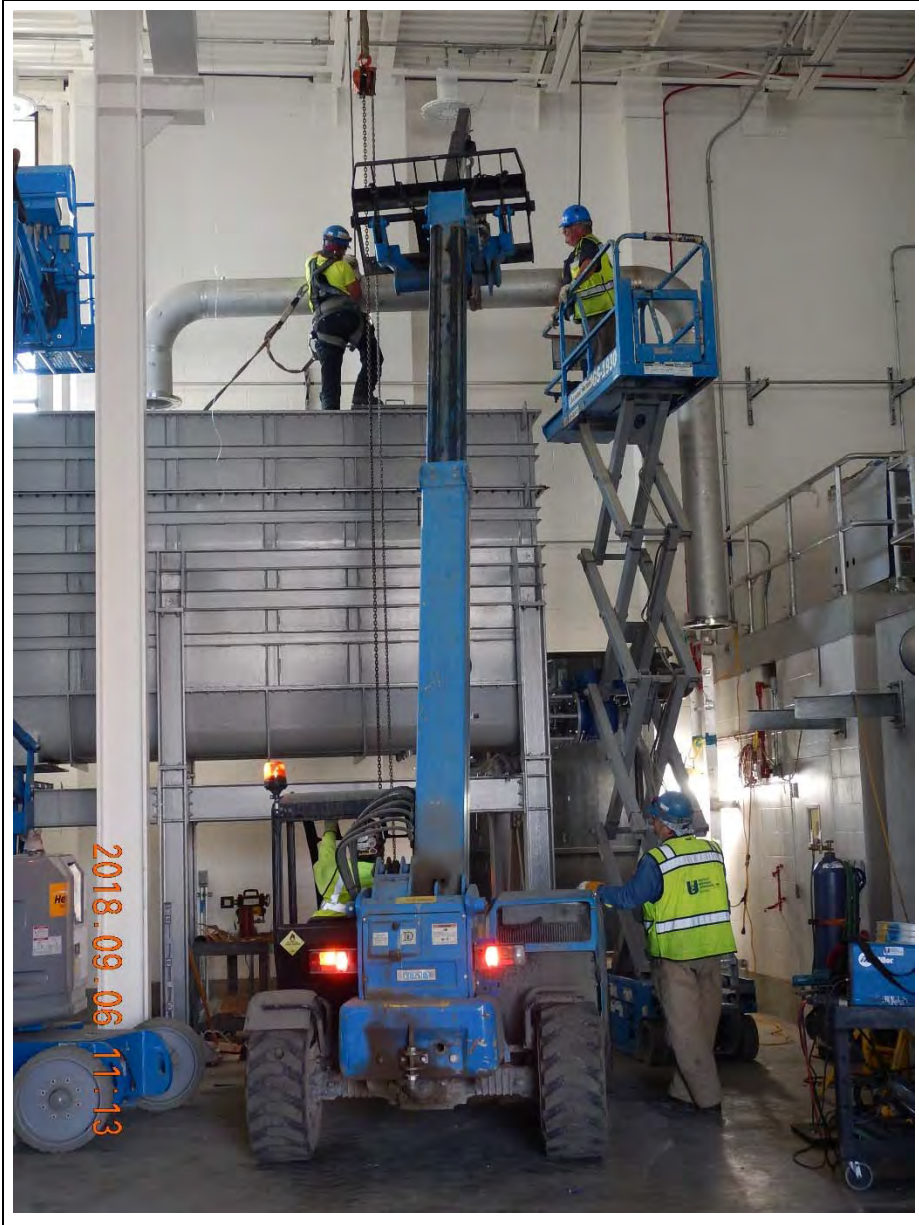
Photo #6

Area 50 Biosolids (looking south) on Thursday, September 6<sup>th</sup>.

Pipefitters for University Mechanical are installing a section of 12-inch stainless steel dewatered sludge piping atop a dryer feed hopper.

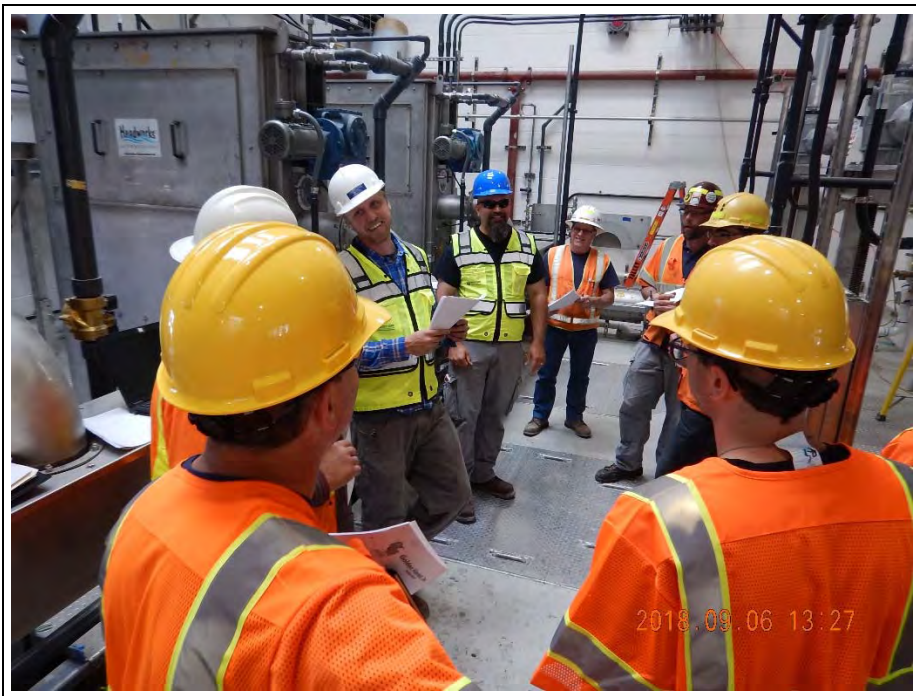
Photo #7

Area 30 Secondary Treatment (looking northwest) on Thursday, September 6<sup>th</sup>.

A field technician for Rotork, Ron Salers (white hardhat), is conducting an operator training class pertaining to motor operated slide gates.

**Start-up Activities.** Several engineers for Suez Water Technologies and Solutions were on site to prepare membrane equipment for start-up (see Photo #13) and facilitate installation of membrane cassettes into membrane tanks (see Photo #31). On September 6<sup>th</sup>, a field technician for Rotork operated electric motor actuators and conducted operator training (see Photo #7), and a representative for Golden Harvest conducted operator training for slide gates (see Photo #8). On September 7<sup>th</sup>, a field service technician for Whitney Equipment Company conducted operator training for raw sewage influent pumps (see Photo #9). On September 27<sup>th</sup>, Huber Technologies and JDV Equipment Corporation representatives conducted operator training classes for a mechanical course screen and screw conveyor, respectively (see Photo #38). On September 28<sup>th</sup>, a technician for TMG Services conducted an operator training class for chemical injection pumps (see Photo #39). Hoffman continued to conduct weekly start-up coordination meetings with its subcontractors and Carollo Engineers.

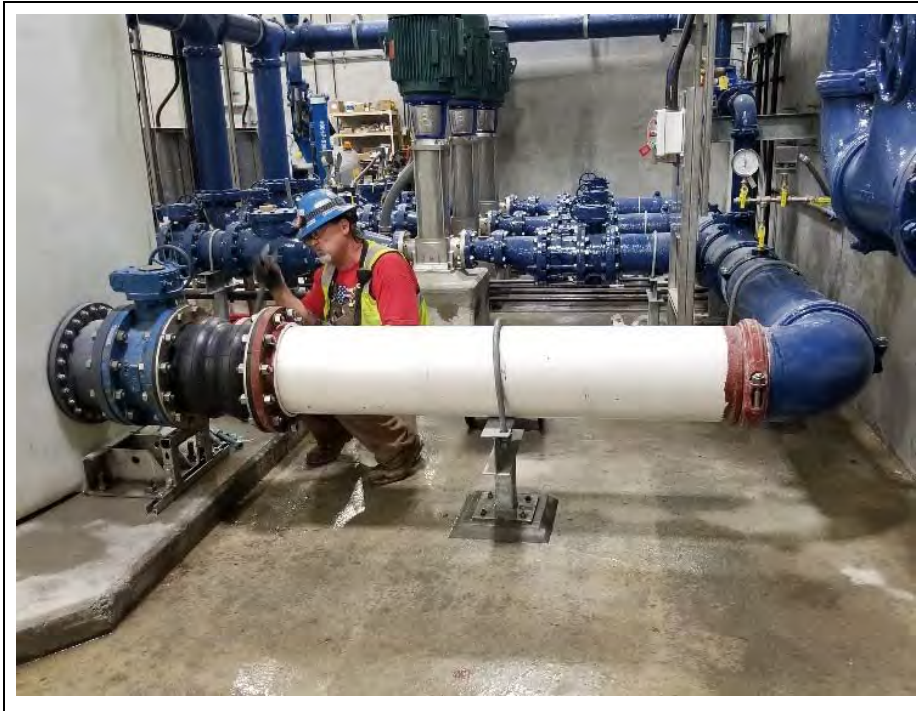
Photo #10

Area 38 Utility Water (looking west) in the gallery under the secondary treatment building on Friday, September 7<sup>th</sup>.

A pipefitter for University Mechanical is installing a flexible joint between a valve and a section of 10-inch ductile-iron utility water piping. A utility water storage tank is left of the valve.

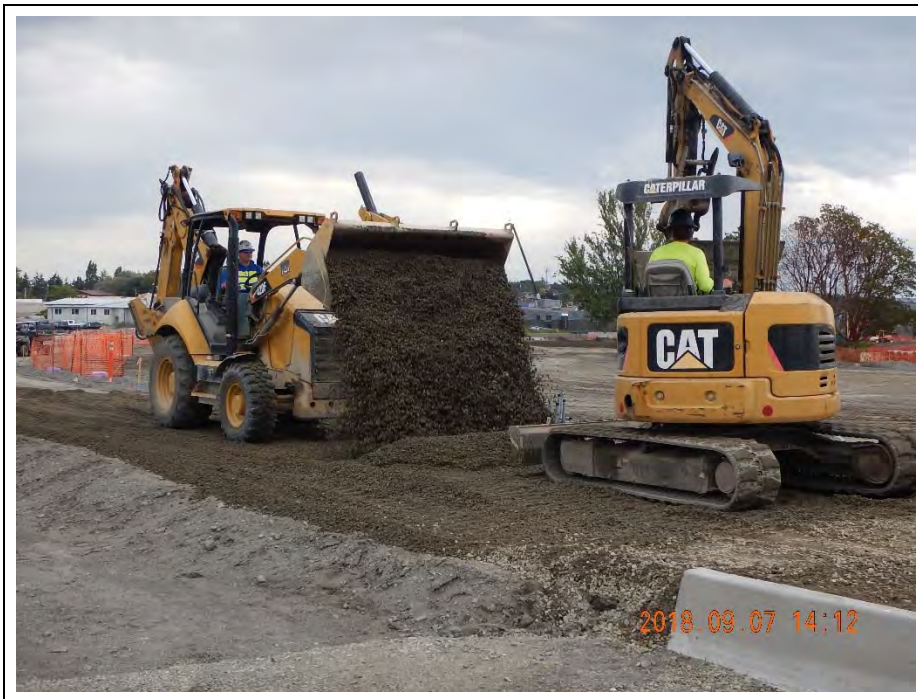
Photo #11

West end of Windjammer Park (looking northeast) on Friday, September 7<sup>th</sup>.

Operators for Interwest Construction are placing crushed rock base for a 10-foot-wide sidewalk that is located next to a parking area.

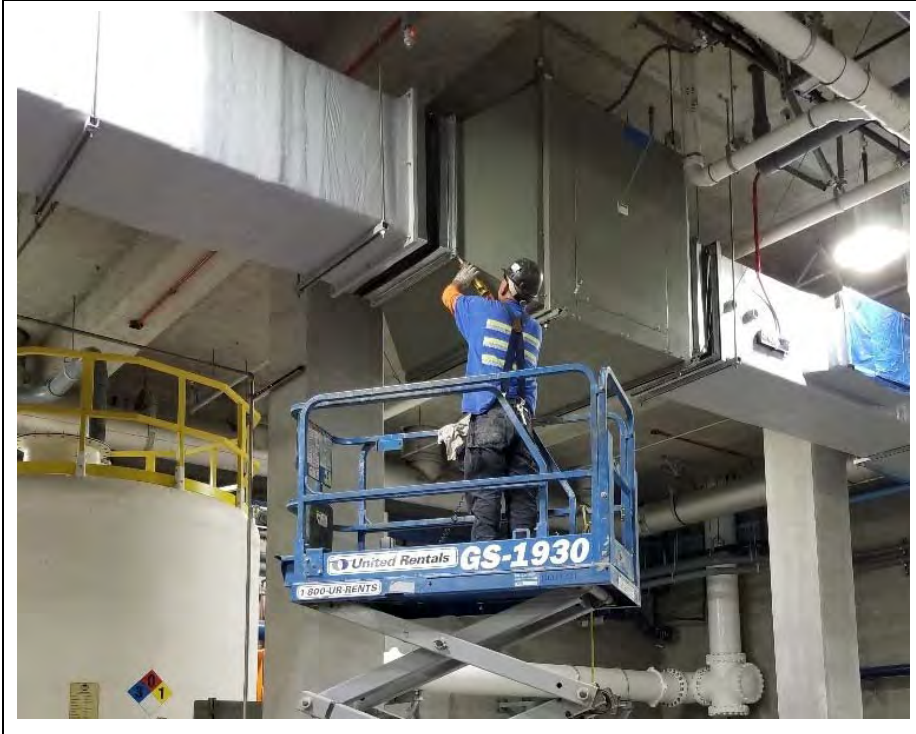
Photo #12

Area 30 Secondary Treatment Building (looking northeast in the gallery) on Tuesday, September 11<sup>th</sup>.

A sheet metal worker for Delta Technology Corporation is caulking a connection between a supply fan and a flexible connector between the fan and a section of fiber reinforced plastic (FRP) duct.

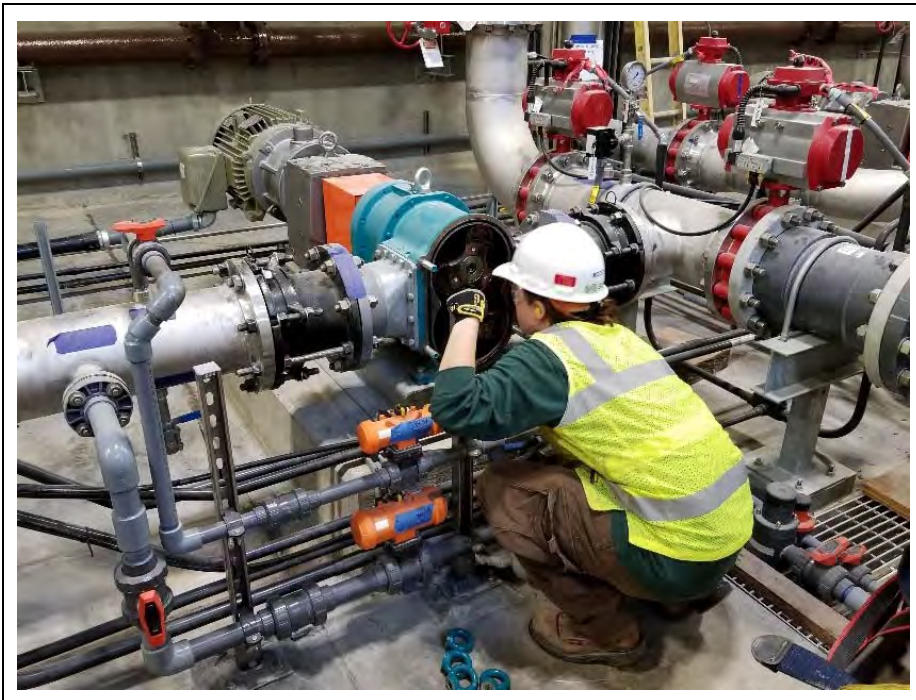
Photo #13

Area 34 membrane Bio-reactor (looking southwest) on Tuesday, September 11<sup>th</sup>.

A commissioning representative for Suez Water Technologies inspects a permeate pump. The permeate pump, when operating, draws wastewater through membrane filters in the membrane tanks.

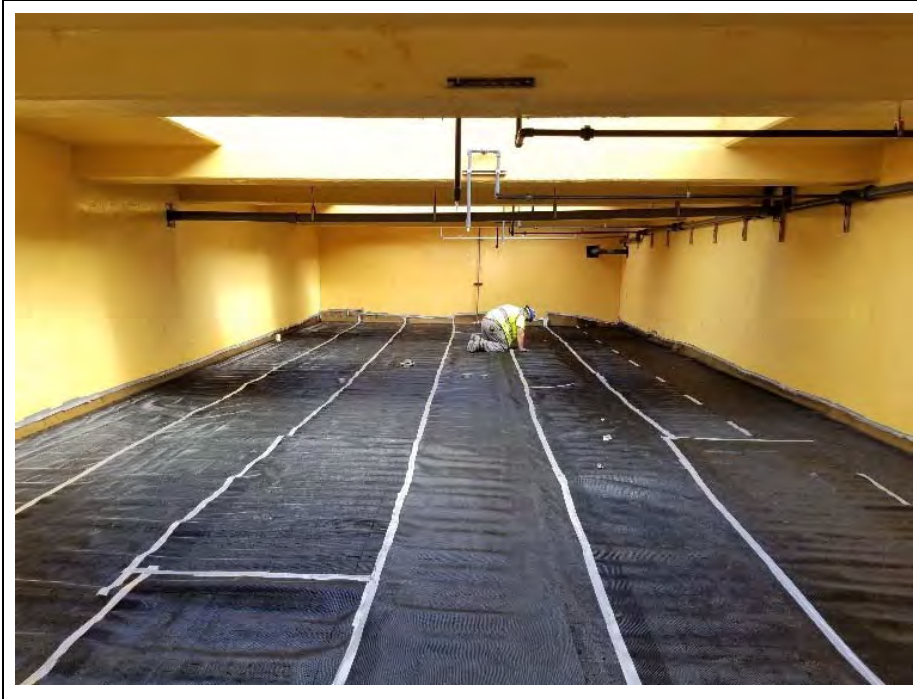
Photo #14

Area 60 Odor Control (looking east) on Tuesday, September 11<sup>th</sup>.

A pipefitter for University Mechanical is installing netting atop air distribution plates within the odor control structure.

**GMPA No. 12 – Odor Control System.** Work on this GMPA is approximately 84% complete. University Mechanical installed polymer netting atop air distribution plates and placed biofilter media inside the odor control structure (see Photos #14 and #15) and in two carbon absorption vessels. Delta Technology Corporation installed four fans within a sound enclosure atop the west side of the odor control structure. Painters for Honeycutt's, Inc., finished repairing the interior coating system at pipe penetrations inside the odor control structure. Valley Electric began to install conduits and conductors associated with fans and other equipment.

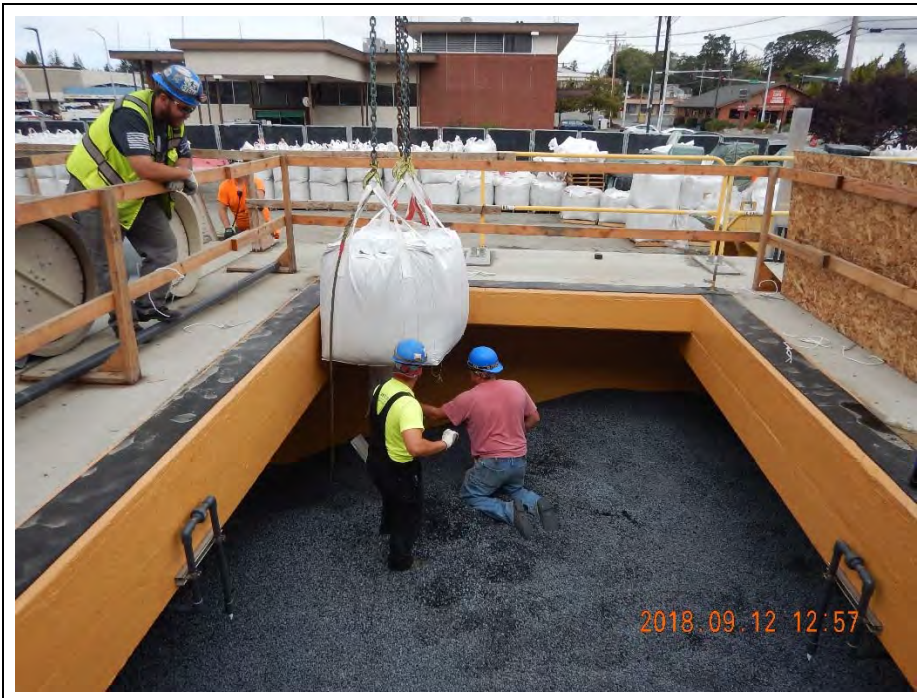
Photo #15

Area 60 Odor Control (looking north) on Wednesday, September 12<sup>th</sup>.

Pipefitters for University Mechanical are about to empty a bag of biofilter media into the odor control structure.

Microorganisms will reside on the surface of the media and consume odorous contaminants and, in the process, clean the air.

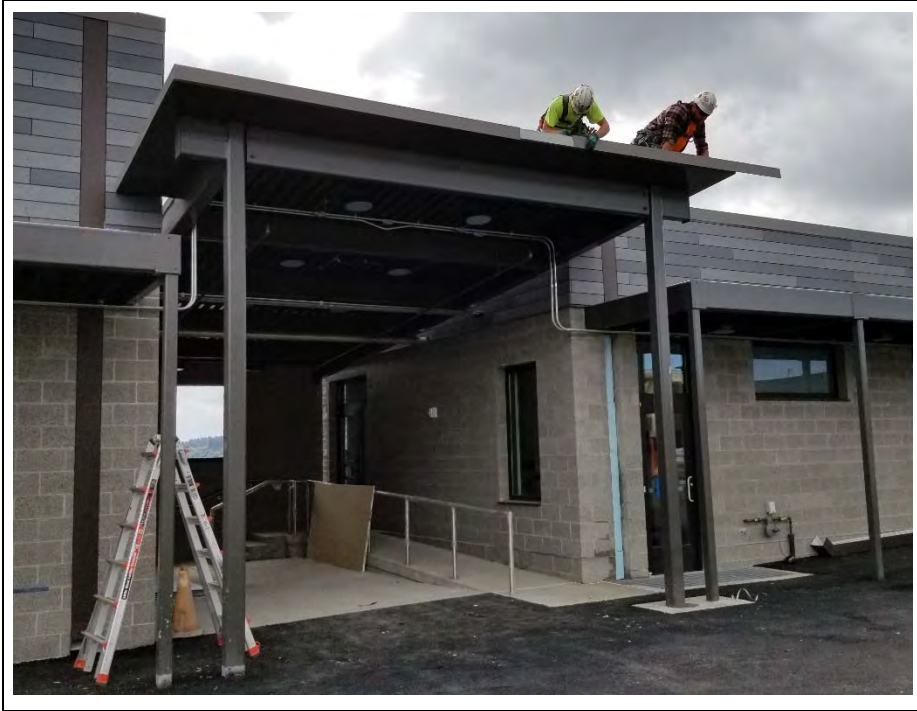
Photo #16

Area 01 Administration and Maintenance Building (looking southwest) on Wednesday, September 12<sup>th</sup>.

Two sheet metal workers for Axiom are installing flashing at a covered storage area between the administration building (right) and the maintenance building (left).

**GMPA No. 11 – Superstructure Construction.** Work on this GMPA is approximately 96% complete. University Mechanical and its subcontractors, Honeywell, EC Company, U.S. Water, and Air Test, Inc., commissioned the HVAC system in the administration and maintenance building, which enabled the City Building Department to issue a temporary certificate of occupancy. Project management staff and City operations staff moved into the building on September 21<sup>st</sup> (see Photo #20). Steelkorr installed aluminum tread plates in the headworks and secondary treatment buildings including atop membrane tanks. A small crew for Penington Painting applied coatings to miscellaneous process piping in the headworks and biosolids buildings and caulked windows frames in all process buildings. Penington Painting touched up damaged coatings where monorail hoist systems were installed in the maintenance and biosolids buildings. The monorail hoist systems were installed this past month by WEMCO (see Photo #32). Axiom finished installing glass-fiber reinforced concrete (GFRC) cladding on the upper exterior of the secondary treatment building. Axiom installed flashing and down spouts at process buildings and at the administration and maintenance building (see Photos #16 and #36).

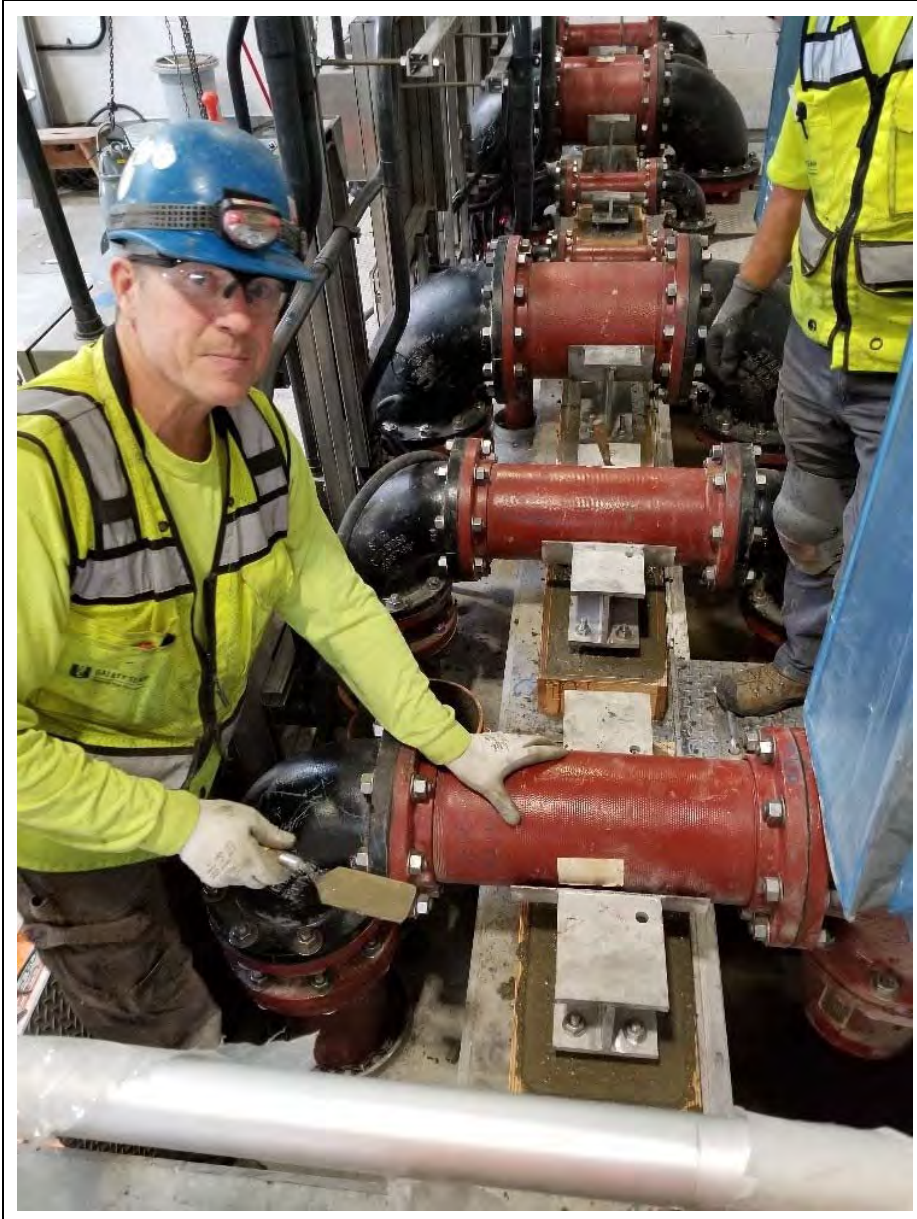
Photo #18

Area 20 Headworks  
(looking west) on  
Wednesday, September  
12<sup>th</sup>.

A carpenter for University  
Mechanical is placing  
grout under pipe supports  
for influent pump  
discharge piping.

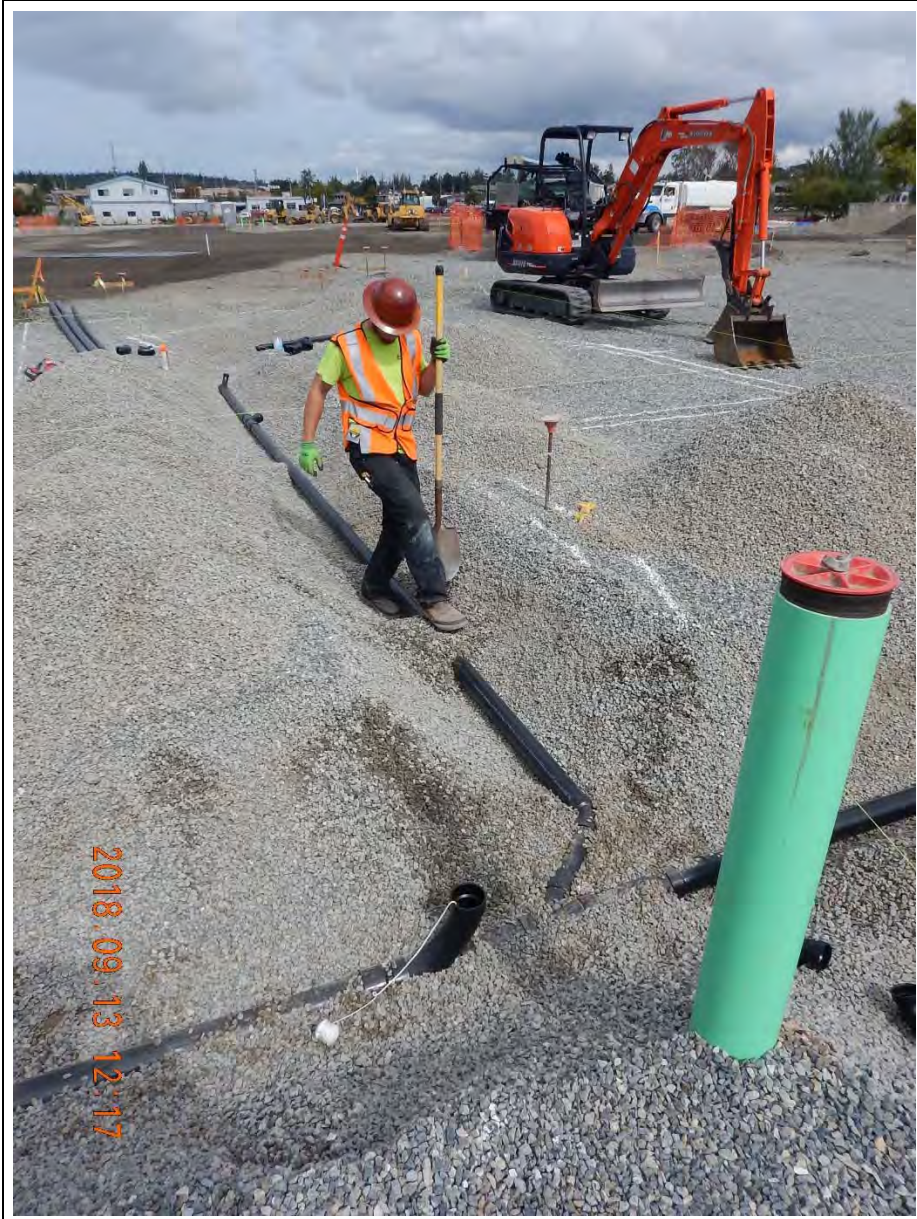
Photo #19

Southwest end of Windjammer Park (looking north) on Thursday, September 13<sup>th</sup>.

A plumber for Eastwood Plumbing Contractors, Inc., is installing PVC drain, waste, and vent piping at the west kitchen.

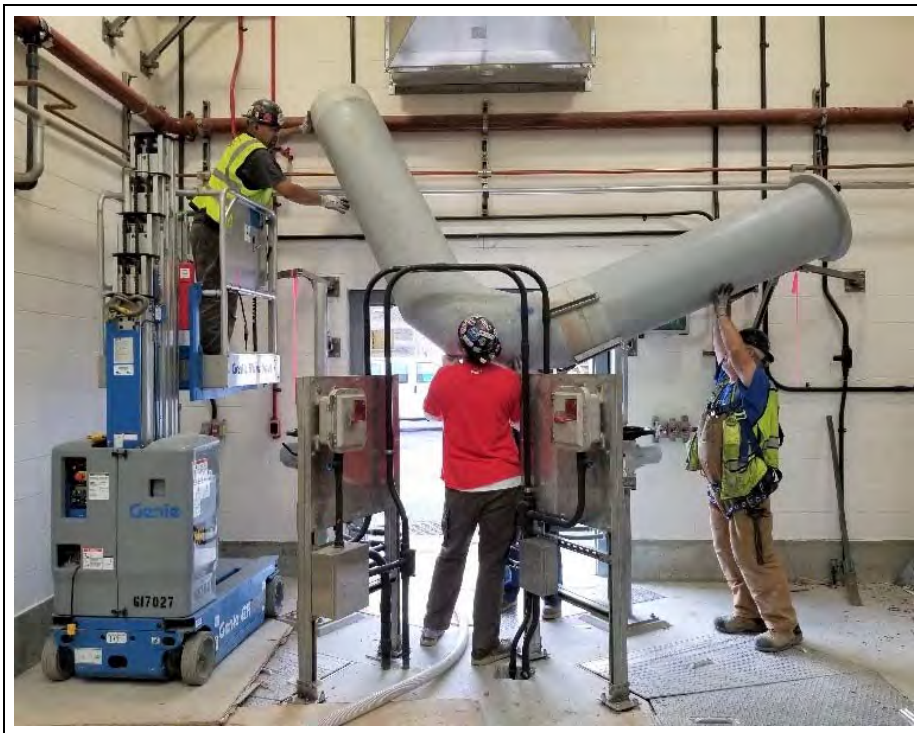
Photo #21

Area 20 Headworks (looking south) on Friday, September 14<sup>th</sup>.

Sheet metal workers for Delta Technology Corporation are lifting into place a section of fiber reinforced plastic (FRP) foul air piping.

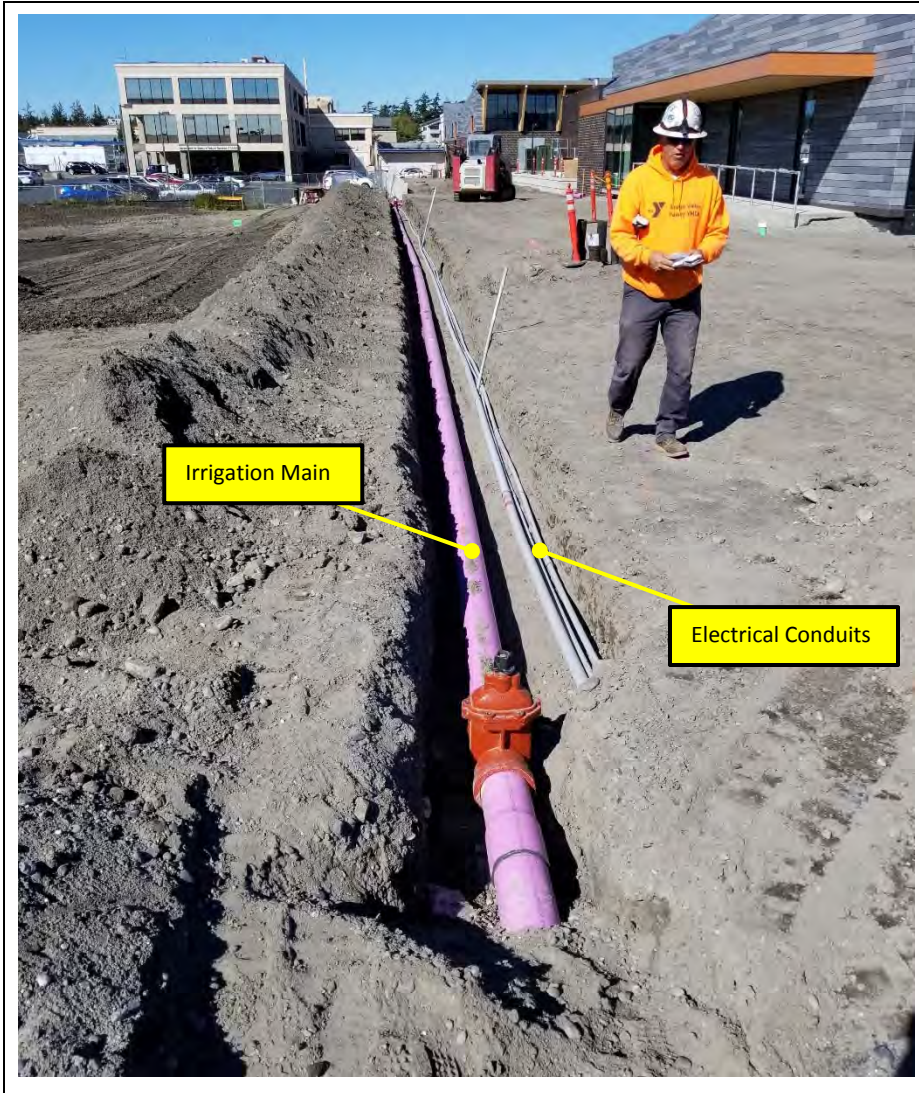
Photo #22

Area adjacent to west side of Area 01 Administration Building (looking north) on Monday, September 17<sup>th</sup>.

An electrician for Valley Electric (orange sweatshirt) placed electrical conduits in a trench next to a 6-inch PVC irrigation main that was just installed by Pacific Earth Works.

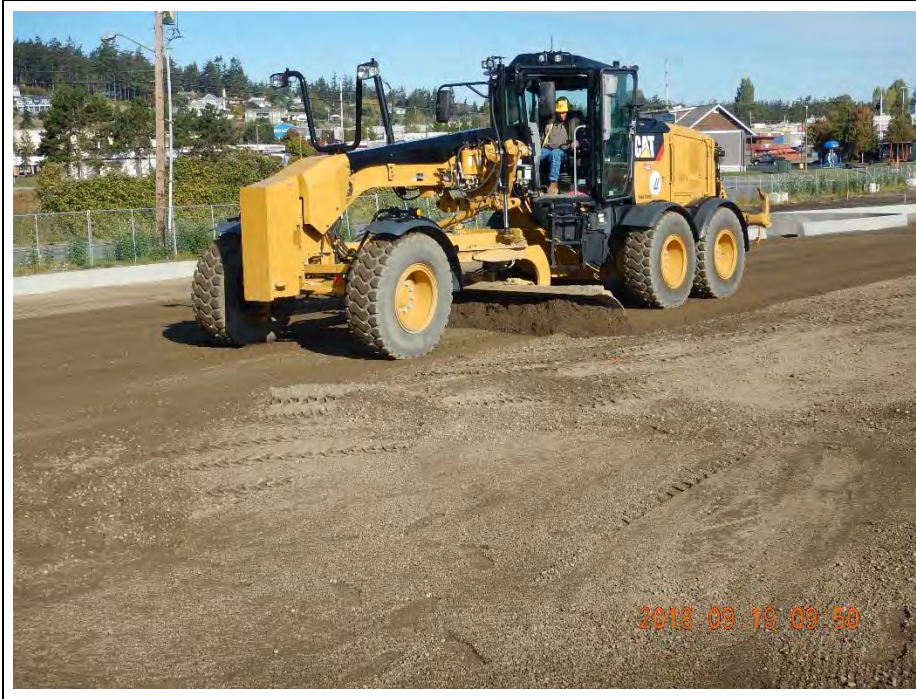
Photo #23

West end of Windjammer Park (looking north) on Wednesday, September 19<sup>th</sup>.

An operator for Lakeside Industries is utilizing a motor grader to spread aggregate base material for a parking lot.

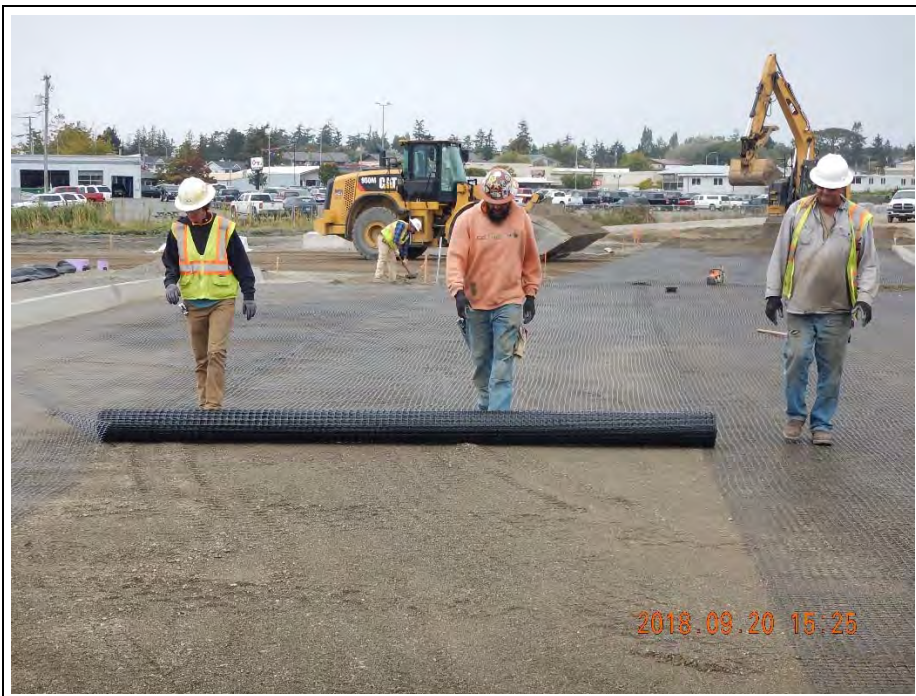
Photo #24

West end of Windjammer Park (looking north) on Thursday, September 20<sup>th</sup>.

An operator and a pipe layer (left) for Interwest Construction are placing geogrid atop compacted aggregate subbase at a not-yet-paved parking lot.

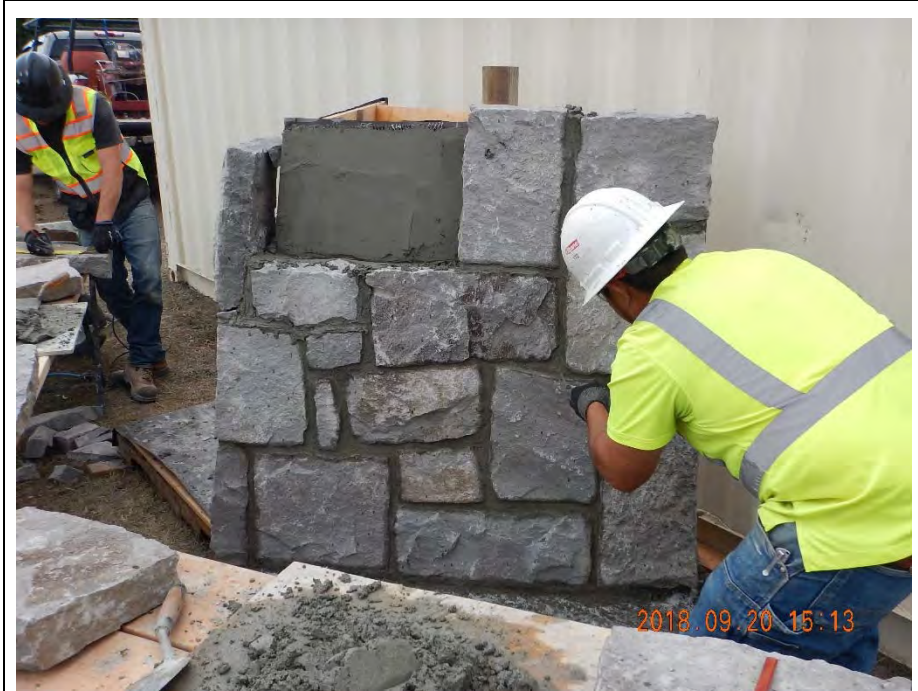
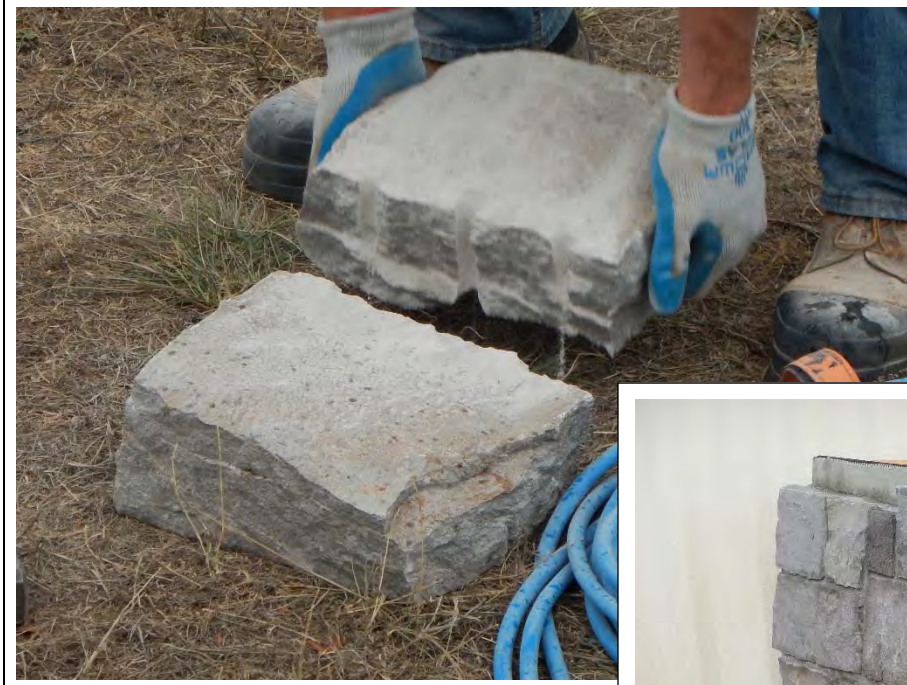
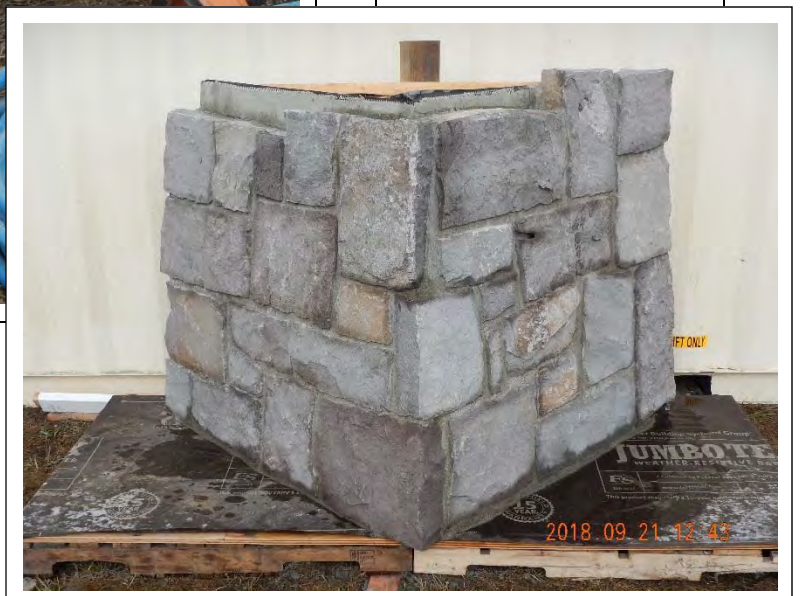
Photo #25

Windjammer Park on Thursday and Friday, September 20<sup>th</sup> and 21<sup>st</sup>.

Masons for Black Rock Masonry are utilizing basalt stone to build a mock-up of a proposed veneer for the east and west kitchens and pavilion.

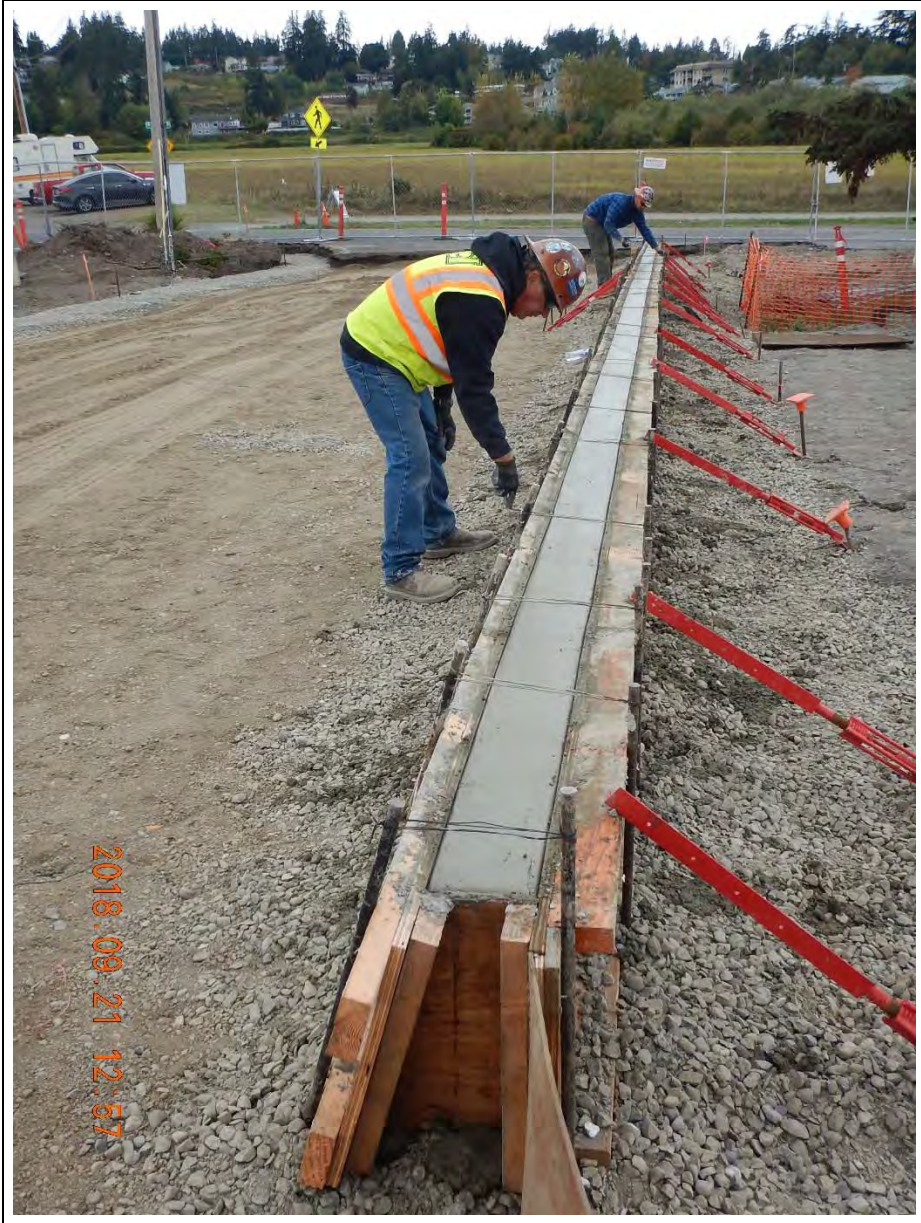
Photo #26

Southwest end of Windjammer Park (looking west) towards Beeksma Drive on Friday, September 21<sup>st</sup>.

Carpenters for Interwest Construction placed concrete for a curb.

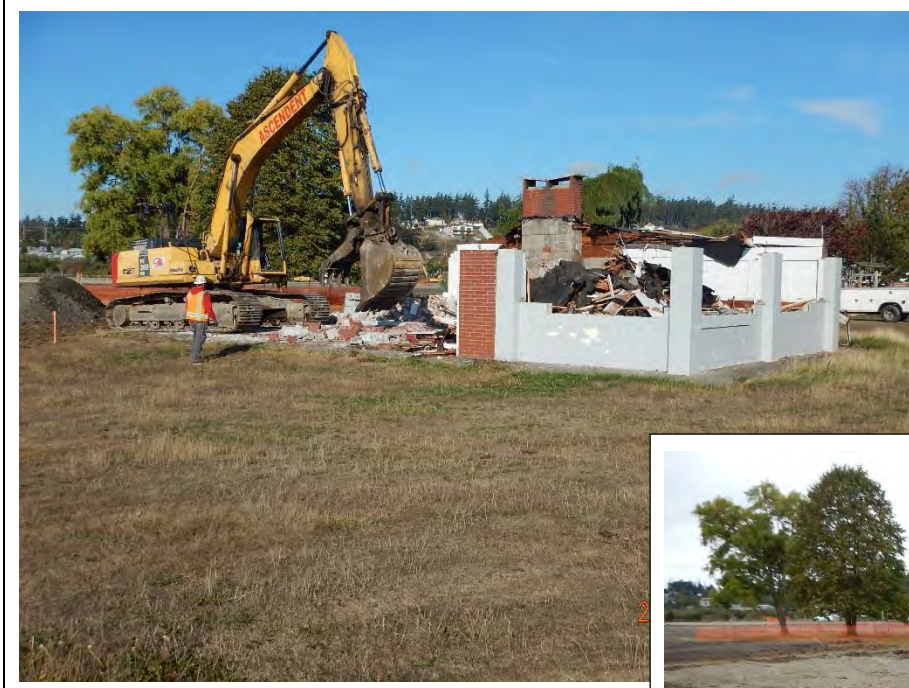
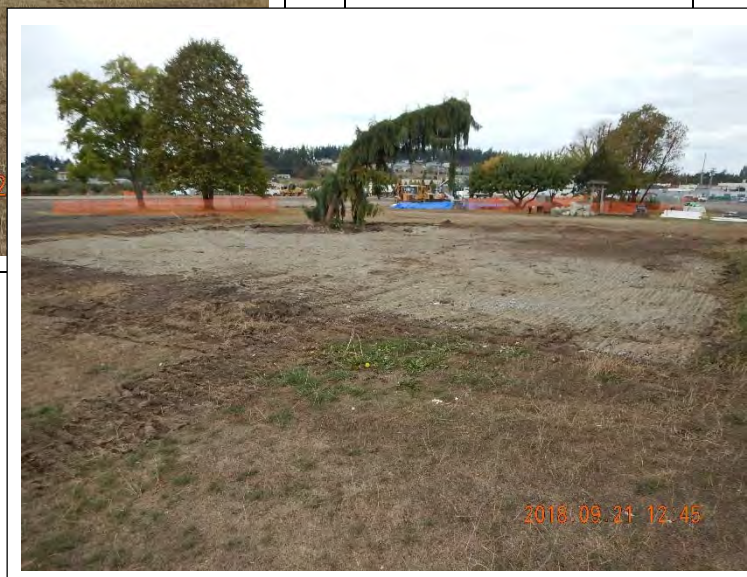
Photo #27

West Kitchen at Windjammer Park (looking northwest) on Tuesday, Wednesday, and Friday, September 18<sup>th</sup>, 19<sup>th</sup>, and 21<sup>st</sup>.

Ascendent Demolition utilized an excavator to demolish the west kitchen.

- Ascendent demolished the west kitchen and a windmill in Windjammer Park (see Photos #27 and #29) and began demolishing the old Whidbey Island Bank building (see Photo #41).
- Construction activities continued in Windjammer Park (see Photos #11, #17, #19, #22, #23, #24, #25, #26, #33, #34, #35, and #42).
- Start-up activities continued. Vendors operated equipment and conducted operator training (see Photos #7, #8, #9, #13, #31, #38 and #39).
- Biofilter media was placed in the odor control structure (see Photos #14 and #15) and membrane cassettes were placed in membrane tanks (see Photo #31).
- A temporary certificate of occupancy (TCO) was obtained from the building department for the administration and maintenance building (see Photo #20), which is substantially complete and is currently occupied by project management and City operations staff.

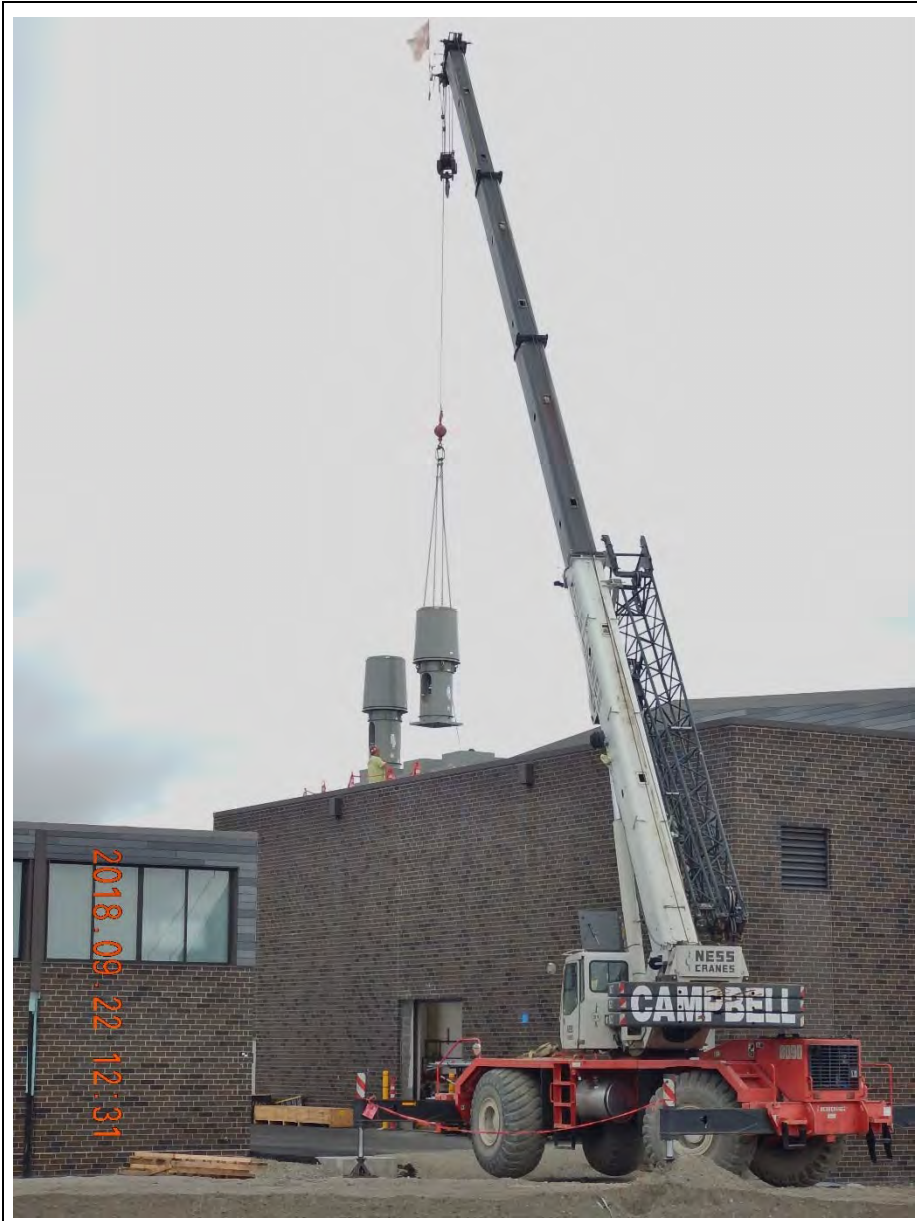
Photo #28

Area 50 Biosolids Building  
(looking northeast) on  
Saturday, September 22<sup>nd</sup>.

An operator for Ness  
Campbell Crane & Rigging  
is utilizing an all-terrain  
crane to place a high  
plume fan atop the load  
out portion of the biosolids  
building. Sheet metal  
workers for Delta  
Technology Corporation  
are responsible for  
installing the fans.

**GMPA No. 9 – Mechanical, Electrical, and Process Systems.** Work on this GMPA is approximately 95% complete. Valley Electric continued to install disconnect switches, local and vendor control panels, conduits, and conductors for influent pumps, motor-actuated slide gates, coarse and fine screen conveyors and washer/compactors, a grit basin mixer, and grit pumps in the headworks building (see Photos #3, #4, and #5). Valley Electric continued to terminate conductors at motor starters, vendor control panels, a process control module, and a network panel in the electrical and control rooms in the headworks building. Valley Electric installed liquid level sensors in channels in the headworks building and in membrane tanks in the secondary treatment building. Valley Electric installed conduits and conductors for fire detection systems (see Photo #37) and roll-up doors in the headworks, biosolids, and secondary treatment buildings. Valley Electric continued to install conduits for instrumentation, local and vendor control panels, and other equipment in the secondary treatment building and in the gallery under the secondary treatment building. Valley Electric continued to terminate conductors at motor starters, process control modules (PCMs), and control panels in the electrical building. Towards the last half of the month, Valley Electric focused on work in the biosolids building as work in other areas neared completion. University Mechanical placed grout to further support influent pumps in wetwells and influent pump discharge piping at a discharge channel in the headworks building (see Photo #18). University Mechanical placed grout under pipe support base plates associated with membrane system piping in the secondary treatment building. University Mechanical installed membrane cassettes in membrane tanks in the secondary treatment building (see Photo #31). University Mechanical installed small diameter piping and fittings between an effluent line and an automatic sampler at the ultraviolet reactors in the secondary treatment building. University Mechanical continued to assemble biosolids dryer equipment (see Photo #6) and Delta Technology Corporation installed ductwork associated with the biosolids dryer in the biosolids building. Delta Technology Corporation continued to install fiber reinforced plastic (FRP) foul air piping and HVAC ductwork and equipment in the secondary treatment building and in the headworks building (see Photos #12 and #21). Delta Technology Corporation installed exhaust fans atop the load out area of the biosolids building (see Photo #28).
