City of Oak Harbor  
City Council Agenda Bill

Bill No. 5. c. ii.  
Date: October 16, 2018  
Subject: Clean Water Facility Update

# Clean Water Facility Project

**MONTHLY PROGRESS REPORT**

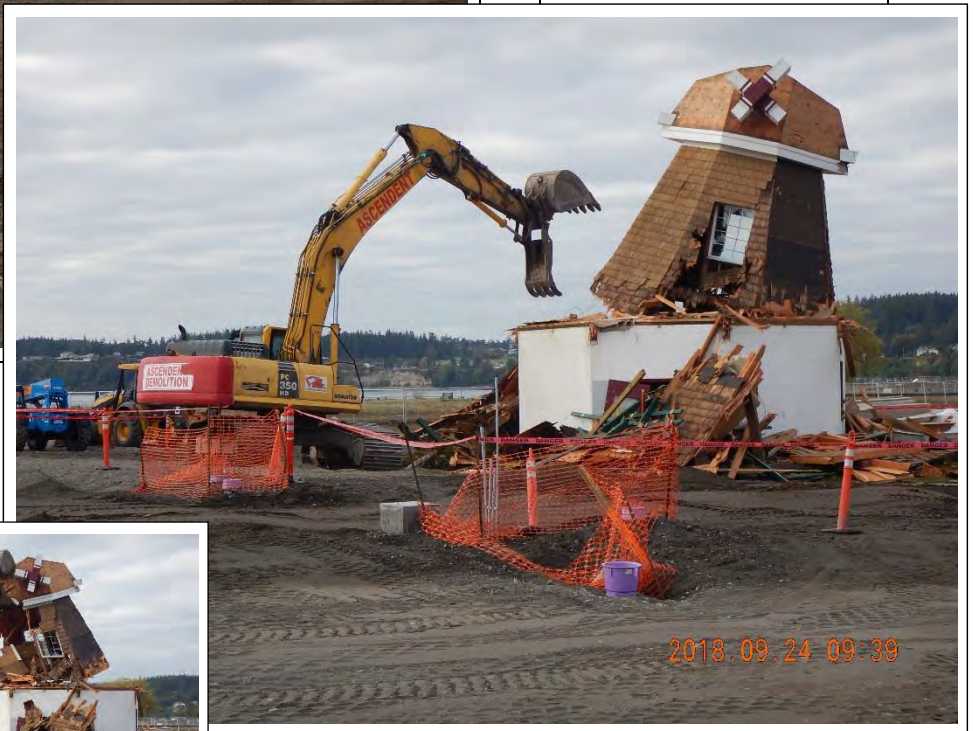
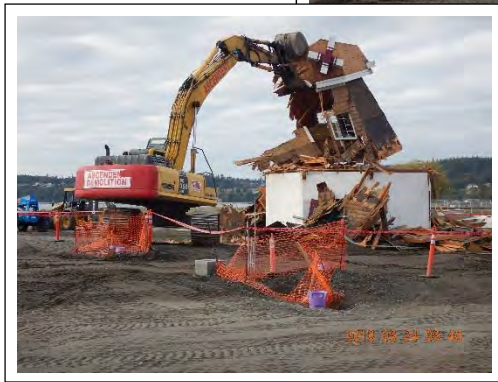
Photo #29

Windmill at Windjammer Park (looking southwest) on Monday, September 24<sup>th</sup>.

Ascendent Demolition is utilizing an excavator to demolish a faux windmill.

- Ascendent demolished the west kitchen and a windmill in Windjammer Park (see Photos #27 and #29) and began demolishing the old Whidbey Island Bank building (see Photo #41).
- Construction activities continued in Windjammer Park (see Photos #11, #17, #19, #22, #23, #24, #25, #26, #33, #34, #35, and #42).
- Start-up activities continued. Vendors operated equipment and conducted operator training (see Photos #7, #8, #9, #13, #31, #38 and #39).
- Biofilter media was placed in the odor control structure (see Photos #14 and #15) and membrane cassettes were placed in membrane tanks (see Photo #31).
- A temporary certificate of occupancy (TCO) was obtained from the building department for the administration and maintenance building (see Photo #20), which is substantially complete and is currently occupied by project management and City operations staff.

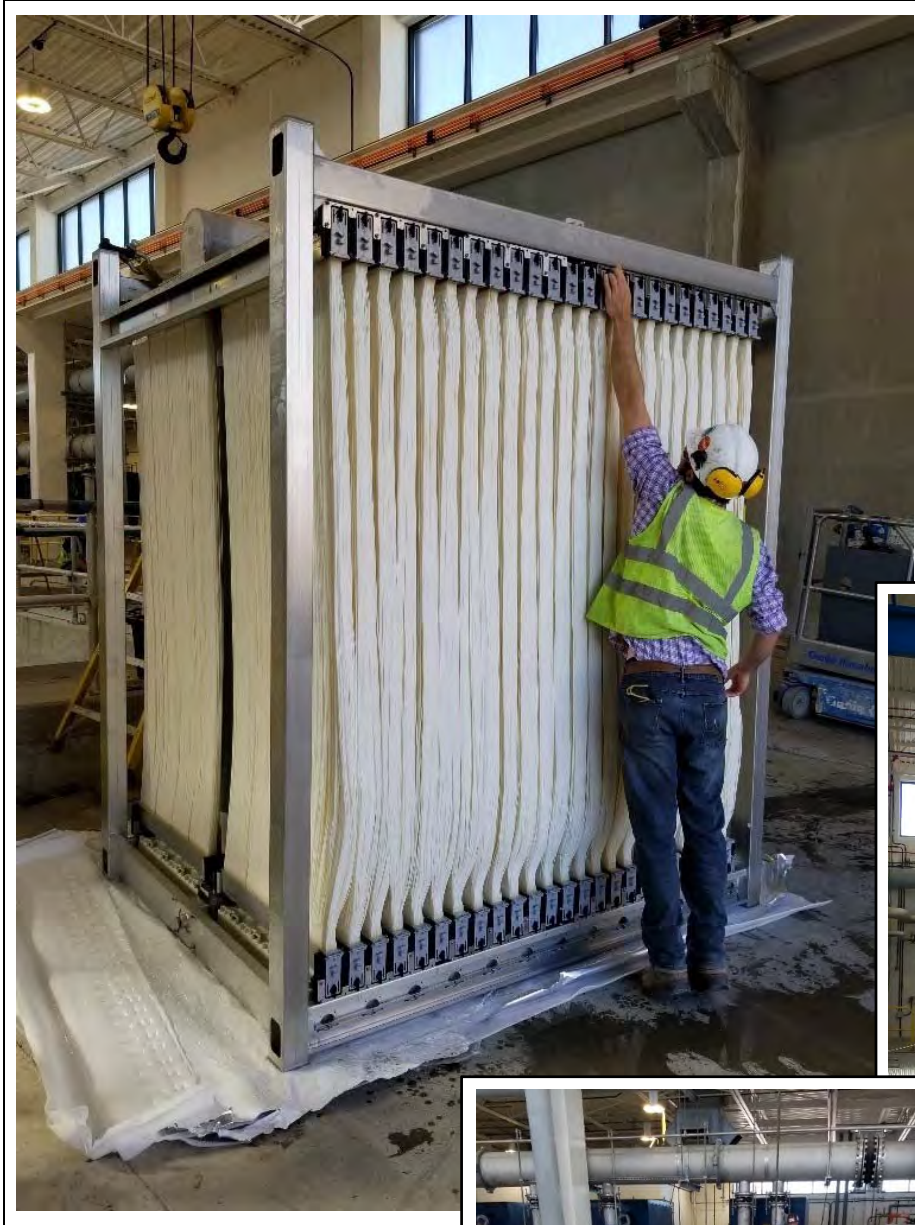
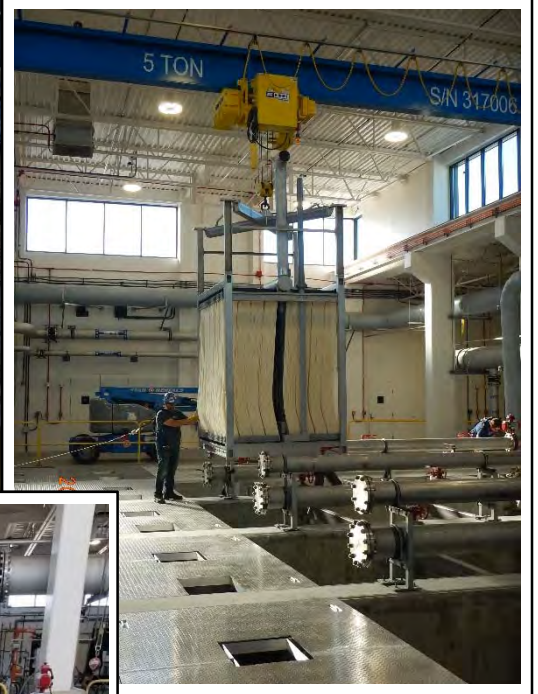
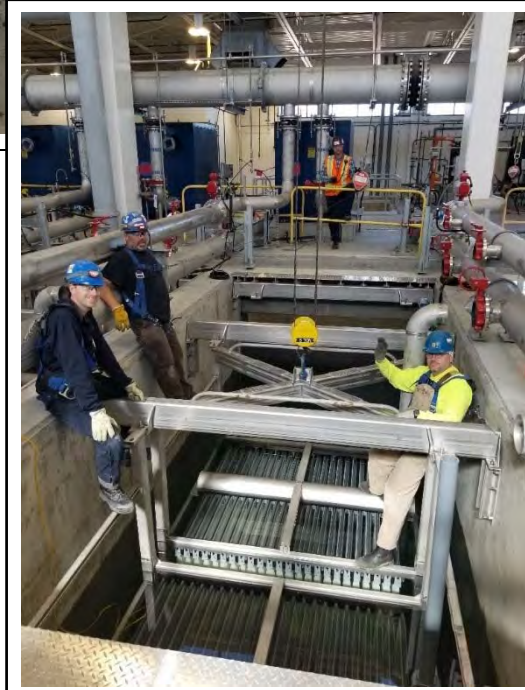
Photo #31

Area 30 Secondary Treatment Building on Monday, September 24<sup>th</sup>.

Top: A technician for Suez Water Technologies, Sean Mercer, inspects a membrane cassette.

Lower Right: Pipefitters for University Mechanical are placing a membrane cassette into a membrane tank.

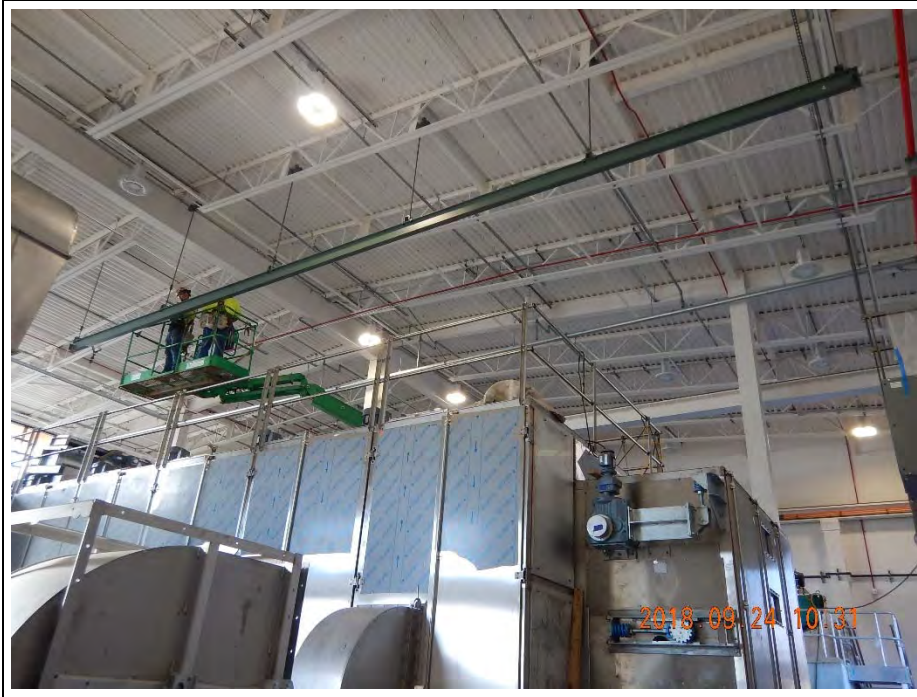
Photo #32

Area 50 Biosolids (looking northeast) on Monday, September 24<sup>th</sup>.

Ironworkers for WEMCO, Inc., are installing a ½-ton monorail system over a biosolids dryer.

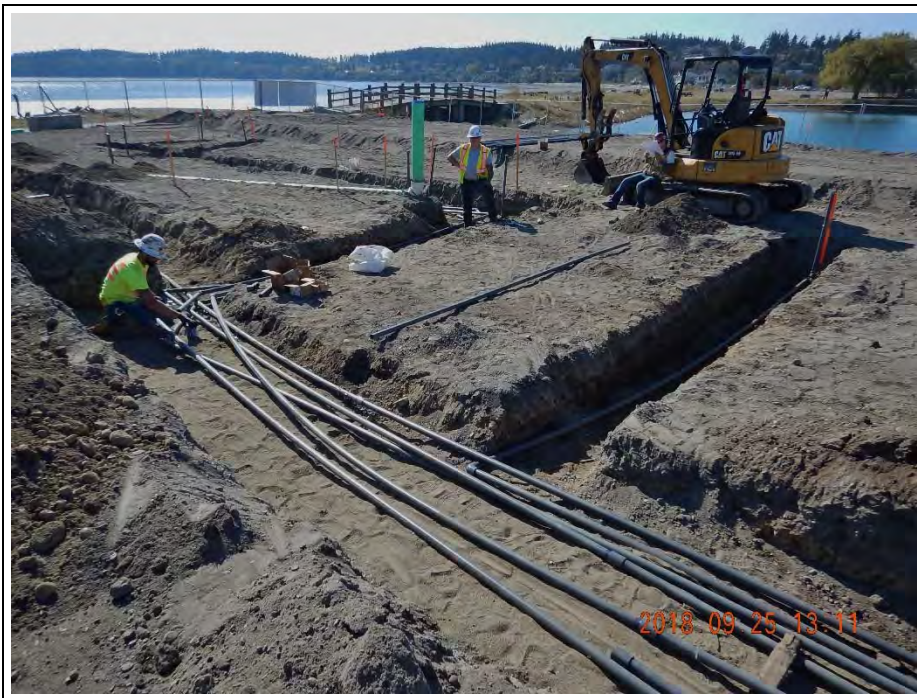
Photo #33

South end of Windjammer Park (looking southwest) on Tuesday, September 25<sup>th</sup>.

A laborer for Interwest Construction is placing small diameter PVC pipe in trenches. The PVC piping system will serve the new splash park.

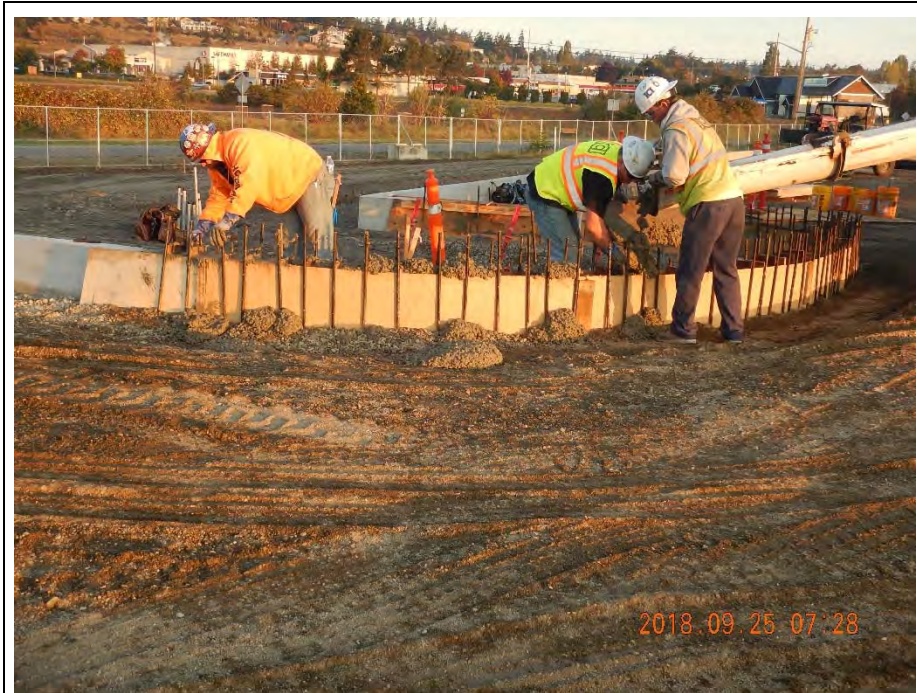
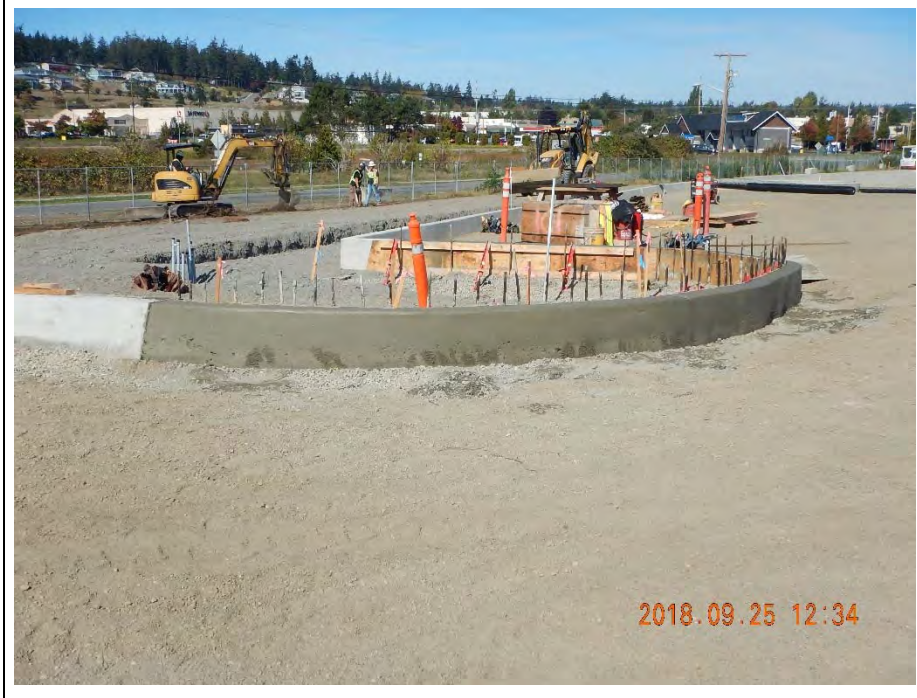
Photo #34

Southwest end of Windjammer Park (looking northwest) on Tuesday, September 25<sup>th</sup>.

Top: Carpenters for Interwest Construction are placing concrete for a section of curb.

Bottom: The curb after the carpenters removed the forms.

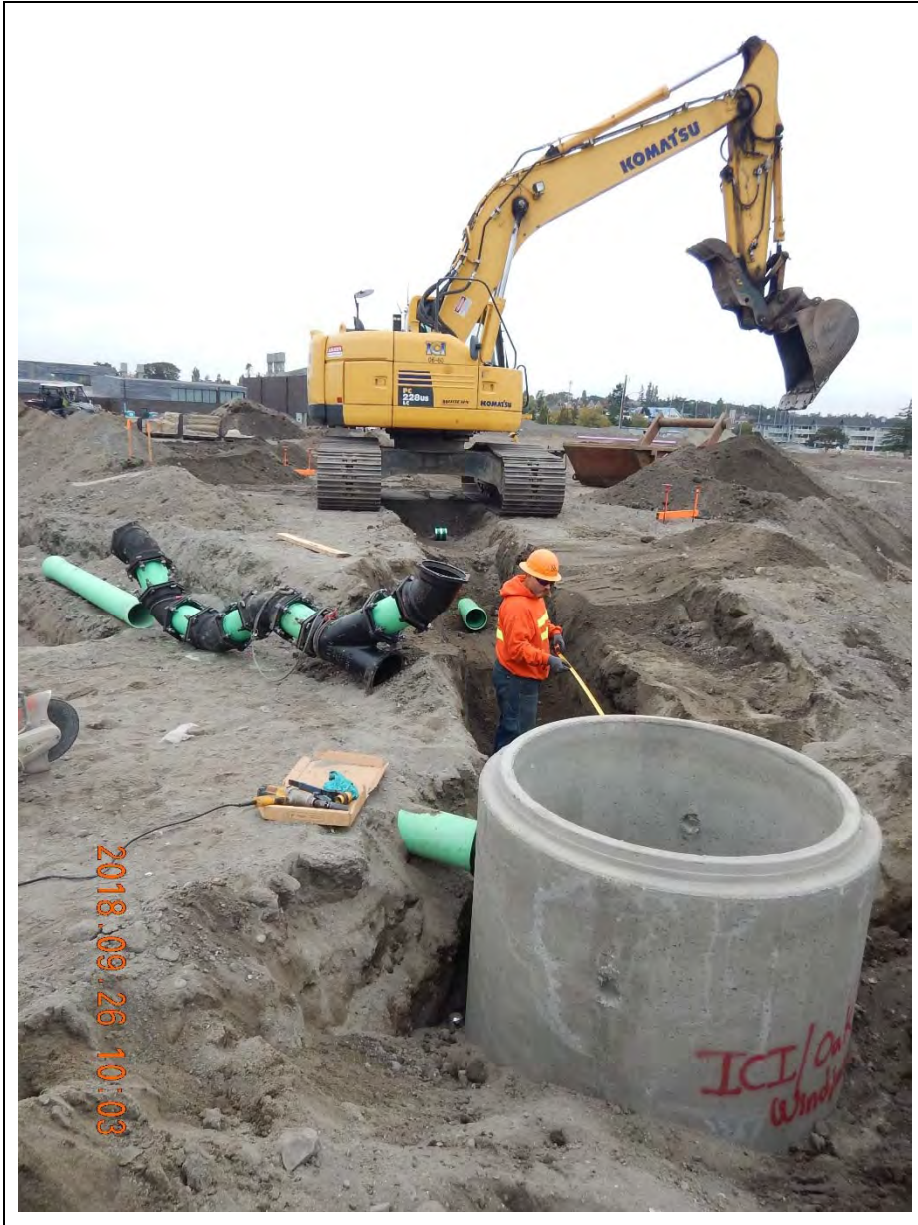
Photo #35

South end of Windjammer Park (looking northeast) on Wednesday, September 26<sup>th</sup>.

A pipe layer for Interwest Construction is about to install an 8-inch P trap made of PVC pipe spools and ductile-iron fittings. The P trap will prevent odorous gases from rising up through the manhole, which is located at the south end of the new splash park.

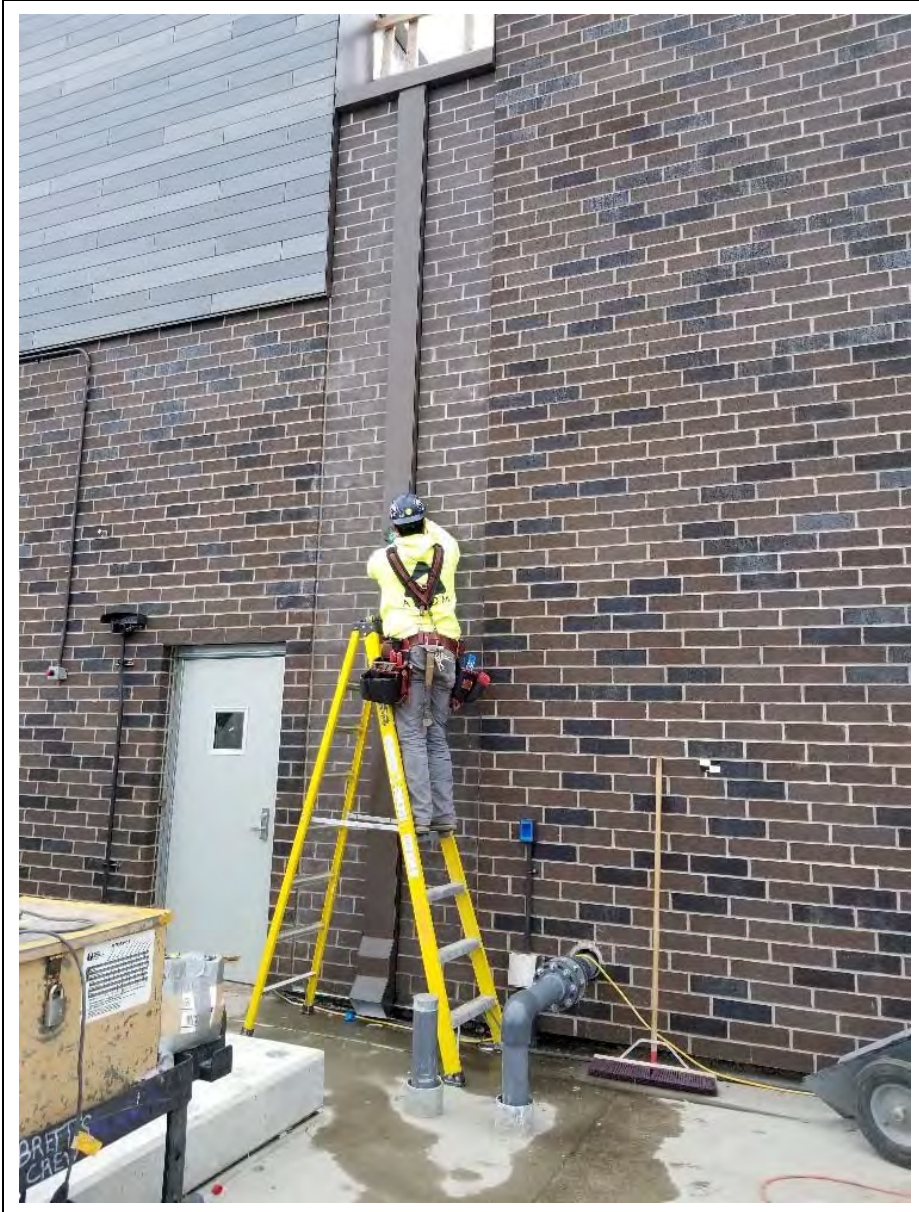
Photo #36

Area 20 Headworks  
(looking southeast) on  
Wednesday, September  
26<sup>th</sup>.

A sheet metal worker for  
Axiom is installing a sheet  
metal down spout.

**GMPA No. 11 – Superstructure Construction.** Work on this GMPA is approximately 96% complete. University Mechanical and its subcontractors, Honeywell, EC Company, U.S. Water, and Air Test, Inc., commissioned the HVAC system in the administration and maintenance building, which enabled the City Building Department to issue a temporary certificate of occupancy. Project management staff and City operations staff moved into the building on September 21<sup>st</sup> (see Photo #20). Steelkorr installed aluminum tread plates in the headworks and secondary treatment buildings including atop membrane tanks. A small crew for Penington Painting applied coatings to miscellaneous process piping in the headworks and biosolids buildings and caulked windows frames in all process buildings. Penington Painting touched up damaged coatings where monorail hoist systems were installed in the maintenance and biosolids buildings. The monorail hoist systems were installed this past month by WEMCO (see Photo #32). Axiom finished installing glass-fiber reinforced concrete (GFRC) cladding on the upper exterior of the secondary treatment building. Axiom installed flashing and down spouts at process buildings and at the administration and maintenance building (see Photos #16 and #36).

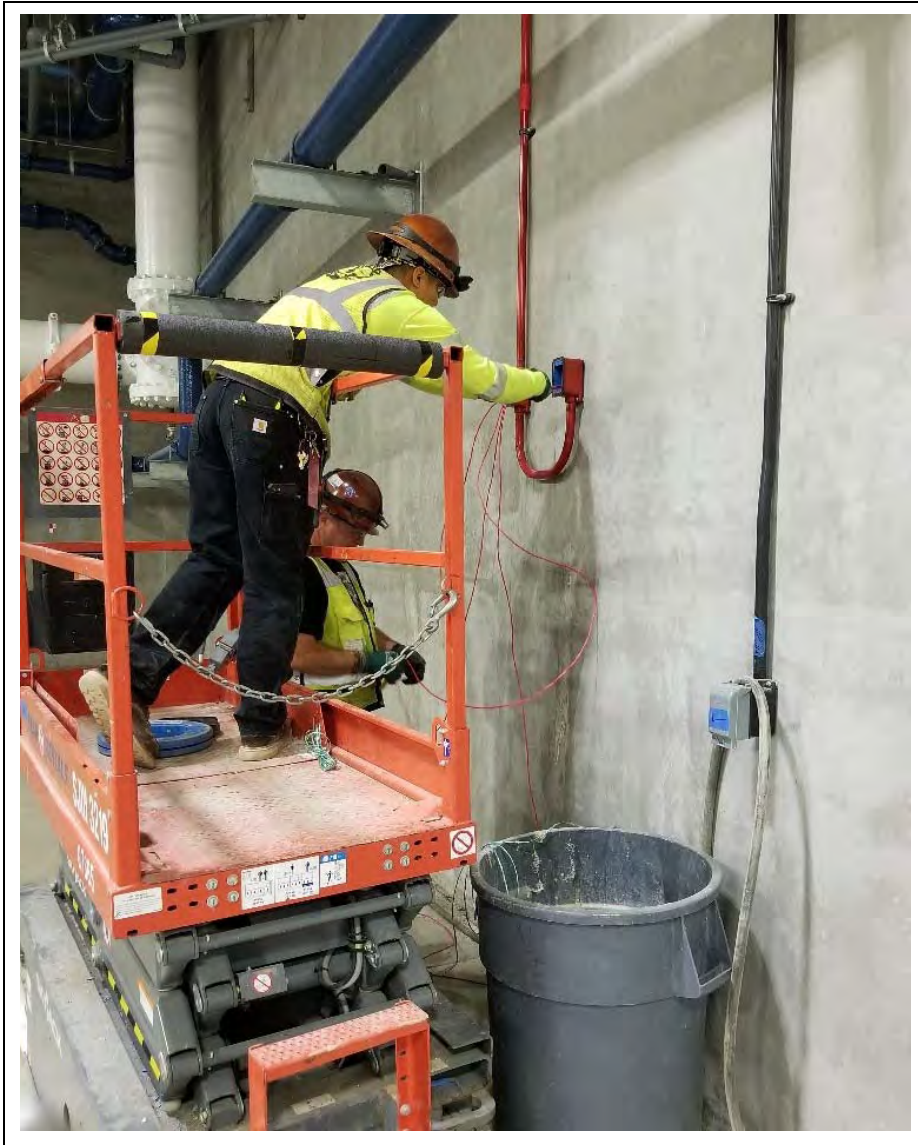
Photo #37

Area 35 RAS/WAS Pumping (looking northeast) on Wednesday, September 26<sup>th</sup>.

Electricians for Valley Electric are pulling conductors through conduit for a fire detection system.

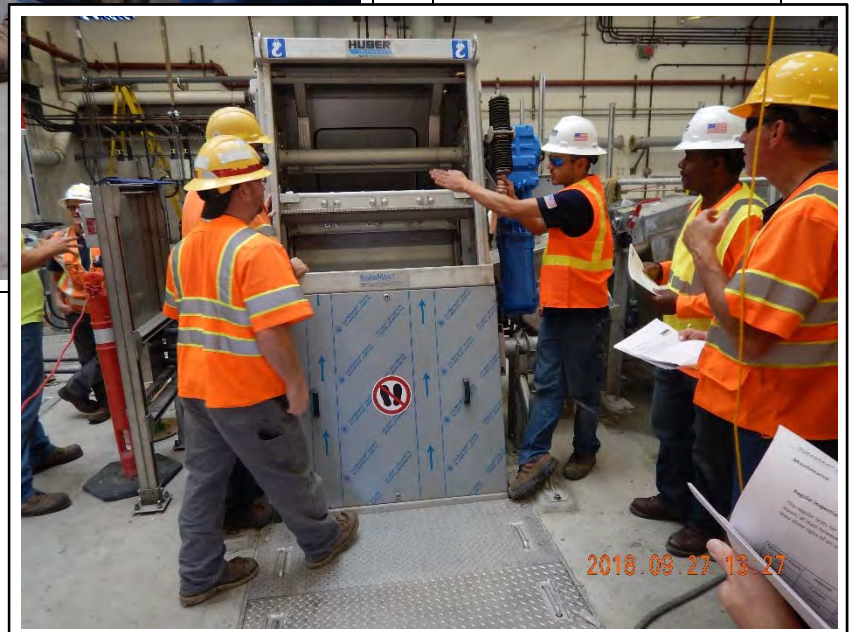
Photo #38

Area 20 Headworks (looking north) on Thursday, September 27<sup>th</sup>.

Top: JDV Equipment Corporation representative Mike Reade is conducting an operator training class pertaining to a screw conveyor associated with a mechanical coarse screen (seen below).

Bottom: Huber Technologies technician Christian Reyer (seen pointing) conducts an operator training session pertaining to a mechanical coarse screen.

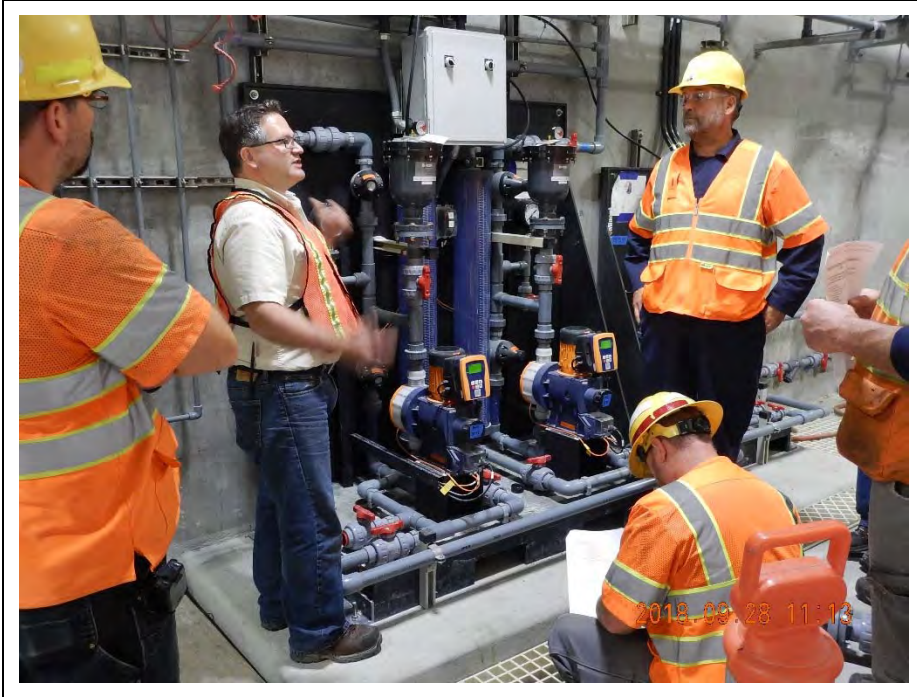
Photo #39

Area 37 NaOH and HOCL Chemical Facilities (looking northeast) on Friday, September 28<sup>th</sup>.

TMG Services technician Brian Yarnell (left, without hardhat) conducts an operator training class pertaining to chemical injection pumps.

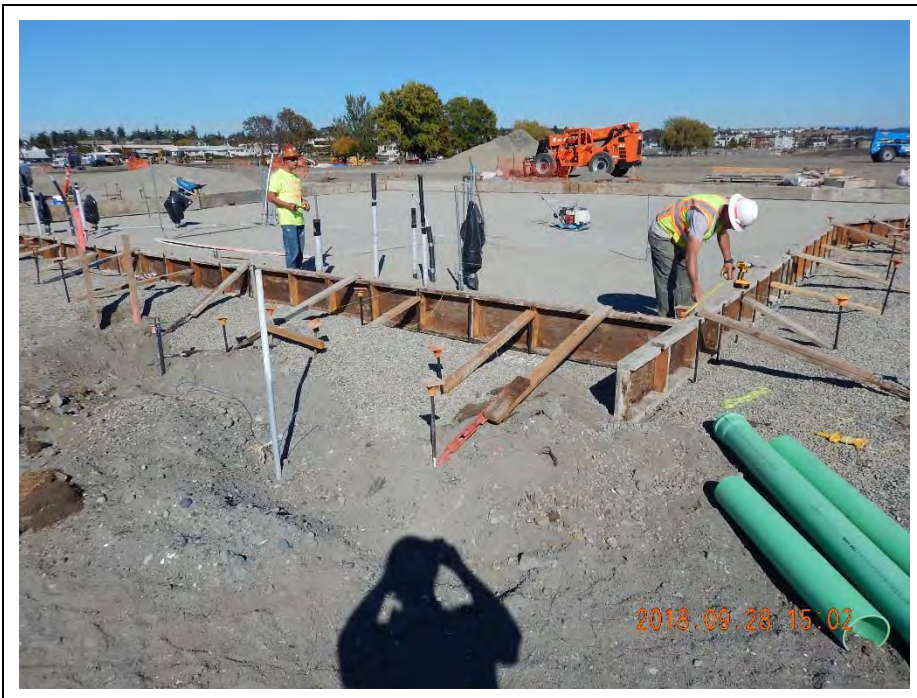
Photo #40

Southwest end of Windjammer Park (looking east) on Friday, September 28<sup>th</sup>.

Carpenters for LangCo NW are installing forms for a slab-on-grade for the west kitchen.

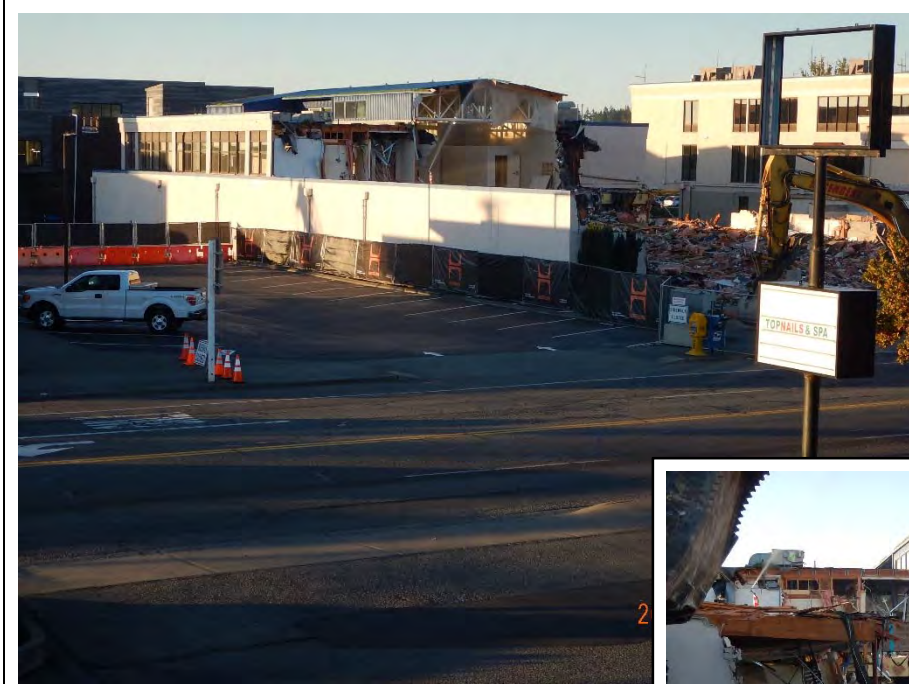
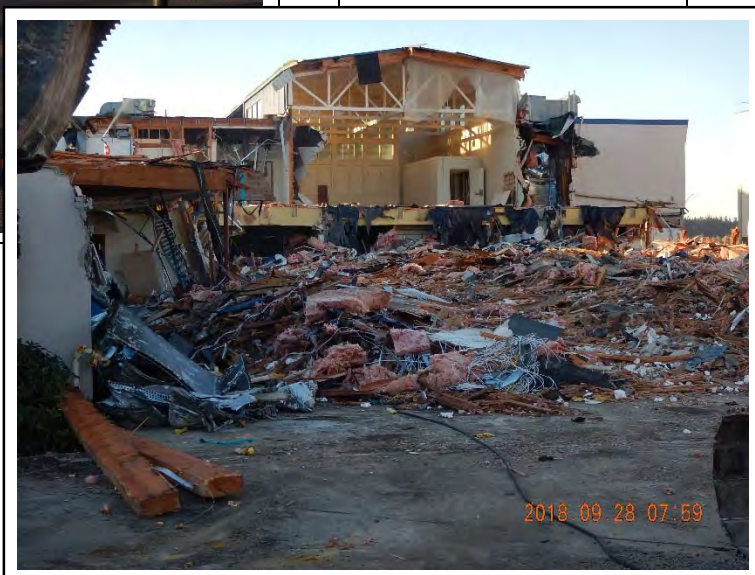
Photo #41

The old Whidbey Island Bank Building (looking southwest).

Bottom: The old Whidbey Island Bank Building (looking southwest) on Friday, September 28<sup>th</sup>, after demolition began.

See Photo #2 for an aerial view of this activity.

**GMPA No. 13 – Civil Site Work.** Work on this portion of GMPA No. 13 is approximately 33% complete. Interwest Construction filled and compacted on-site earthen material adjacent to the west sides of the aeration blower and electrical buildings. Interwest Construction installed removable bollards throughout the inner yard of the clean water facility, and Interwest Construction installed 12-inch PVC storm drain piping adjacent to the south side of the administration and maintenance building. Ascendent began demolishing the old Whidbey Island Bank building (see Photo #41).
