City of Oak Harbor
City Council Agenda Bill

Bill No. 5. c. i.
Date: November 20, 2018
Subject: Clean Water Facility Update

Clean Water Facility Project

MONTHLY PROGRESS REPORT

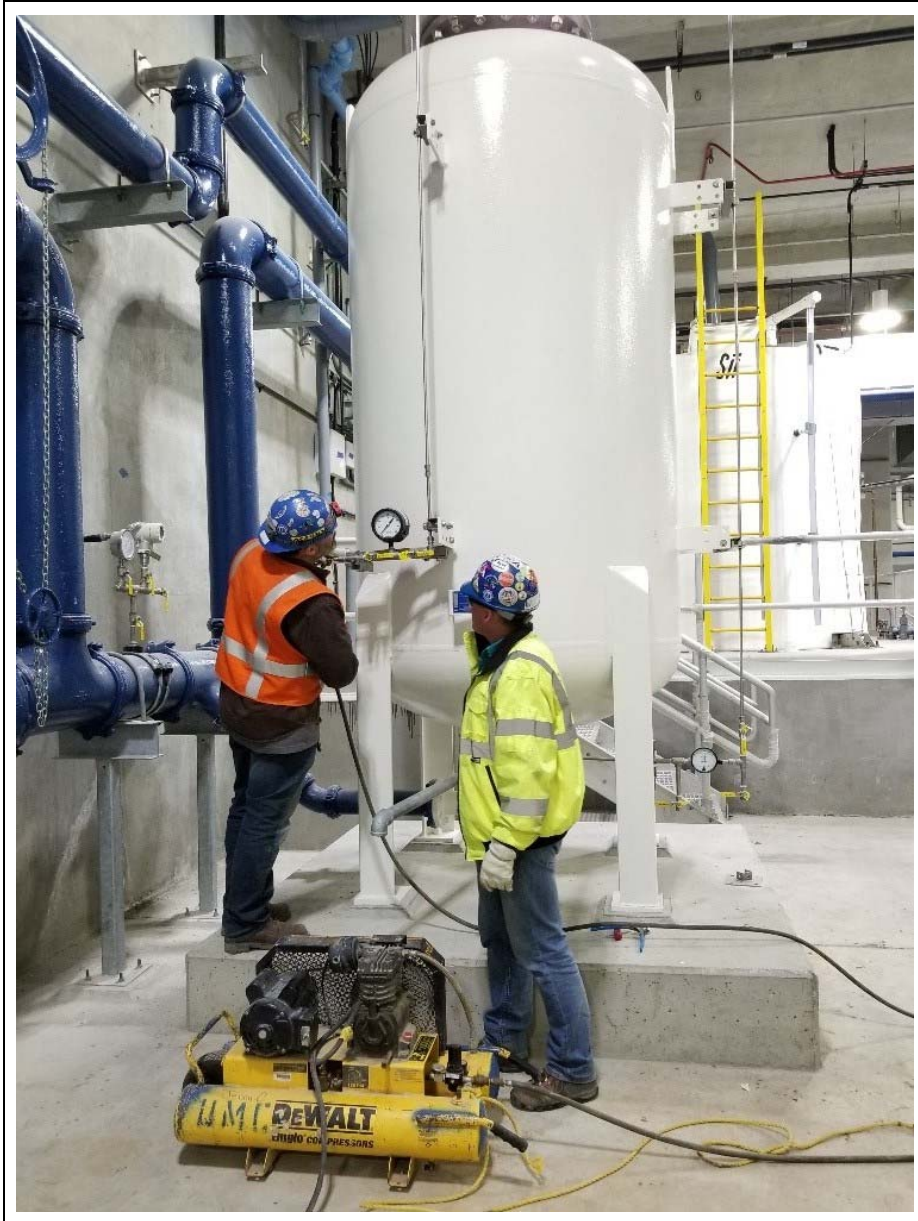
Photo #3

Area 38 Utility Water
(looking east) on
Thursday, October 4th.

Pipefitters for University
Mechanical, Brett
Angelocci (left) and
Sergey Sapozhnikov, are
utilizing an air compressor
to pressurize the bladder
inside a hydro pneumatic
tank that makes up part of
a utility water system.

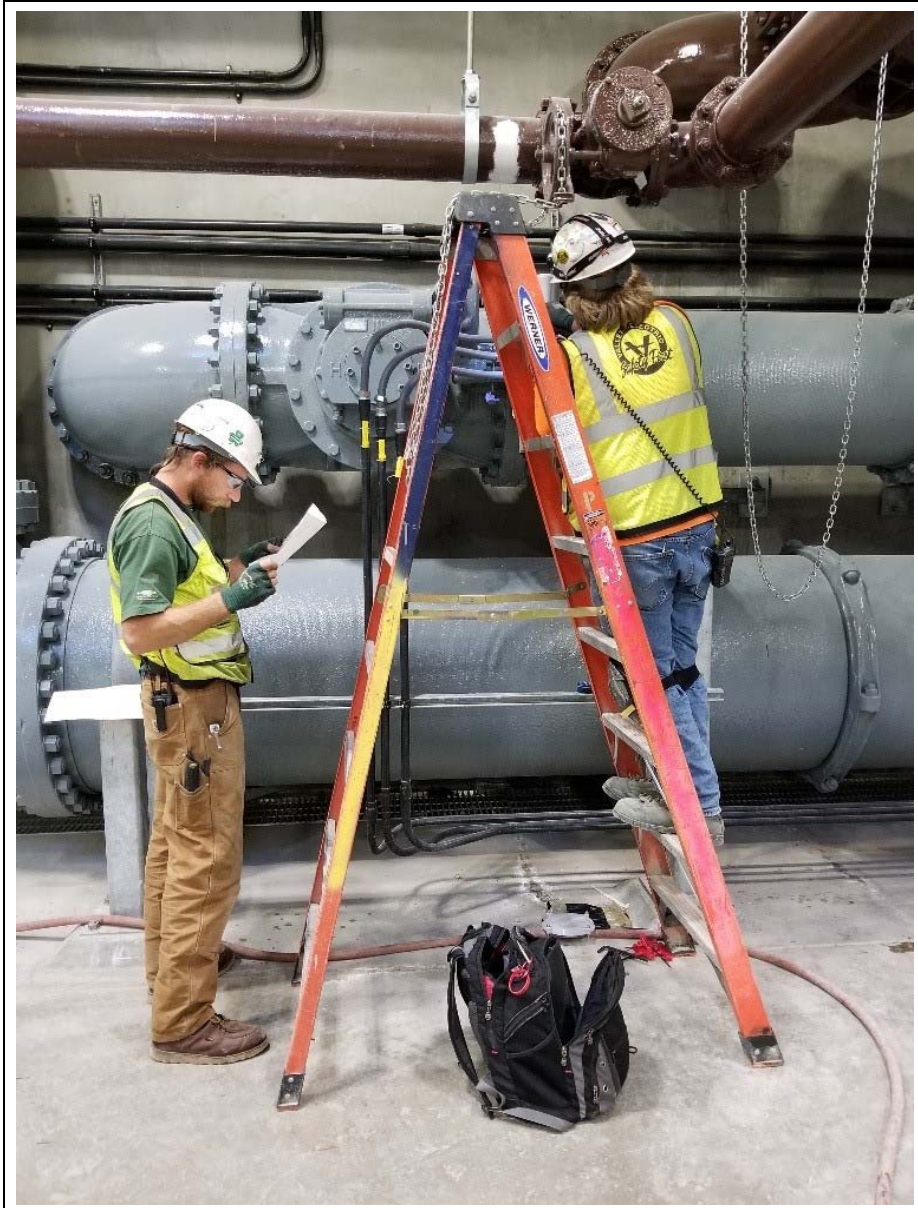
Photo #4

Area 35 RAS/WAS
Pumping (looking south)
on Thursday, October 4th.

Electricians for Valley
Electric are evaluating a
problem with a motor
operated valve actuator.

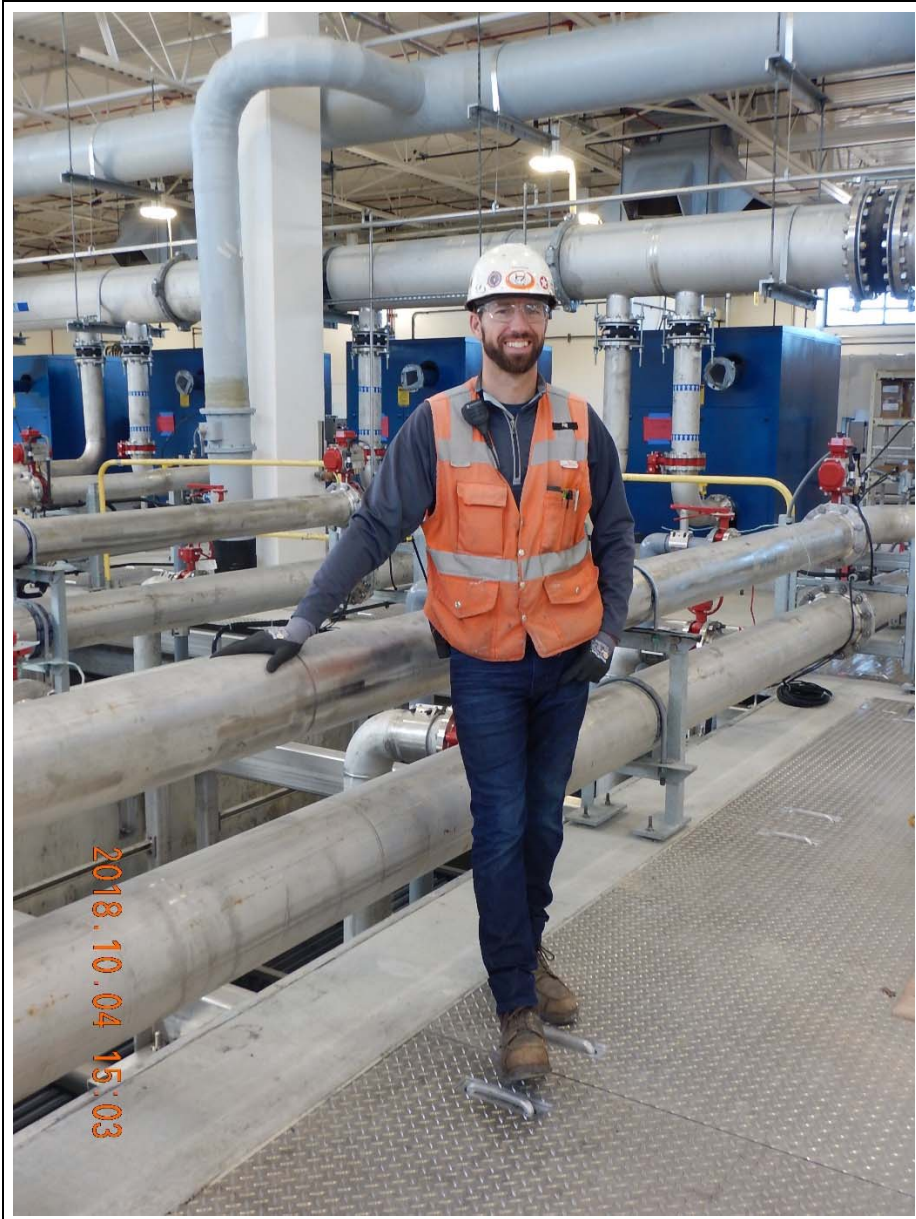
Photo #5

Area 30 Secondary Treatment Building (looking northwest) on Thursday, October 4th.

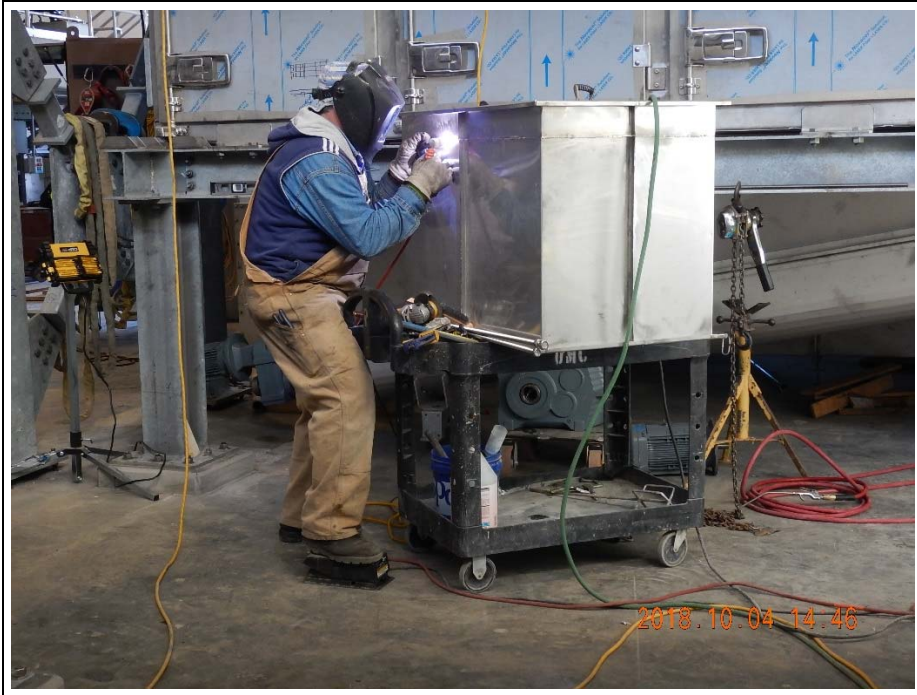
Photo #6

Area 50 Biosolids Building
(looking east) on
Thursday, October 4th.

A pipefitter for University
Mechanical is welding on a
section of stainless steel
ductwork that will become
part of the biosolids dryer
system.

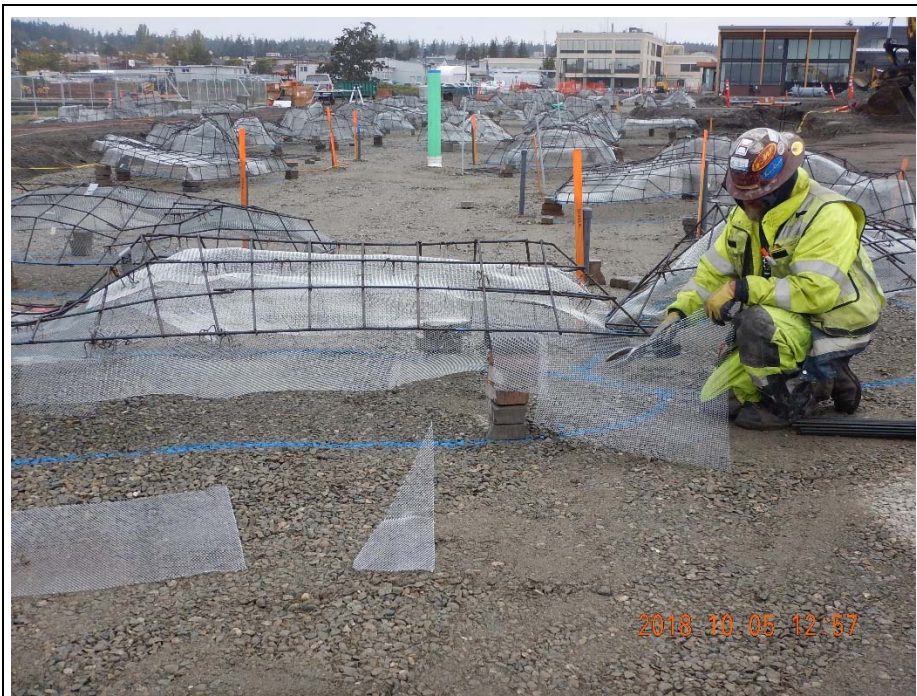
Photo #7

South end of Windjammer
Park (looking north at the
splash park) on Friday,
October 5th.

A carpenter for Turnstone
Construction is cutting
steel mesh to facilitate
construction of a faux rock
for the splash park.

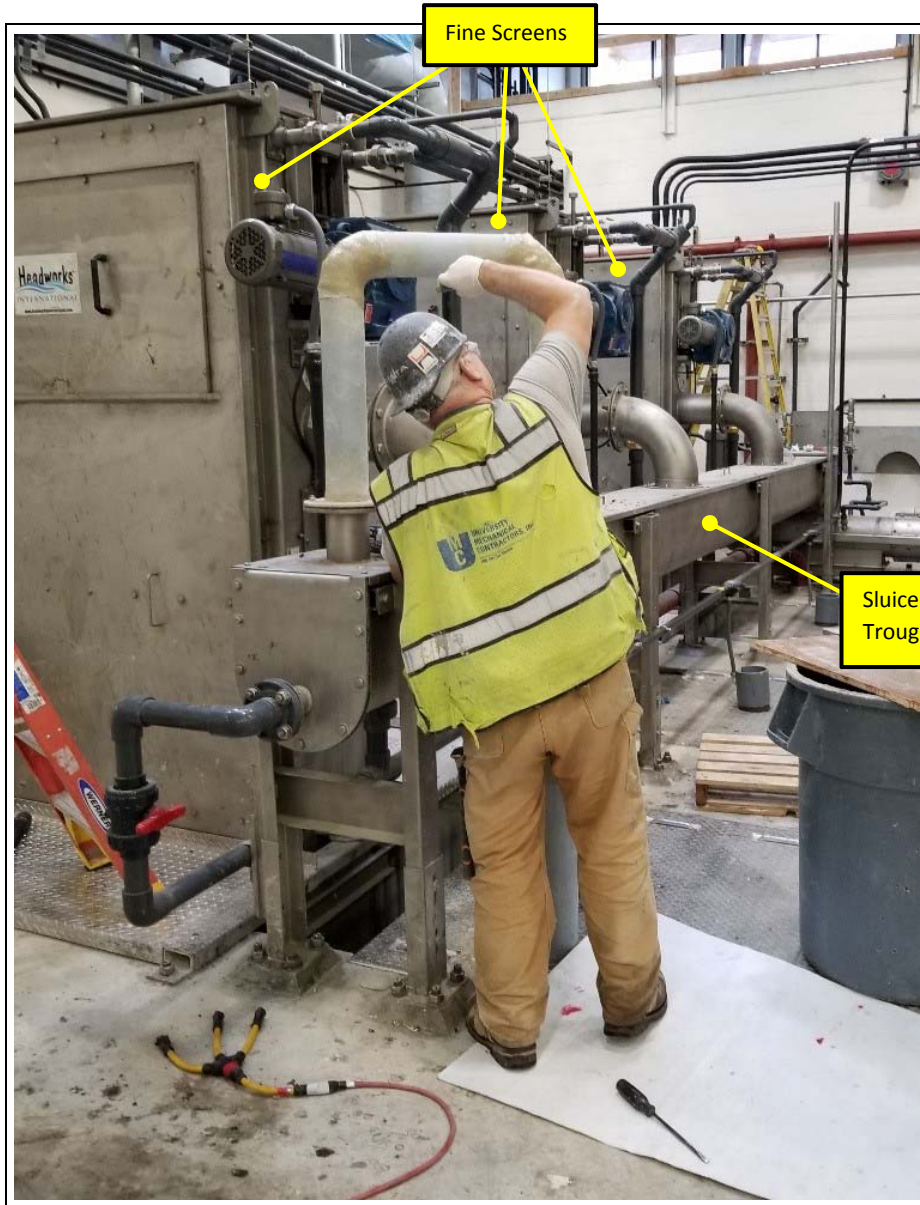
Photo #8

Area 20 Headworks (looking east) on Monday, October 8th.

A sheet metal worker for Delta Technology Corporation is installing fiber reinforced plastic (FRP) foul air piping between a sluice trough (associated with three fine screens) and a fine screen channel.

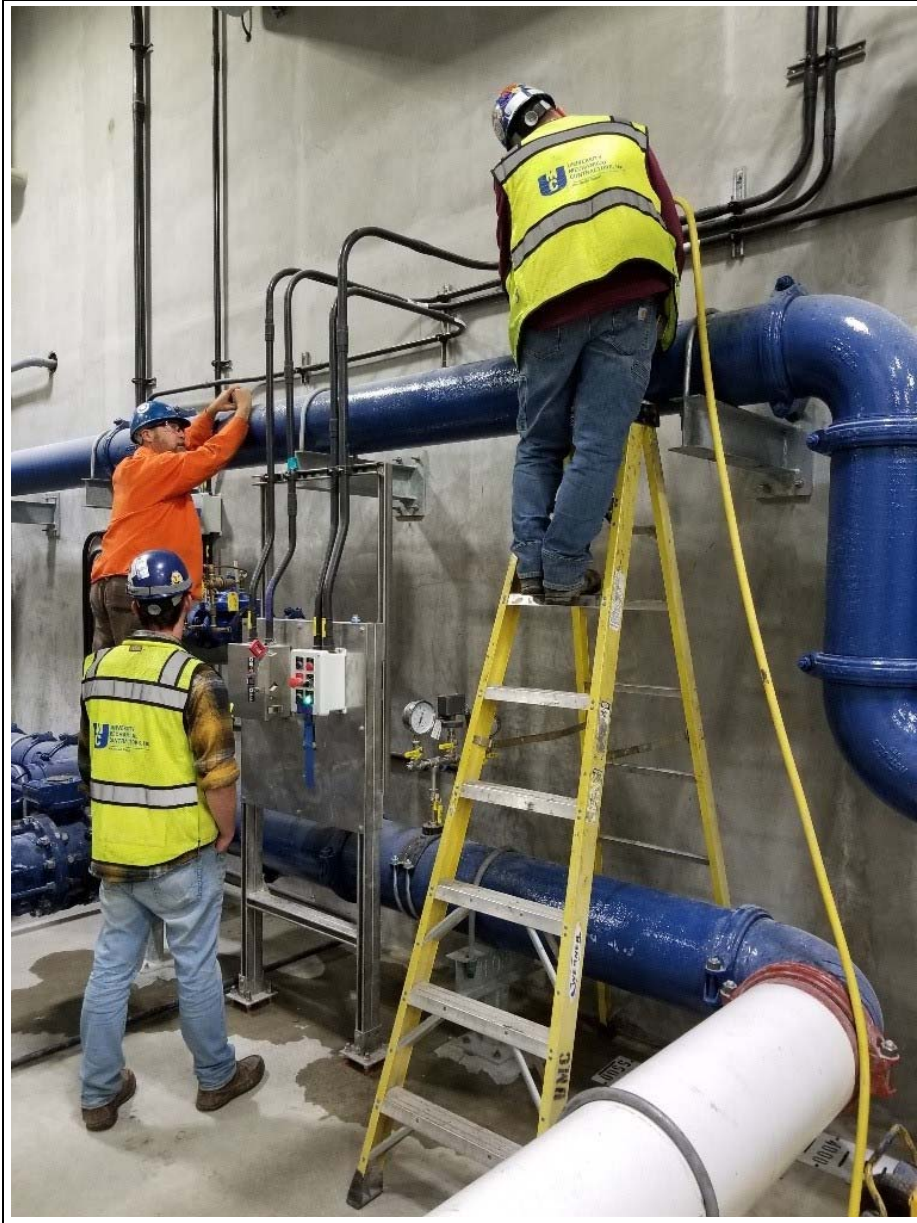
Photo #9

Area 38 Utility Water
(looking northwest) on
Tuesday, October 9th.

Pipefitters for University
Mechanical are testing a
pressure relief valve that
is part of a utility water
distribution system. The
pipefitters verified that the
pressure relief valve
opened at 175 psi.

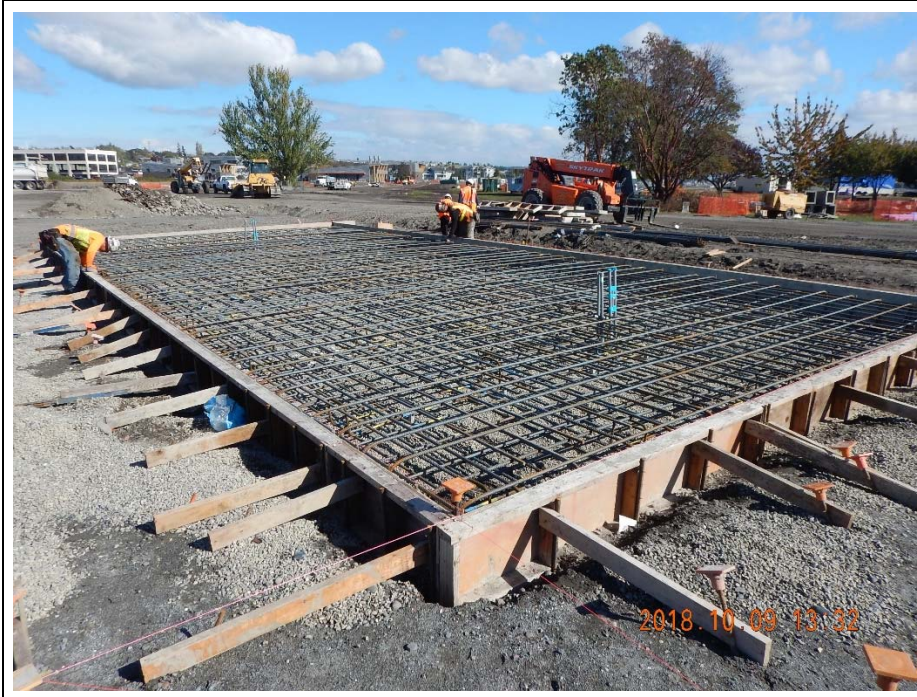
Photo #10

West end of Windjammer Park (looking east) on Tuesday, October 9th.

Ironworkers for Morse Steel Services are placing reinforcing steel for a concrete slab-on-grade for a pavilion.

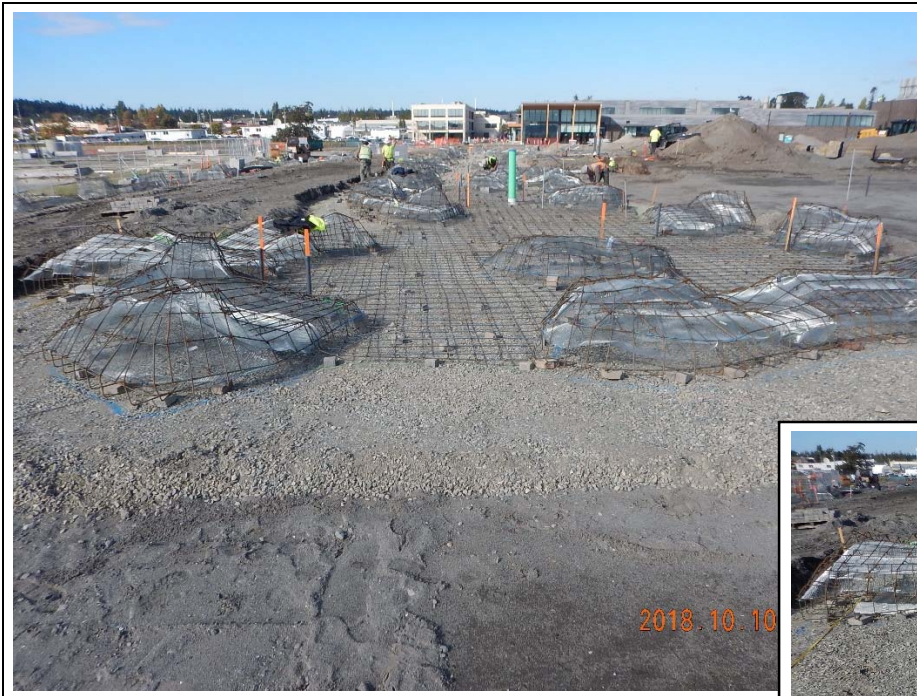
Photo #11

South end of Windjammer Park (looking north at the splash park) on Wednesday, October 10th.

Turnstone Construction is using rebar and steel mesh to build faux rocks.

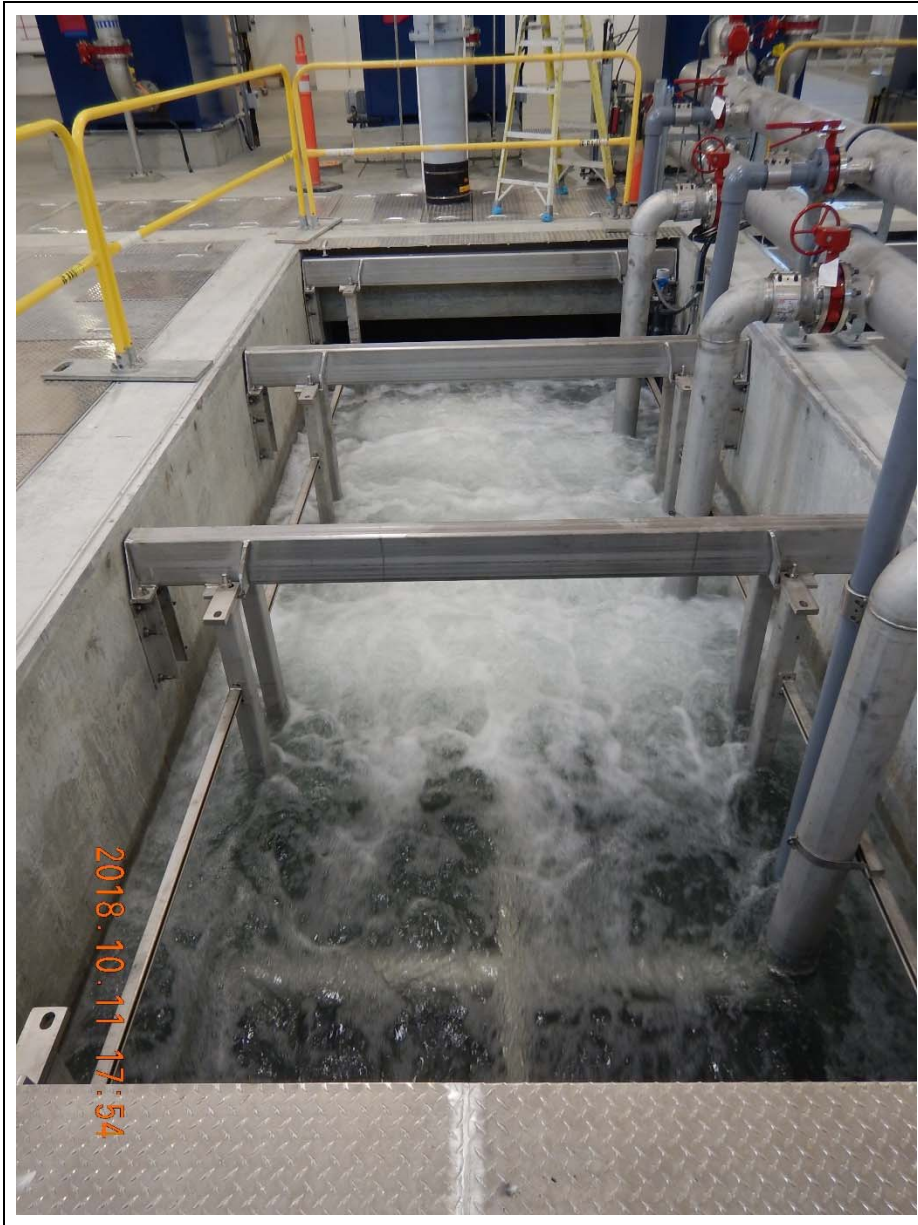
Photo #12

Area 30 Secondary Treatment Building (looking north) on Thursday, October 11th.

A commissioning representative for Suez Water Technologies, Kathleen McAllister (not seen in the photo), is operating the membrane filtration system from a vendor control panel in the electrical room.

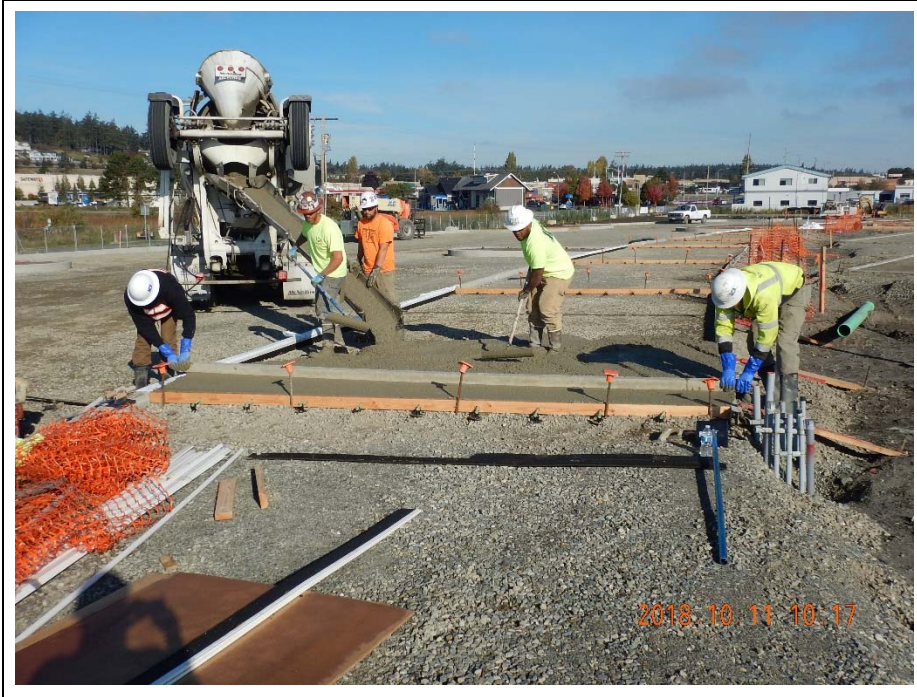
Photo #13

West end of Windjammer Park (looking northwest) on Thursday, October 11th.

Carpenters and laborers for Interwest Construction are placing concrete for a sidewalk.

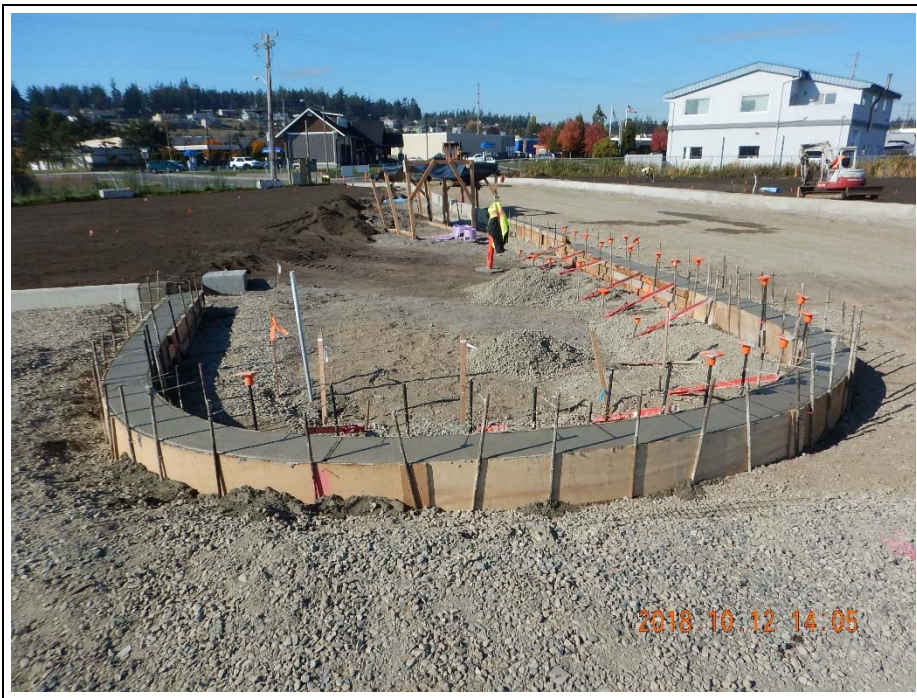
Photo #14

Northwest entrance to Windjammer Park (looking northwest) on Friday, October 12th.

Interwest Construction placed concrete for a curb.

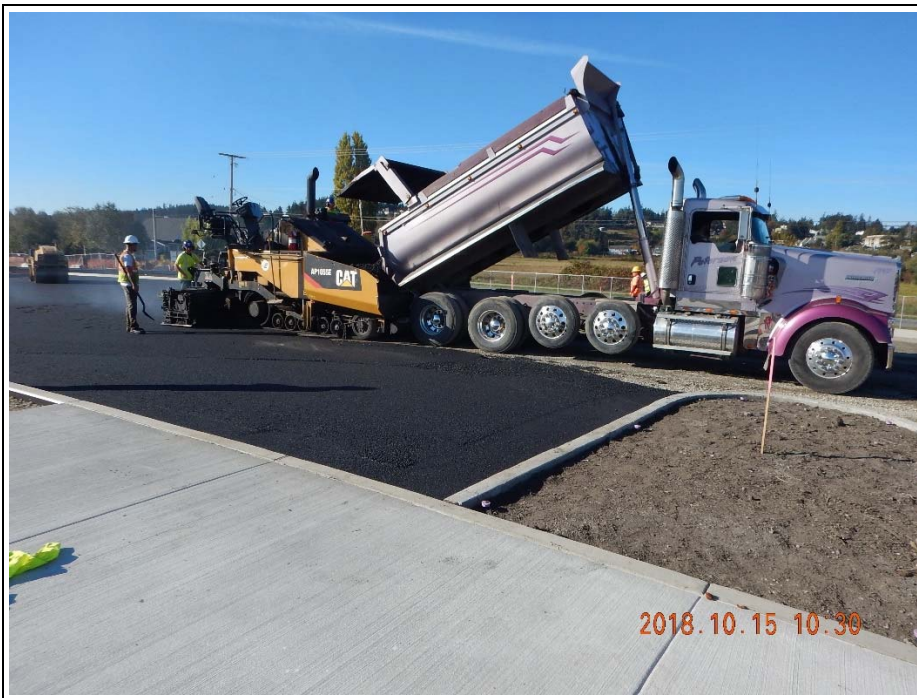
Photo #16

West end of Windjammer Park (looking southwest) on Monday, October 15th.

Operators and laborers for Lakeside Industries are utilizing an asphalt paving machine to place hot-mix asphaltic concrete (AC) pavement for a parking lot.

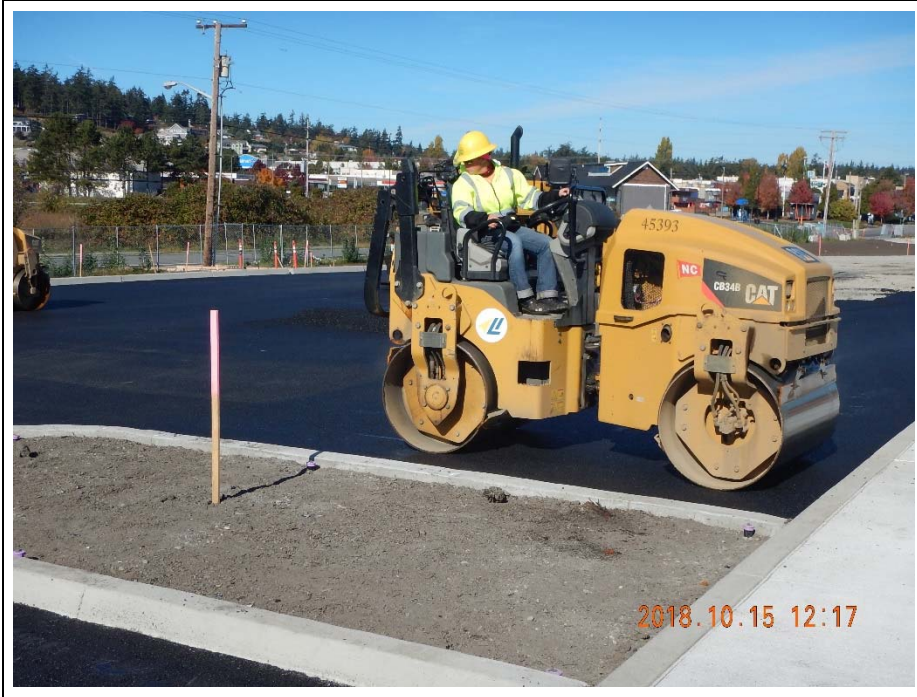
Photo #17

West end of Windjammer Park (looking northwest) on Monday, October 15th.

An operator for Lakeside Industries is utilizing a smooth drum roller to increase the density (i.e., compact) newly placed hot-mix AC pavement.

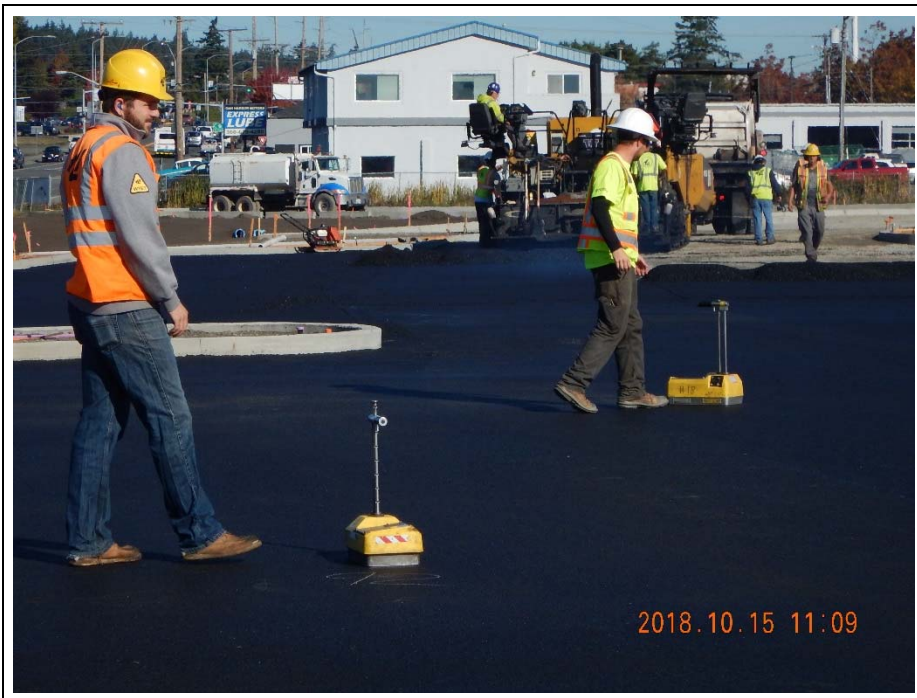
Photo #18

West end of Windjammer Park (looking north) on Monday, October 15th.

A quality assurance technician for Lakeside Industries (left) and an inspector for GeoTest Services (right) are utilizing nuclear density gauges to measure the density of compacted AC pavement. The inspector for GeoTest represents the City. A paving machine is seen in the background placing new pavement.

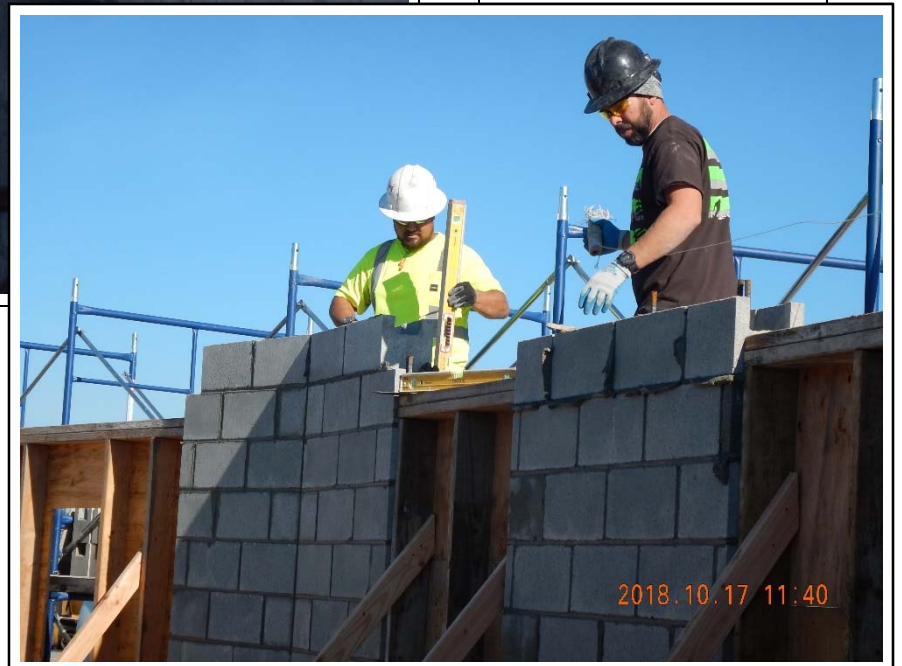
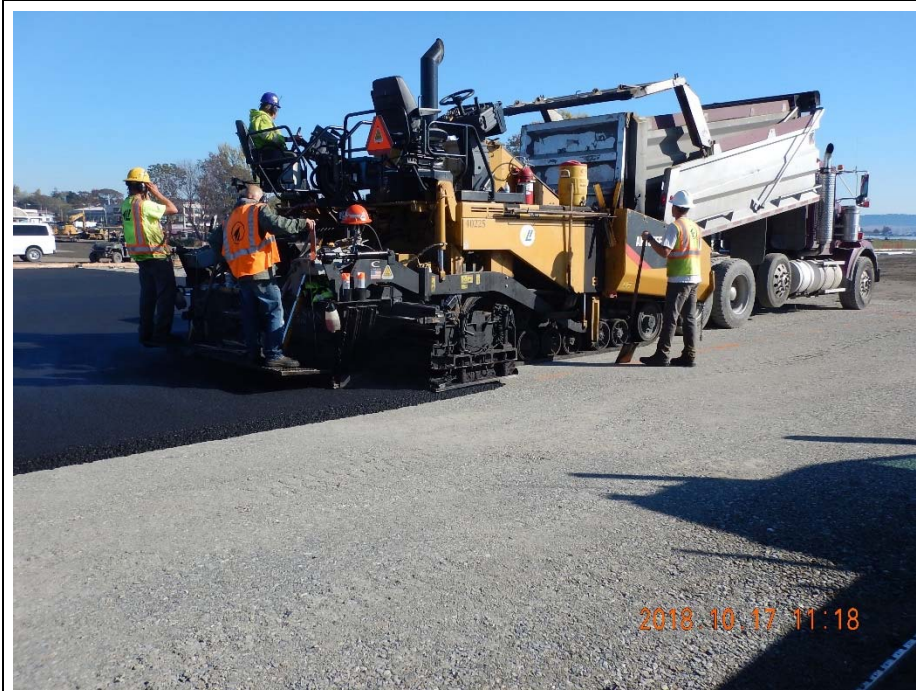
Photo #20

West end of Windjammer Park.

Top: Lakeside Industries is placing AC pavement for two basketball courts (looking northeast) on Wednesday, October 17th.

Bottom: The basketball courts (looking northwest) on Thursday, October 18th, after paving is complete.

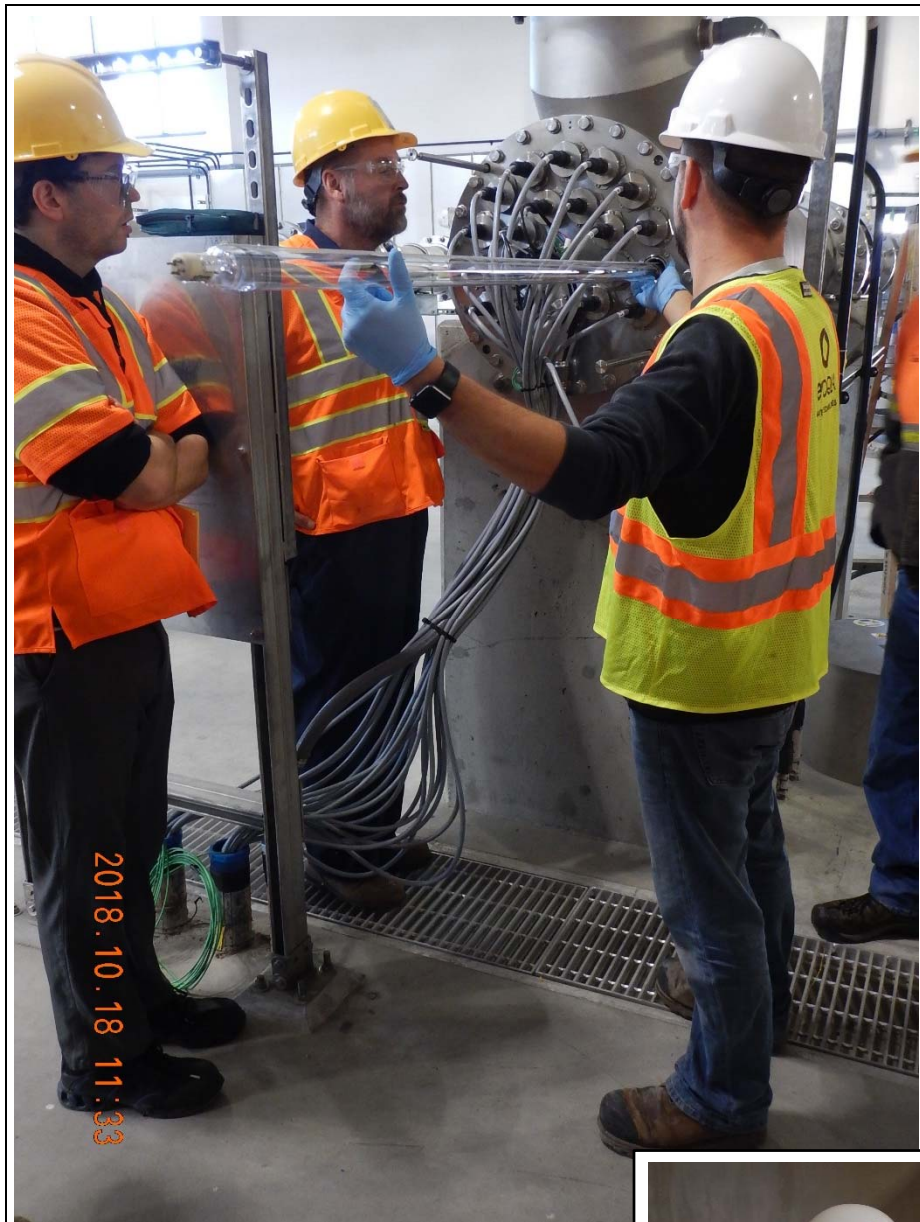
Photo #22

Area 30 Secondary Treatment Building (looking north) on Thursday, October 18th.

Top: EVOQUA Water Technologies project manager Greg Manier (right) is conducting an operator training class. He is seen demonstrating how to remove one of 20 ultraviolet lights from an ultraviolet (UV) reactor. The ultraviolet lights neutralize microorganisms in membrane effluent before the membrane effluent is discharged into Oak Harbor Bay.

Bottom: Mr. Manier explains how to use an operator interface terminal (i.e., a touch-screen) located on the door of a vendor control panel.

GMPA No. 1 – MBR System and UV Disinfection Equipment (Procurement) and Engineering Support. Work on this GMPA is approximately 83% complete. Throughout the month of October, representatives of Suez Water Technologies began operating and testing the membrane filtration system with potable water (see Photo #12) and, during the week beginning Monday, October 29th, began conducting 40 hours of operator training classes (see Photo #51). On Thursday, October 18th, a representative of EVOQUA conducted an operator training class pertaining to UV disinfection equipment (see Photo #22). Start-up testing must be completed before this GMPA is deemed complete.

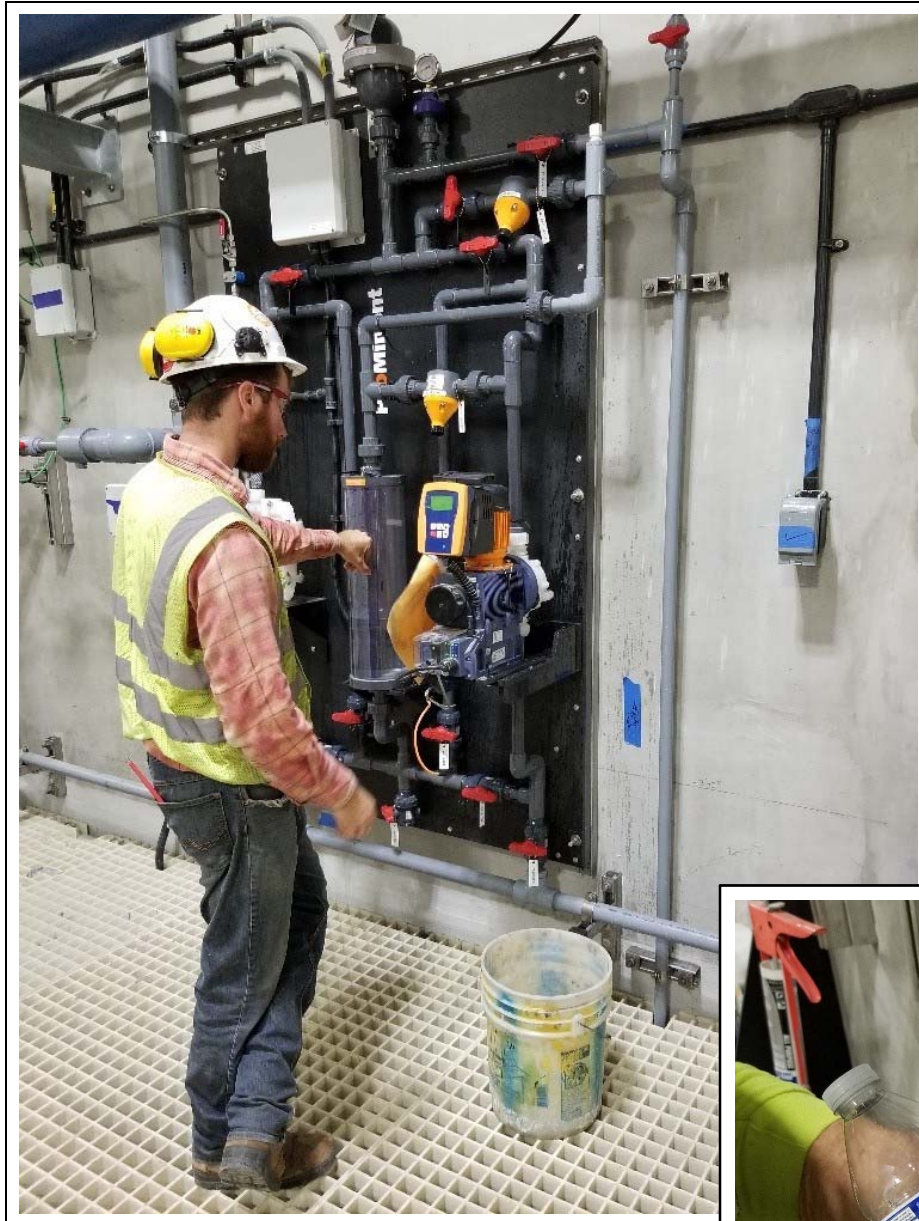
Photo #23

Bottom: A chemical leak detector is being tested by verifying that it can detect water in a plastic bottle. The sensor detects the water in the bottle without making contact with the water.

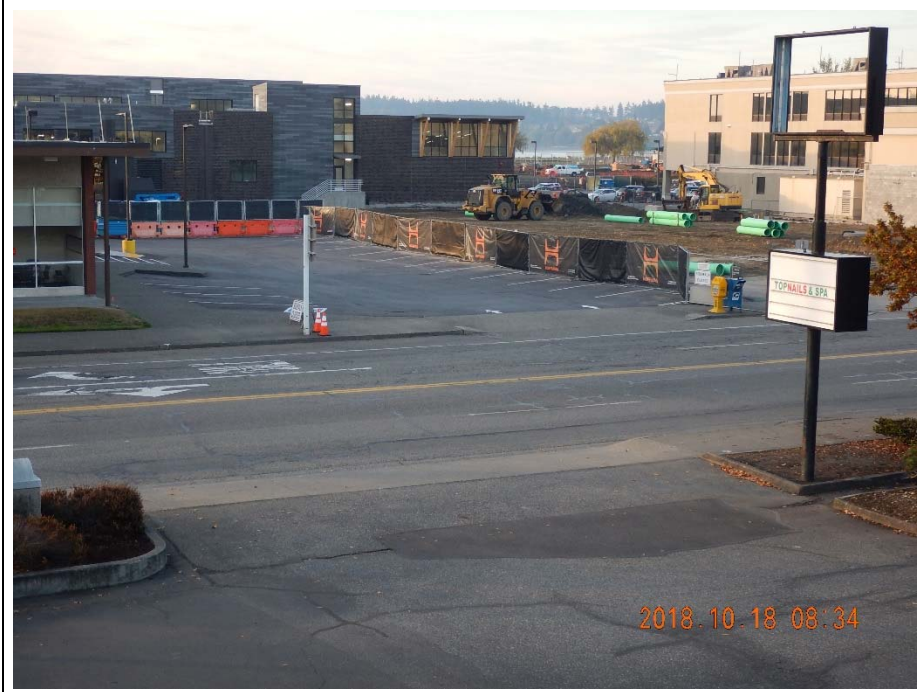
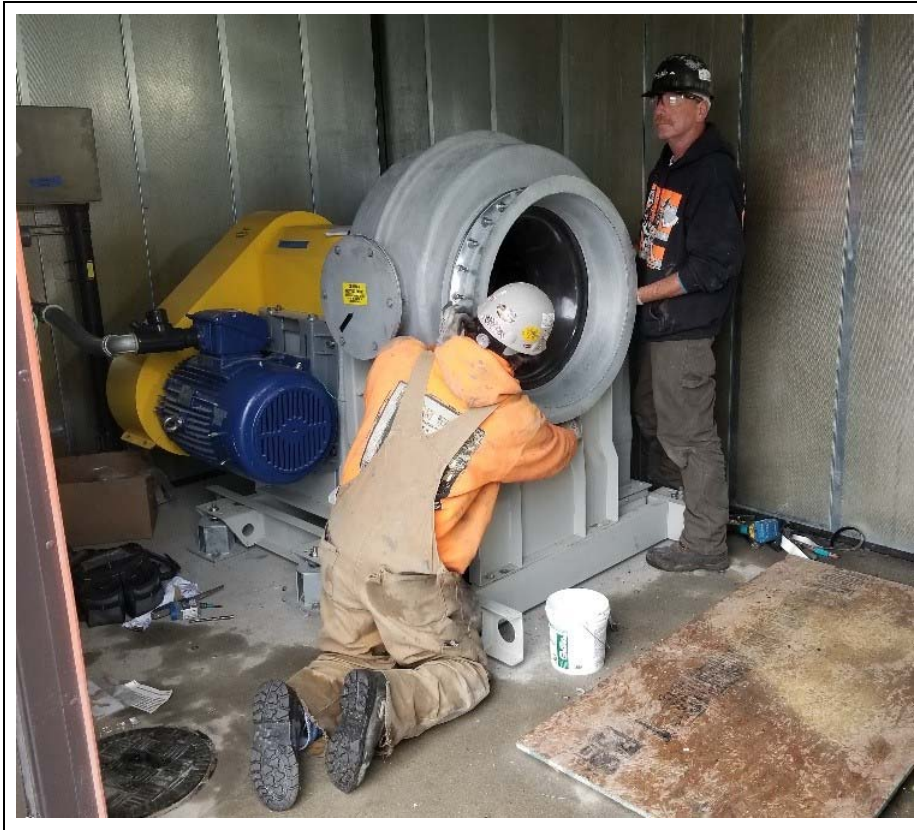
Photo #25

Area 60 Odor Control
(looking southwest) on
Monday, October 22nd.

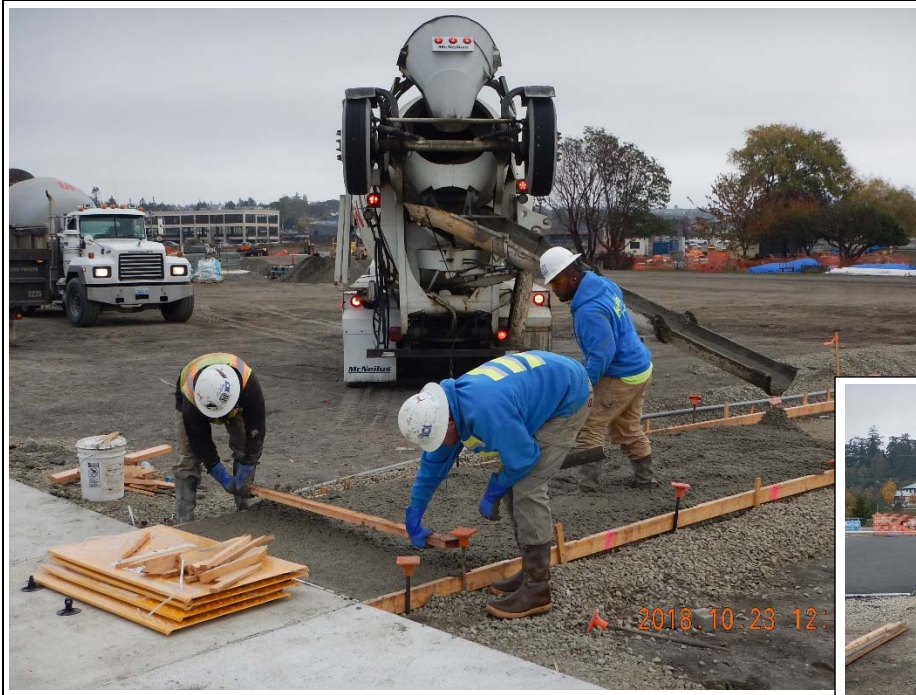
Photo #28

West end of Windjammer Park (looking east and northwest) on Tuesday, October 23rd.

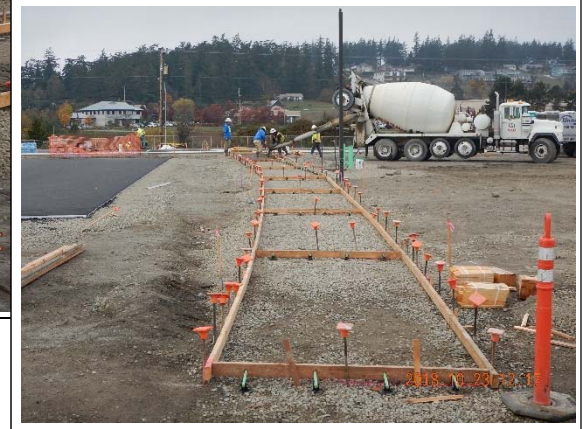
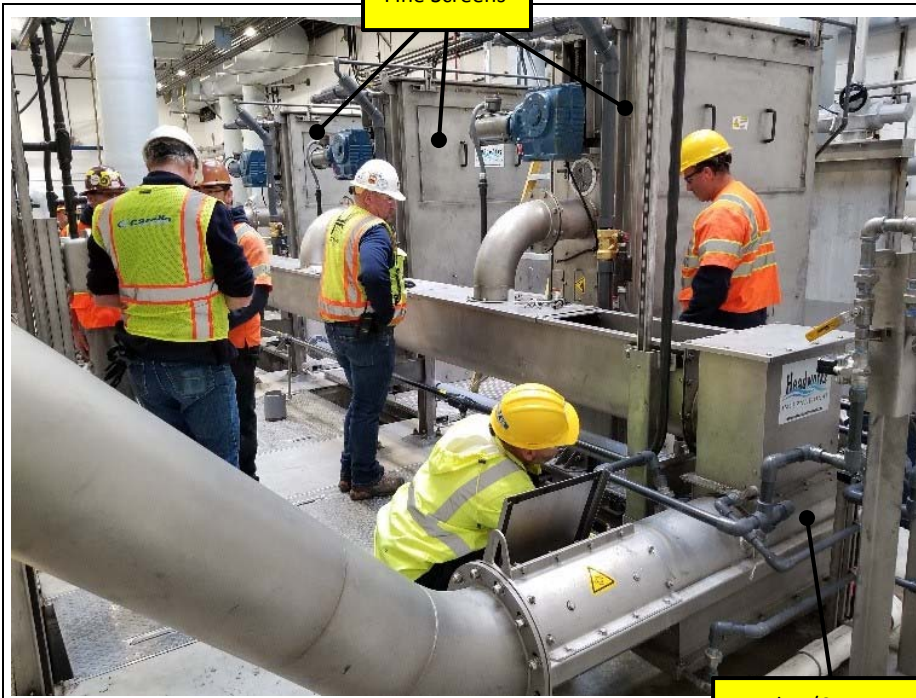
Photo #29

Fine Screens

Washer/Compactor

Representatives of Carollo Engineers, Hoffman Construction, and the City are operating and testing fine screens and a washer/compactor.

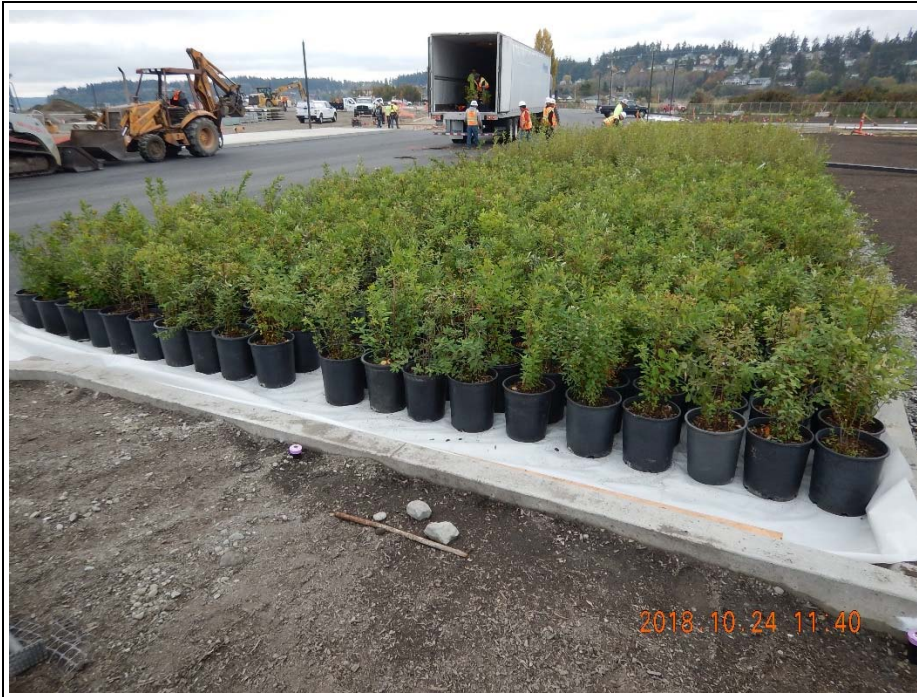
Photo #32

Northwest end of Windjammer Park (looking southwest) on Wednesday, October 24th.

Pacific Earth Works is receiving its first shipment of plantings for the park.

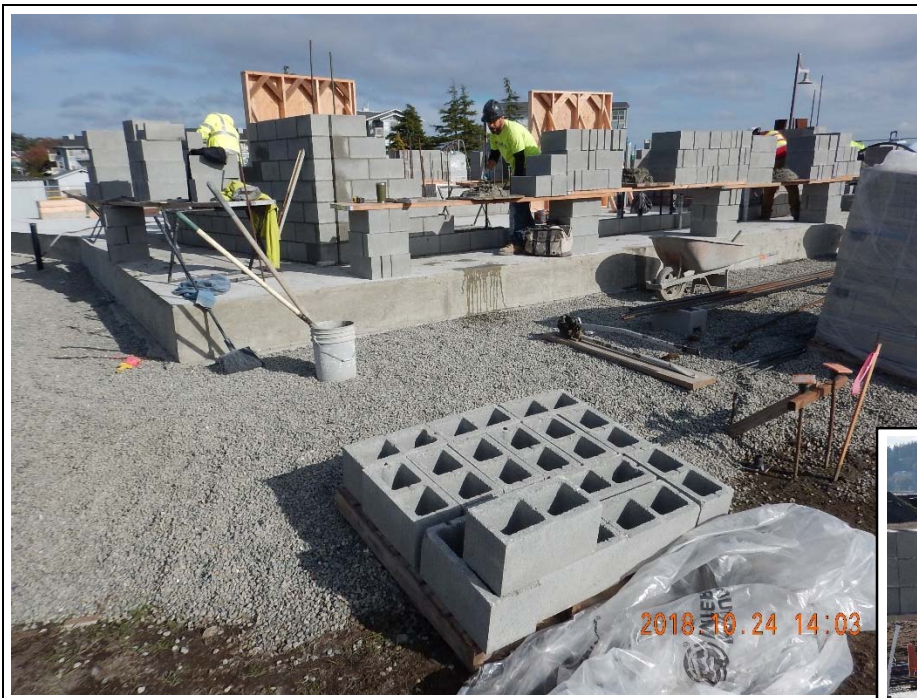
Photo #33

Southeast end of Windjammer Park (looking east and west) on Wednesday, October 24th.

Brick masons for Black Rock Masonry are placing CMU blocks for the east kitchen.

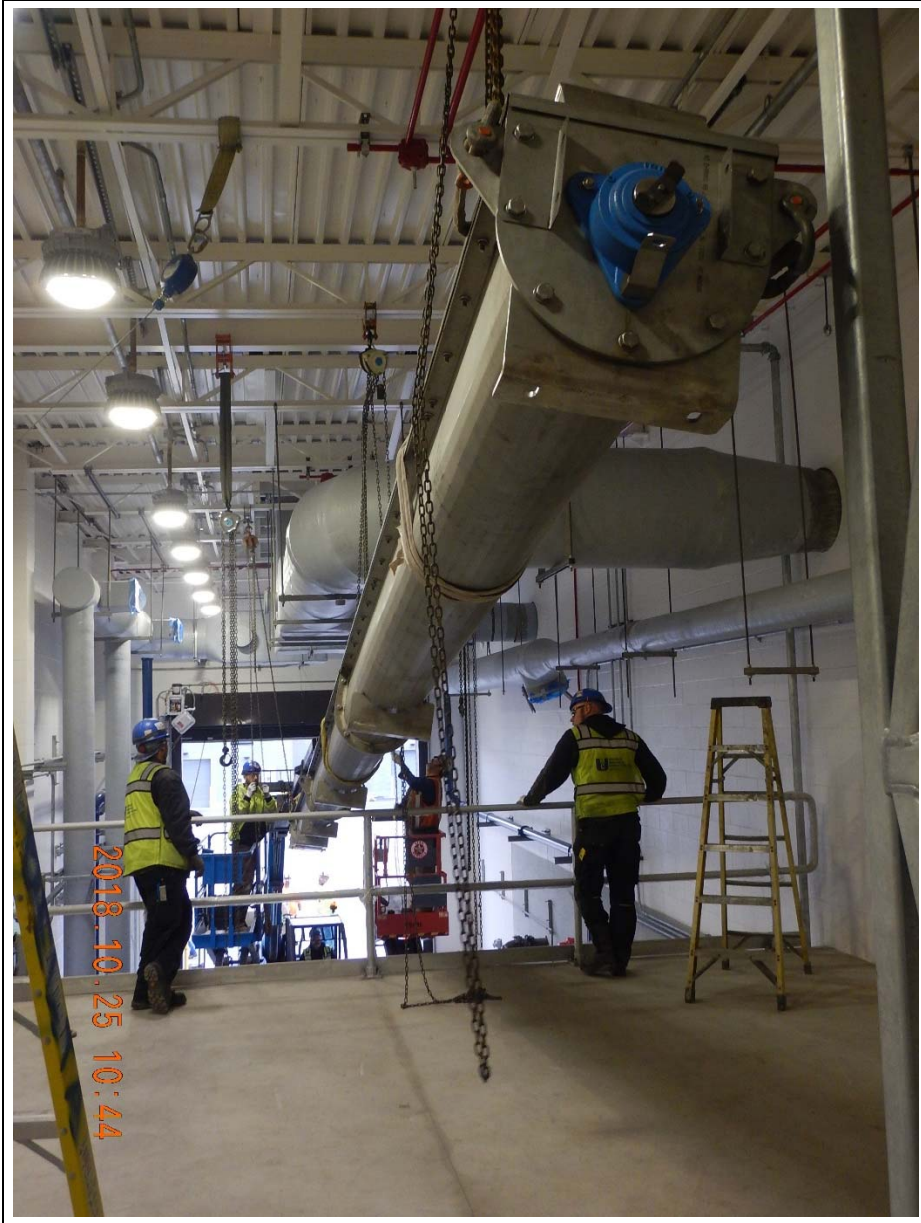
Photo #37

Pipefitters for University Mechanical are installing a section of a transfer conveyor system. The transfer conveyor system will convey biosolids from the dryer system to a rollout bin.
