City of Oak Harbor
City Council Agenda Bill

Bill No. 5. c. i.
Date: November 20, 2018
Subject: Clean Water Facility Update

Clean Water Facility Project

MONTHLY PROGRESS REPORT

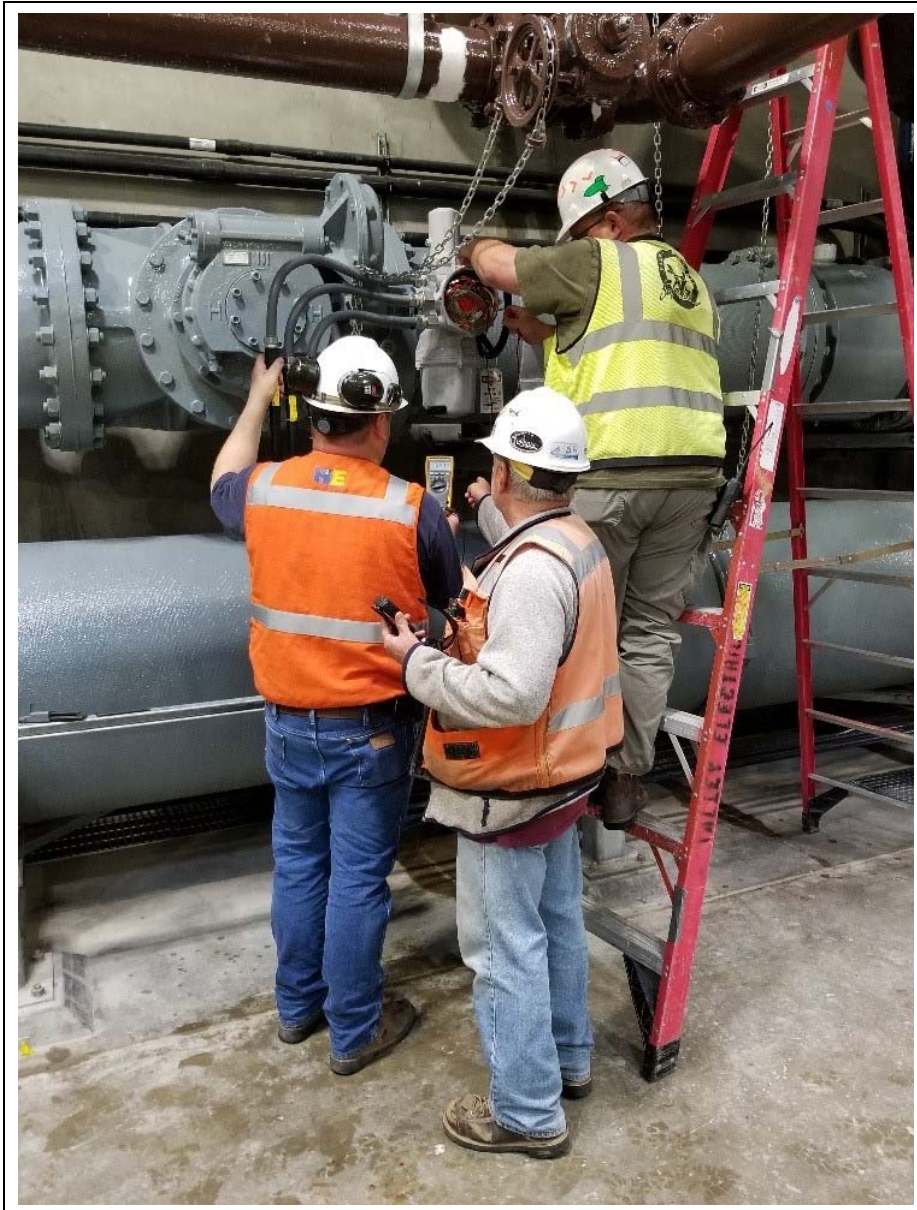
Photo #39

An electrician for Valley Electric, Dan Weiland (top right), and a technician for QualiTEQ (left) are troubleshooting a problem with a motor operated valve actuator. Hoffman's superintendent, Bryan Shirley, is in the middle.

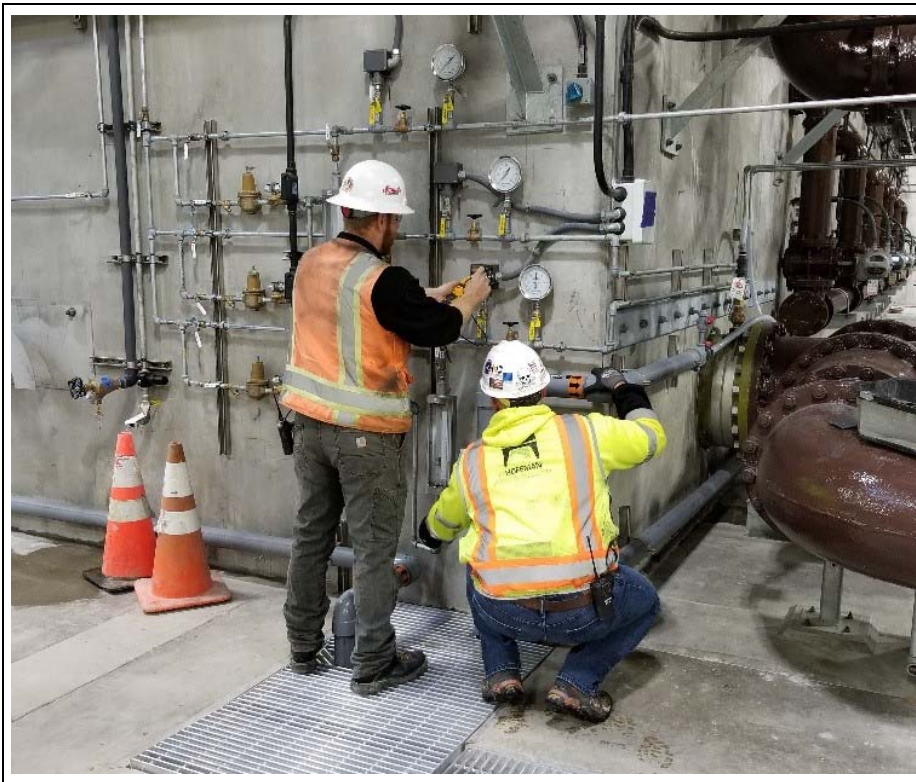
Photo #41

An electrician for Valley Electric (left) and a project engineer for Hoffman are checking a seal water pressure switch associated with a return activated sludge (RAS) pump. The switch shuts off the RAS pump if seal water pressure drops below a set point.

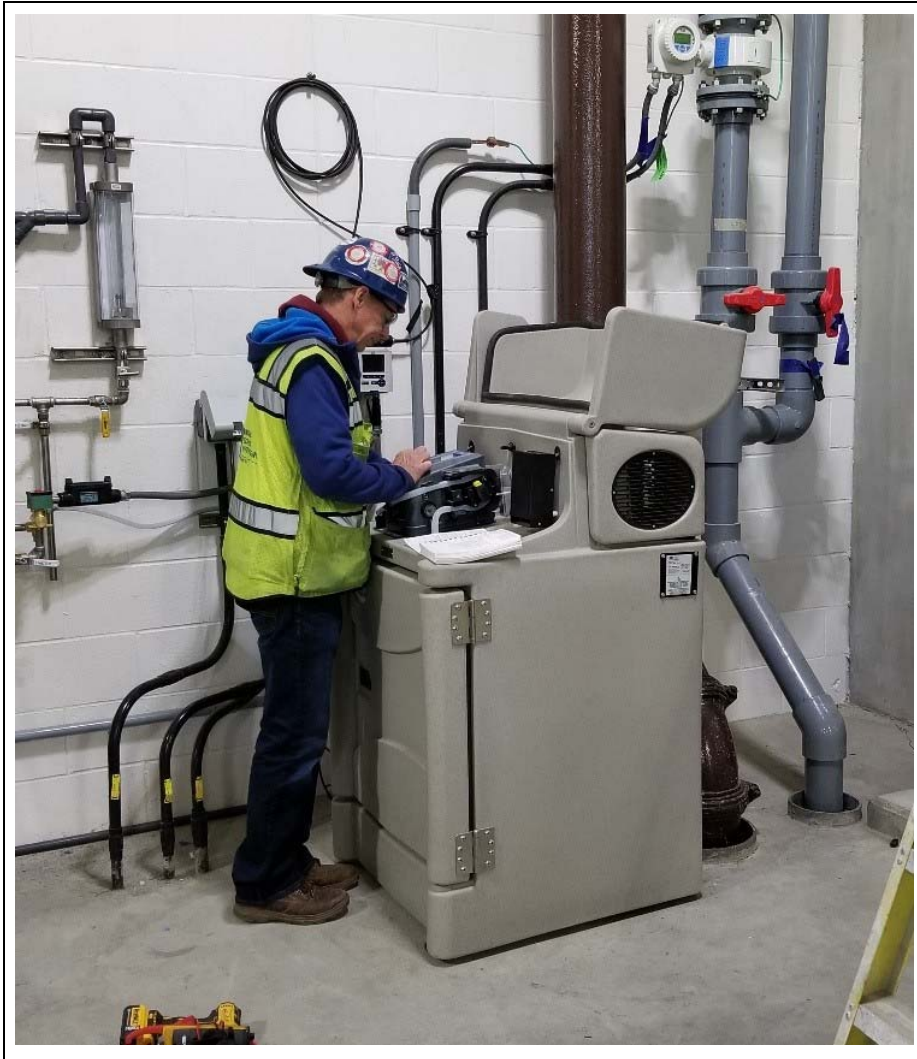
Photo #42

A pipefitter for University Mechanical, Vern Roach, is programming an automatic sampler. The automatic sampler in the photo collects samples of membrane effluent. The samples are tested in the City's new laboratory for biological oxygen demand (BOD), total dissolved solids (TDS), potential hydrogen (pH), and other water quality parameters.

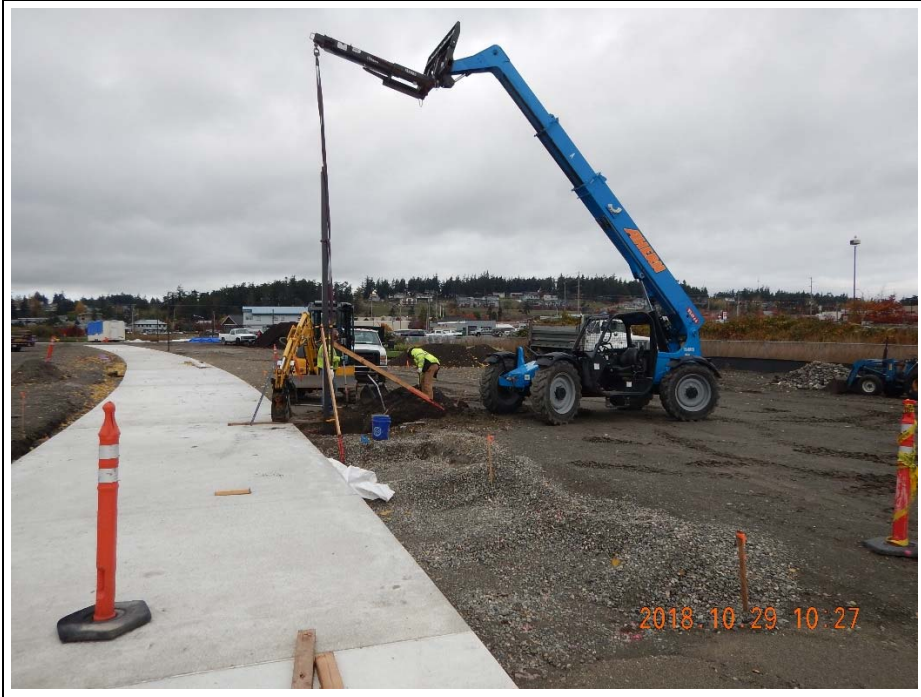
Photo #43

North end of Windjammer Park (looking west) on Monday, October 29th.

Electricians for Valley Electric are installing a fiberglass light pole next to a recently constructed walkway.

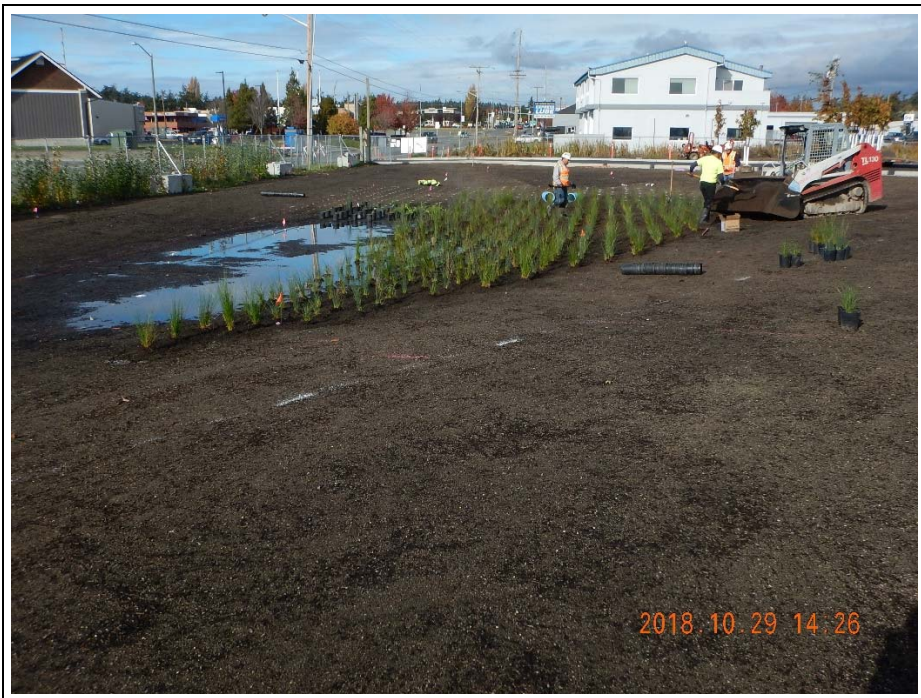
Photo #44

Northwest end of Windjammer Park (looking north) on Monday, October 29th.

Landscapers for Pacific Earth Works begin to plant wetland enhancement plantings at a storm water detention pond.

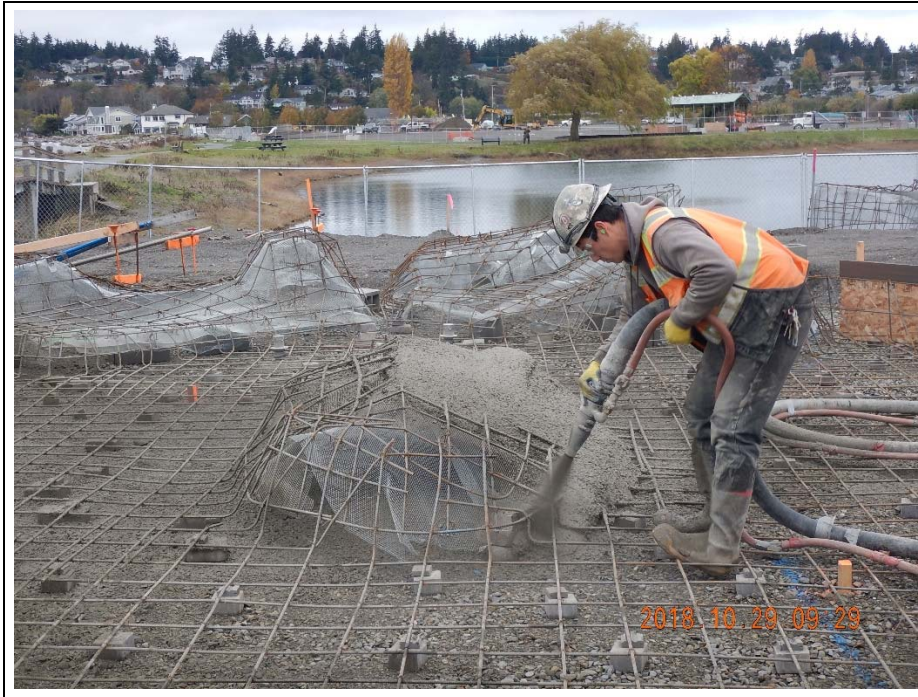
Photo #45

South end of Windjammer Park (looking west towards the lagoon) on Monday, October 29th.

A laborer for Turnstone Construction is placing concrete for a faux rock at the splash park by means of the "shotcrete" method.

GMPA No. 13 – Windjammer Park Improvements. Work on this portion of GMPA No. 13 is approximately 38% complete. Interwest Construction installed PVC spray piping for the splash park and PVC piping for a water feature next to the administration building. Interwest Construction placed, graded, and compacted on-site earthen material and imported aggregate base material for curbs, sidewalks, and a parking area at the southwest corner of the park. Interwest Construction continued to build formwork and place concrete for curbs, sidewalks, and walkways at the west and north ends of the park (see Photos #13, #14, and #28). Interwest Construction's subcontractor, Lakeside Industries, graded base rock for two basketball courts and for a traffic circle (see Photo #15). During the third week of October, Lakeside Industries placed and compacted asphaltic concrete (AC) pavement for a parking lot at the west side of the park (see Photos #16 through #18). Lakeside Industries also placed pavement for the two basketball courts (see Photo #20). At the end of October, Interwest Construction placed and compacted imported aggregate base material for seat walls near the pavilion and the west kitchen. Pacific Earth Works installed irrigation system lateral piping (including spray nozzles) and placed and graded top soil at the west and north ends of the park. Pacific Earth Works installed irrigation lateral piping and placed and graded top soil at a storm water detention pond located just west of the administration building. Pacific Earth Works received its first shipment of plantings (see Photo #32) and began to place wetland enhancement plantings at a storm water detention pond near the northwest entrance to the park (see Photo #44). At the end of October, Pacific Earth Works installed irrigation system lateral piping for a water feature located adjacent to the west and south sides of the administration building. Valley Electric continued to install buried PVC electrical conduits throughout the park and began installing fiberglass light posts (see Photo #43). Valley Electric also installed a copper grounding cable throughout a slab-on-grade for the splash park (Turnstone Construction attached the grounding cable to brass nozzles and cast iron drain inlets so they are grounded). At the end of October, Valley Electric excavated and installed conduit for an electrical service connection at the southwest corner of the park. P&L General Contractors and its subcontractors, Valdez Construction, Morse Steel Services, and LangCo NW, built formwork and placed reinforcing steel and concrete for the east and west kitchens and pavilion (see Photo #10). Another one of P&L General Contractors' subcontractors, Black Rock Masonry, began placing CMU block for walls for the east and west kitchens (see Photos #19 and #33). Turnstone Construction assembled, fabricated, and placed reinforcing steel and steel mesh for faux rocks for a splash park (see Photos #7 and #11). At the end of October, Turnstone Construction placed concrete for the faux rocks by means of the "shotcrete" method (see Photos #45 and #46).

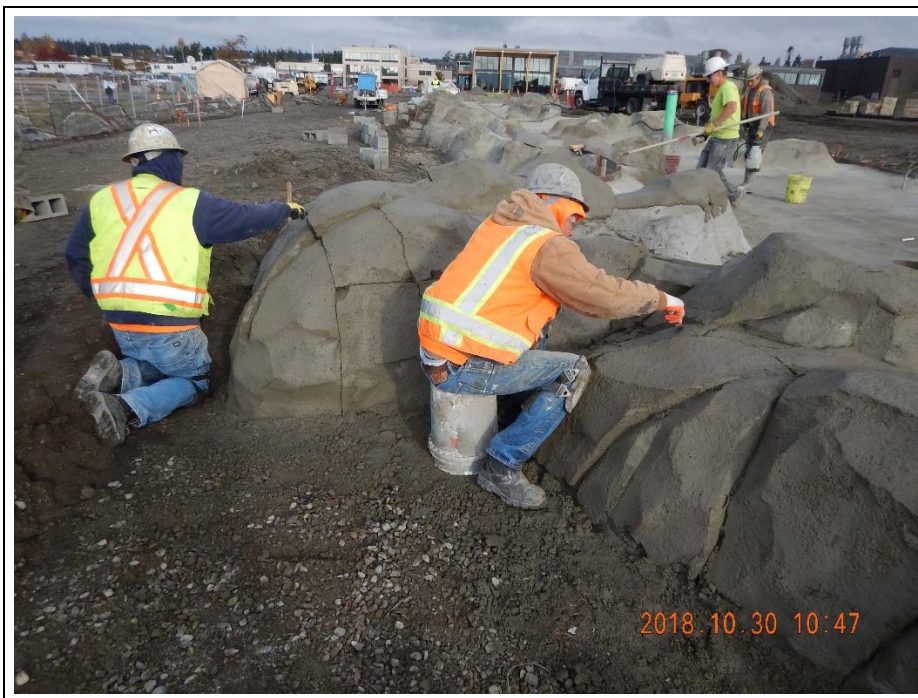
Photo #46

South end of Windjammer Park (looking north towards the administration building) on Tuesday, October 30th.

Laborers for Turnstone Construction are "sculpting" concrete for faux rocks at the splash park.

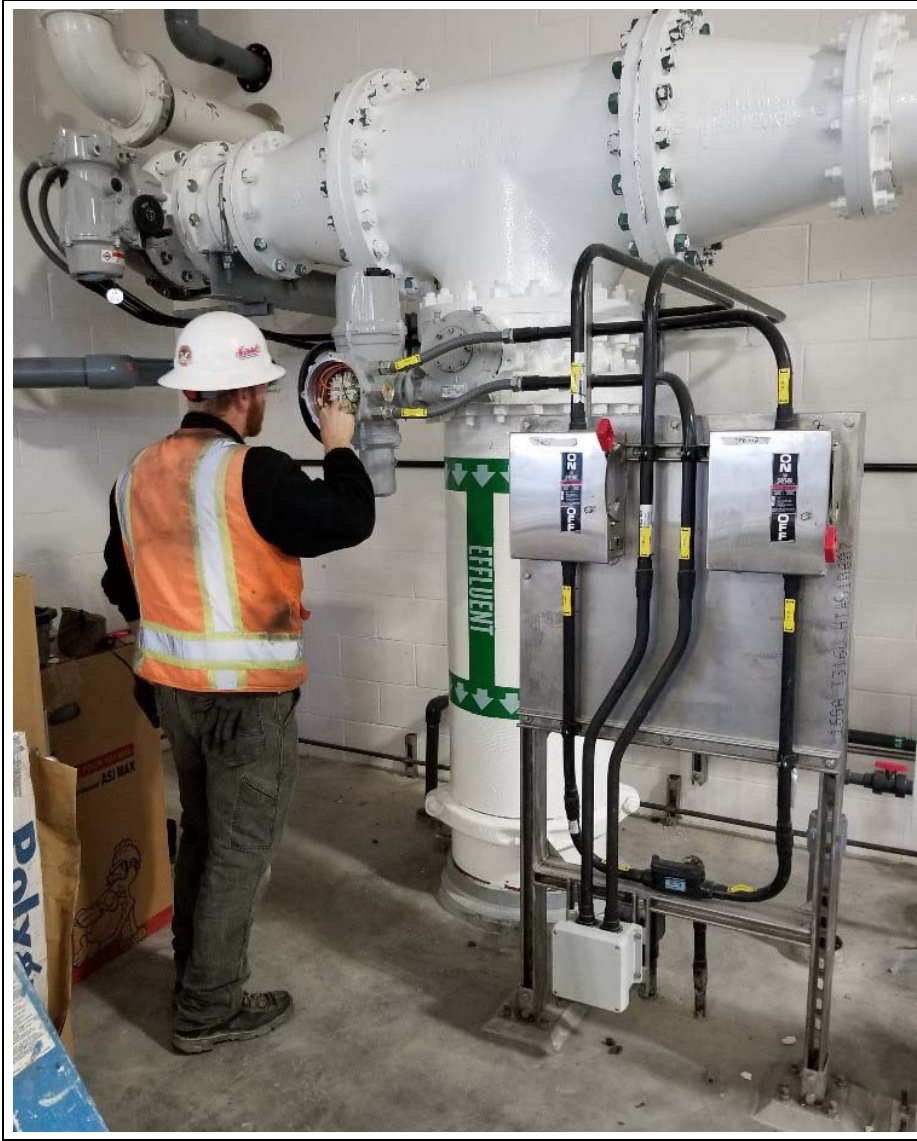
Photo #47

Area 36 UV Disinfection
(looking northeast) on
Tuesday, October 30th.

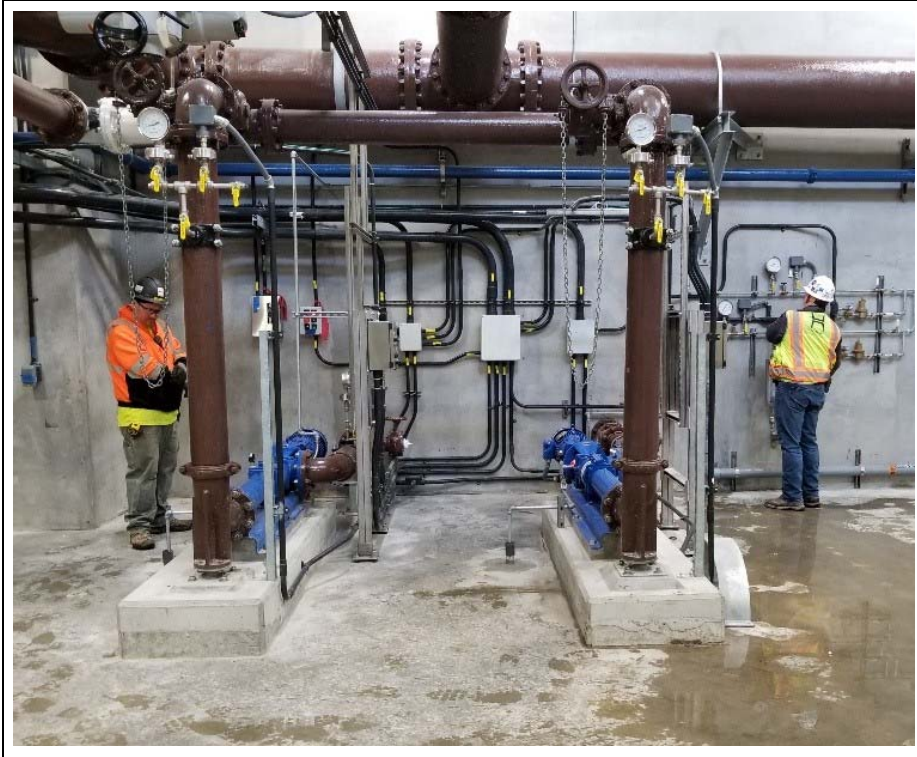
Photo #48

Workers for Hoffman Construction are verifying that seal water pressure switches associated with waste activated sludge (WAS) transfer pumps are operating correctly.

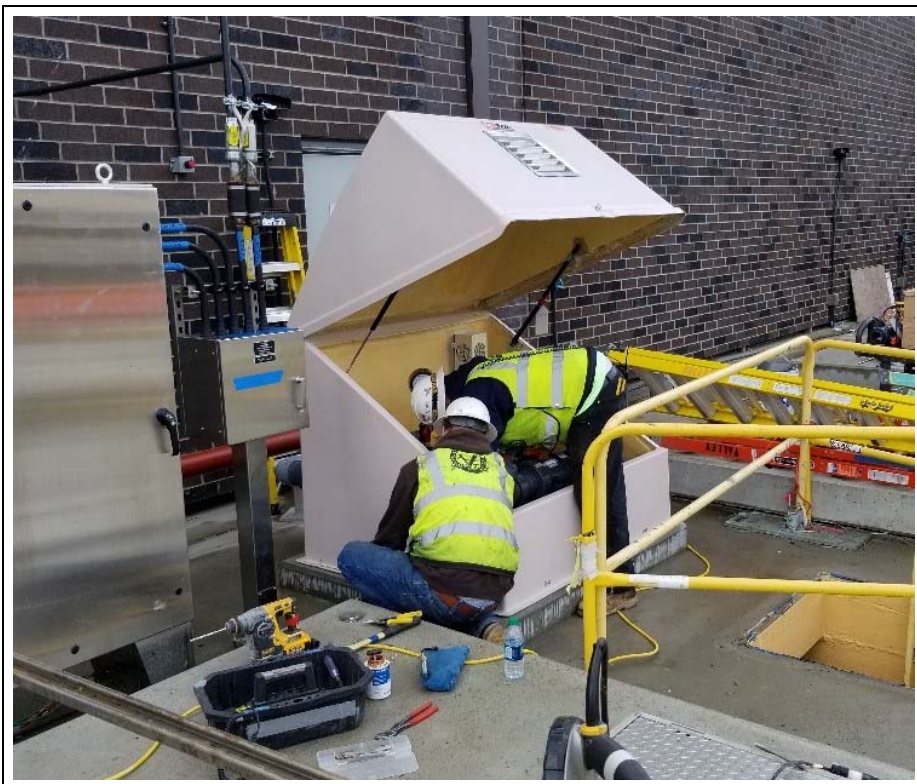
Photo #49

Area 60 Odor Control (looking southwest) on Tuesday, October 30th.

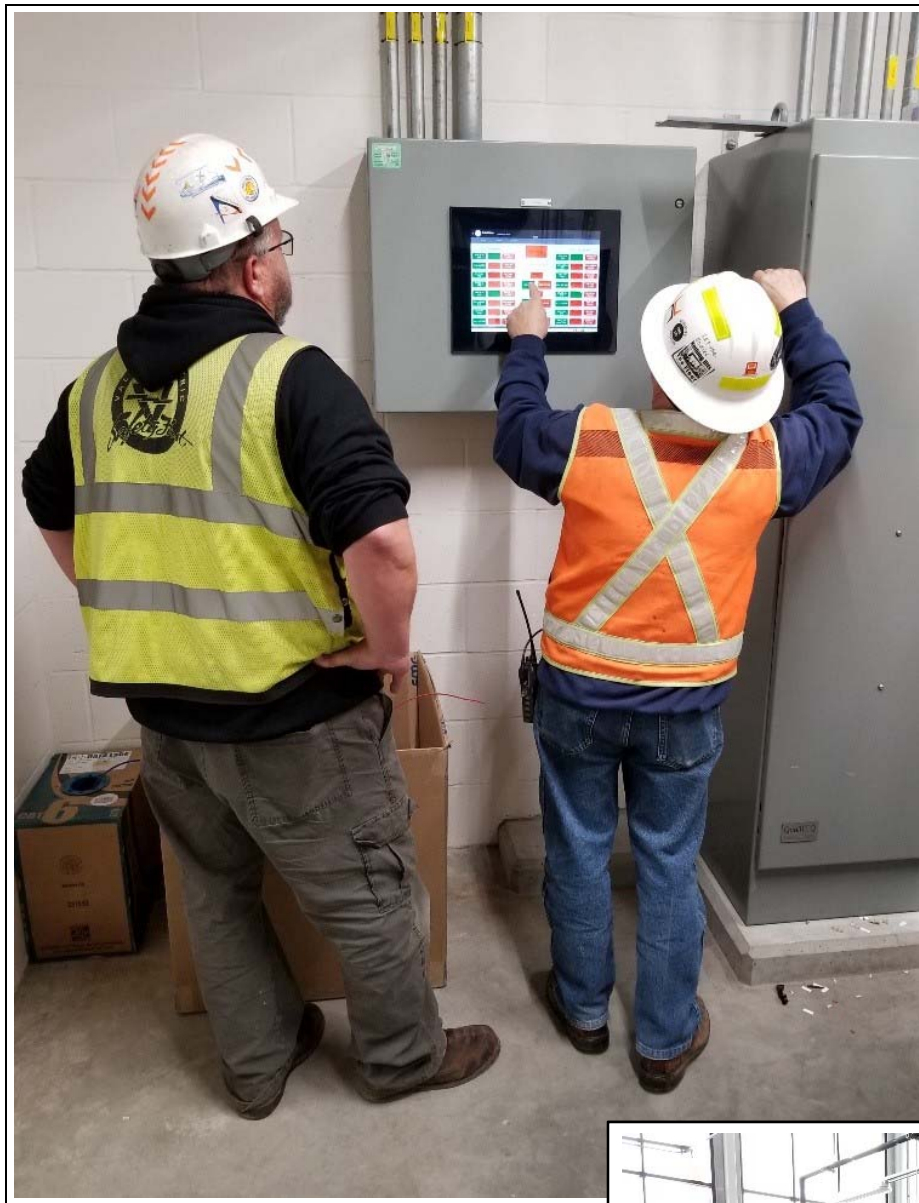
Photo #50

Top: Plant supervisor Phil Matthews (right) opens the main circuit breaker to the clean water facility by means of an operator interface terminal (i.e., a touchscreen). An electrician for Valley Electric, Dan Weiland (left), is observing. Opening the main circuit breaker to the clean water facility simulates a power outage, which causes the engine-generator to operate thereby providing back-up power.

Bottom: Mr. Weiland is closing the main circuit breaker to the clean water facility (located at the main switchgear) to simulate a return to normal utility power.

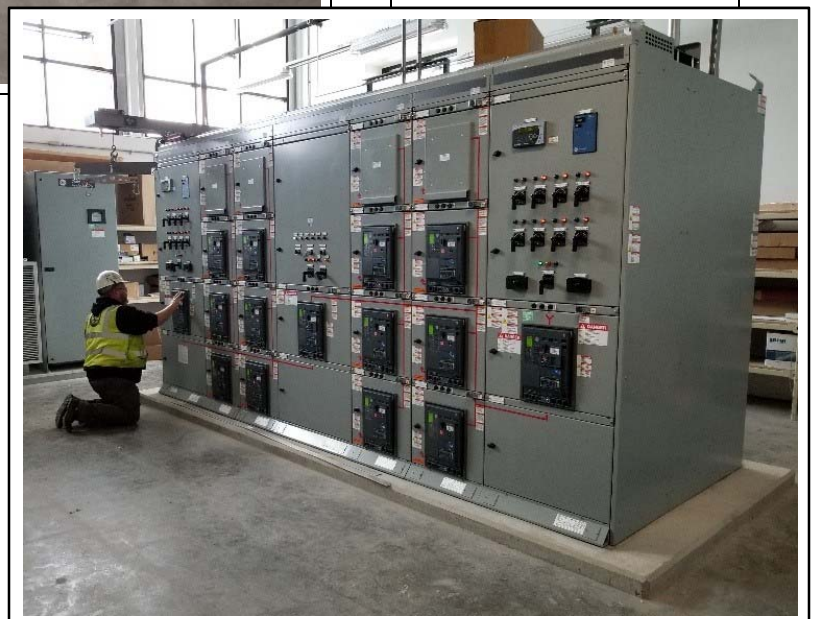
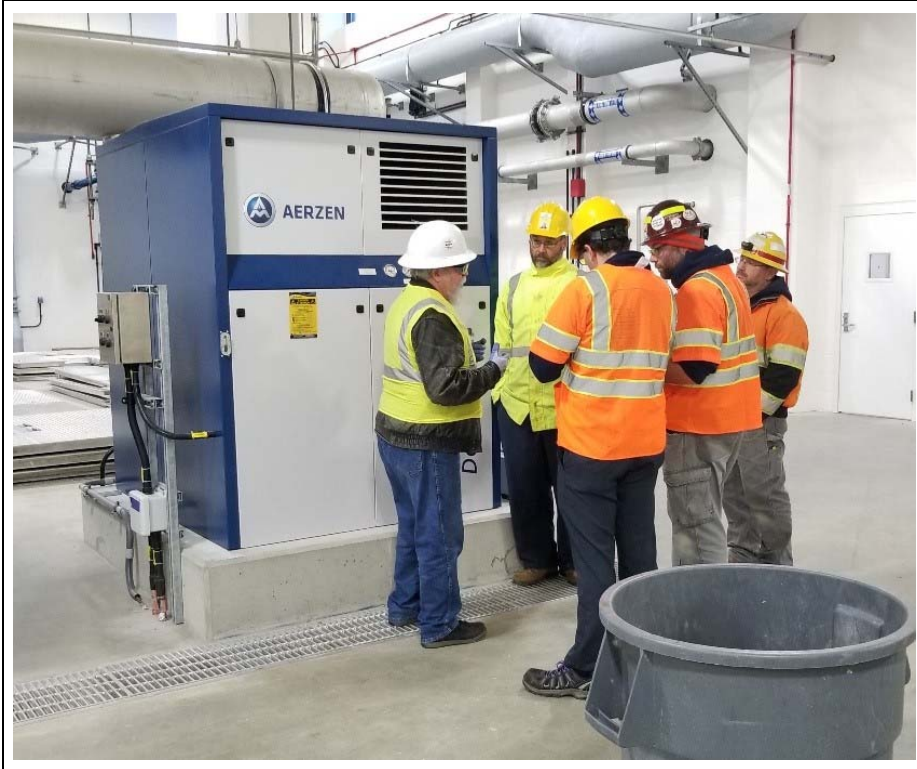
Photo #51

Area 30 Secondary Treatment Building (looking southwest) on Wednesday, October 31st.

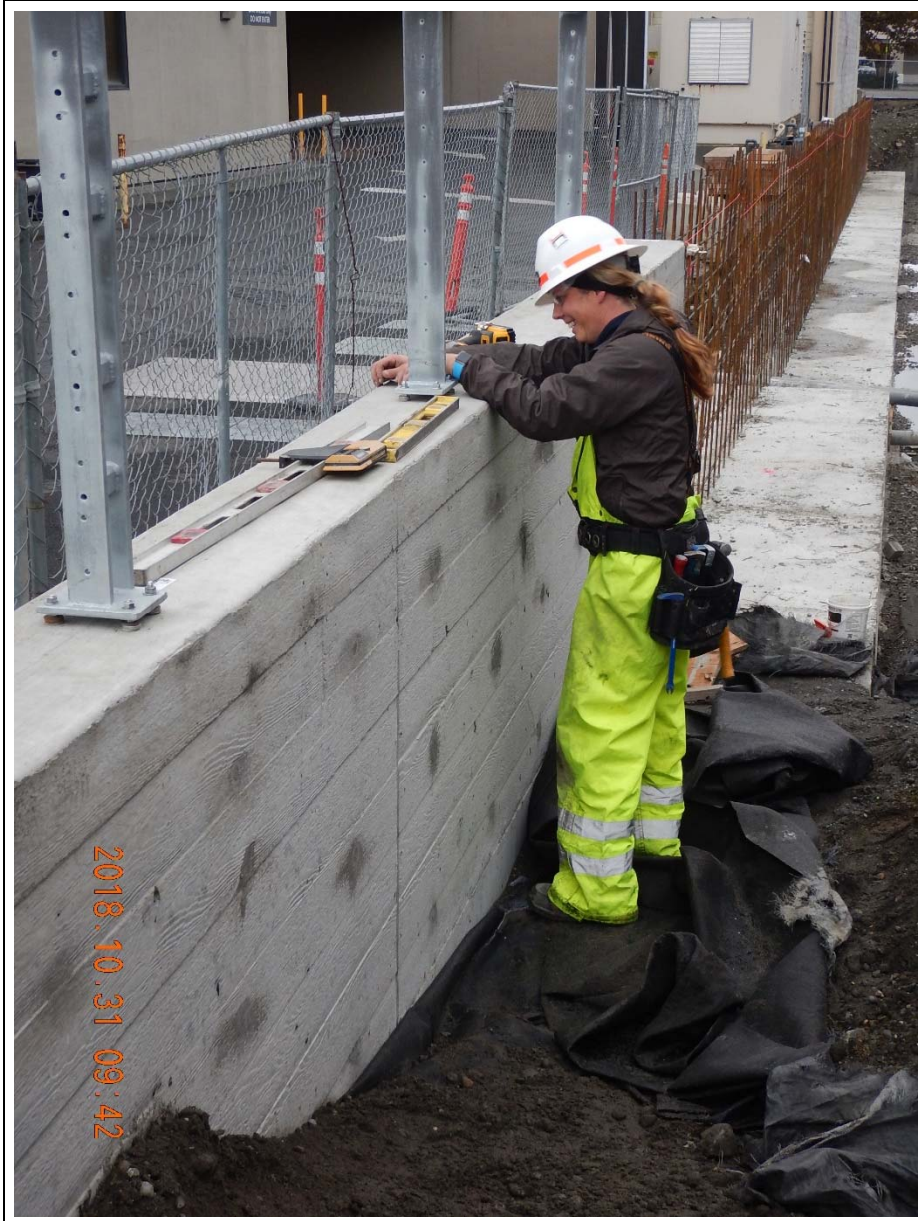
Photo #53

A carpenter for P&L General Contractors is attaching galvanized steel posts to the top of a retaining wall. The posts are part of a stainless steel cable guardrail system. The retaining wall is located along the property line between the clean water facility (to the east) and the Beachview Property (to the west).

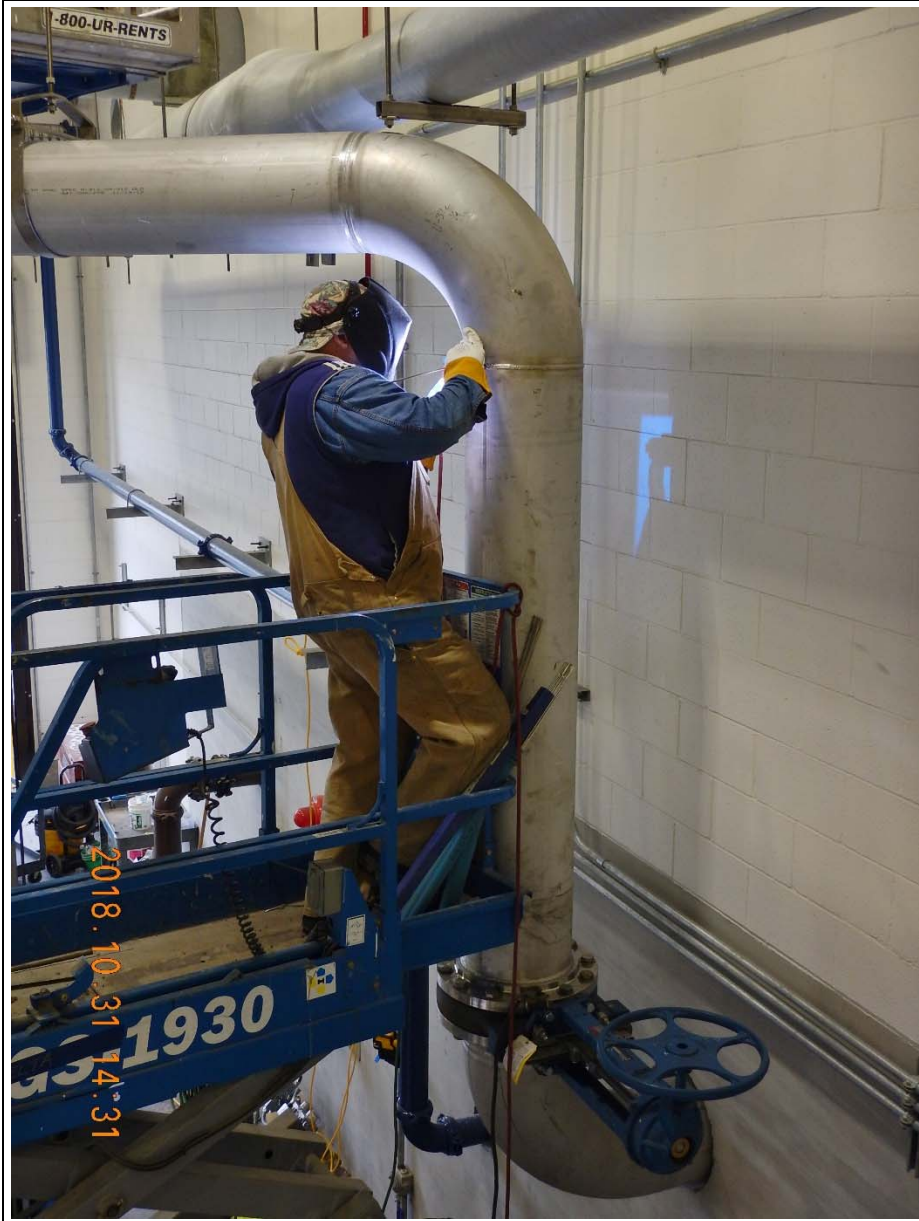
Photo #54

A pipefitter for University
Mechanical is welding
stainless steel dewatered
sludge piping.
