City of Oak Harbor
City Council Agenda Bill

Bill No. 5. c. ii.
Date: December 18, 2018
Subject: Clean Water Facility Update

Clean Water Facility Project

November 2018

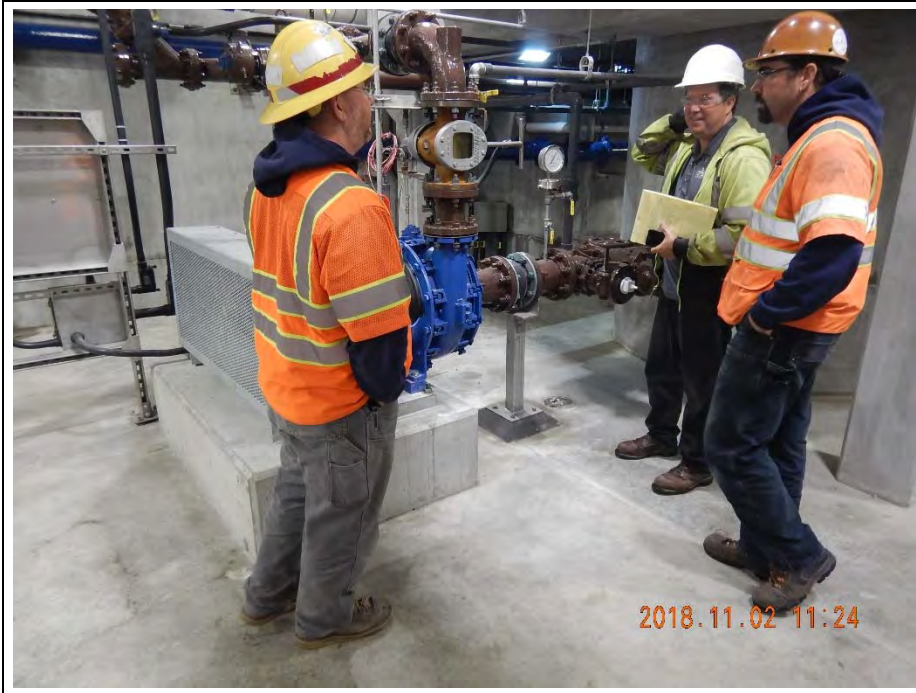
Photo #3

Area 20 Headworks (looking northwest) on Friday, November 2nd.

APSCO service supervisor Clay Daly (white hardhat) is conducting an operator training class pertaining to grit pumps.

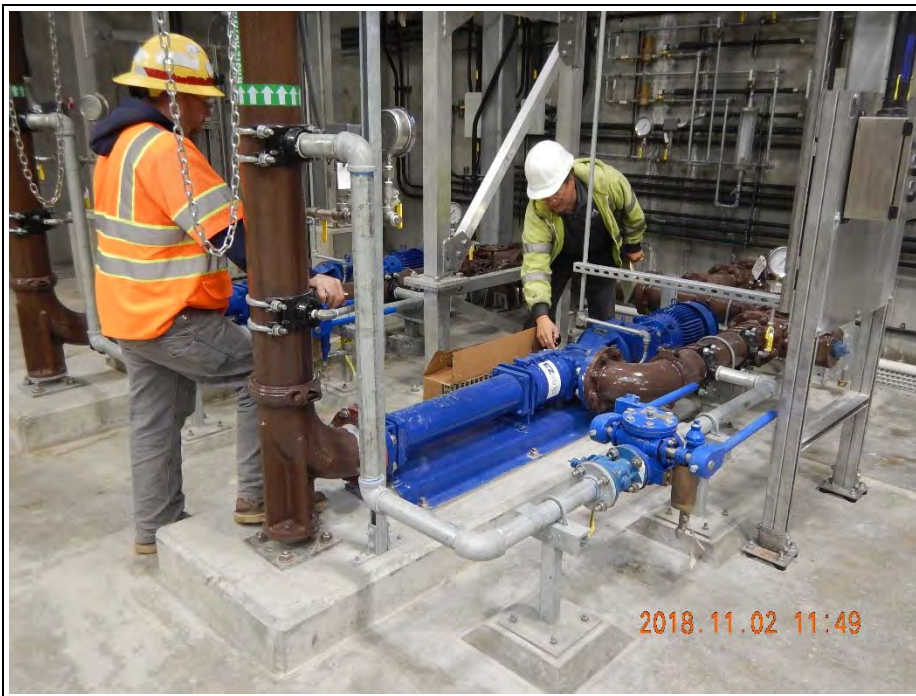
Photo #4

Area 35 RAS/WAS Pumping (looking southeast) on Friday, November 2nd.

APSCO service supervisor Clay Daly (right) is conducting an operator training class pertaining to waste activated sludge (WAS) transfer pumps.

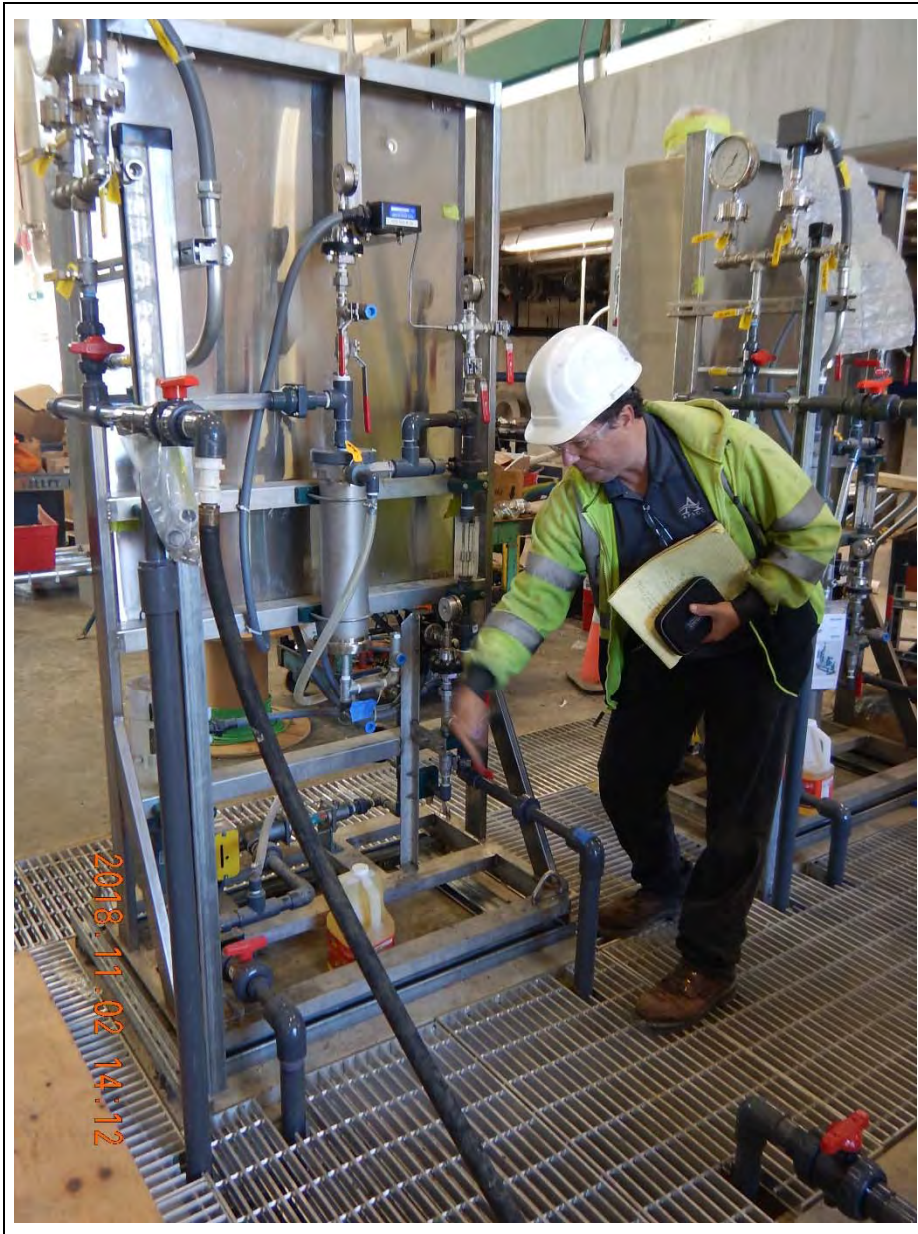
Photo #5

Area 50 Biosolids Building (looking southwest) on Friday, November 2nd.

APSCO service supervisor Clay Daly is conducting an operator training class pertaining to a polymer blending unit.

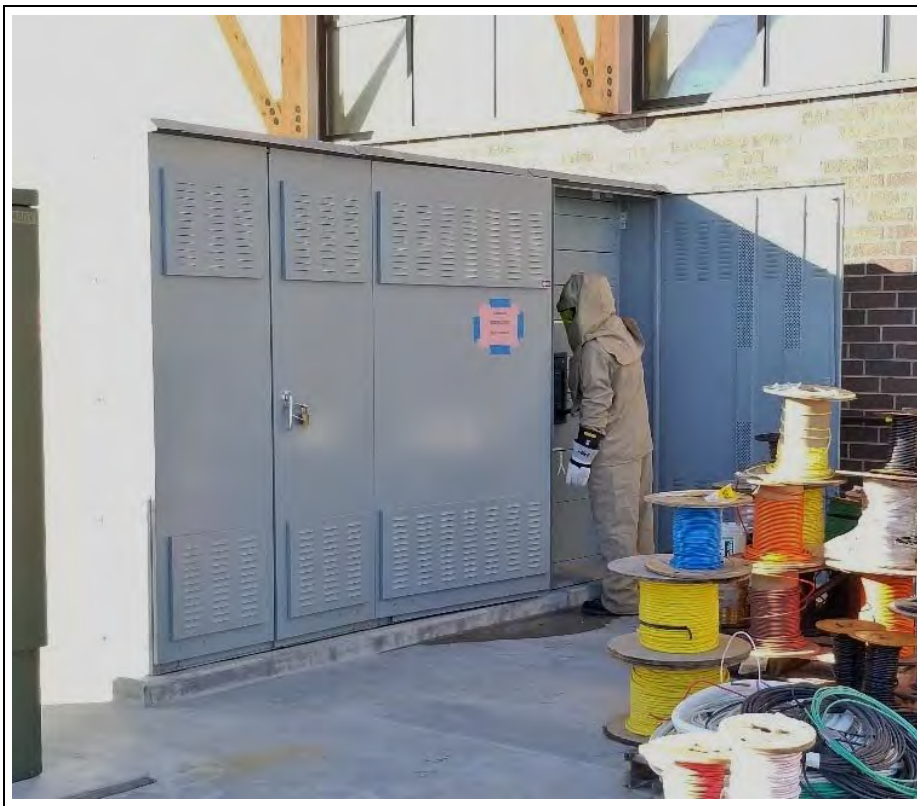
Photo #7

Area 70 Generator Yard (looking northwest) on Friday, November 2nd.

An electrician for Valley Electric is wearing an arc flash suit when operating a circuit breaker located in a utility metering enclosure.

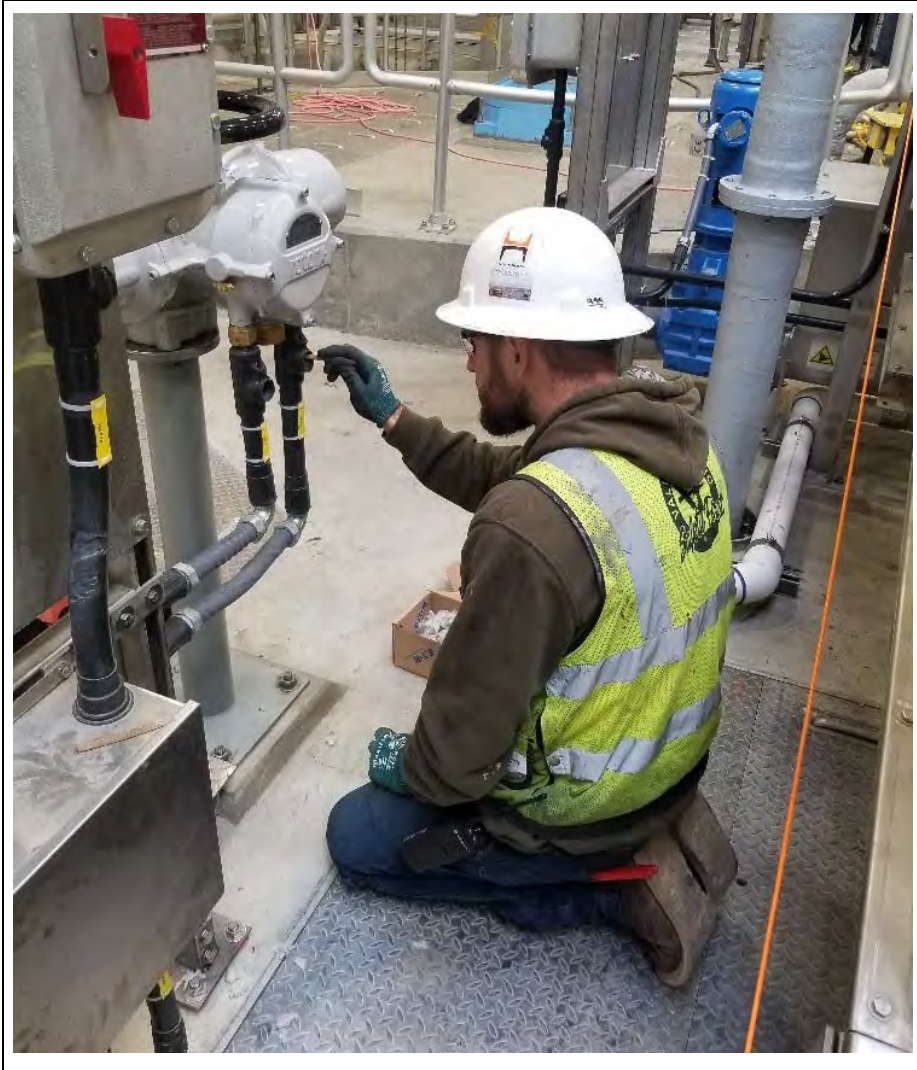
Photo #8

Area 20 Headworks
(looking east) on Friday,
November 2nd.

An electrician for Valley
Electric is placing sealing
compound in a conduit
fitting.

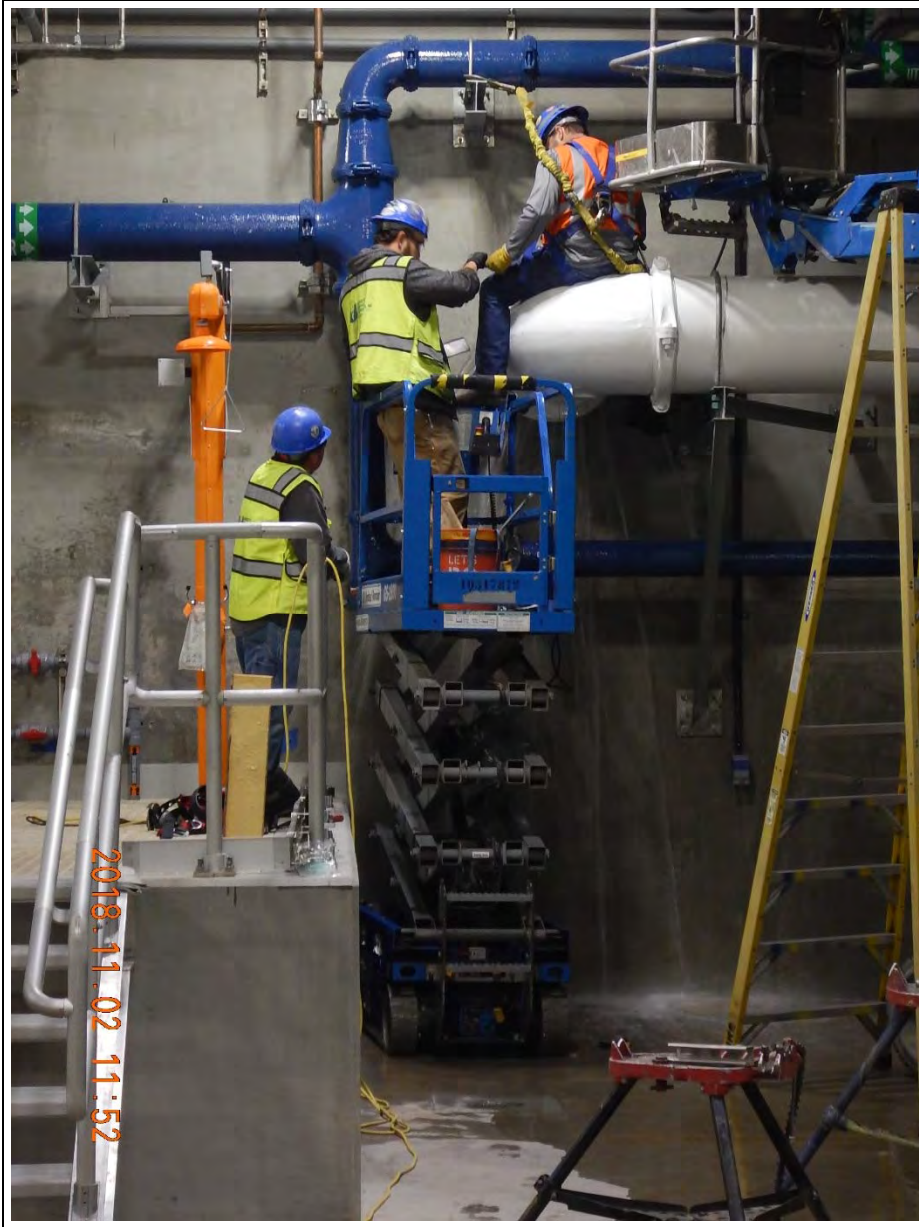
Photo #9

Area 35 RAS/WAS
Pumping (looking south)
on Friday, November 2nd.

Pipefitters for University
Mechanical are removing a
blind flange between two
flanged fittings that make
up part of a 20-inch
effluent piping system.
Removal of this blind
flange allows the
discharge of effluent into a
24-inch effluent pipeline
and out into Oak Harbor
Bay.

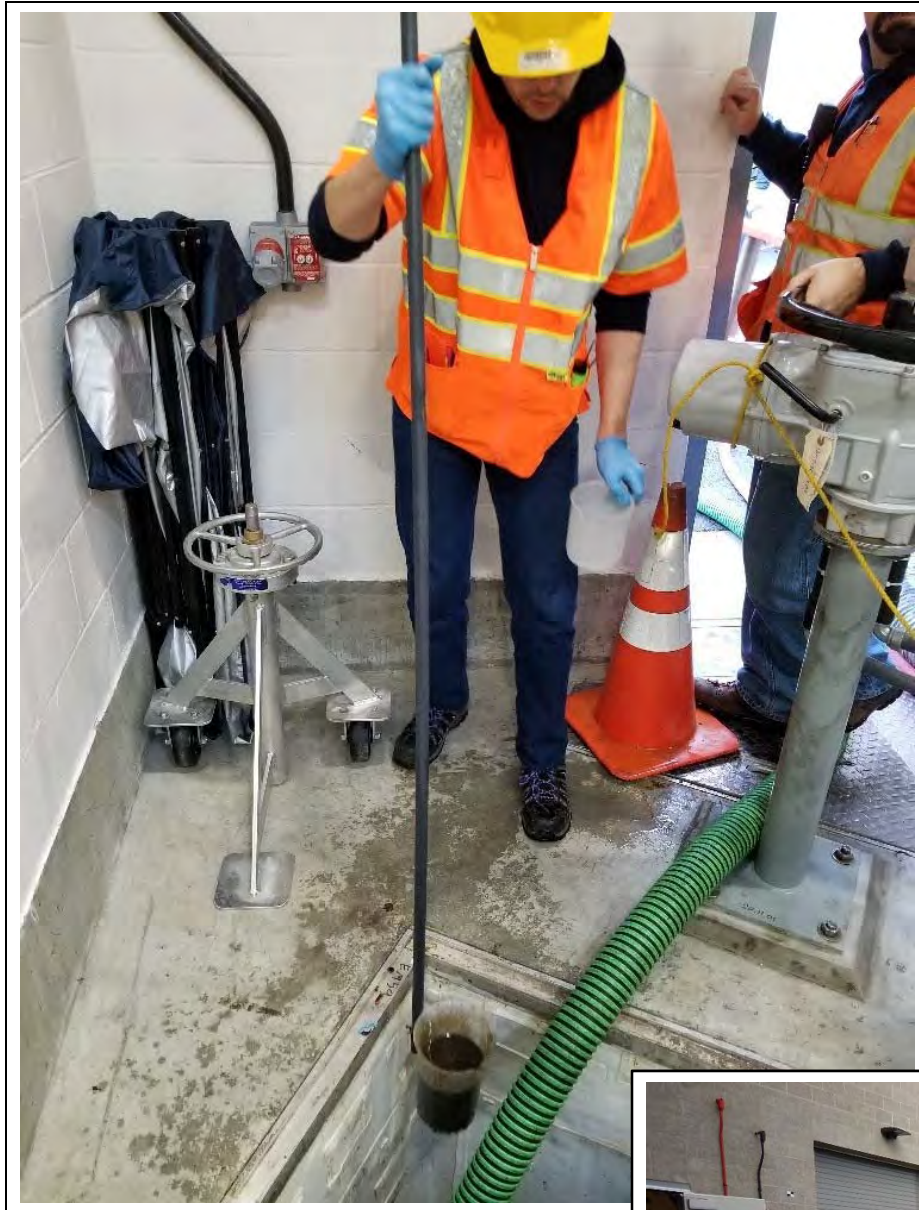
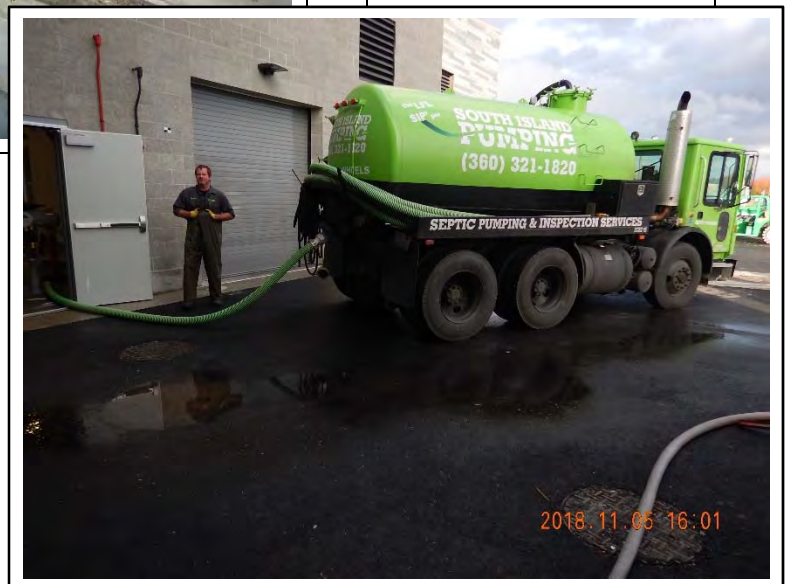
Photo #10

Area 20 Headworks on Monday, November 5th.

Bottom (looking northeast): A driver for South Island Pumping is discharging "seed sludge" from Coupeville's wastewater treatment plant into a coarse screen channel in the headworks building.

- Wastewater was introduced into the plant on November 5th (see Photos #10 and #12) and the City's operations staff began operating the plant.
- Turnstone placed concrete for a water feature next to the administration building (see Photo #28) and for faux rocks and logs at the splash park (see Photos #35, #41, and #45).
- A ribbon cutting ceremony occurred on November 29th (see Photos #50 through #54).
- The City's operations staff began discharging effluent through a 24-inch outfall pipeline and into Oak Harbor Bay on November 29th.

Start-up Activities. On Monday, November 5th, the City's operations staff began operating the plant after wastewater was introduced into the plant (see Photos #10, #12, #19, and #36). A commissioning representative for Suez Water Technologies, Kathleen McAllister, continued to work on site full-time during the first half of the month to facilitate the operation, testing, and calibration of membrane filtration equipment. On November 2nd, a training specialist for Suez Water Technologies, Wayne Key, finished conducting 40 hours of operator training pertaining to the membrane filtration system (see Photo #6). Also on November 2nd, APSCO service supervisor Clay Daly conducted operator training classes pertaining to grit pumps, WAS transfer pumps, and polymer blending equipment (see Photos #3, #4, and #5). On November 6th, a representative of DP Wilson, John Wilson, conducted an operator training class pertaining to odor control fans at the odor control structure (see Photo #13). On November 7th, Seepex control systems designer Kurt Werner and Granich Engineered Products representative Ken Hogan conducted an operator training class pertaining to centrifuge cake pumps (see Photo #16). On November 9th, Northstar Chemical delivered sodium hydroxide to the clean water facility (see Photo #22). On November 28th, Biorem representative Jeremy Wachtman conducted an operator training class pertaining to odor control equipment (see Photo #48). On November 29th, the operations staff began discharging effluent into a 24-inch outfall pipeline and into Oak Harbor Bay. Representatives of the City, Hoffman, and Carollo Engineers continued to meet each week to coordinate start-up activities and facilitate resolution of problems encountered during start-up. Valley Electric, University Mechanical, and other subcontractors and vendors also participated in meetings and start-up activities.

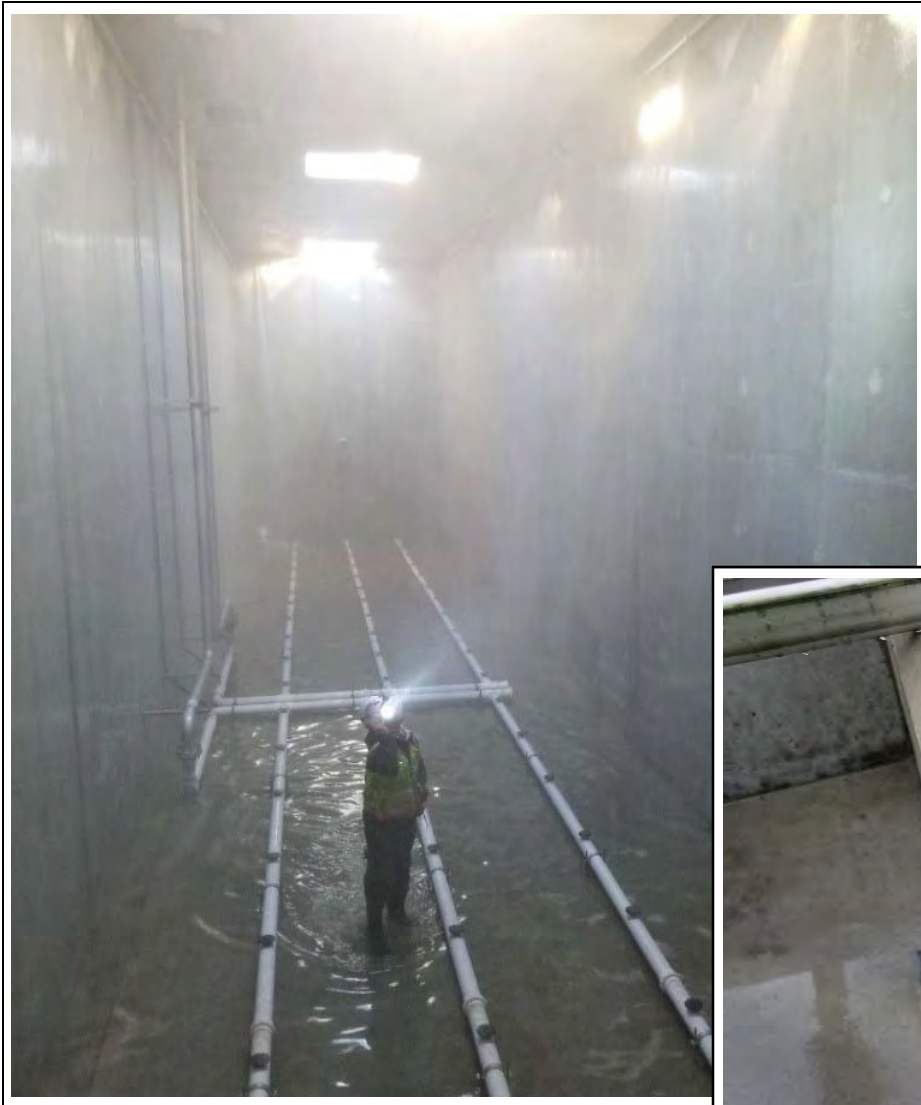
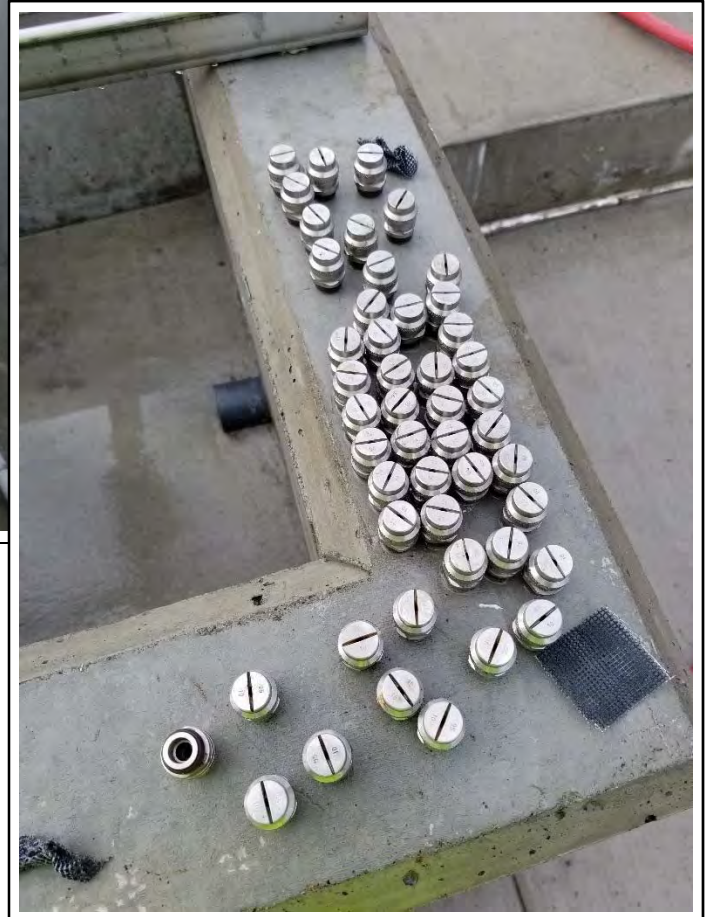
Photo #11

Area 33 WAS Storage (looking north) on Tuesday, November 6th.

An engineer for Hoffman Construction, Adam Jorgensen, is inspecting a foam abatement system during operation to determine that the stainless steel nozzles (seen below) are spraying properly.

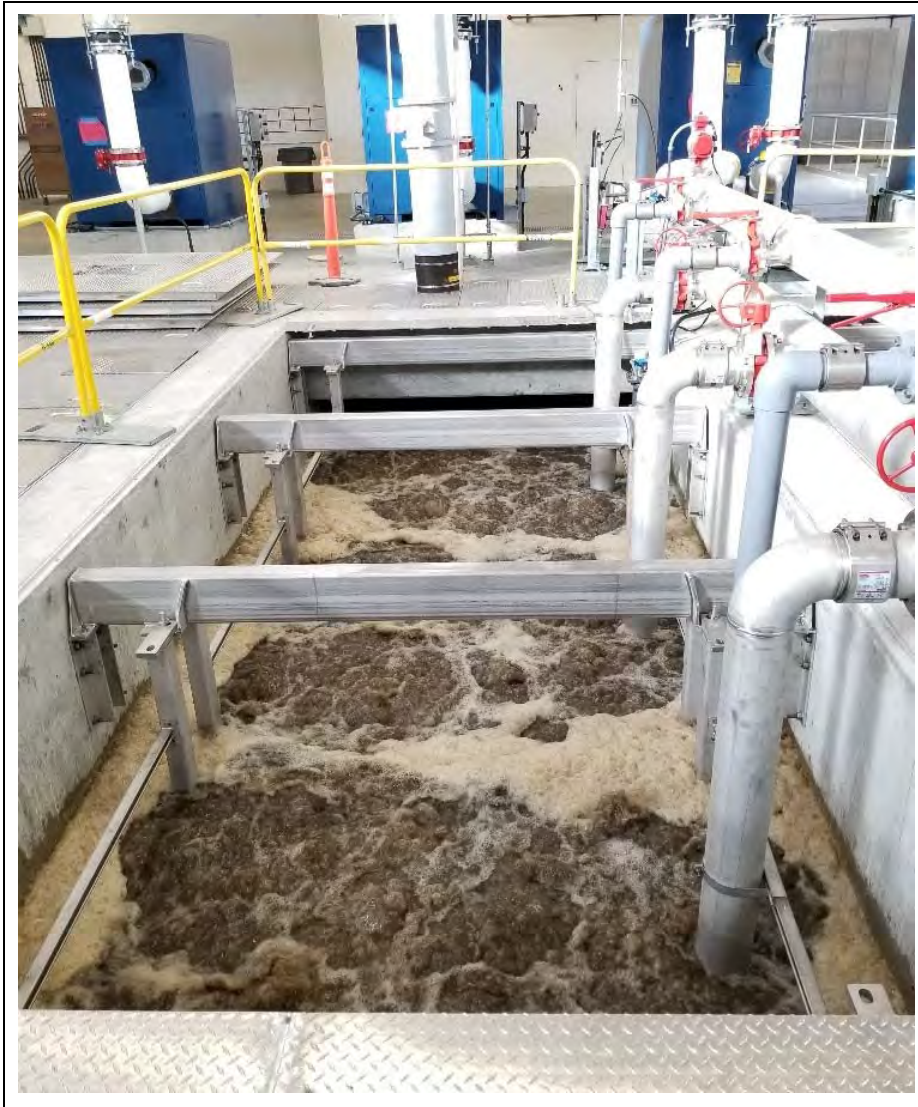
Photo #12

Area 30 Secondary Treatment Building (looking north down into a membrane tank) on Tuesday, November 6th.

Wastewater has been introduced into a membrane tank for the first time.

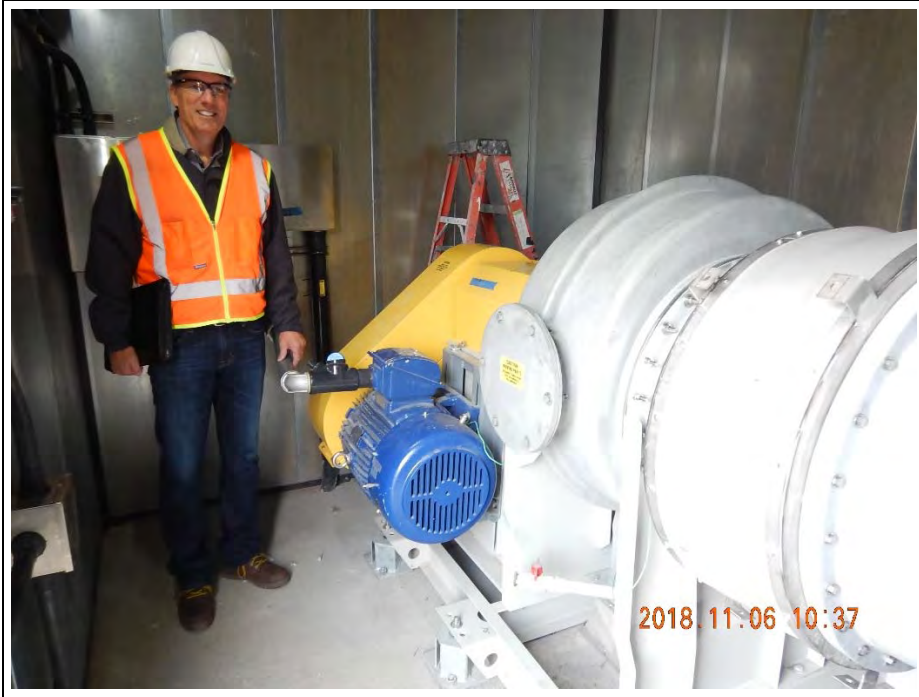
Photo #13

Area 60 Odor Control (looking southwest) at an odor control fan on Tuesday, November 6th.

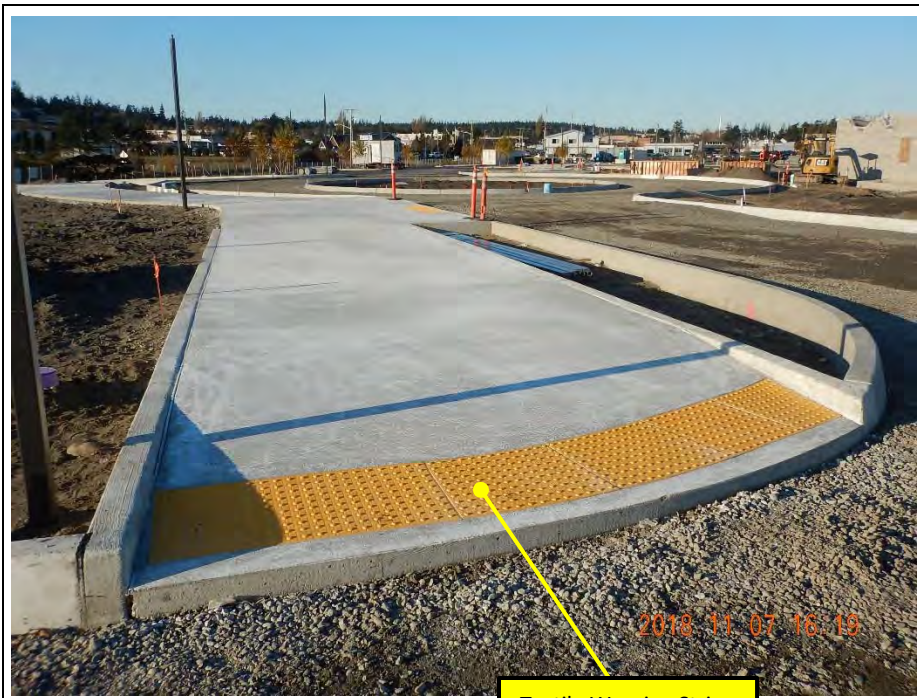
Photo #14

Southwest end of Windjammer Park (looking north) on Wednesday, November 7th.

This photo depicts tactile warning strips that carpenters for Interwest Construction embedded into a ramp at the end of a sidewalk. There are multiple installations of these strips in sidewalks in the park.

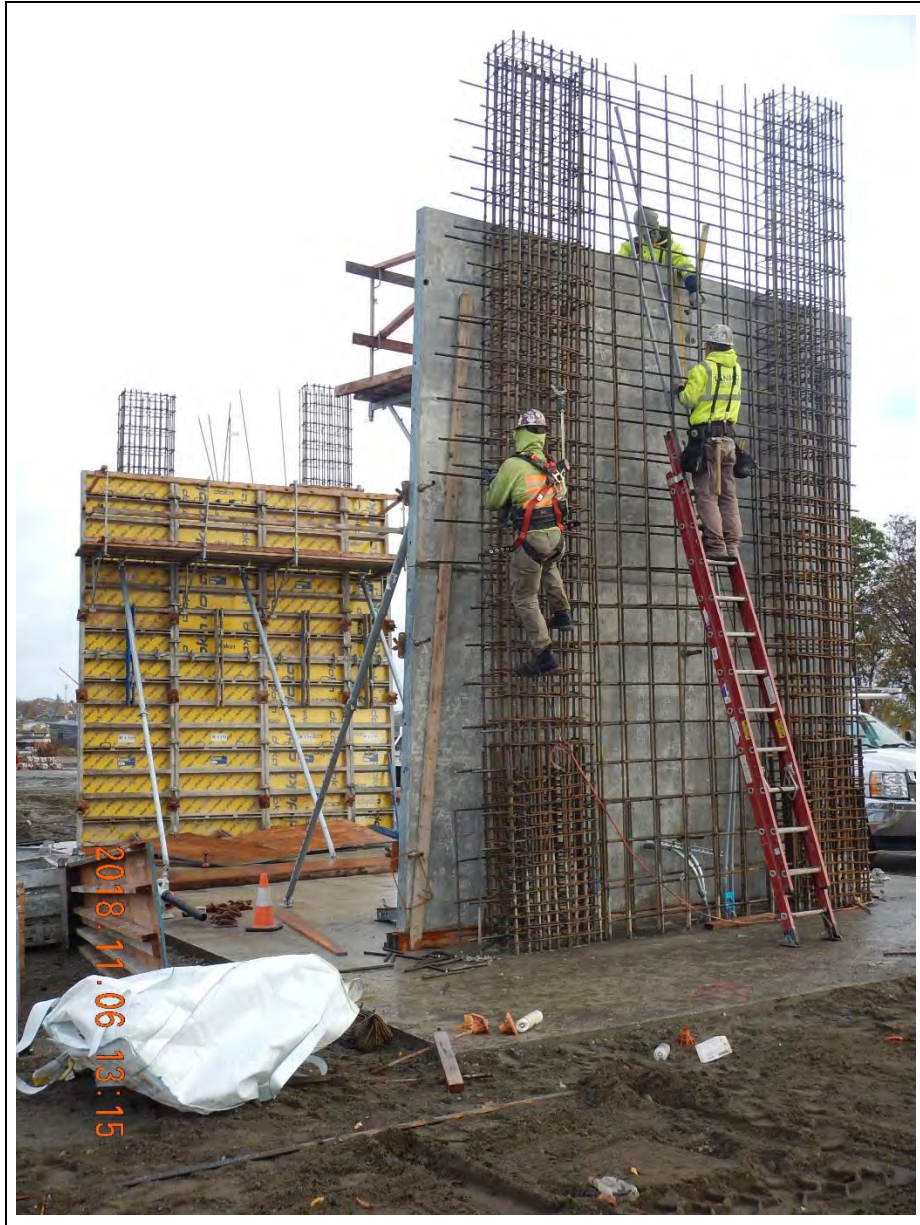
Photo #15

West end of Windjammer Park (looking northeast) on Wednesday, November 7th.

Ironworkers for Morse Steel Service are installing reinforcing steel for walls for a pavilion.

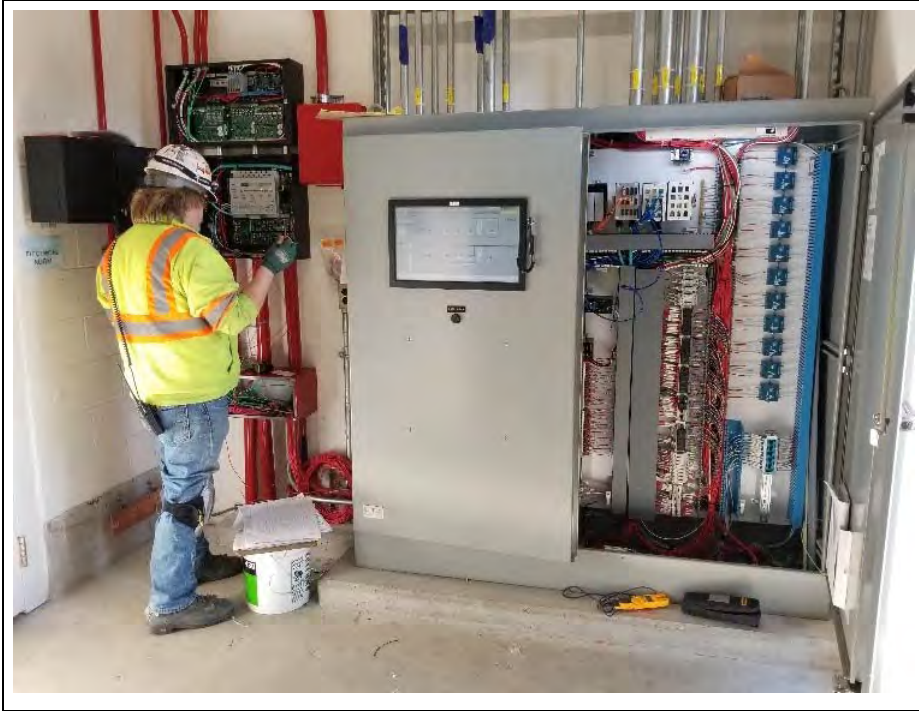
Photo #17

Area 20 Headworks (looking east in the control room) on Wednesday, November 7th.

An electrician for Valley Electric is terminating wires at a fire alarm control panel. A process control module (PCM) is seen at the right.

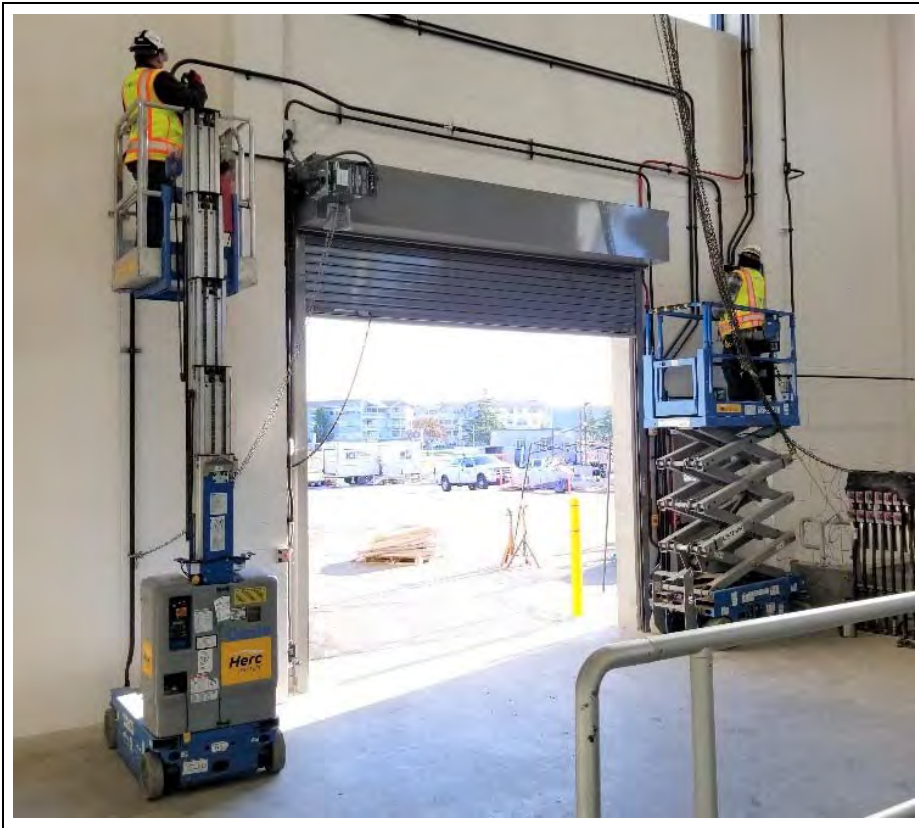
Photo #18

Area 30 Secondary Treatment Building (looking southeast) on Thursday, November 8th.

Low voltage electricians for EZ Interface are installing conductors for an access and security system.

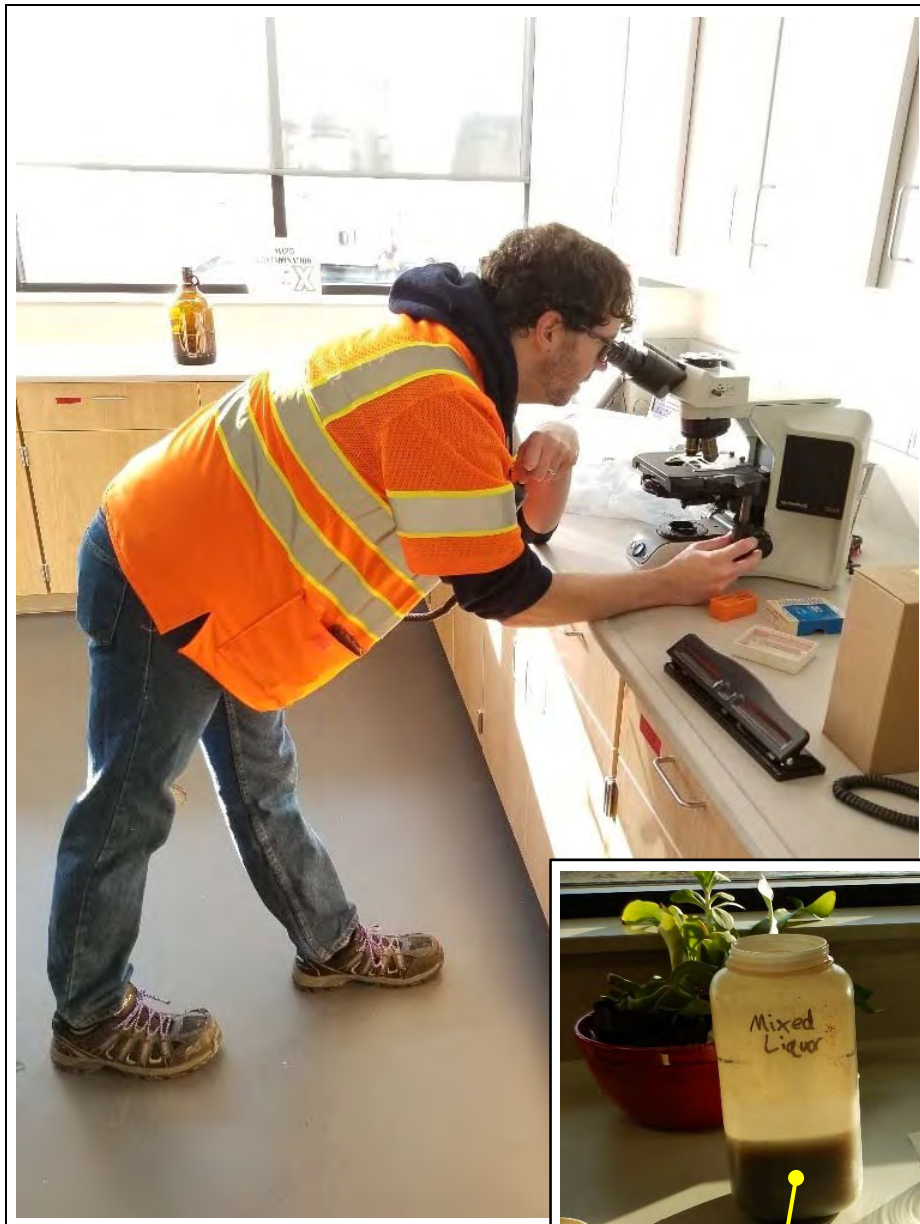
Photo #19

Area 01 Administration Building (looking south in the laboratory) on Thursday, November 8th.

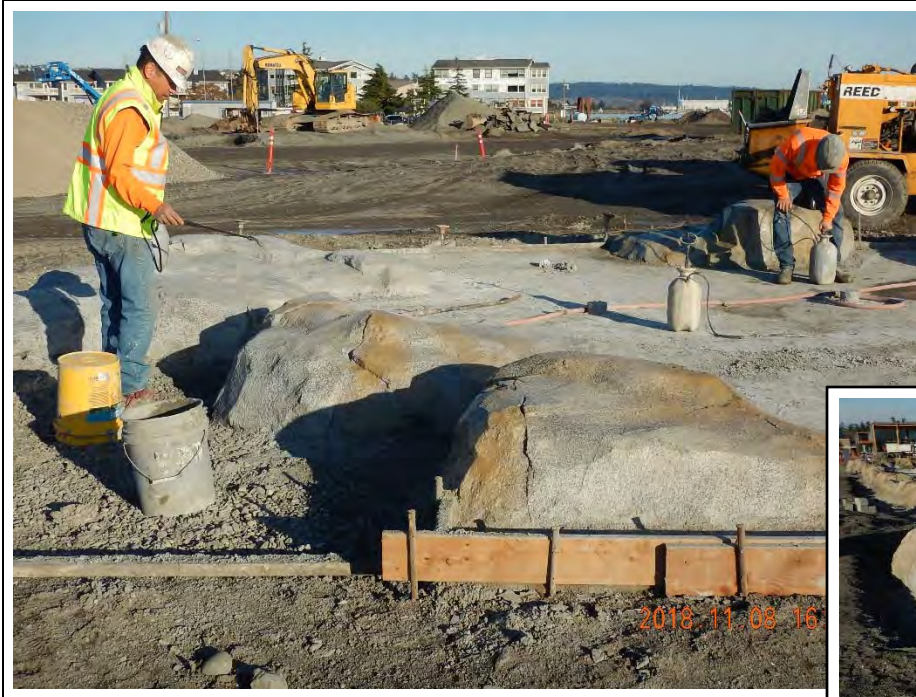
Photo #20

South end of Windjammer Park (looking east at the splash park) on Thursday, November 8th.

A carpenter for Turnstone Construction is applying brown paint to faux rocks.

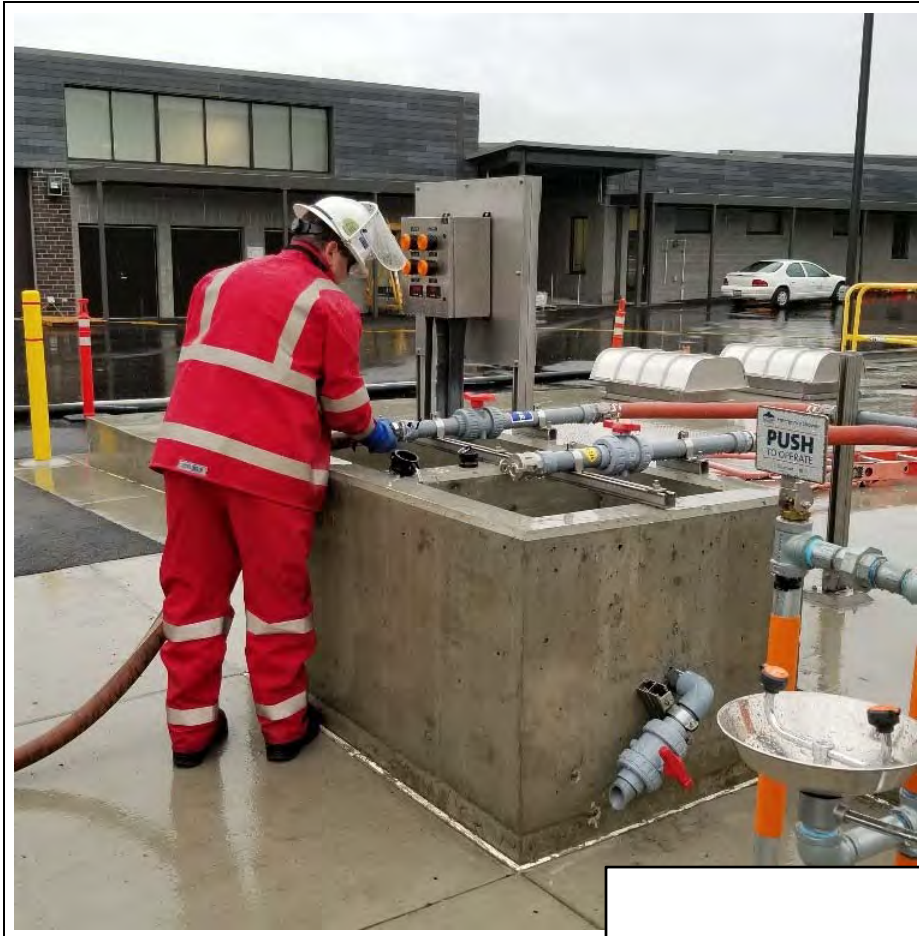
Photo #22

A driver for Northstar Chemical is preparing to discharge NaOH (sodium hydroxide) into a CPVC fill line that discharges into a chemical tank in the gallery area under the secondary treatment building.

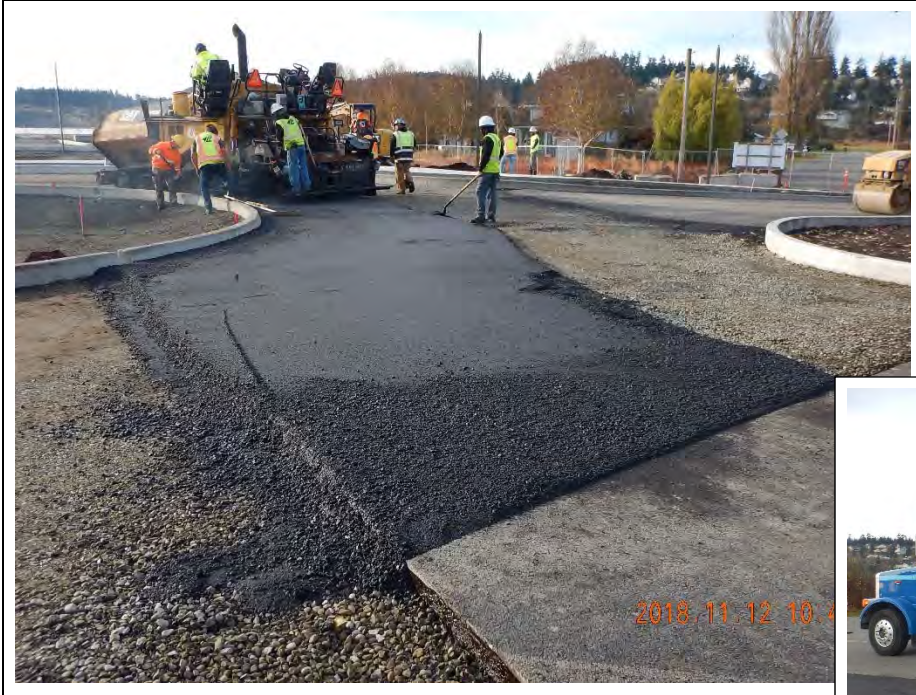
Photo #24

West end of Windjammer Park (looking southwest and west) on Monday, November 12th.

Lakeside Industries is paving at a parking area and on Beeksma Drive.

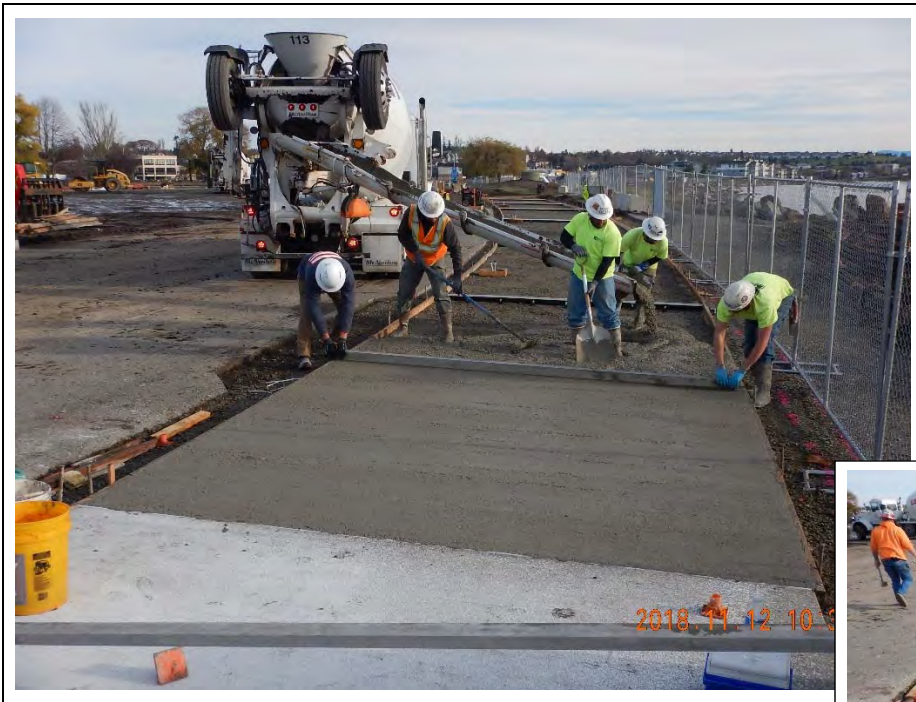
Photo #25

Southwest end of Windjammer park (looking east) on Monday, November 12th.

Carpenters for Interwest Construction are placing concrete for a sidewalk.

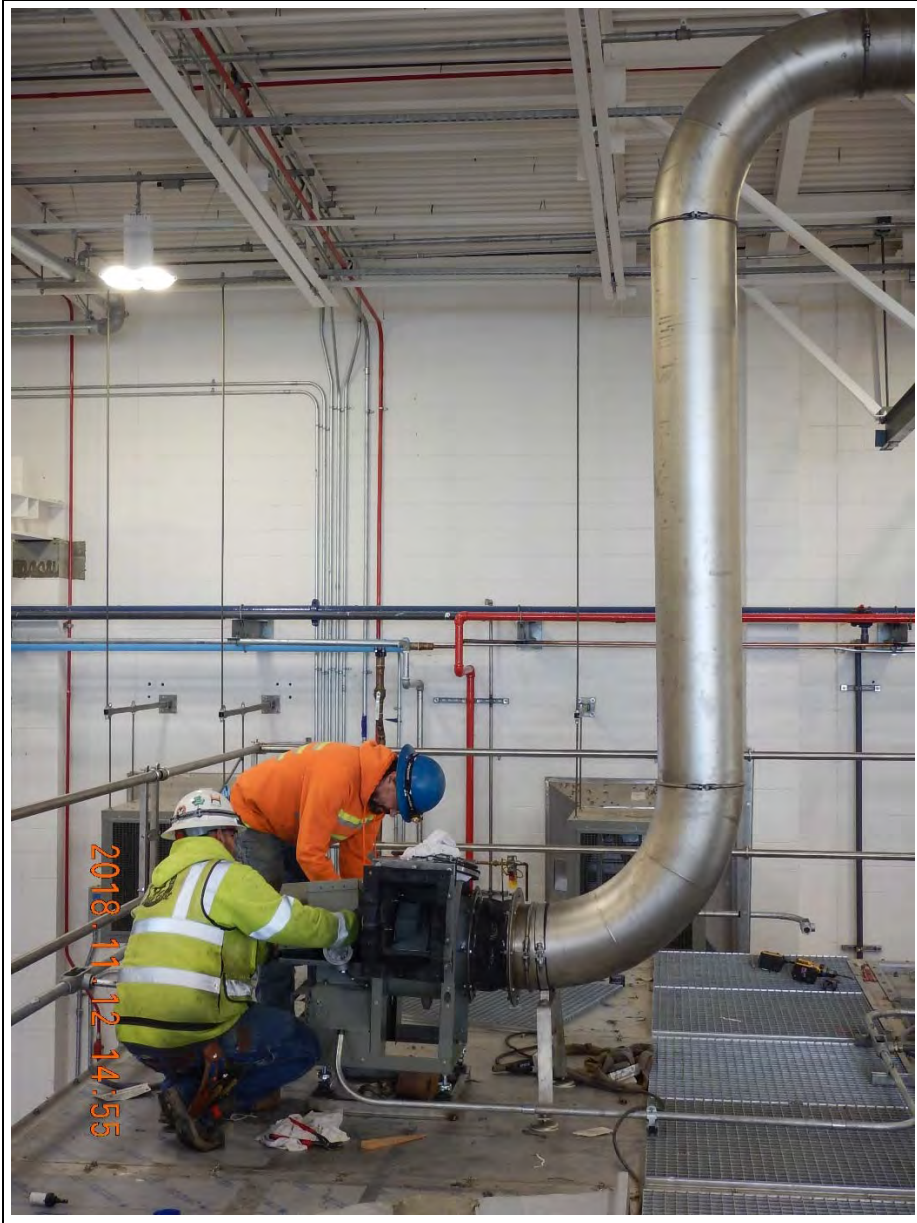
Photo #26

Electricians for Valley
Electric are installing
conduits and conductors
for a dryer exhaust fan
atop the biosolids dryer.

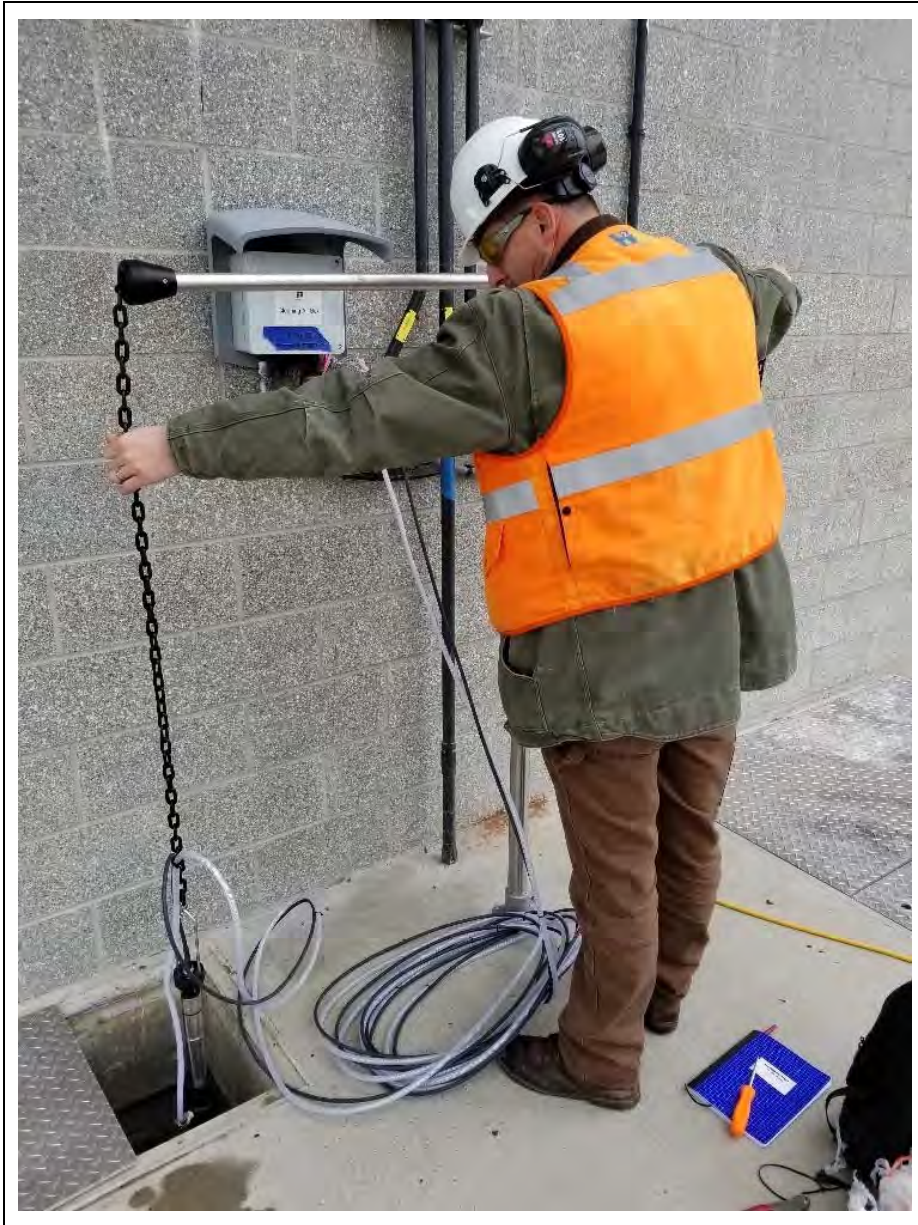
Photo #27

An electrician for QualiTEQ, Chris Degutis, is lowering a sensor into an aeration basin. The sensor measures dissolved oxygen.

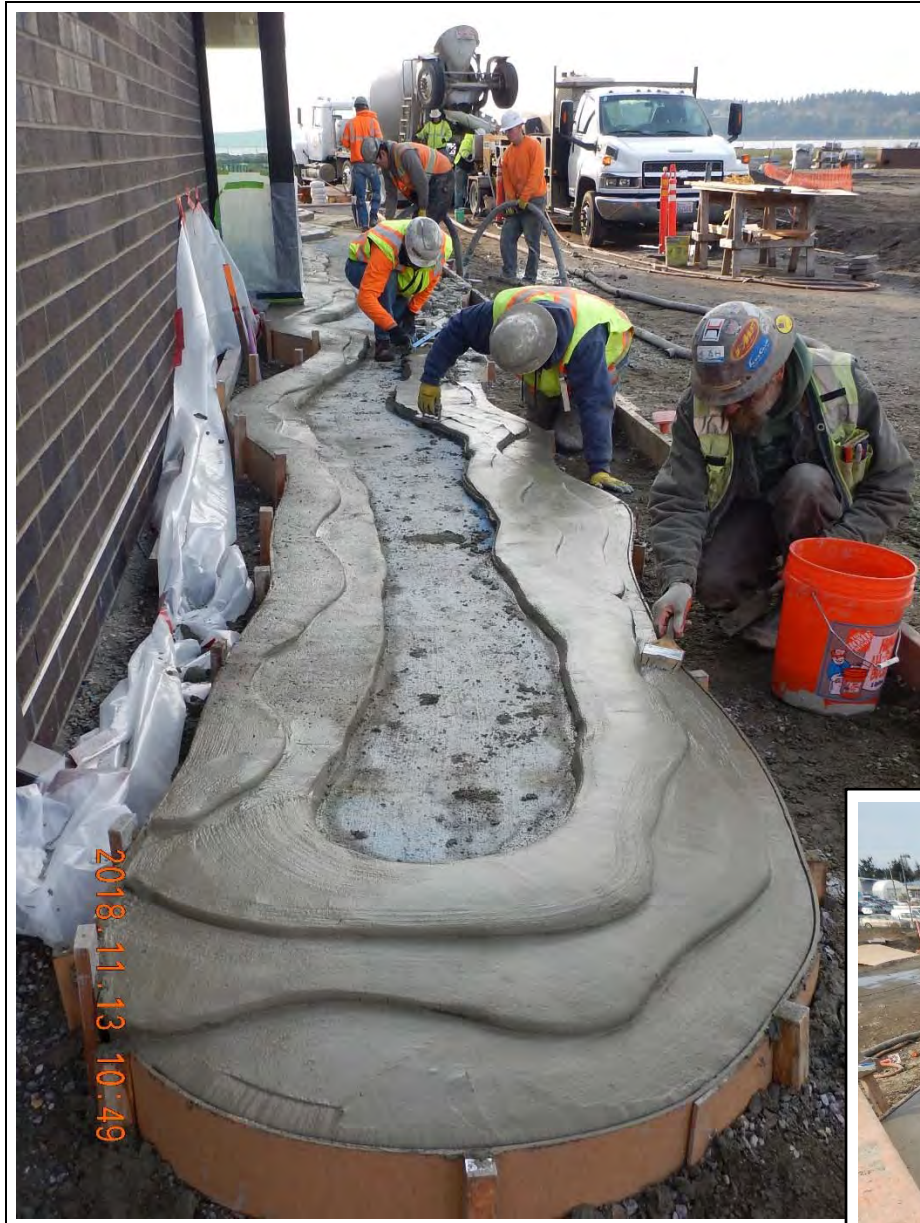
Photo #28

Workers for Turnstone Construction are placing and "sculpting" concrete for a water feature.

Interwest Construction constructed two 8-inch drop structures adjacent to a sanitary sewer manhole located in an area south of the maintenance and biosolids buildings (see Photo #33). Interwest Construction placed, graded, and compacted on-site earthen material adjacent to the west sides of the aeration-blower and electrical buildings and the west side of the generator yard. P&L General Contractors installed screen walls made of weathering steel at the odor control structure (see Photo #21), generator yard (see Photo #30), and at an outdoor break area between the administration and maintenance buildings. Turnstone Construction placed concrete by means of the "shotcrete" method for a water feature located adjacent to the west and south sides of the interpretive center portion of the administration building (see Photo #28).
