City of Oak Harbor
City Council Agenda Bill

Bill No. 5. c. ii.
Date: December 18, 2018
Subject: Clean Water Facility Update

Clean Water Facility Project

November 2018

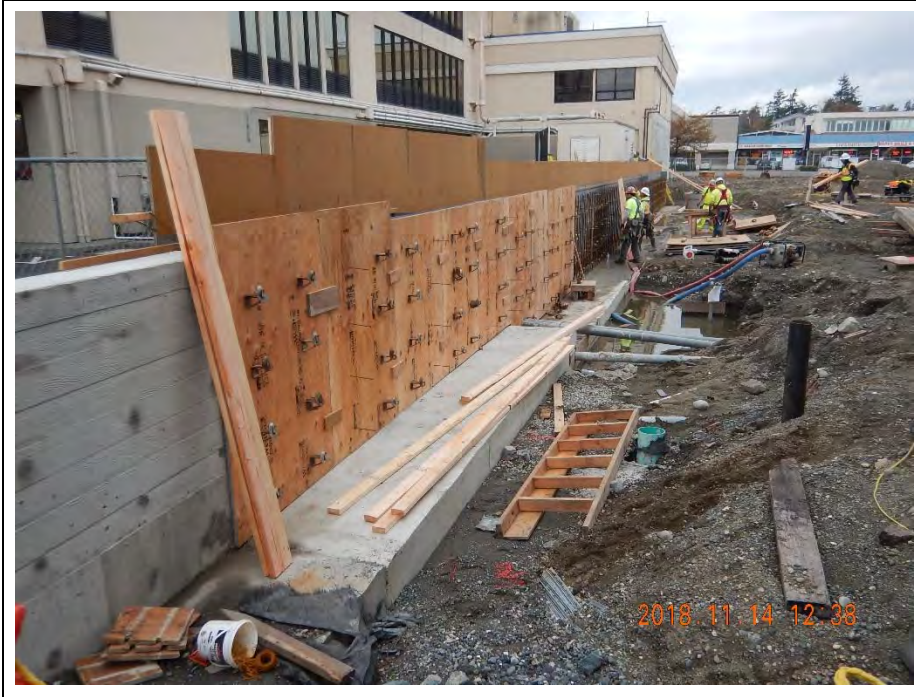
Photo #29

Carpenters for Interwest Construction are placing forms for a concrete retaining wall located along the property line between the clean water facility to the east (right) and the Bayview property to the west (left).

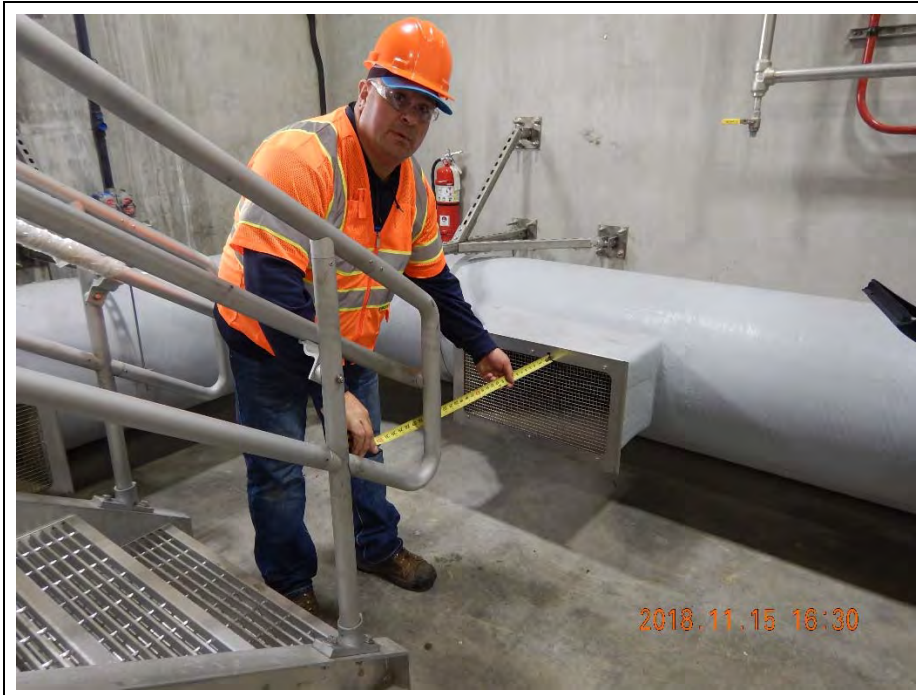
Photo #31

City building inspector
Cody West is measuring
the distance between the
bottom of a stairway and
the nearest foul air duct.

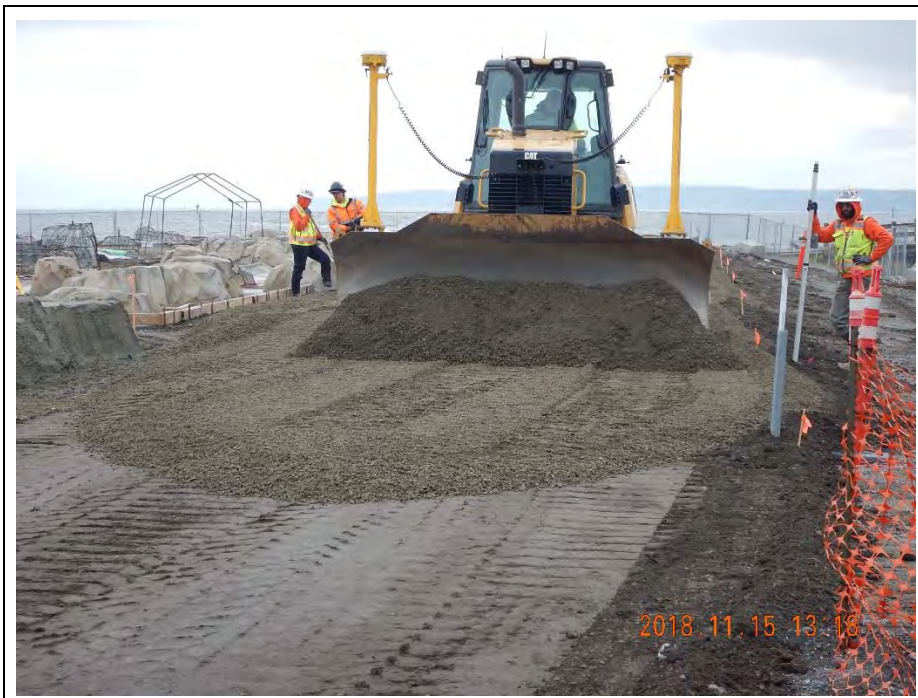
Photo #32

South end of Windjammer
Park (looking south along
the west side of the splash
park) on Thursday,
November 15th.

GMPA No. 13 – Windjammer Park Improvements. Work on this portion of GMPA No. 13 is approximately 45% complete. Interwest Construction placed and graded on-site and imported earthen material at the southwest corner of the park, at the west side of the splash park (see Photo #32), and at the area south of the administration building. Interwest Construction continued to build formwork and place concrete for curbs, sidewalks, walkways, seatwalls, and benches at the west and north ends of the park (see Photos #14 and #25). Interwest Construction began building forms and placing reinforcing steel for a planter box located adjacent to the west side of the west kitchen. Lakeside Industries placed and compacted asphaltic concrete (AC) pavement for a parking area and traffic circle near the new southwest entrance to the park (see Photo #24). Pacific Earth Works placed topsoil and plantings on the south and north sides of the northwest entrance to the park. Pacific Earth Works placed wetland enhancement plantings in a storm water detention pond located just west of the administration building. Pacific Earth Works installed irrigation system lateral piping within a traffic circle near the southwest entrance to the park and adjacent to a walkway at the north end of the park. Valley Electric continued to install conduit, conductors, and fiberglass light posts throughout the park (see Photo #40). Valley Electric also installed a copper grounding cable throughout a slab-on-grade for a water feature located adjacent to the west and south sides of the interpretive center portion of the administration building (Turnstone Construction attached the grounding cable to cast iron drain inlets so they are grounded). P&L General Contractors placed galvanized steel embeds in CMU Block walls at the east and west kitchens. P&L General Contractors received glulam beams for the east and west kitchens and pavilion. Subcontractors for P&L General Contractors, LangCo NW and Morse Steel Services, assembled formwork and placed reinforcing steel for the pavilion (see Photo #15). Another one of P&L General Contractors' subcontractors, Black Rock Masonry, continued to place CMU block for walls for the east and west kitchens. On November 12th, Black Rock Masonry filled CMU block walls with grout at the east and west kitchens. Turnstone Construction placed concrete for faux rocks and logs at the splash park by means of the "shotcrete" method (see Photo #35). Turnstone Construction then "sculpted" the faux rocks and logs (see Photo #41) and painted them to make them look more realistic (see Photo #20). At the end of November, Turnstone Construction placed grout to form the final bottom of the splash park (see Photo #45).

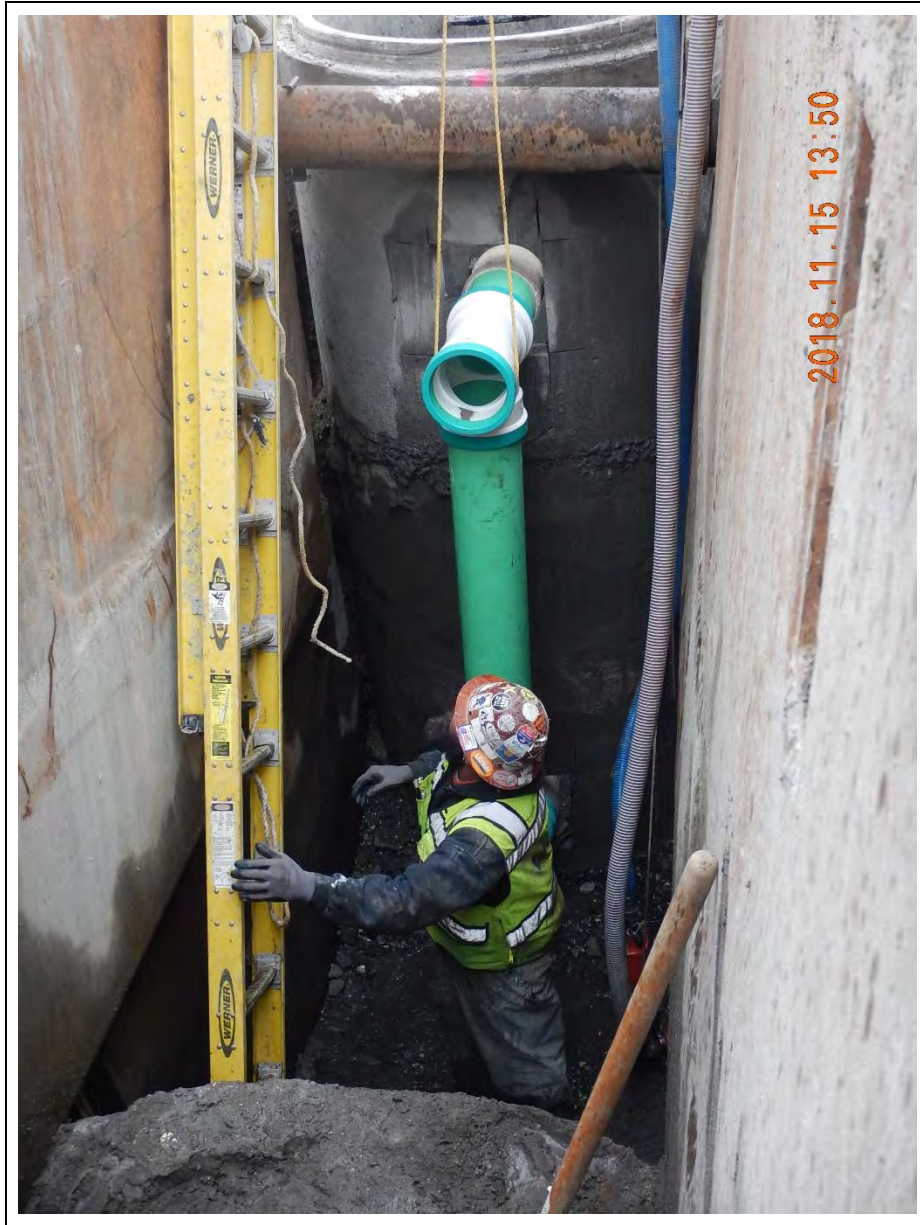
Photo #33

A pipe layer for Interwest Construction, John Pino, is installing an 8-inch PVC "drop" on a sanitary sewer manhole. Drops minimize cascading effects when a sanitary sewer intersects a manhole with a significantly different invert elevation.

Interwest Construction constructed two 8-inch drop structures adjacent to a sanitary sewer manhole located in an area south of the maintenance and biosolids buildings (see Photo #33). Interwest Construction placed, graded, and compacted on-site earthen material adjacent to the west sides of the aeration-blower and electrical buildings and the west side of the generator yard. P&L General Contractors installed screen walls made of weathering steel at the odor control structure (see Photo #21), generator yard (see Photo #30), and at an outdoor break area between the administration and maintenance buildings. Turnstone Construction placed concrete by means of the "shotcrete" method for a water feature located adjacent to the west and south sides of the interpretive center portion of the administration building (see Photo #28).

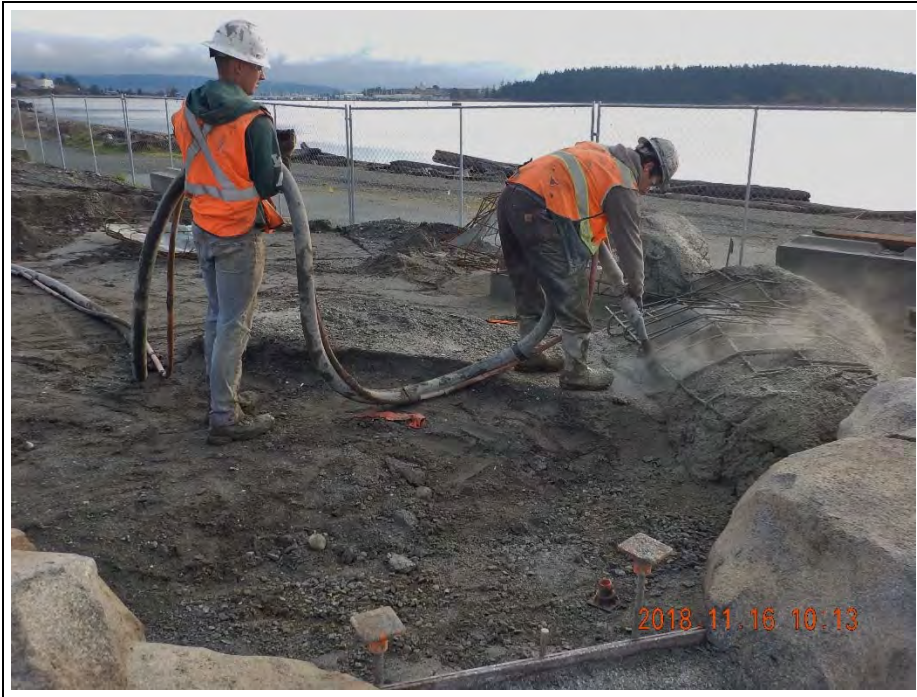
Photo #35

Laborers for Turnstone Construction are placing concrete for a faux rock by means of the "shotcrete" method (i.e., the concrete is pumped and sprayed into place).

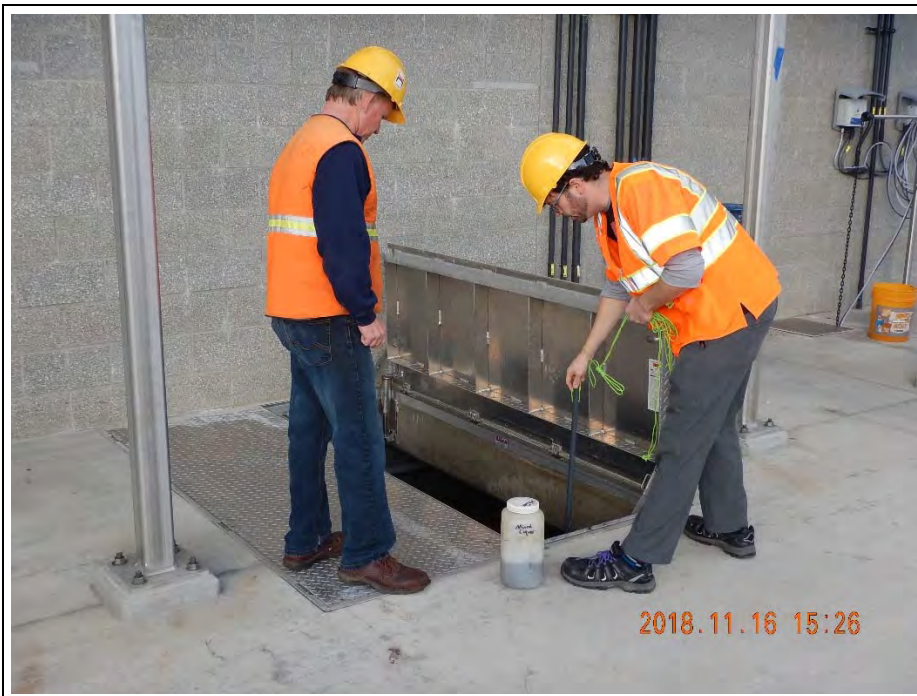
Photo #36

Area 31 Aeration Basins (looking northeast) on Friday, November 16th.

A City plant operator, Cory Prusher, is collecting a sample of mixed liquor from an aeration basin. Mixed liquor is a mixture of raw wastewater and activated sludge.

Start-up Activities. On Monday, November 5th, the City's operations staff began operating the plant after wastewater was introduced into the plant (see Photos #10, #12, #19, and #36). A commissioning representative for Suez Water Technologies, Kathleen McAllister, continued to work on site full-time during the first half of the month to facilitate the operation, testing, and calibration of membrane filtration equipment. On November 2nd, a training specialist for Suez Water Technologies, Wayne Key, finished conducting 40 hours of operator training pertaining to the membrane filtration system (see Photo #6). Also on November 2nd, APSCO service supervisor Clay Daly conducted operator training classes pertaining to grit pumps, WAS transfer pumps, and polymer blending equipment (see Photos #3, #4, and #5). On November 6th, a representative of DP Wilson, John Wilson, conducted an operator training class pertaining to odor control fans at the odor control structure (see Photo #13). On November 7th, Seepex control systems designer Kurt Werner and Granich Engineered Products representative Ken Hogan conducted an operator training class pertaining to centrifuge cake pumps (see Photo #16). On November 9th, Northstar Chemical delivered sodium hydroxide to the clean water facility (see Photo #22). On November 28th, Biorem representative Jeremy Wachtman conducted an operator training class pertaining to odor control equipment (see Photo #48). On November 29th, the operations staff began discharging effluent into a 24-inch outfall pipeline and into Oak Harbor Bay. Representatives of the City, Hoffman, and Carollo Engineers continued to meet each week to coordinate start-up activities and facilitate resolution of problems encountered during start-up. Valley Electric, University Mechanical, and other subcontractors and vendors also participated in meetings and start-up activities.

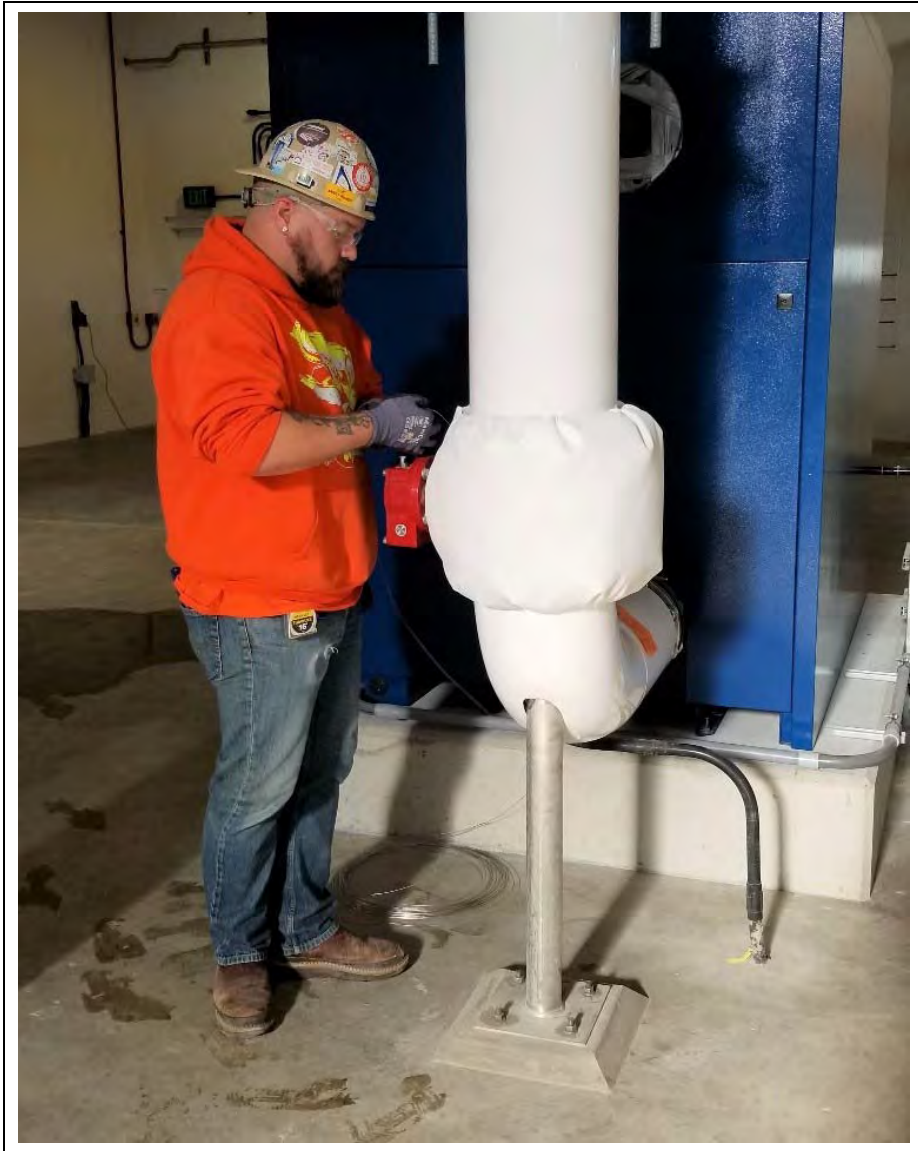
Photo #38

An insulator for D&G Insulation is wrapping insulation around aeration air piping at the discharge side of a membrane air scour blower.

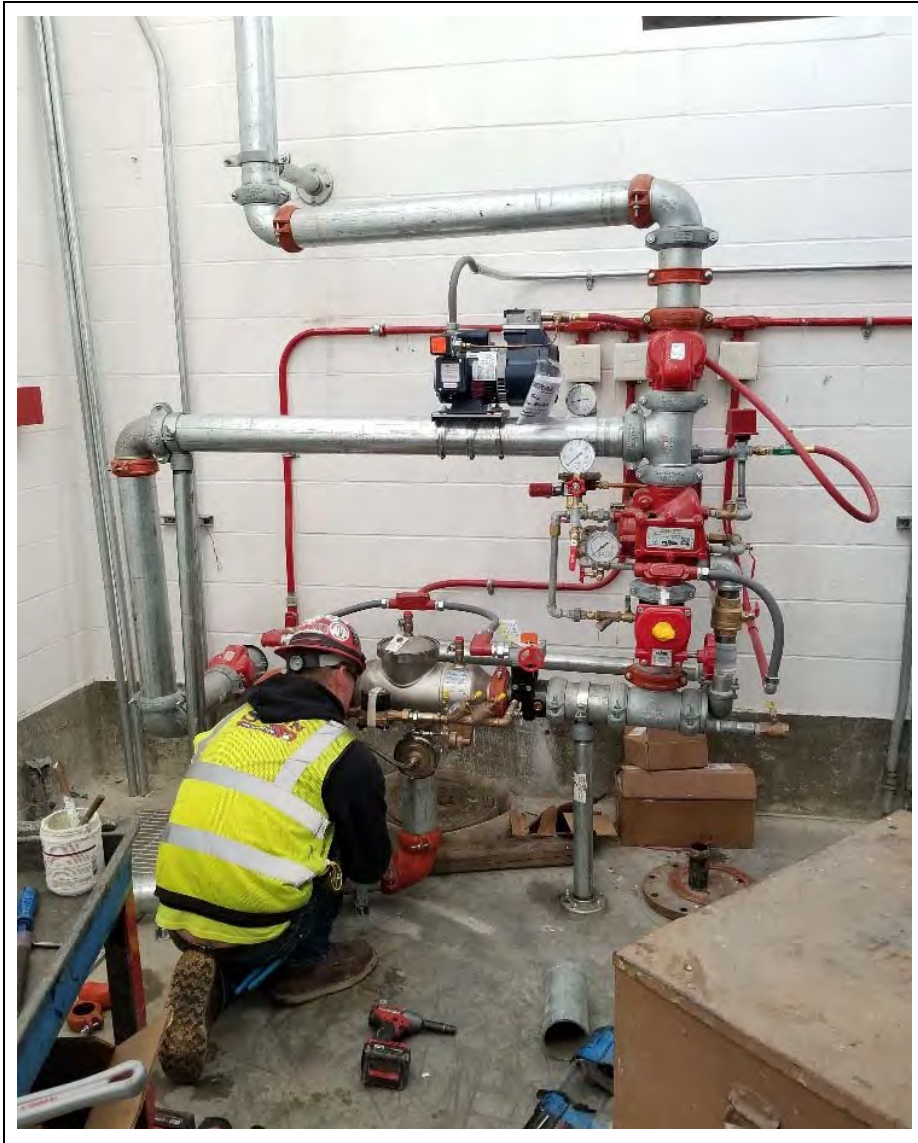
Photo #39

A pipefitter for Shinn
Mechanical is installing a
drain line for a backflow
prevention device that is
part of a fire suppression
system.

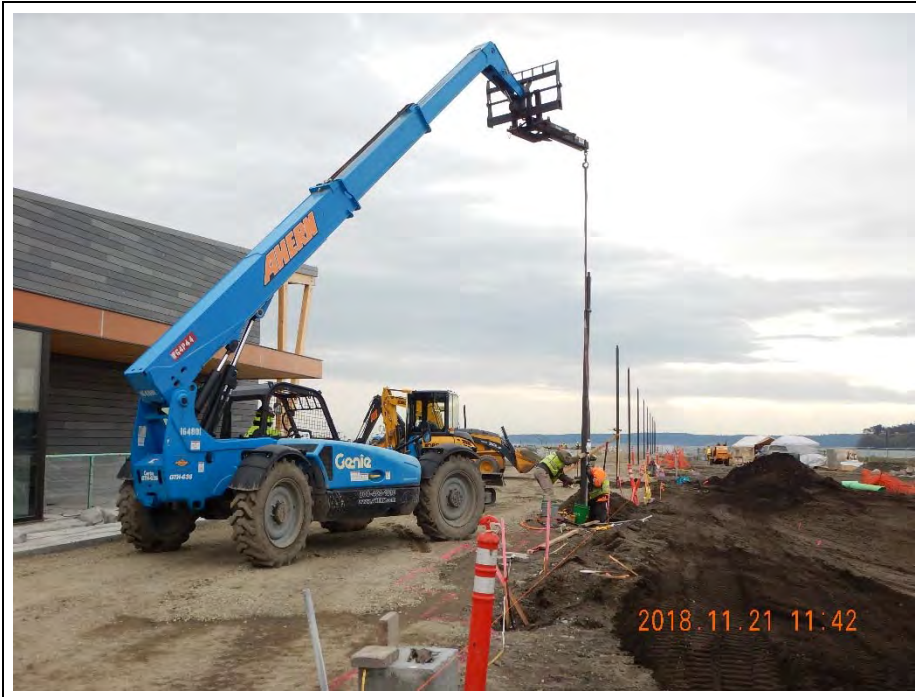
Photo #40

Electricians for Valley Electric are installing fiberglass light poles along a walkway that, when finished, will connect Pioneer Way to Oak Harbor Bay.

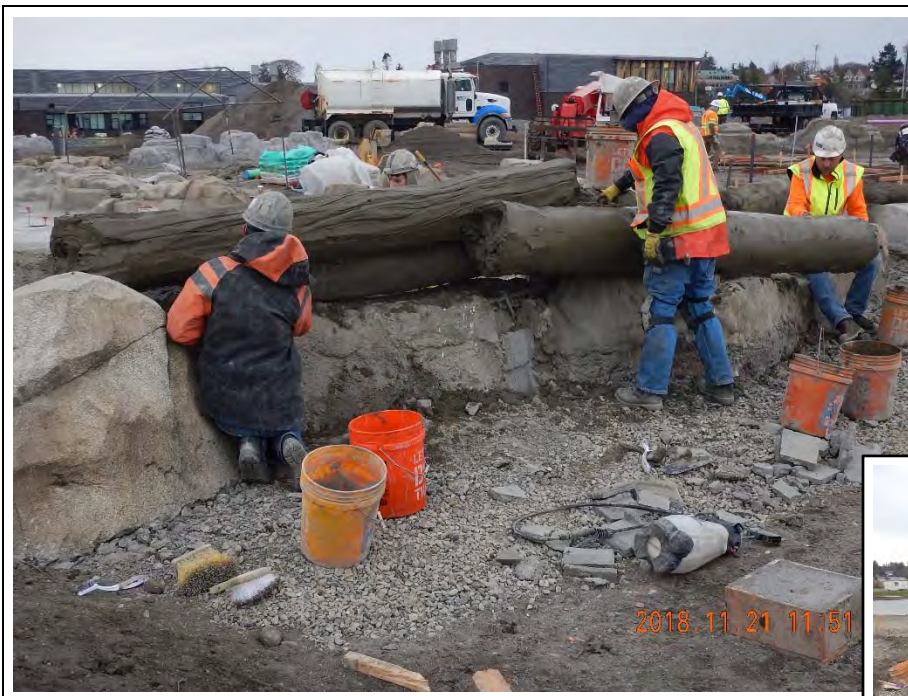
Photo #41

South end of Windjammer Park (looking north and west) on Wednesday, November 21st.

Laborers for Turnstone Construction are "sculpting" concrete for faux logs

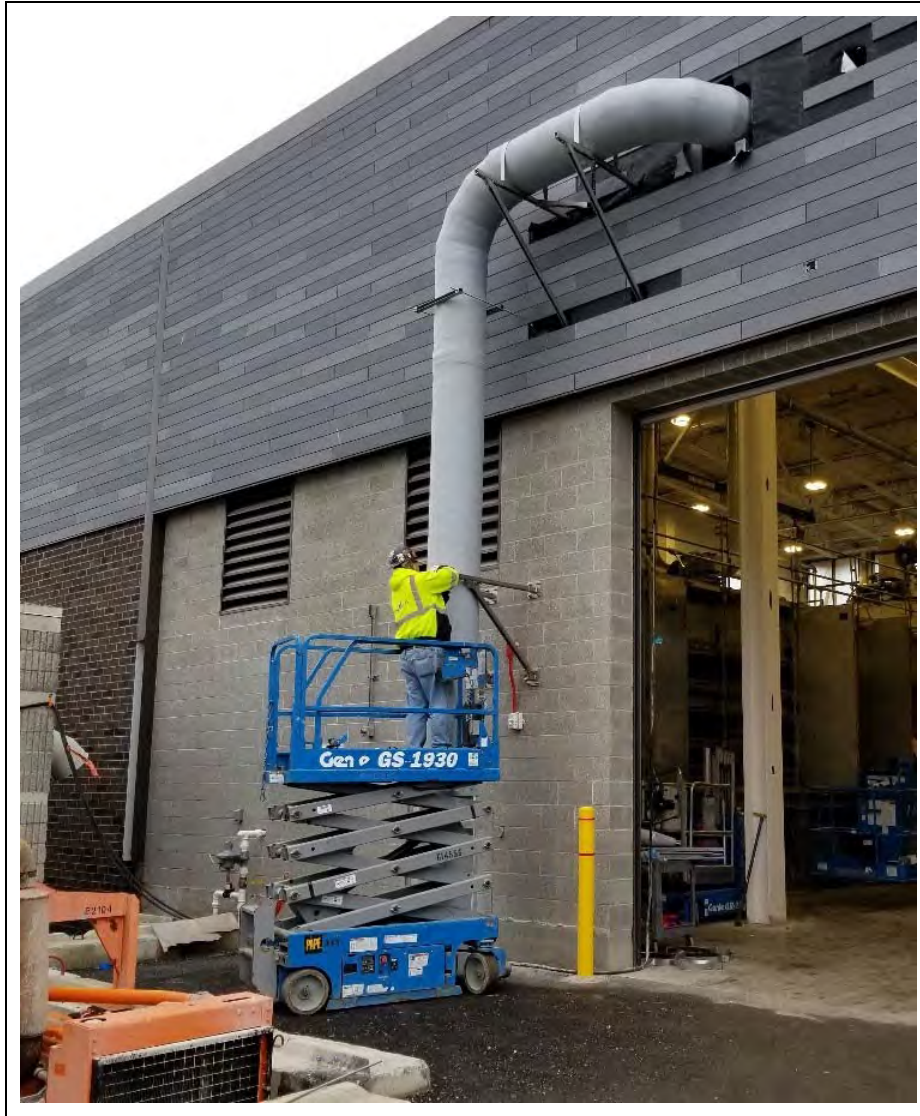
Photo #42

A sheet metal worker for
Delta Technology
Corporation is installing a
pipe support for fiber
reinforced plastic (FRP)
foul air piping.

GMPA No. 9 – Mechanical, Electrical, and Process Systems. Work on this GMPA is approximately 98% complete. Valley Electric continued to facilitate start-up activities in the secondary treatment and headworks buildings by identifying and solving miscellaneous electrical and communications problems that occurred during initial operation of process equipment (see Photo #7). Valley Electric installed liquid level sensors in the RAS/WAS wetwells, placed sealing compound in conduit fittings (see Photo #8), labeled conduits, and facilitated instrument installation and start-up with its subcontractor, QualiTEQ, at the aeration basins (see Photo #27) and WAS storage tanks. Valley Electric installed trace heating on piping associated with chemical facilities. Valley Electric continued to install conduits and conductors in the biosolids building for control panels, instruments, and miscellaneous equipment including centrifuges, centrifuge cake pumps, dryer feed pumps, motor-operated valves and diverter gates, polymer blending equipment, polymer dilution water booster pumps, an air compressor, and electric motors associated with a biosolids dryer and its conveyor system (see Photo #26). Valley Electric and its subcontractor, Redhawk Fire and Security, continued to terminate conductors and test equipment associated with a fire suppression system (see Photos #17 and #23). University Mechanical, similar to Valley Electric, continued to facilitate start-up activities in the secondary treatment and headworks buildings by resolving miscellaneous mechanical problems that occurred during initial operation of process equipment (see Photos #9 and #11). University Mechanical continued to assemble and install equipment associated with a biosolids dryer in the biosolids building (see Photos #44 and #47) including installation of a steel frame to support a bin cover hoist in the loadout area. Two carpenters for University Mechanical continued to place grout under base plates for pipe and equipment supports in the biosolids building, in the secondary treatment building, and in the gallery under the secondary treatment building. University Mechanical continued to perform miscellaneous mechanical work including labeling piping systems, installing additional pipe supports associated with membrane effluent piping, and installing level indicators at chemical and utility water storage tanks (see Photo #43). University Mechanical's subcontractor, D&G Insulation, wrapped insulation around air scour piping in the secondary treatment building (see Photo #38) and HVAC piping in the electrical building. University Mechanical's subcontractor, Delta Technology Corporation, installed a dust collector (see Photo #37) in the loadout area and continued to install fiber reinforced plastic (FRP) foul air piping throughout the biosolids building (see Photo #42).

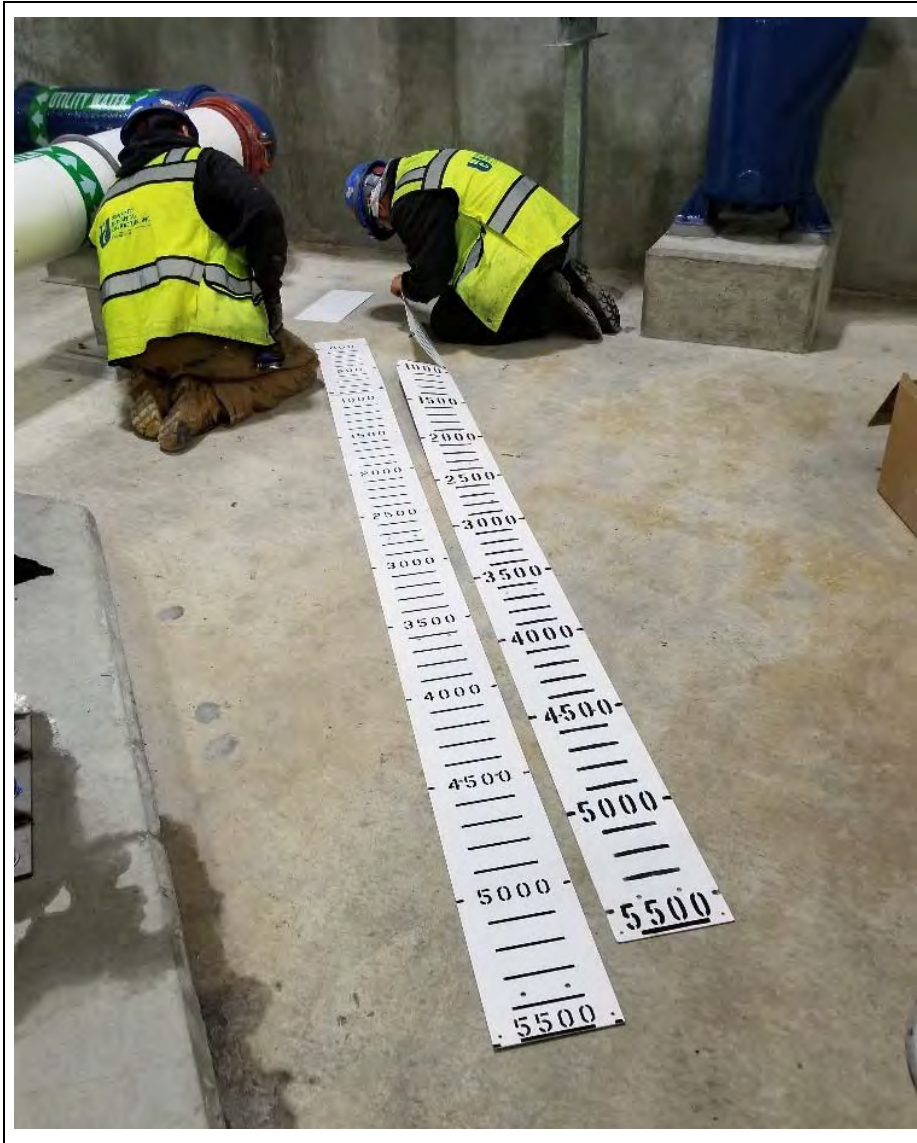
Photo #43

Two pipefitters for University Mechanical are preparing level indicators for chemical and utility water storage tanks.

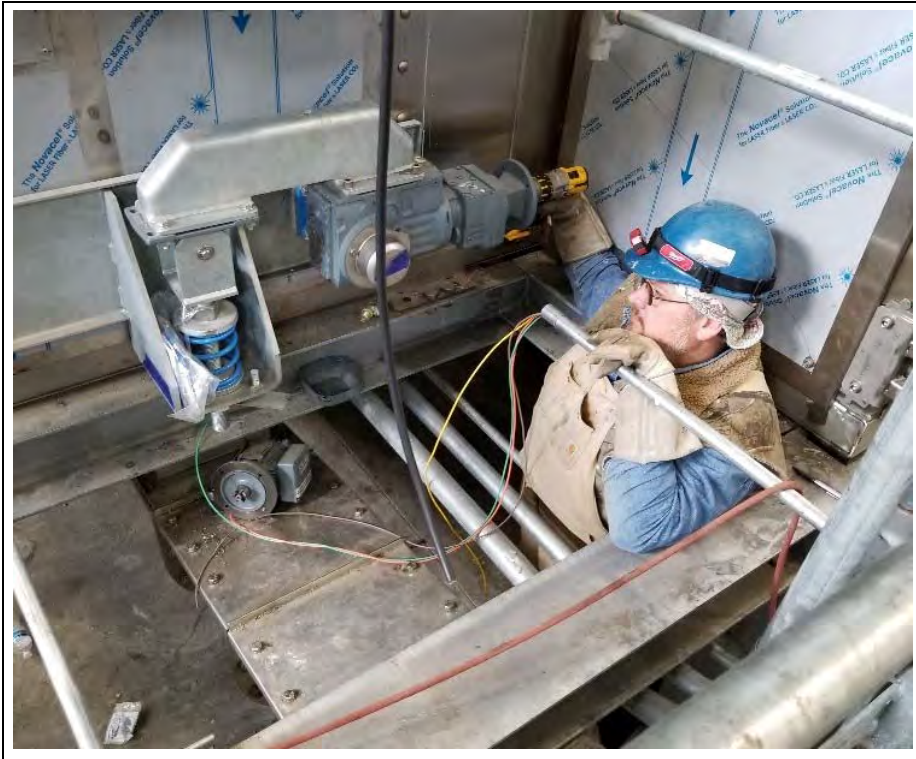
Photo #44

A millwright for University Mechanical is installing a scraping device inside a biosolids dryer.

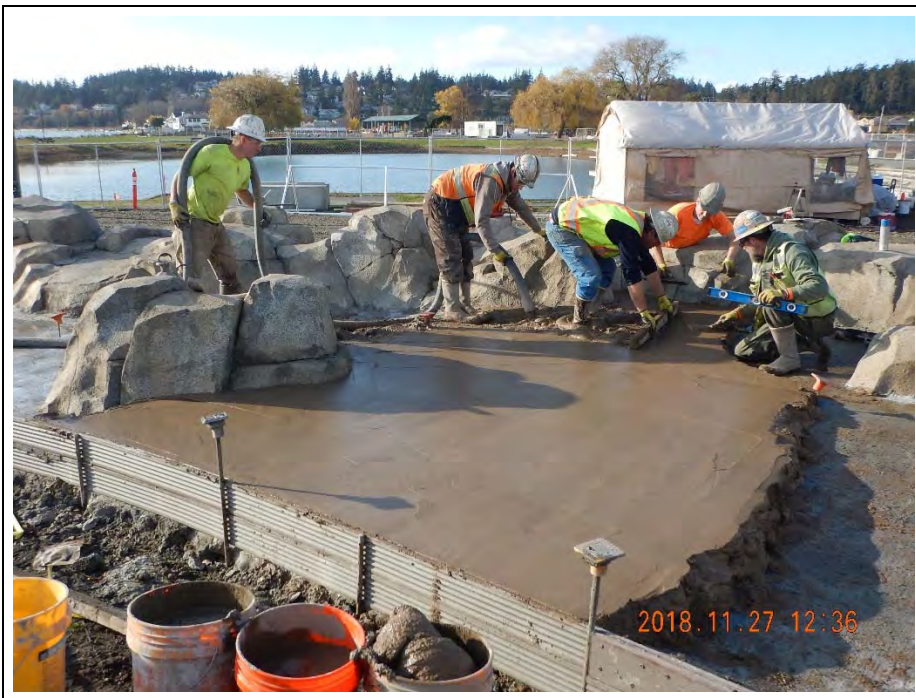
Photo #45

Laborers for Turnstone Construction are placing grout atop a structural concrete slab-on-grade to form the final bottom of a splash park.

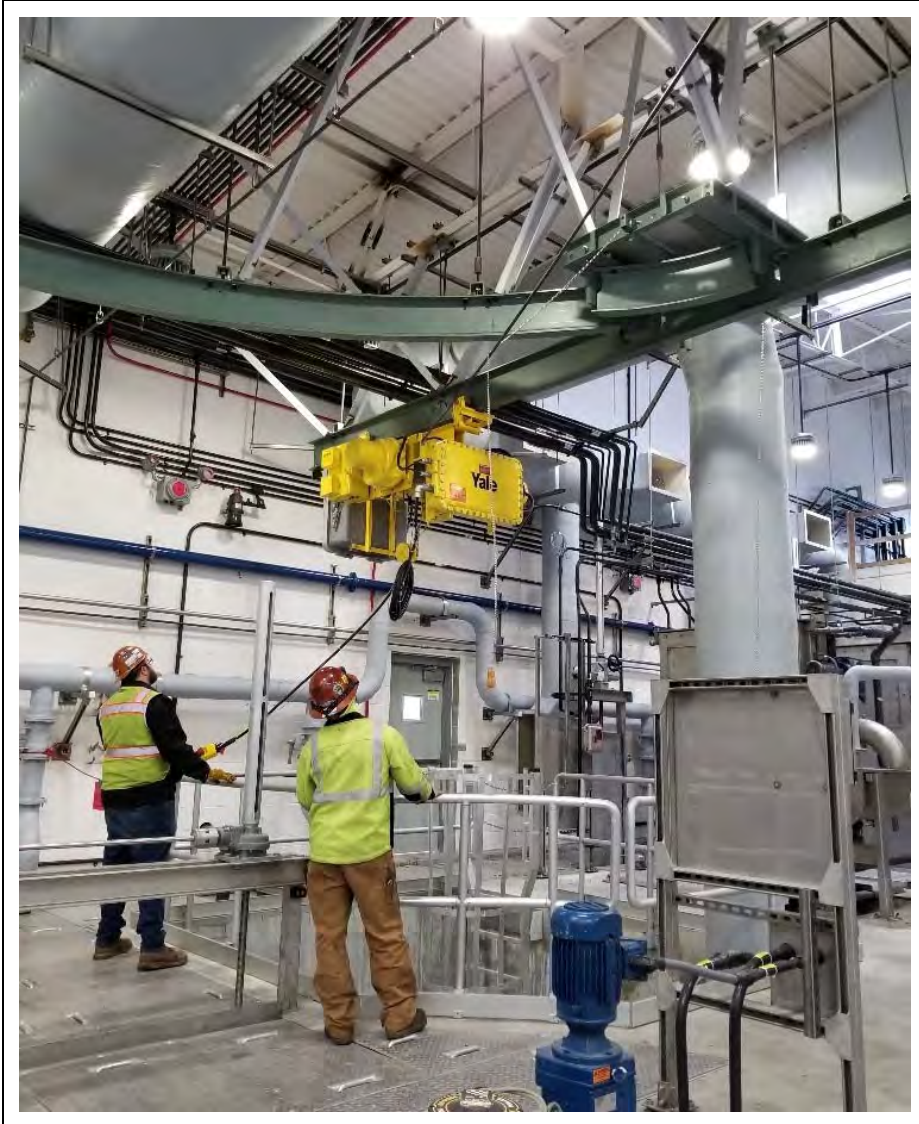
Photo #46

Ironworkers for WEMCO
are operating a just
installed hoist to verify
that it works properly.

GMPA No. 11 – Superstructure Construction. Work on this GMPA is approximately 98% complete. WEMCO installed a monorail and a hoist in the headworks building (see Photo #46). WEMCO also load tested a monorail and hoist in the biosolids building. Valley Electric and its subcontractor, EZ Interface, installed a security and access control system (see Photos #18 and #34). Honeywell and EC Electric worked on the HVAC system in the administration building. Shinn Mechanical installed a drain line for a backflow prevention device in the headworks building (see Photo #39). Painters for Penington Painting applied coatings in the secondary treatment, headworks, biosolids, and administration buildings.

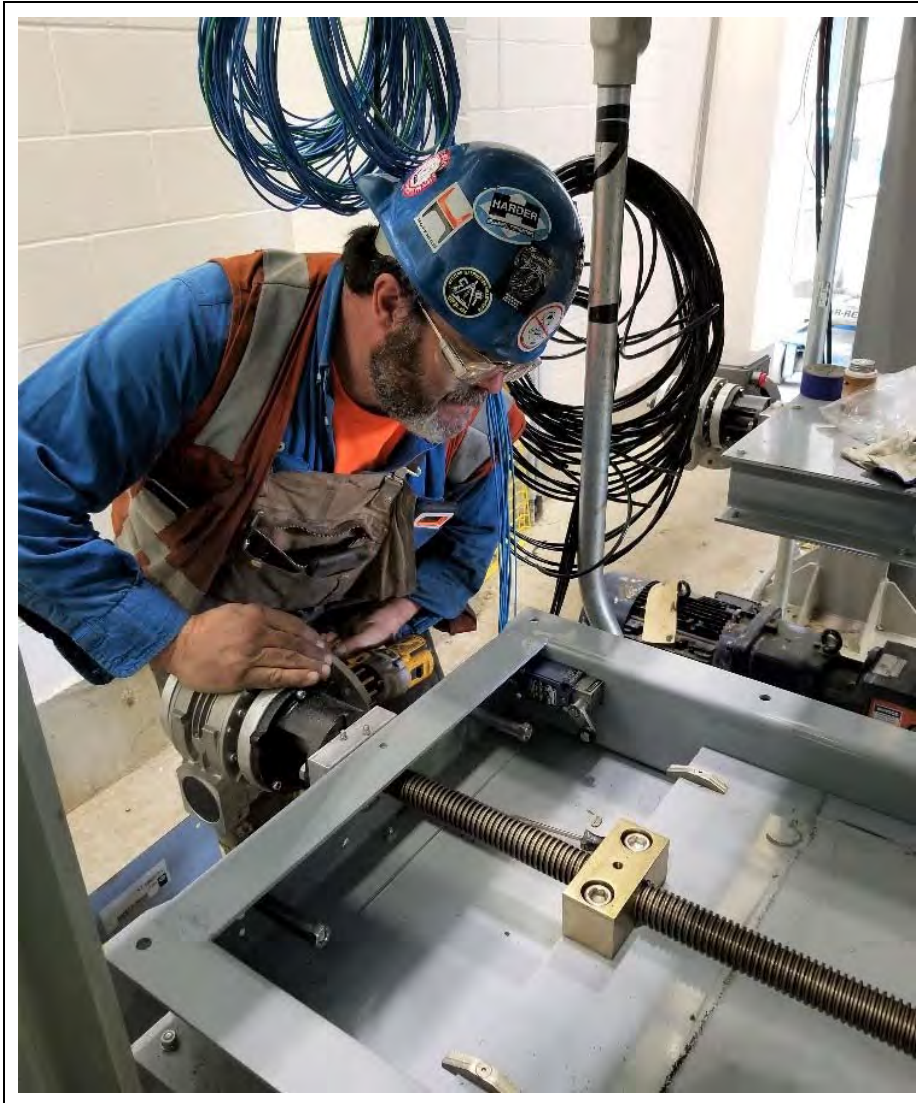
Photo #47

A millwright for University
Mechanical is setting a
limit switch on a knife
gate.

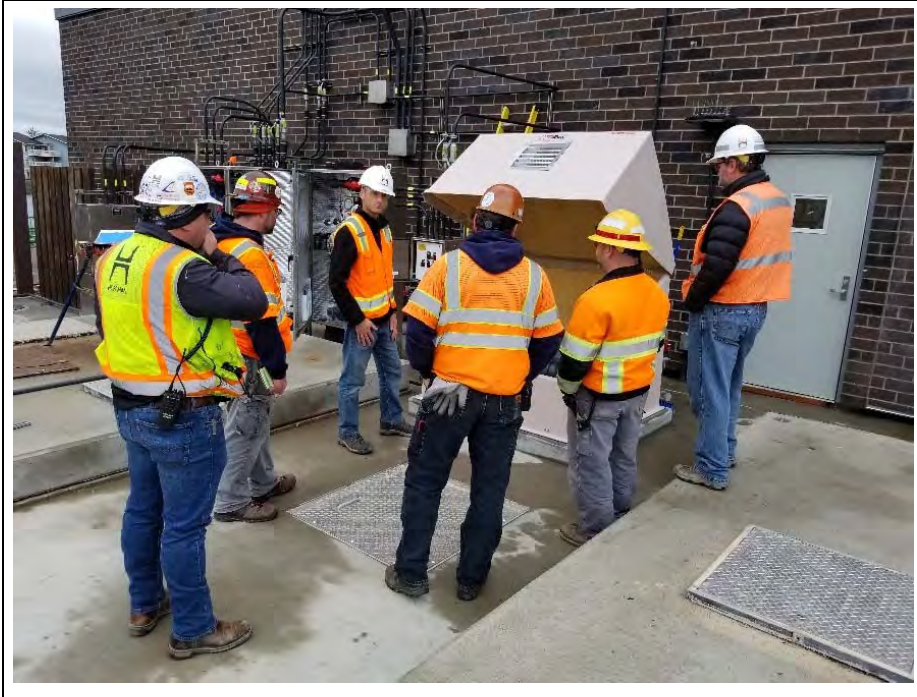
Photo #48

Area 60 Odor Control (looking southeast) on Wednesday, November 28th.

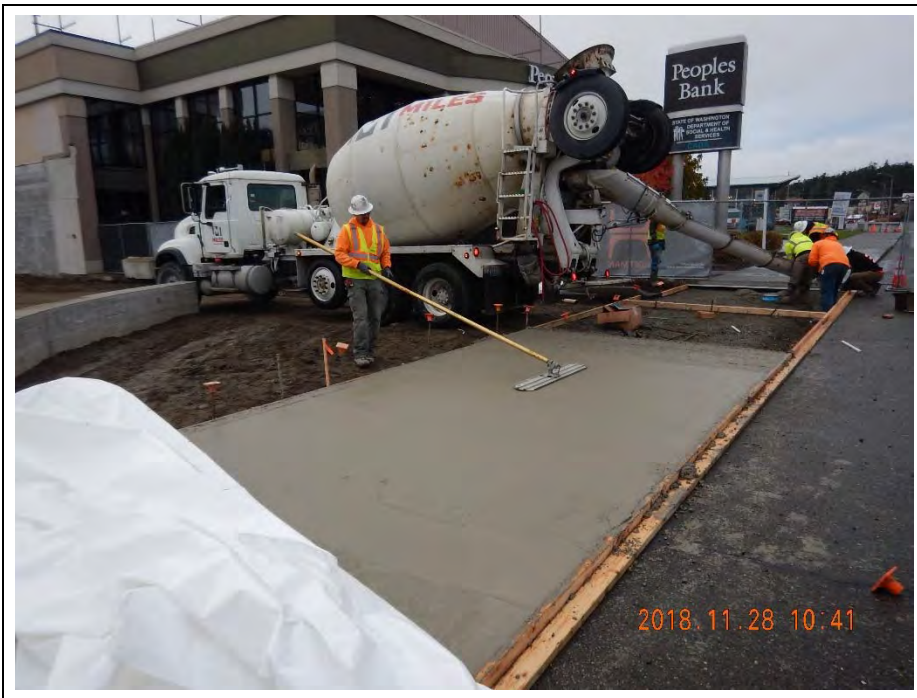
Photo #49

Carpenters for Interwest Construction are placing concrete for a sidewalk adjacent to Pioneer Way where the old Whidbey Island Bank Building was located before demolition.

- Interwest Construction installed and hydrotested a section of 8-inch PVC water line.
- Interwest Construction and its subcontractor, Morse Steel Services, built formwork and placed reinforcing steel, respectively, for the north half of a retaining wall (see Photo #29). Interwest Construction placed concrete for the retaining wall on November 16th.
- Interwest Construction graded existing earthen material.
- Interwest Construction placed and compacted imported aggregate base material where a seatwall and sidewalk are located adjacent to Pioneer Way. Interwest Construction built formwork and placed reinforcing steel and concrete for the seatwall and sidewalk (see Photo #49).
