City of Oak Harbor
City Council Agenda Bill

Bill No. 5. c. i.
Date: February 19, 2019
Subject: Clean Water Facility Update

Clean Water Facility Project

January 2019

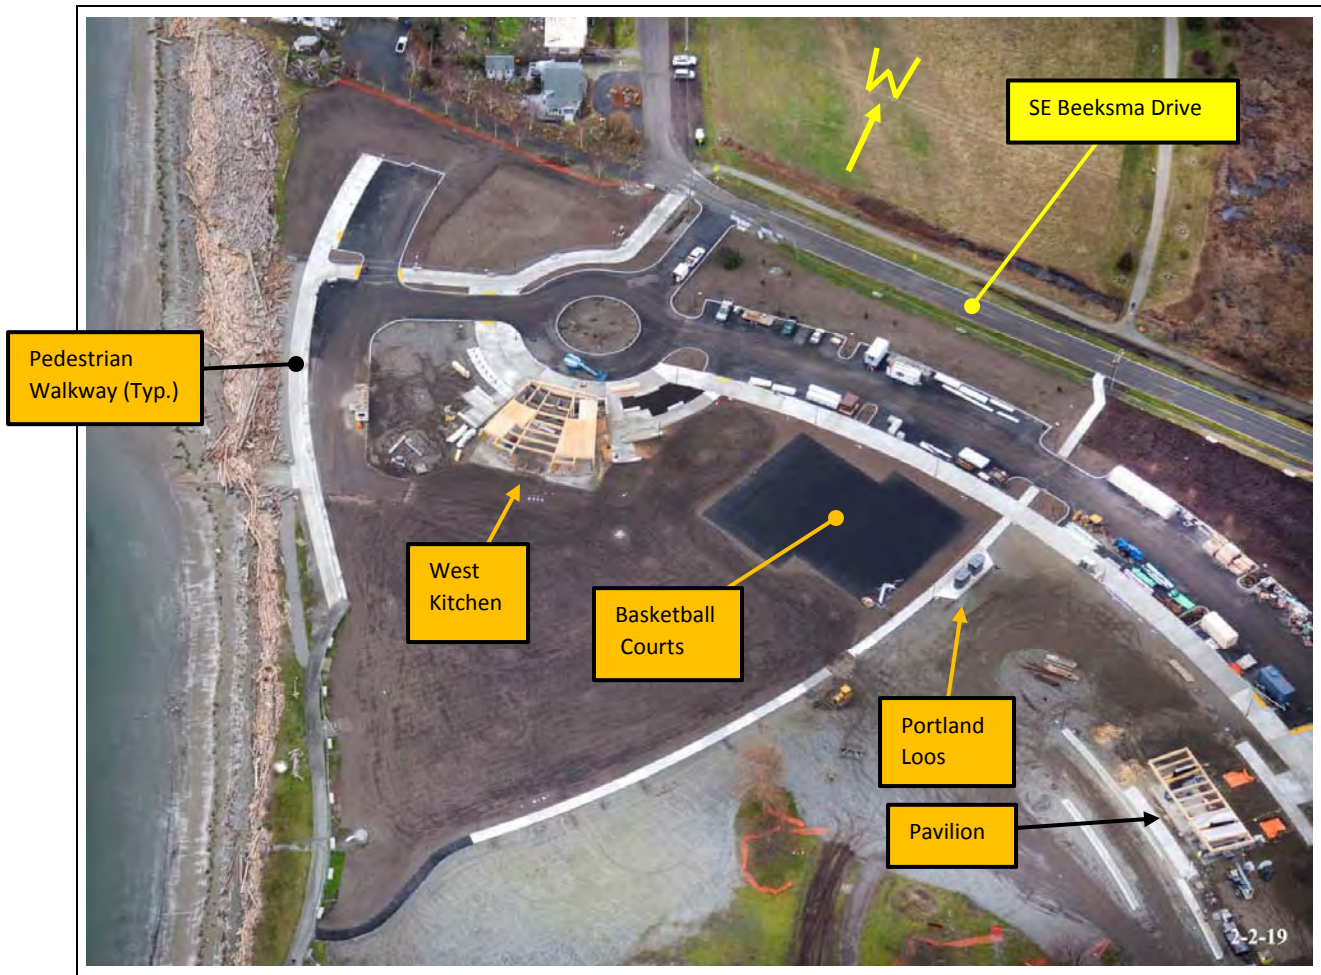
Photo #1B

Aerial photo of the southwest end of Windjammer Park (looking west) on February 2nd, 2019.

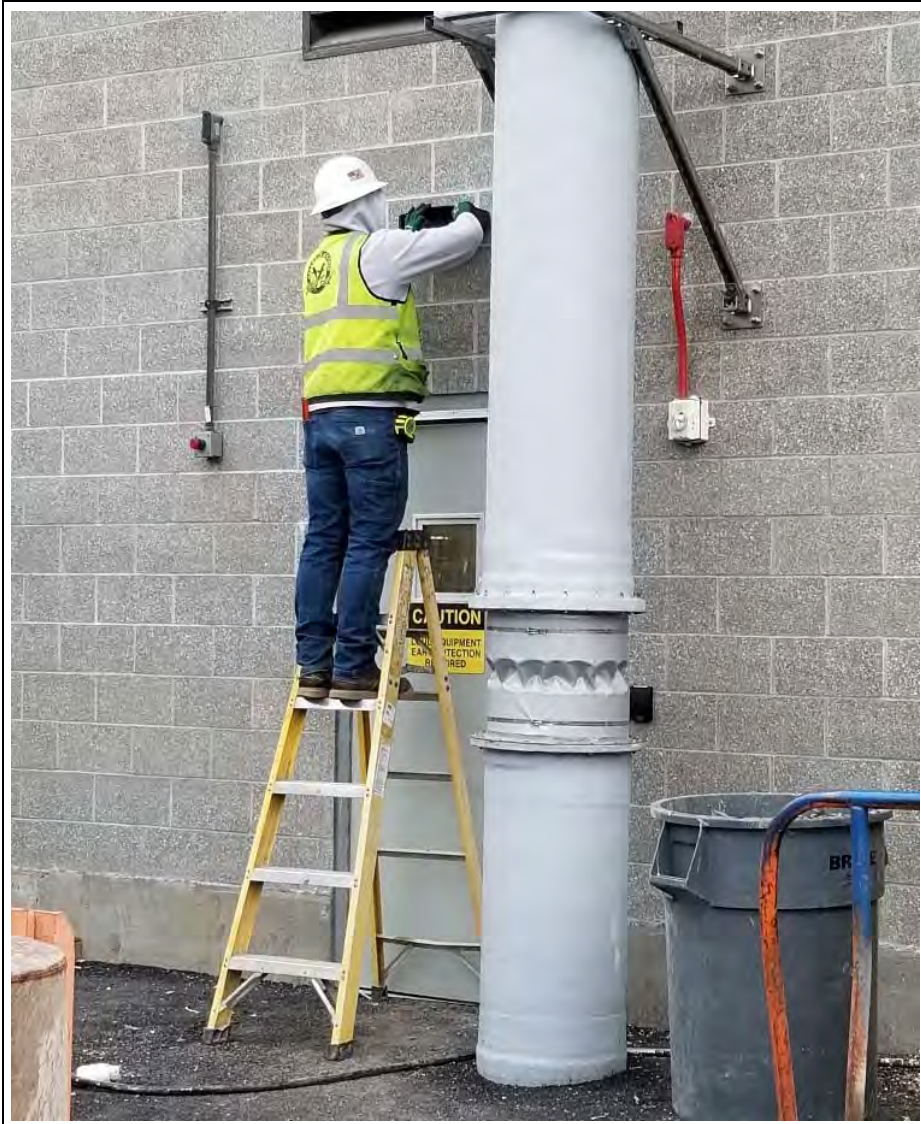
Photo #3

Area 50 Biosolids Building
(looking southeast) on
Wednesday, January 2nd.

An electrician for Valley
Electric is installing a light
fixture over a doorway.

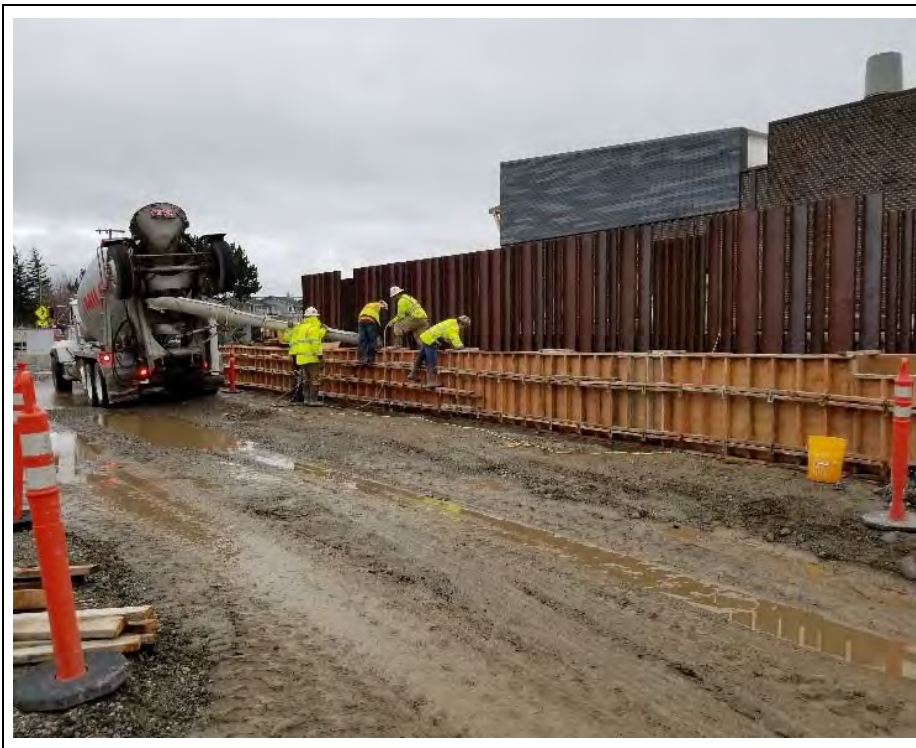
Photo #6

Area adjacent to the north side of Area 20 Odor Control Structure (looking east) on Thursday, January 3rd.

Carpenters and laborers for Interwest Construction are placing concrete for a seat wall.

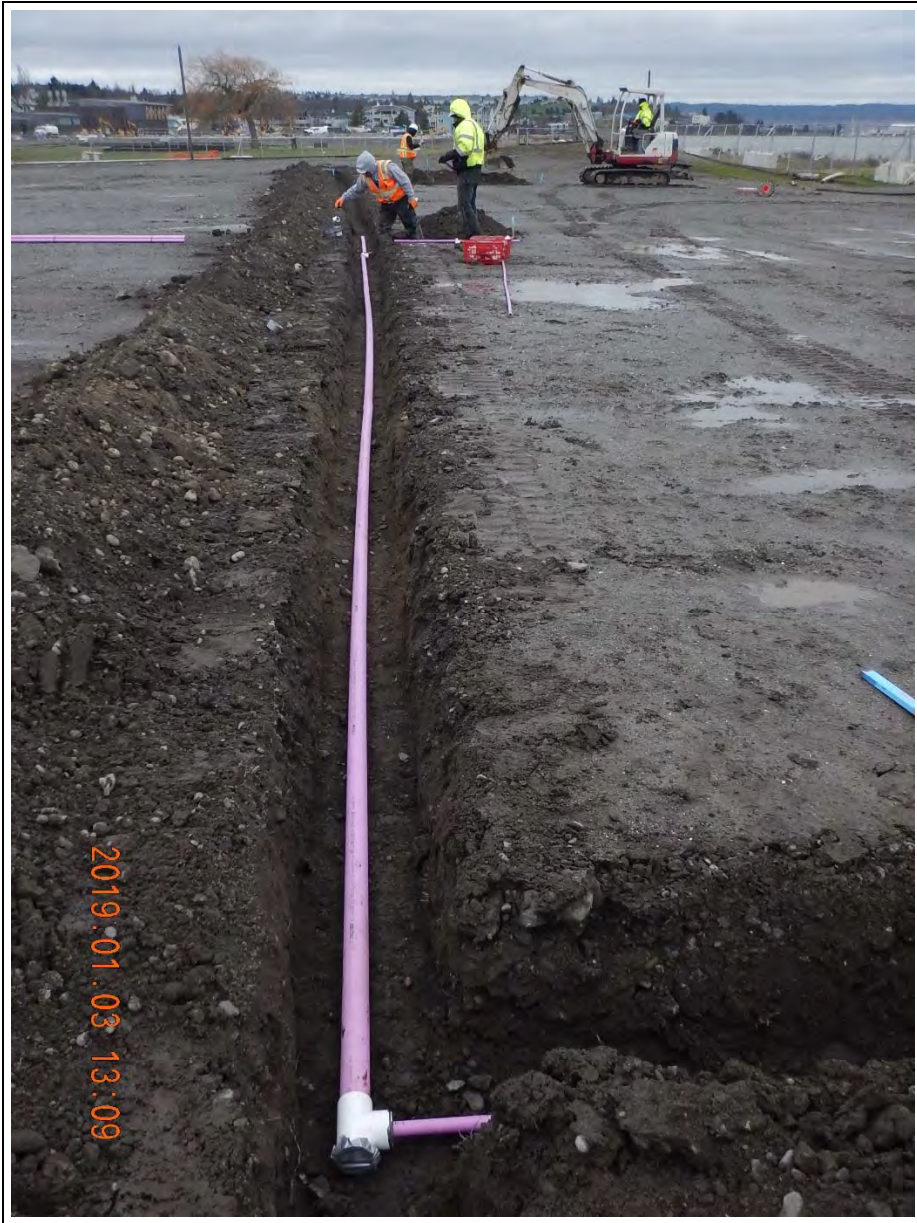
Photo #7

Southwest end of Windjammer Park (looking east from the west kitchen) on Thursday, January 3rd.

Laborers for Pacific Earth Works are installing PVC irrigation pipe. The pink color indicates the use of reclaimed water.

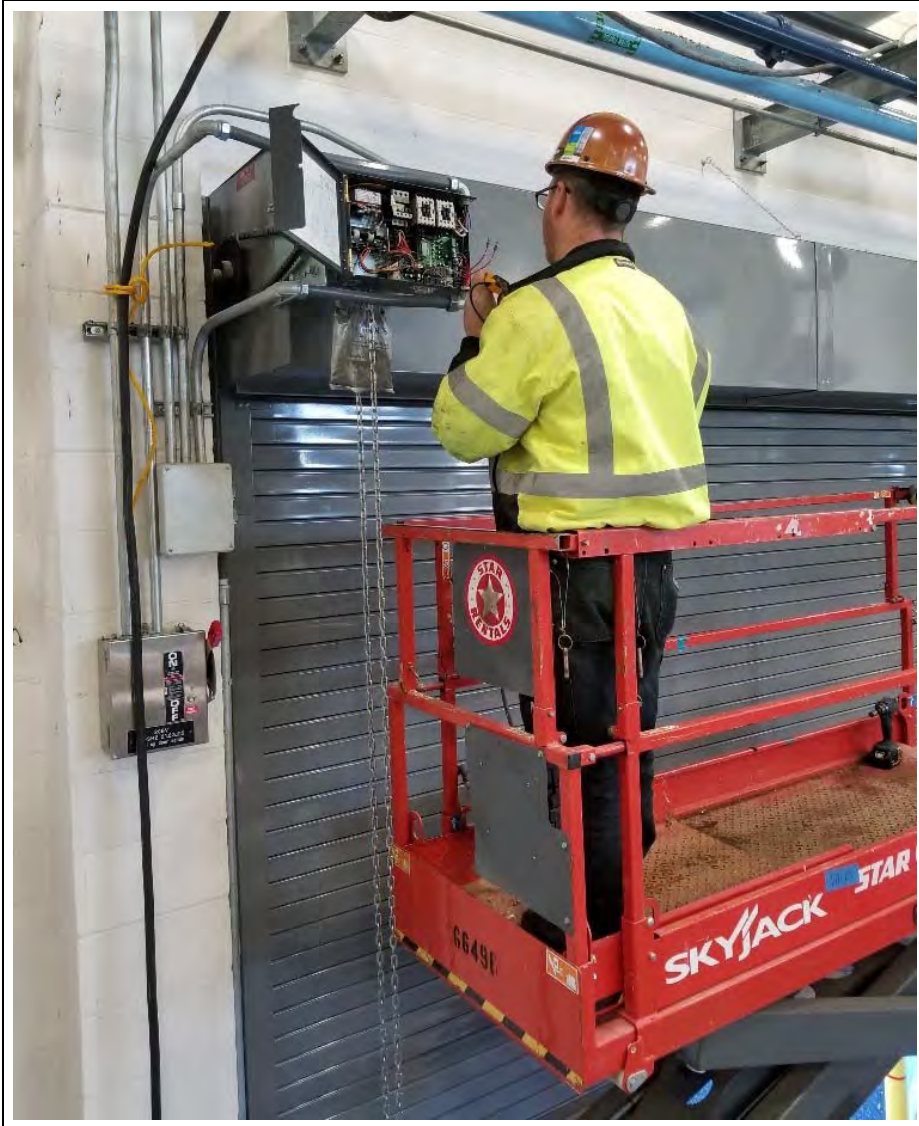
Photo #8

Area 50 Biosolids Building
(looking northeast in
loadout area) on Friday,
January 4th.

A technician for Zesbaugh
is testing conductors for a
motor actuator for a
coiling door.

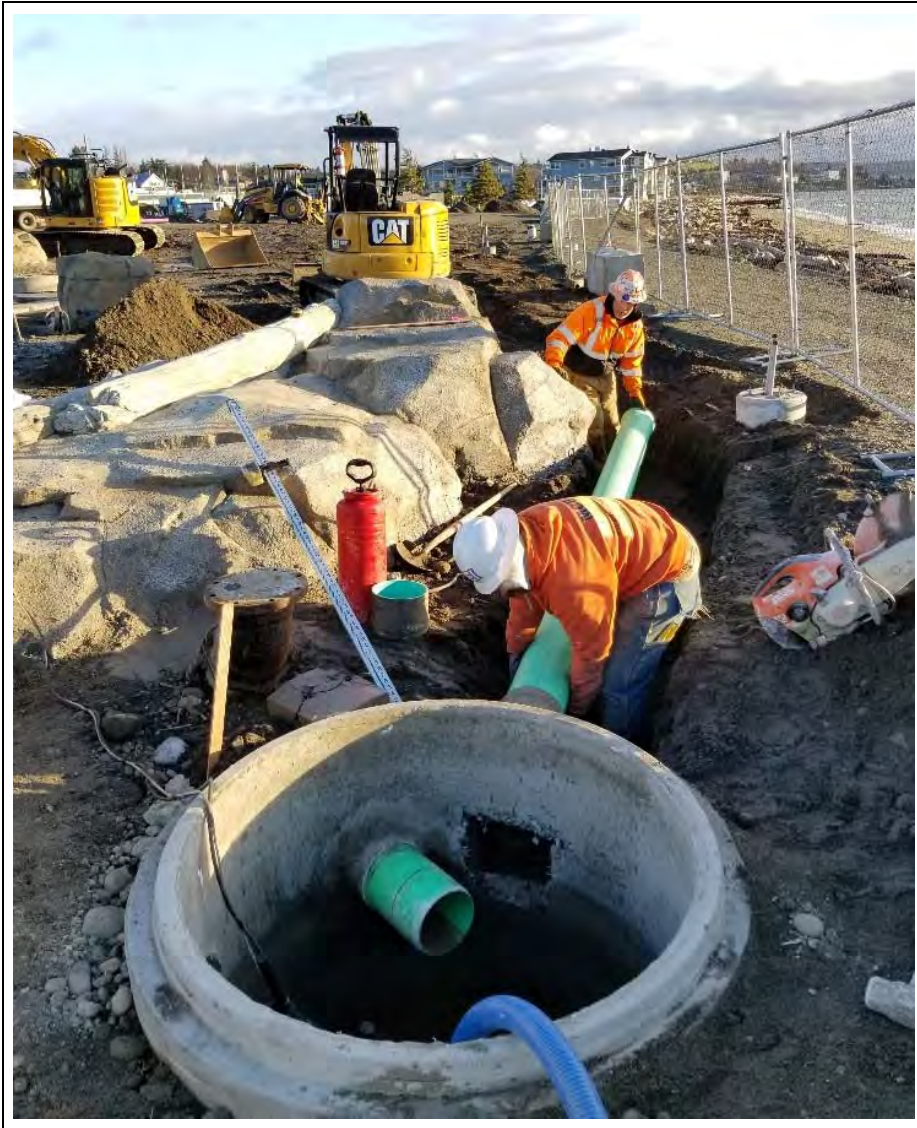
Photo #9

South end of Windjammer Park (looking east) on Friday, January 4th.

A pipe layer and an operator for Interwest Construction are installing an 8-inch PVC sanitary sewer pipe.

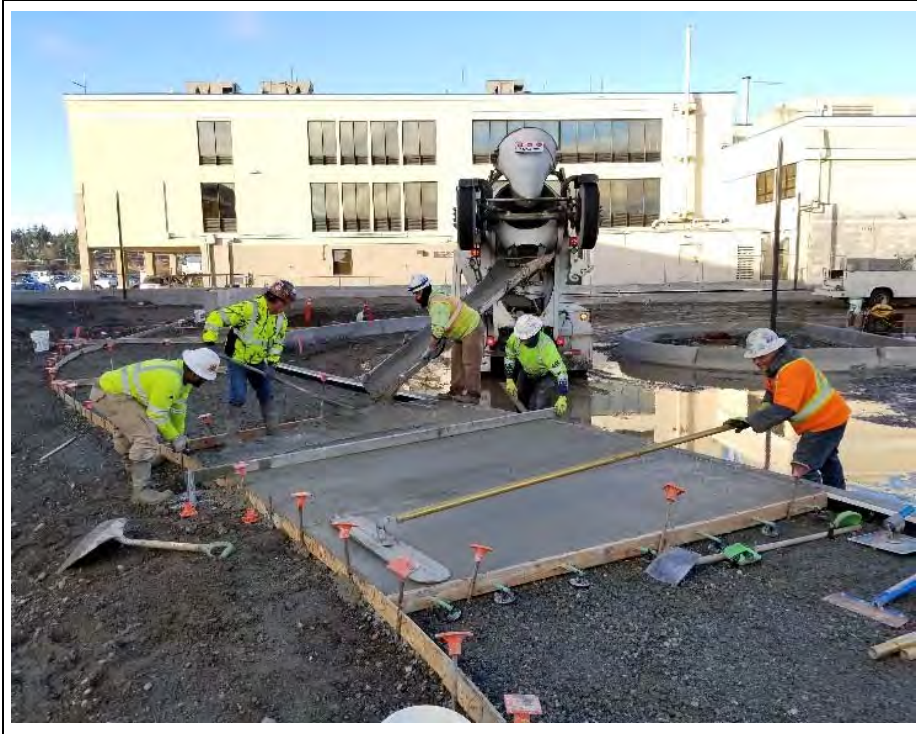
Photo #10

Area north of Area 20 Secondary Treatment Building (looking west) on Friday, January 4th.

Carpenters and laborers for Interwest Construction are placing and finishing concrete for a walkway.

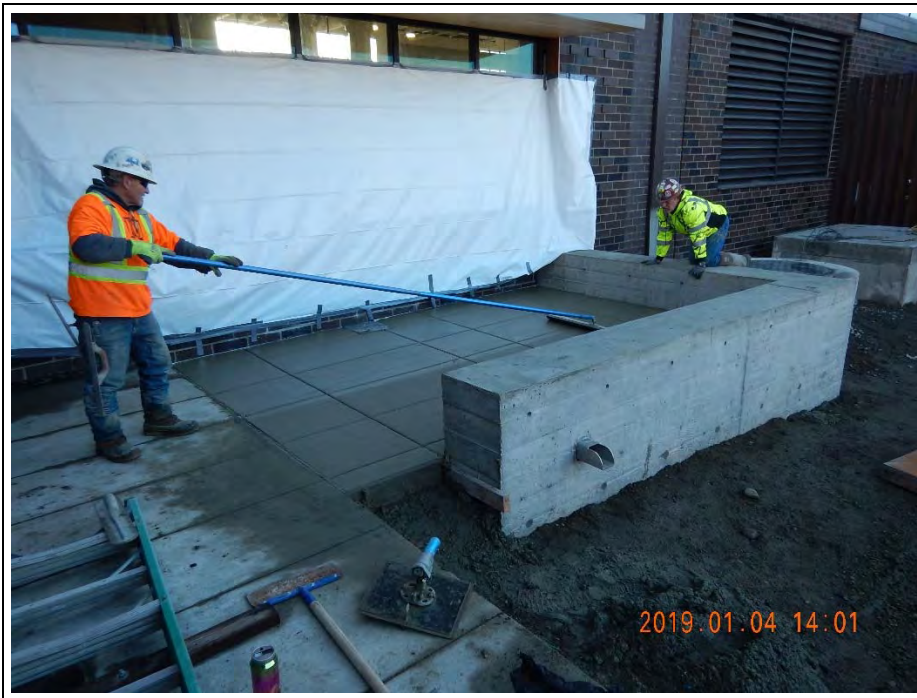
Photo #11

Area adjacent to the north side of Area 20 Secondary Treatment Building (looking southwest) on Friday, January 4th.

A laborer for Interwest Construction is applying a broom finish to concrete at an interpretive viewing deck.

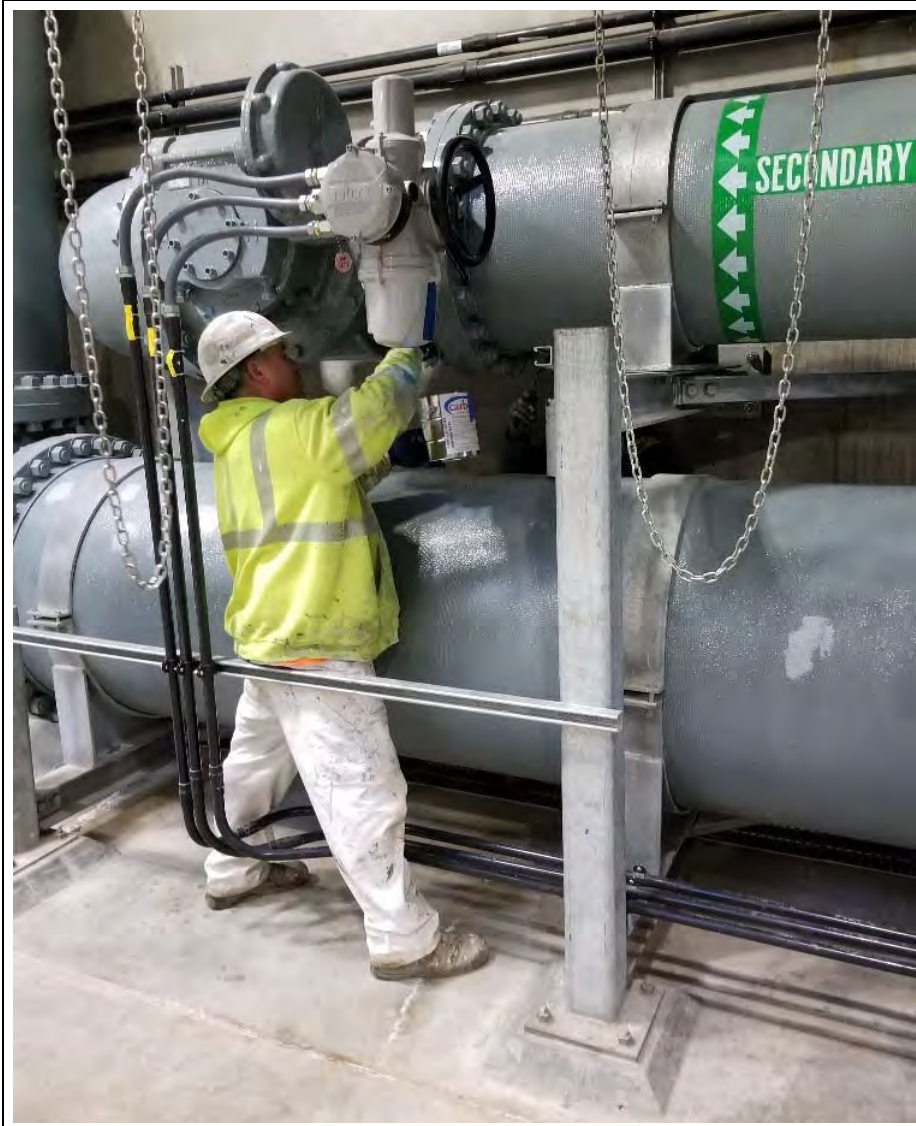
Photo #12

Area 30 Secondary Treatment Building (looking southeast in the gallery) on Monday, January 7th.

A painter for Penington Painting Company is touching up the paint on 36-inch and 24-inch secondary influent piping.

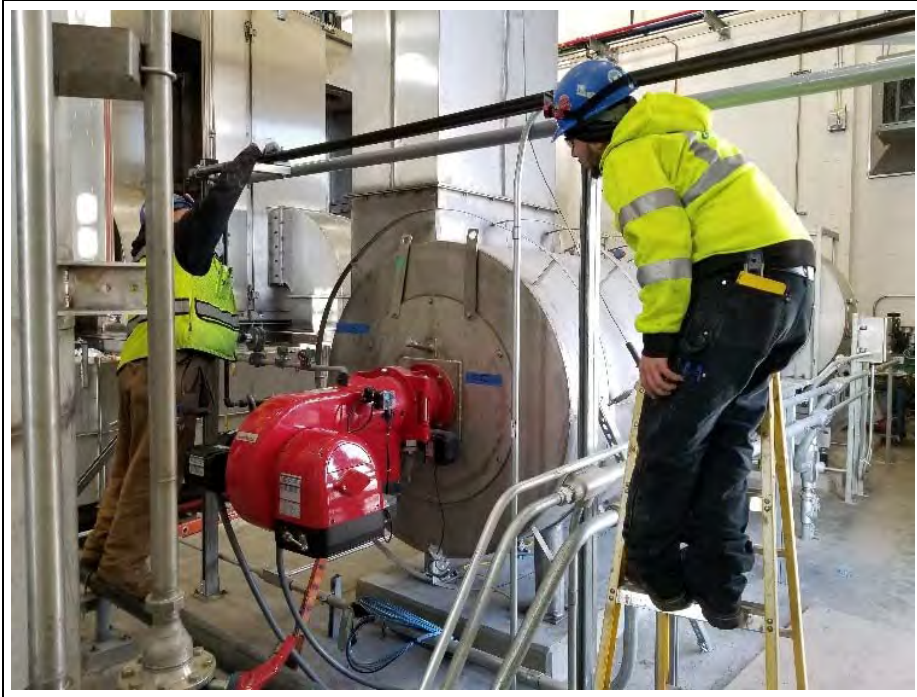
Photo #13

Area 50 Biosolids Building
(looking northwest) on
Monday, January 7th.

Pipefitters for University
Mechanical are installing
vent piping associated
with a natural gas
pressure regulator.

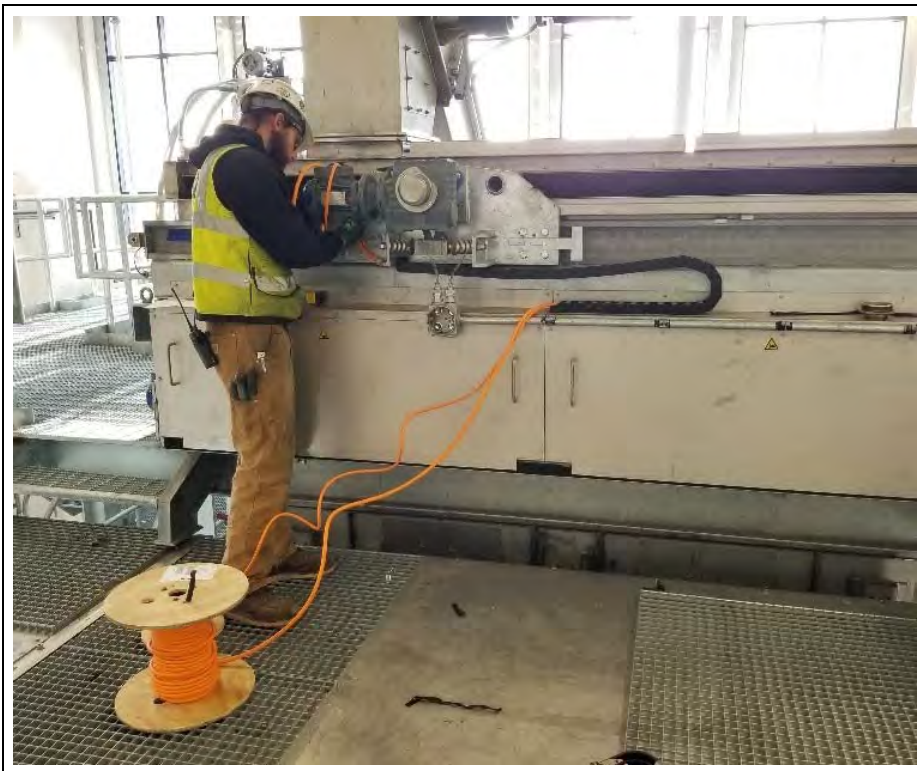
Photo #14

Area 50 Biosolids Building
(looking south atop the
biosolids dryer) on
Monday, January 7th.

An electrician for Valley
Electric is installing
conductors for a sludge
cake feed distributor.

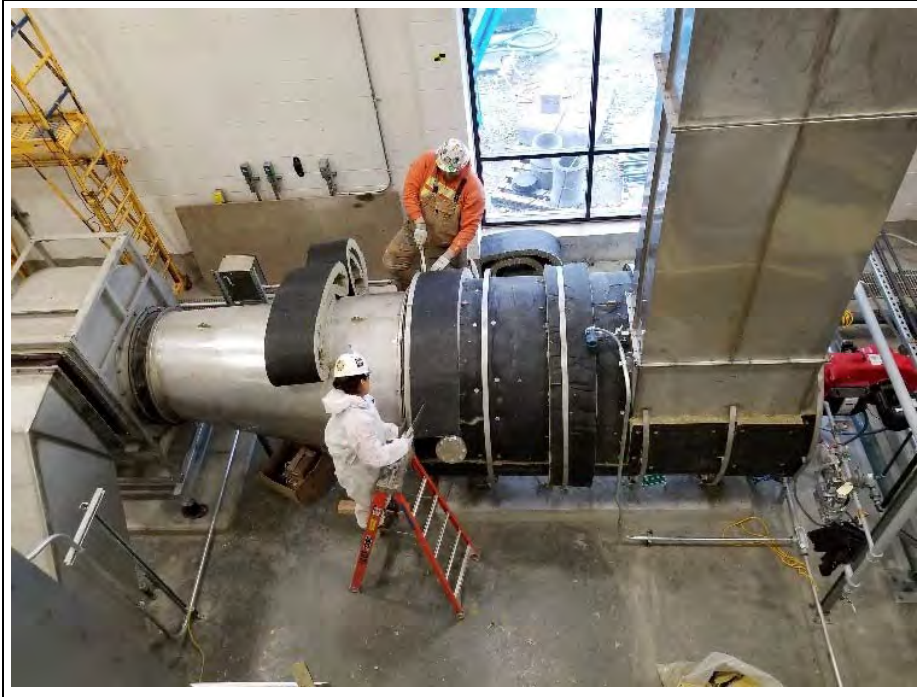
Photo #16

Area 50 Biosolids Building (looking northeast) on Tuesday, January 8th.

GEA Process Engineer Tom Potter is collecting a sample of dewatered waste activated sludge (WAS), i.e., wet cake, from a centrifuge. The wet cake is then conveyed to a biosolids dryer where the wet cake is heated at temperatures up to 350 deg-F. The resulting product is then known as Class A biosolids.

Class A biosolids is a designation for dewatered sludge that meets U.S. EPA guidelines for land application with no restrictions. Thus, Class A biosolids can be legally used as fertilizer at farms, vegetable gardens, and can be sold to home gardeners as compost or fertilizer.

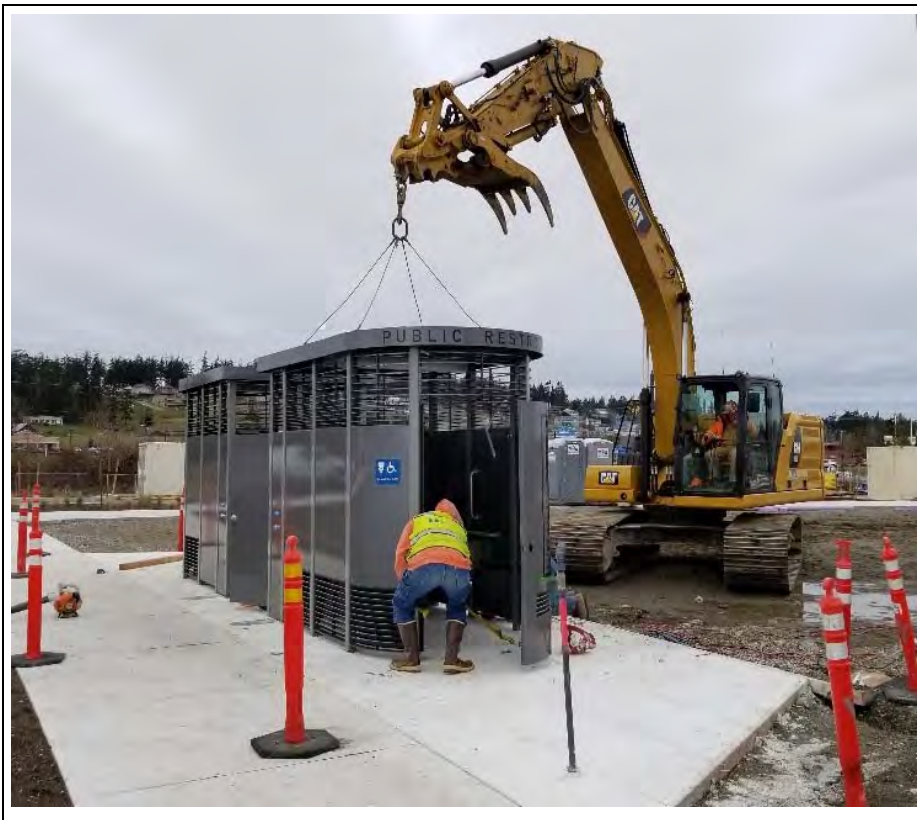
Photo #17

West end of Windjammer Park (looking west) on Tuesday, January 8th.

Interwest Construction is utilizing an excavator to set a Portland Loo in place atop a concrete slab-on-grade.

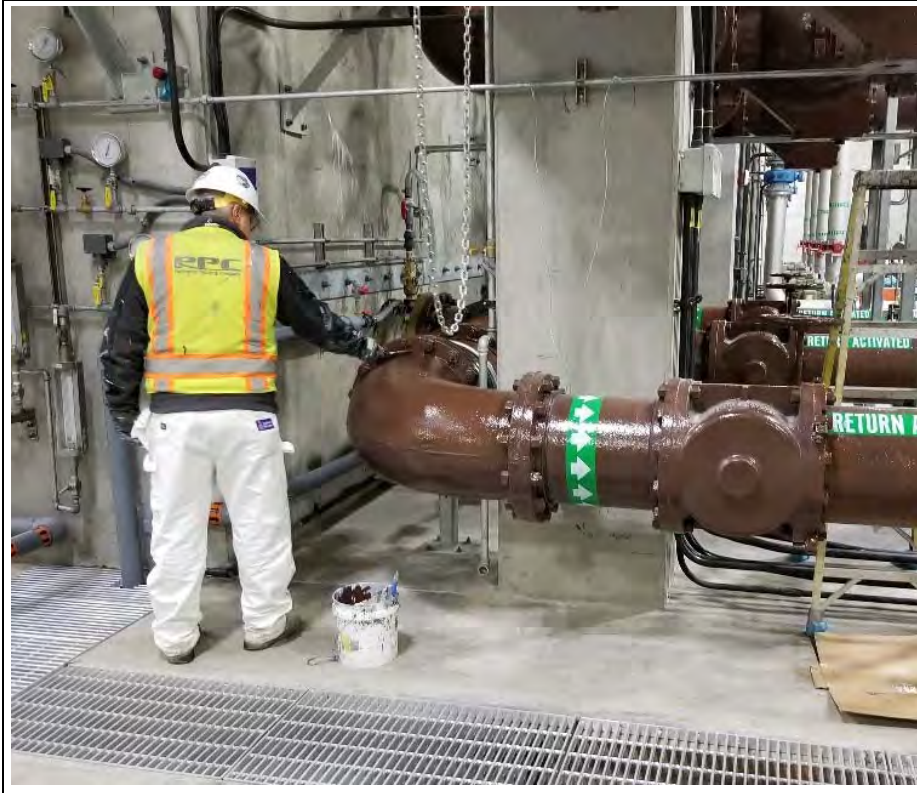
Photo #20

Area 30 Secondary Treatment Building (looking west in the gallery) on Tuesday, January 8th.

A painter for Penington Painting Company is touching up the paint on return activated sludge (RAS) piping.

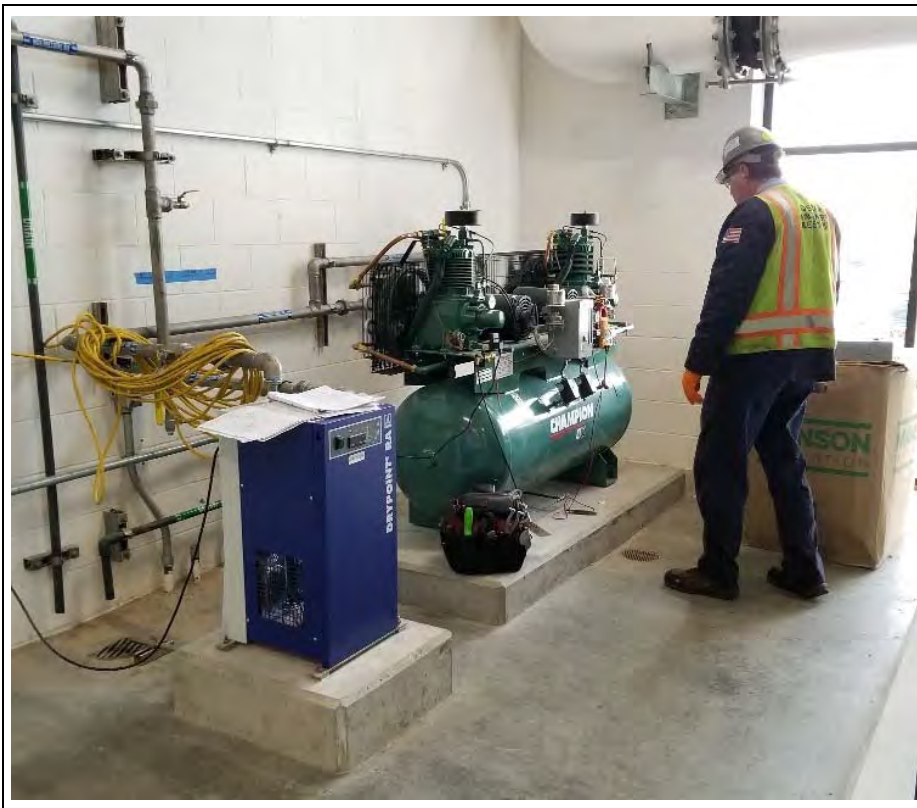
Photo #21

Area 32 Aeration Blower Building (looking west) on Wednesday, January 9th.

A technician for Cascade Machinery and Electric is starting up an air compressor that serves the clean water facility's high pressure air system.

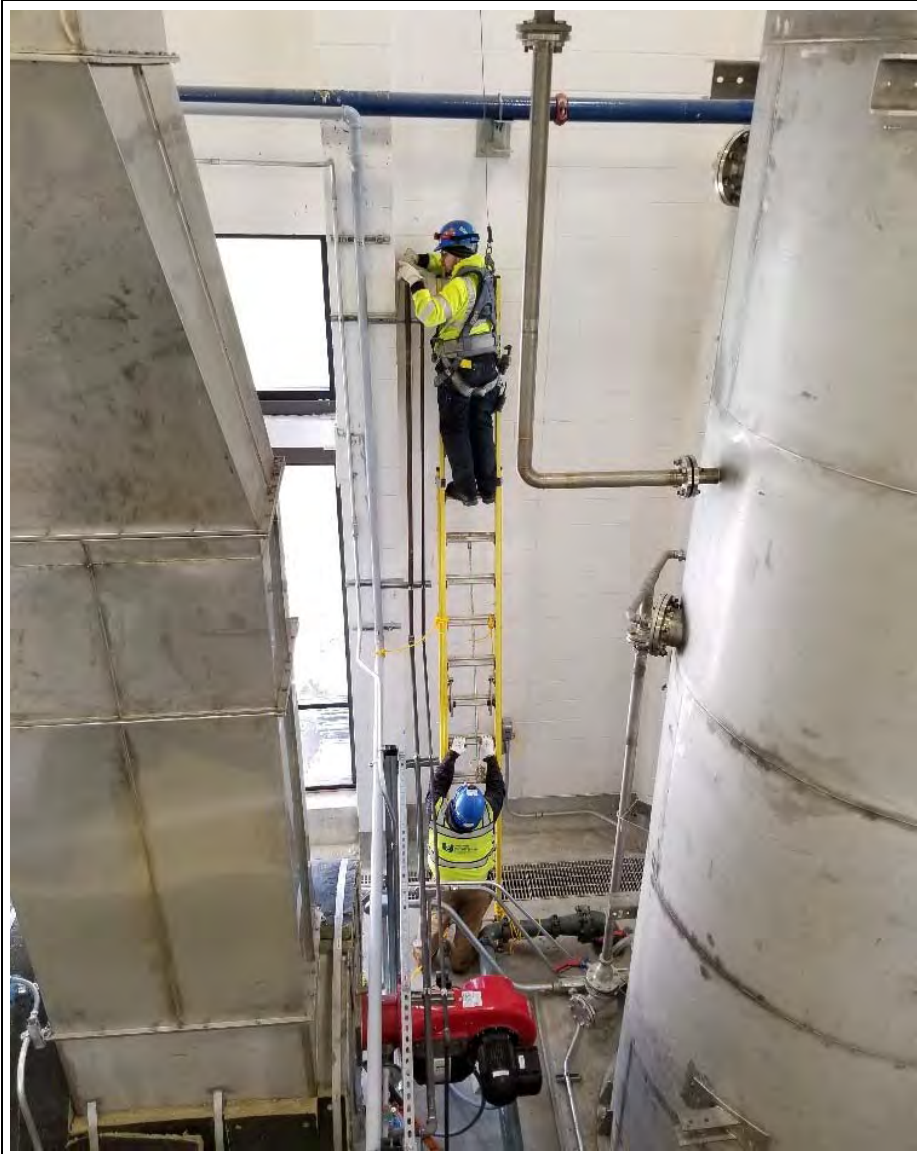
Photo #22

Area 50 Biosolids Building
(looking east) on
Wednesday, January 9th.

Two pipefitters for
University Mechanical are
installing vent piping
associated with a natural
gas pressure regulator.

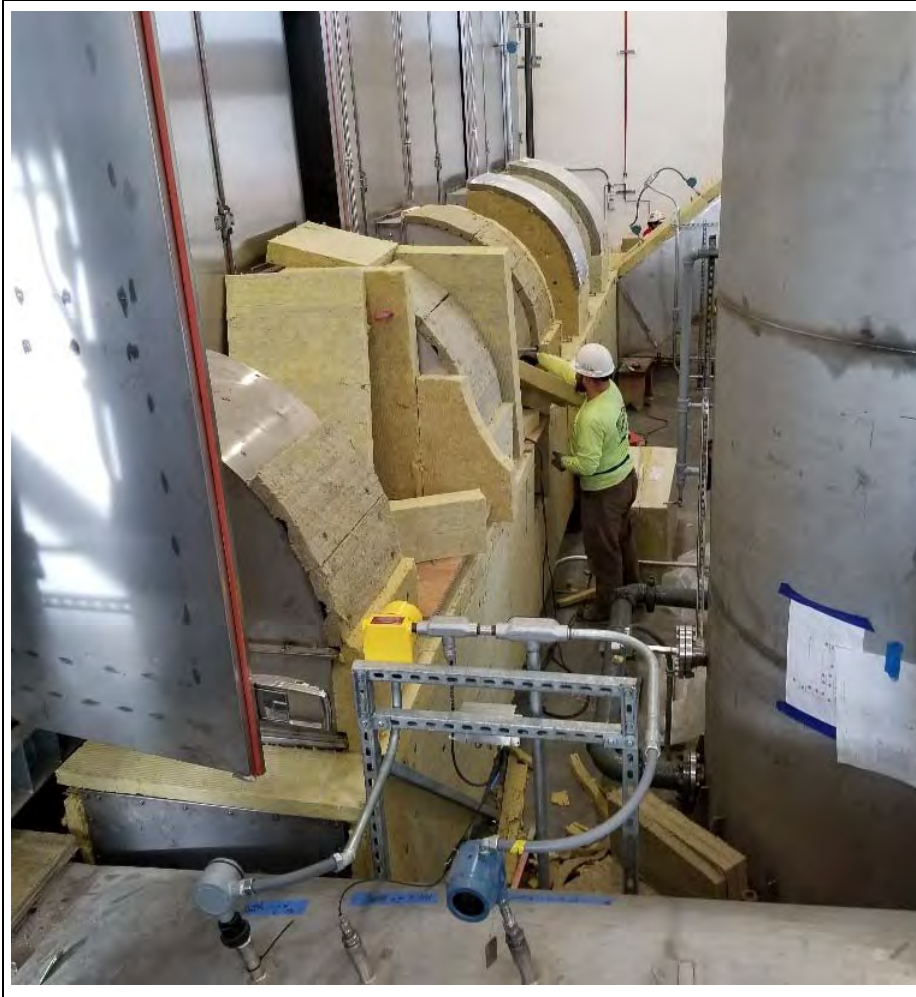
Photo #23

Area 50 Biosolids Building
(looking north) on
Wednesday, January 9th.

A technician for D&G
Mechanical Insulation is
attaching batt insulation to
ducts at the east side of
the biosolids dryer.

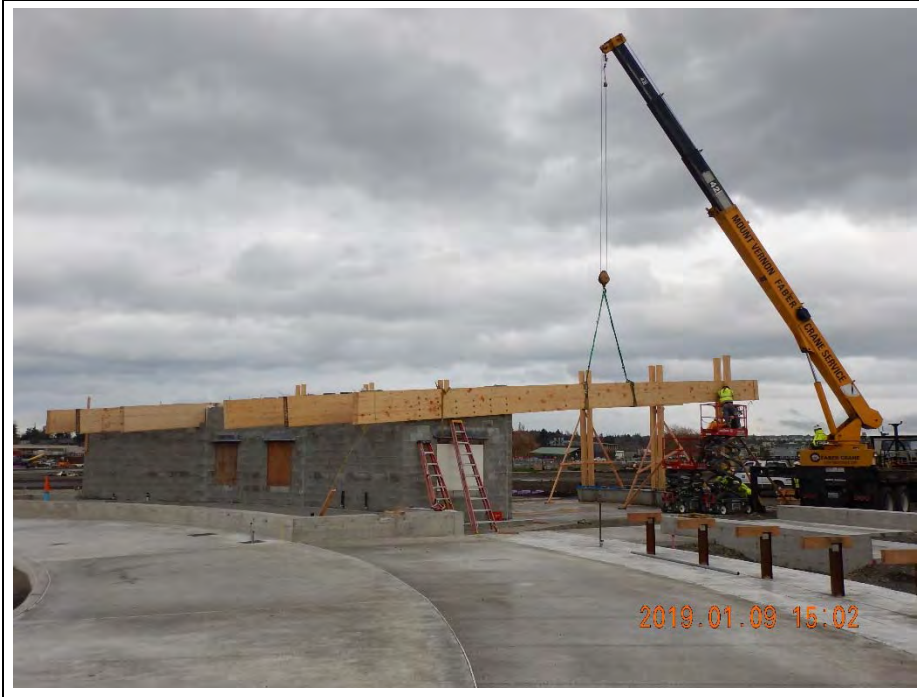
Photo #24

Southwest end of Windjammer Park (looking north at the west kitchen) on Wednesday, January 9th.

P&L General Contractors and Faber Crane Service are setting glulam beams.

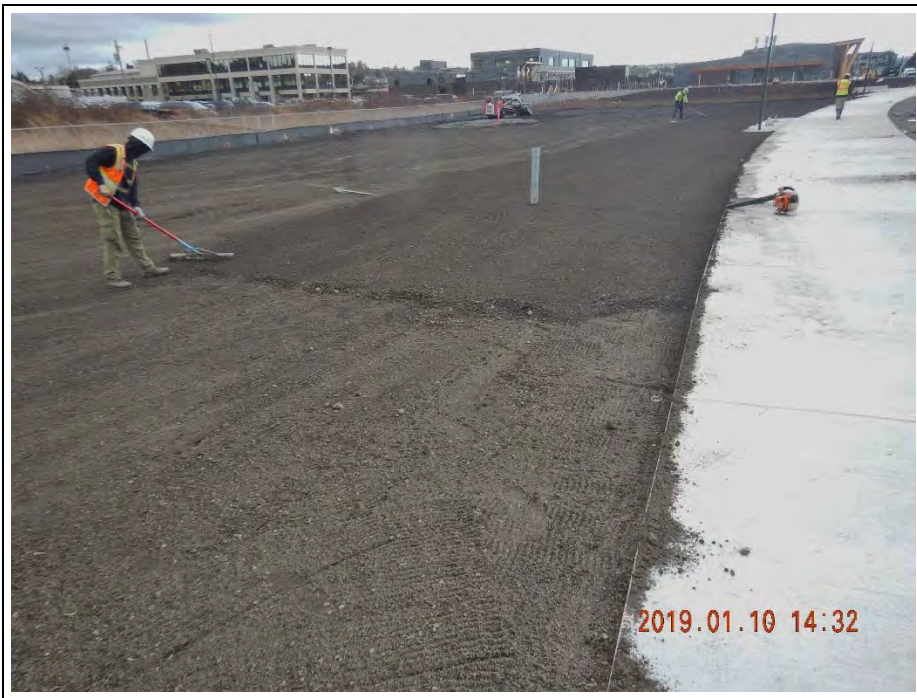
Photo #27

North end of Windjammer Park (looking east) on Thursday, January 10th.

Landscapers for Pacific Earth Works are spreading topsoil in an area that is slated for grass.

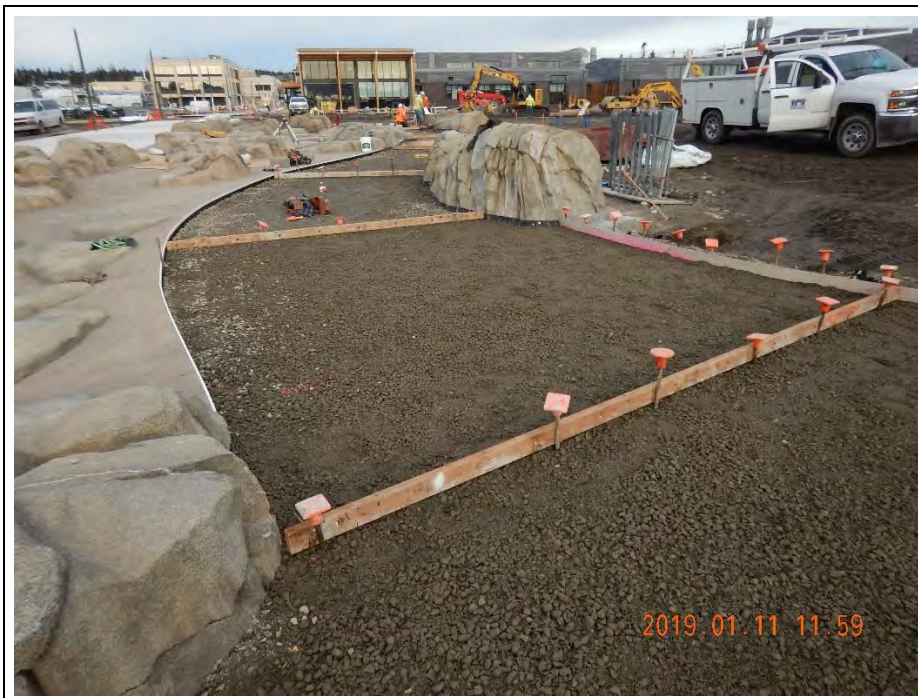
Photo #33

Interwest Construction is building forms for pedestrian concrete pavement between a splash park (left) and a play area (right).

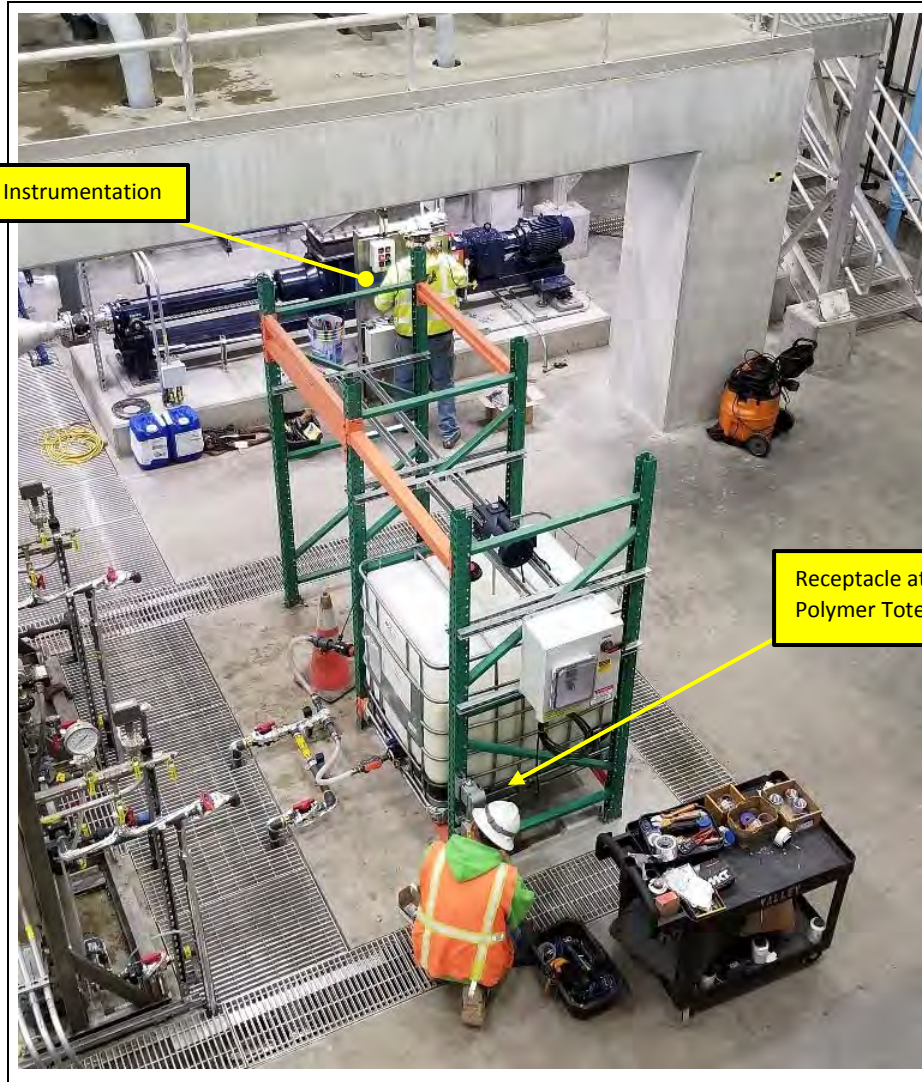
Photo #34

Electricians for Valley Electric are installing instruments and receptacles.

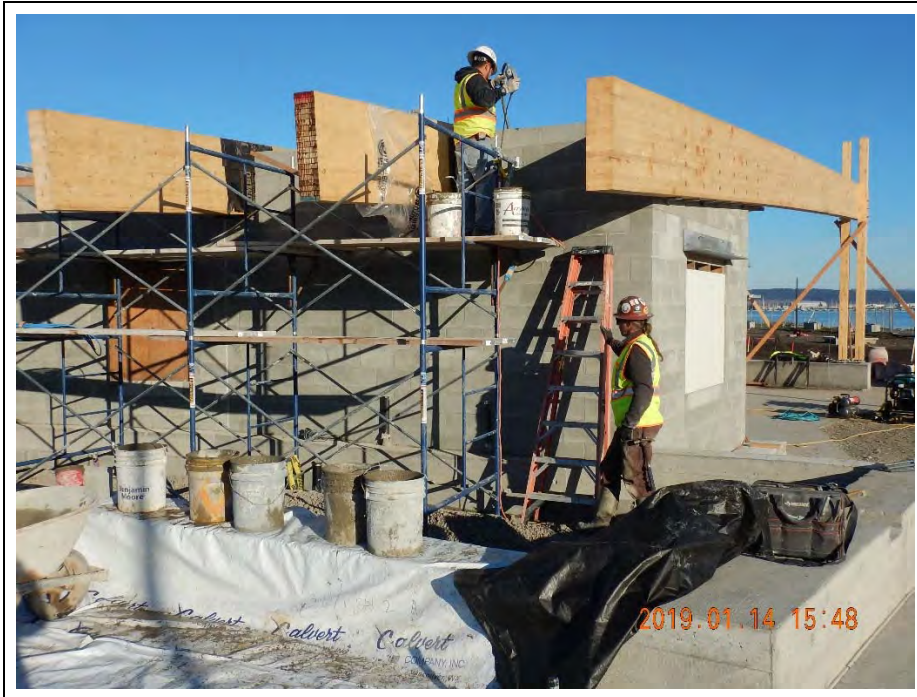
Photo #36

Southwest end of Windjammer Park (looking east at the north side of the west kitchen) on Monday, January 14th.

A carpenter for P&L General Contractors is injecting epoxy into a drilled hole in a CMU block wall. The epoxy facilitates installation of a galvanized steel anchor bolt.

The galvanized steel angle that is seen bolted to the CMU block wall will support a basalt rock façade.

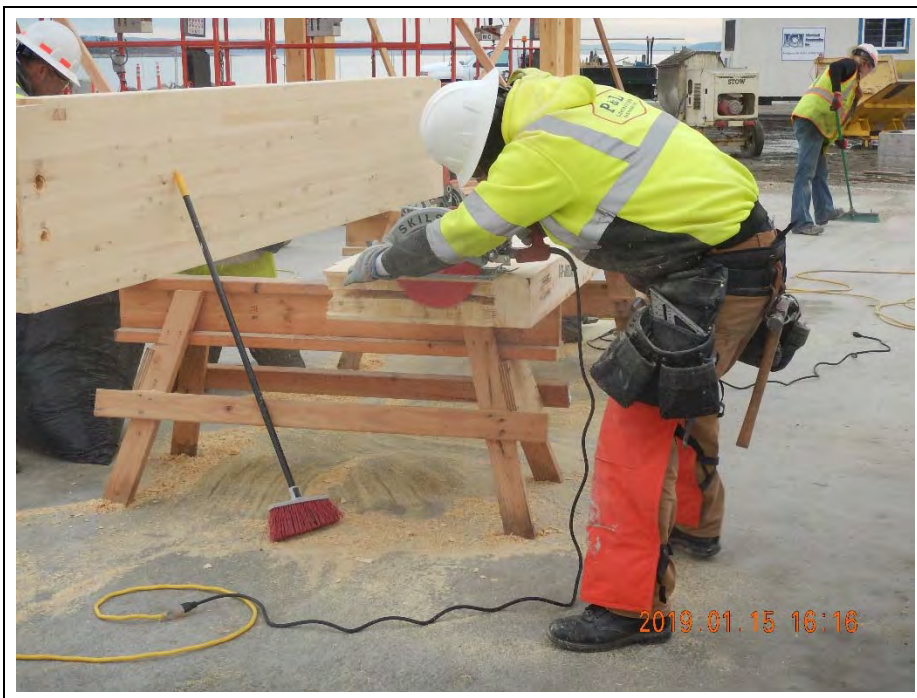
Photo #37

A carpenter for P&L General Contractors is cutting the end of a glulam beam to facilitate a bolted connection of the beam to a knife plate.

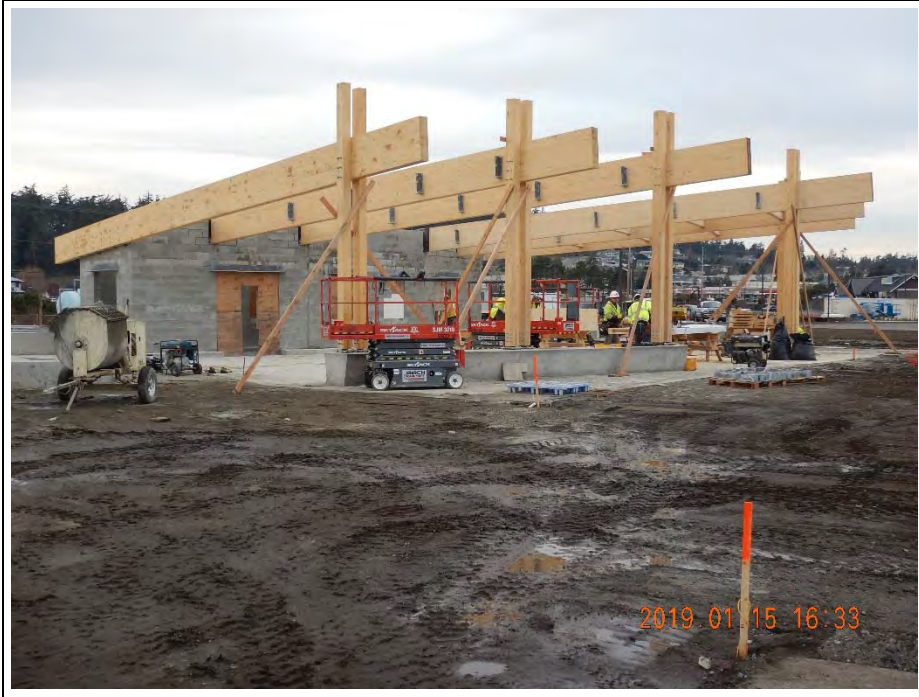
Photo #38

This photo depicts the status of glulam beam installation at the west kitchen.

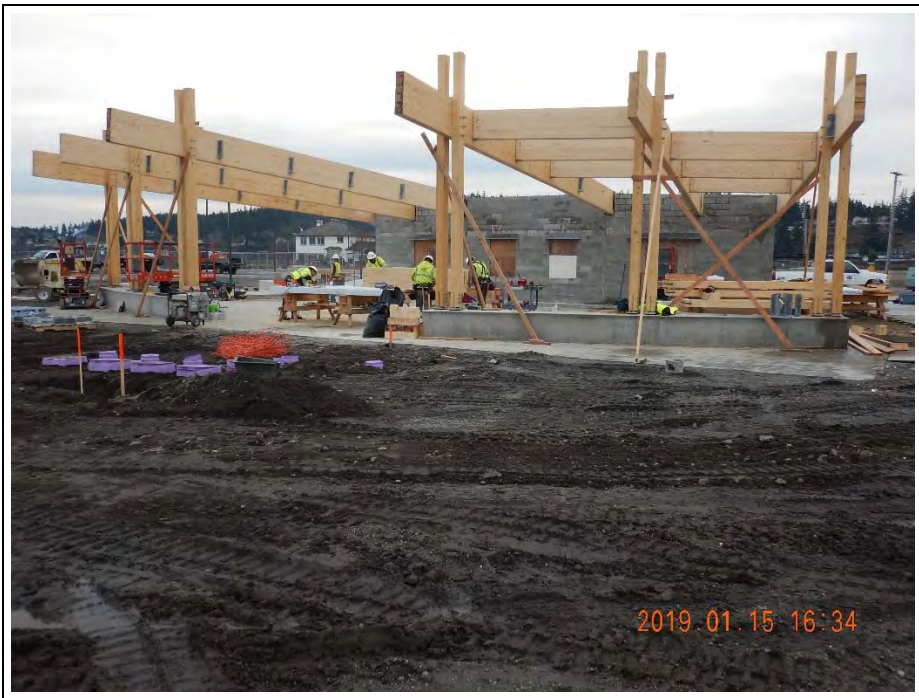
Photo #39

This photo depicts the status of glulam beam installation at the west kitchen.

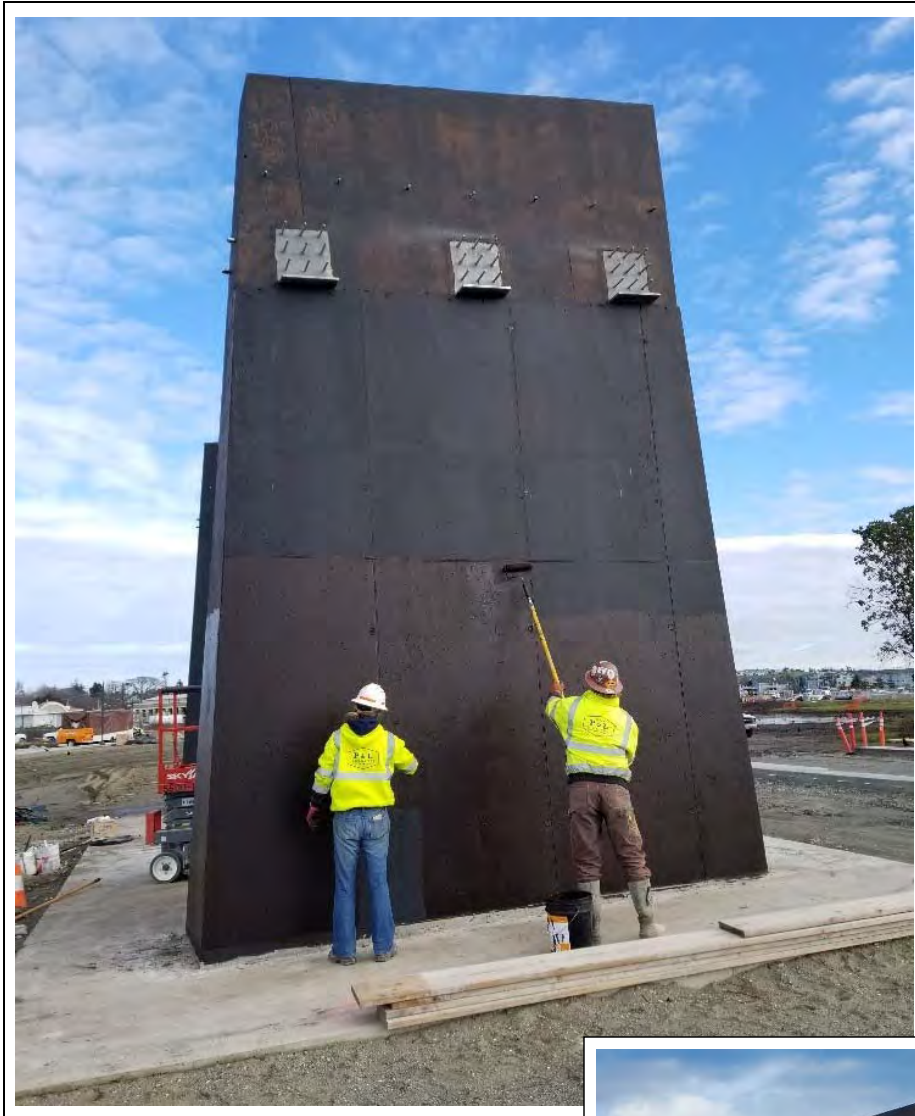
Photo #40

Southwest end of Windjammer Park (looking southwest towards the west kitchen) on Tuesday, January 15th.

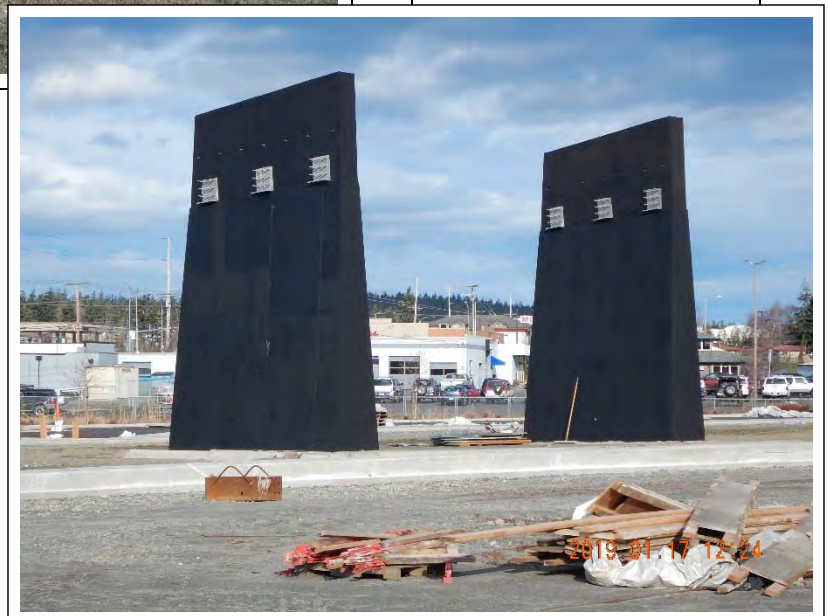
Photo #41

West end of Windjammer Park (looking northeast) on Wednesday, January 16th.

Carpenters for P&L General Contractors are applying a damp proofing compound to a concrete shear wall at the pavilion.
