City of Oak Harbor
City Council Agenda Bill

Bill No. 5. c. i.
Date: February 19, 2019
Subject: Clean Water Facility Update

Clean Water Facility Project

January 2019

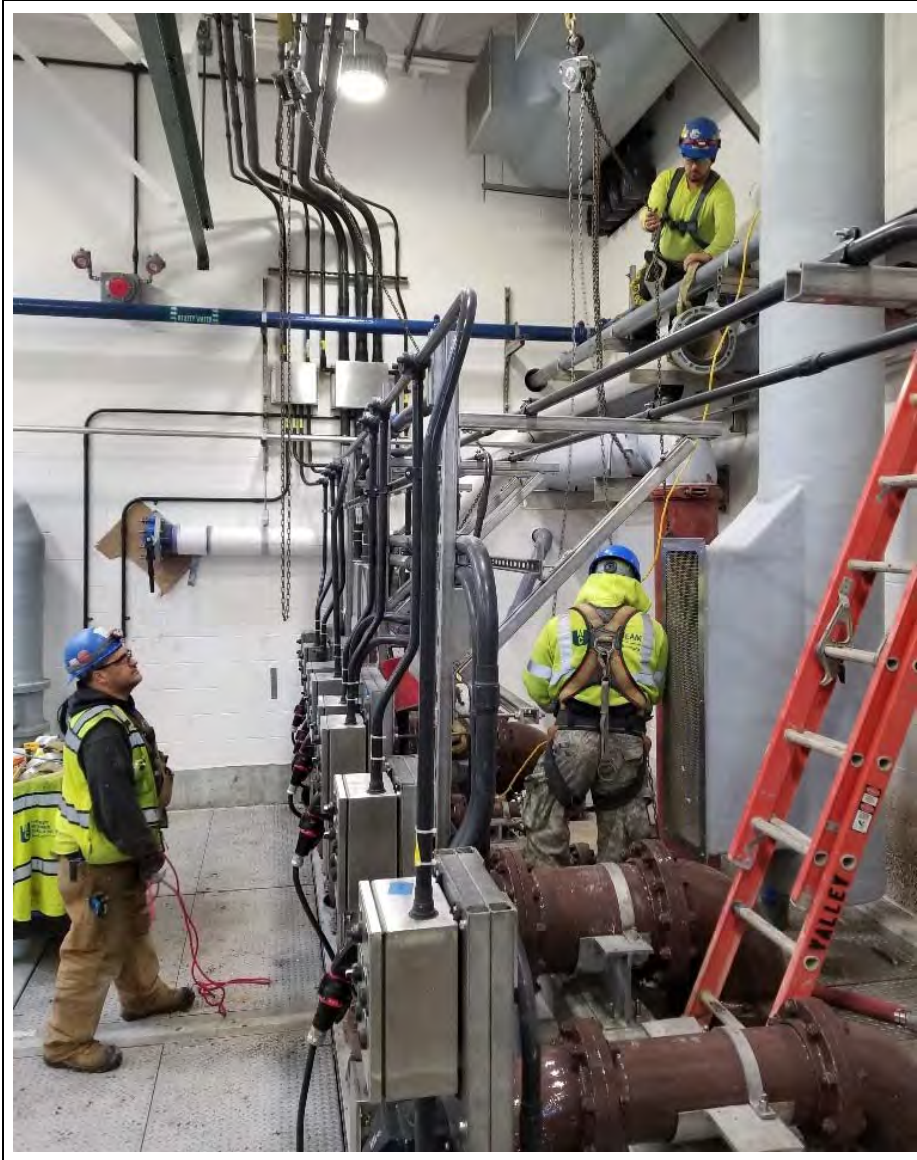
Photo #41

Pipefitters for University
Mechanical are
disassembling temporary
PVC bypass piping that
was used to facilitate
start-up activities.

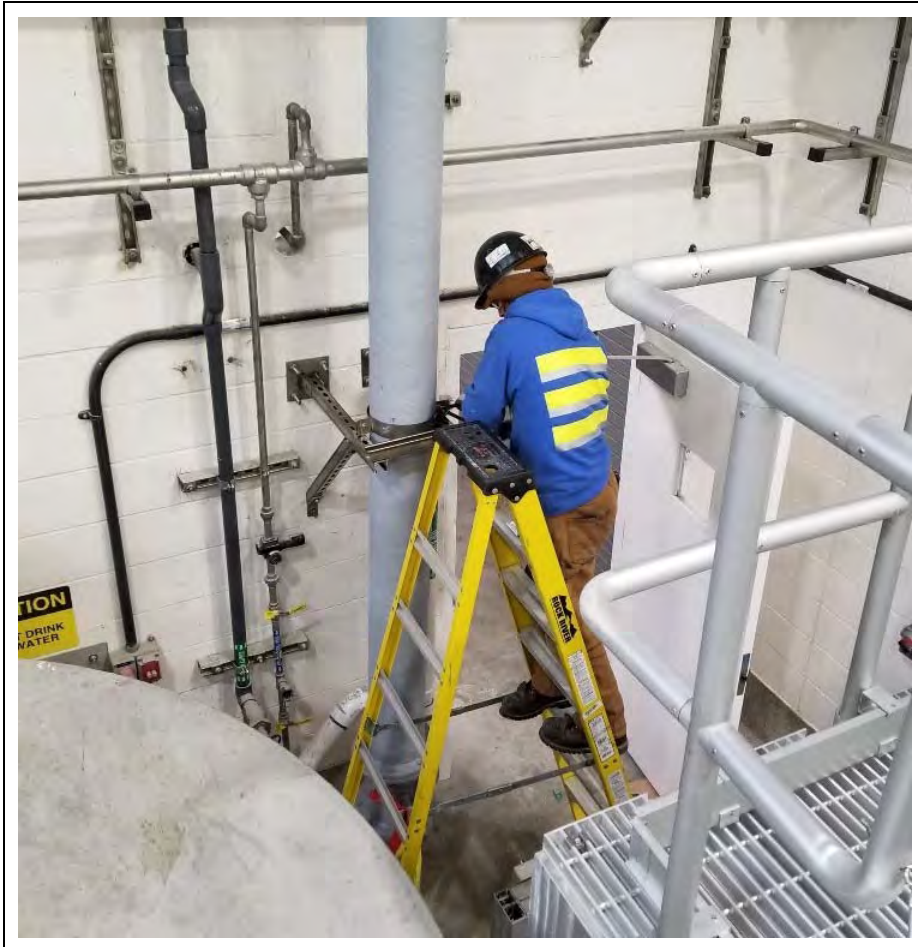
Photo #42

A sheetmetal worker for Delta Technology Corporation is installing a seismic brace on a fiber reinforced plastic (FRP) foul air duct.

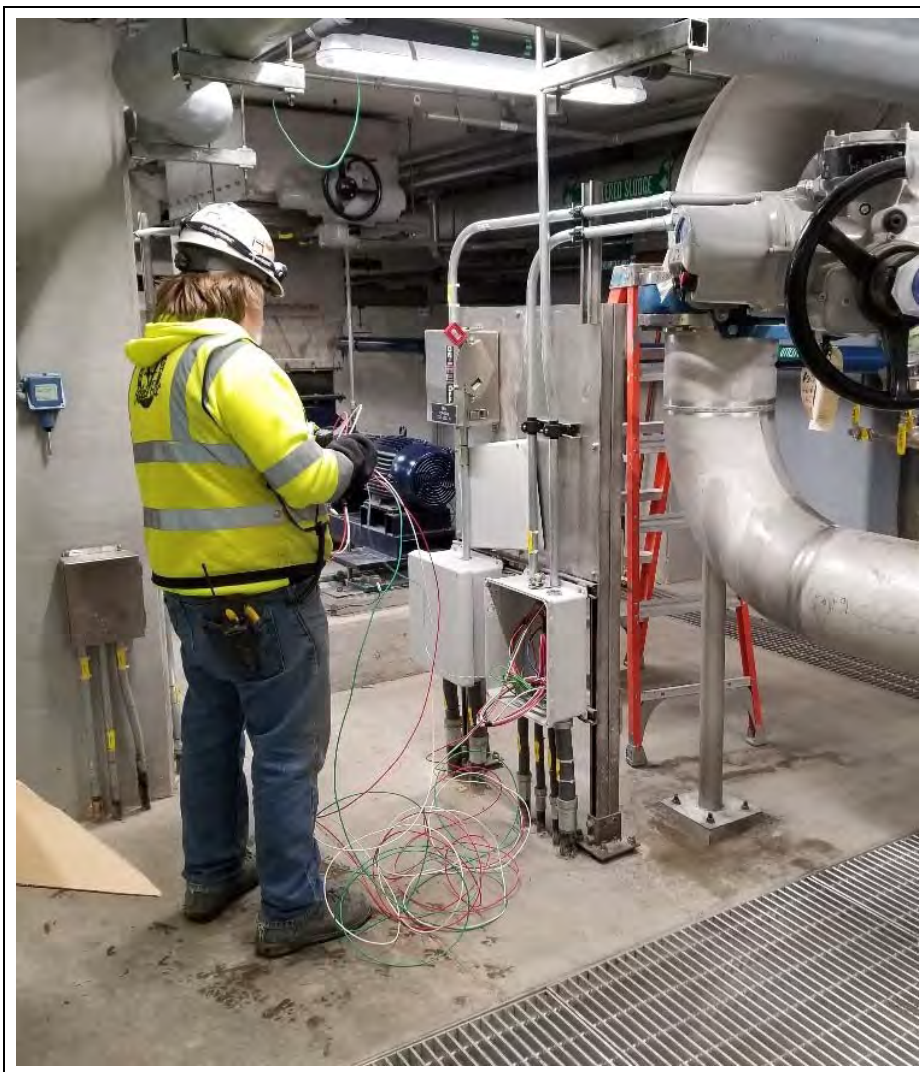
Photo #43

An electrician for Valley
Electric is pulling
conductors into a junction
box that serves motor
operated valves and wet
cake pumps.

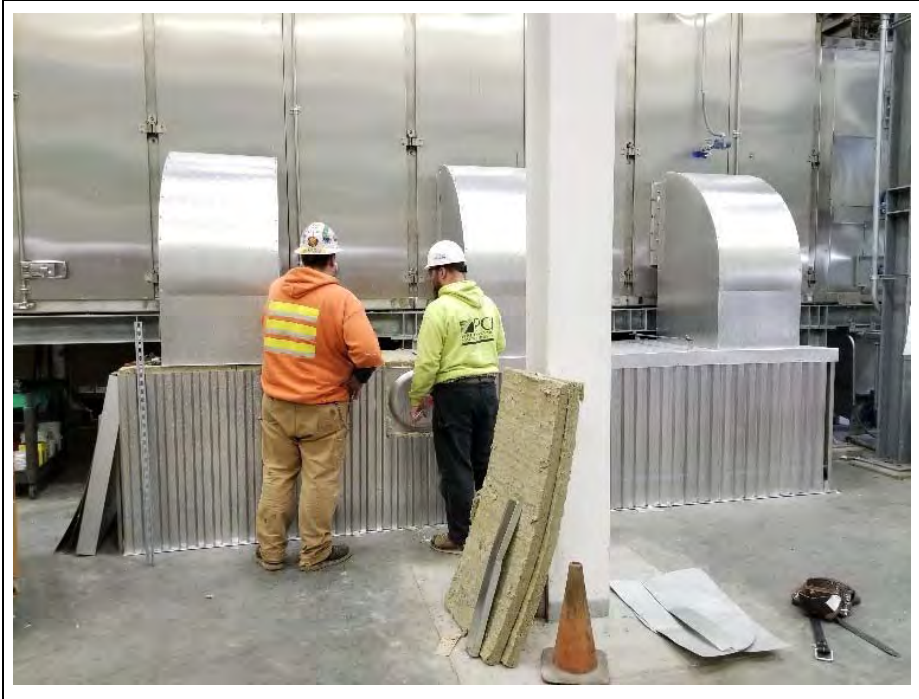
Photo #44

Insulators for D&G
Mechanical Insulation are
placing aluminum
jacketing over batt
insulation.

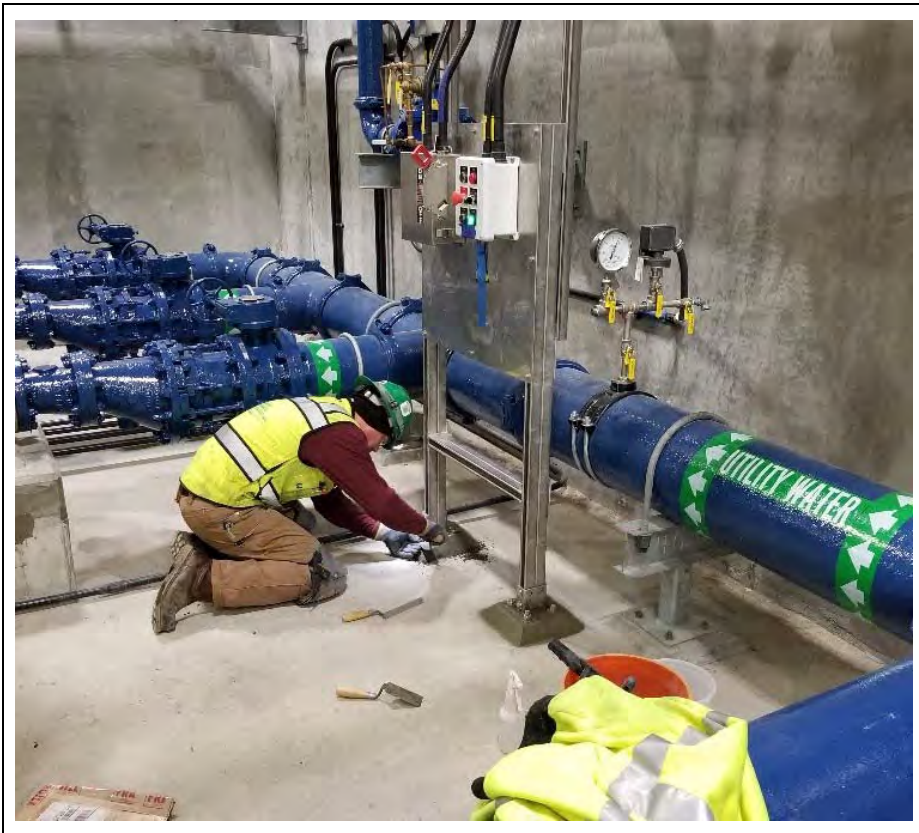
Photo #45

A carpenter for Hoffman is
placing grout under
baseplates that support an
equipment mounting
stand.

GMPA No. 9 – Mechanical, Electrical, and Process Systems. Work on this GMPA is approximately 99% complete. Valley Electric continued to install conduits and conductors in the biosolids building for process control modules, motor control centers, local control panels, and miscellaneous equipment including exterior light fixtures (see Photo #3), a sludge cake feed distributor (see Photo #14), pressure switches at a dryer feed pump seal water manifold, a local control panel for a wet cake pump, and instruments and receptacles (see Photos #34 and #43). Valley Electric installed heat trace conductors and tape to a potable water line that serves an emergency eye wash station. Valley Electric is substantially complete in the Biosolids building; however, Valley Electric will be on site in February to assist Haarslev during start-up activities. Valley Electric installed conduits and conductors and placed sealing compound in conduit fittings at the headworks building (see photo at right). Valley Electric excavated a trench and installed buried conduit between a power pole along SE City Beach Street and the control room in the headworks building to facilitate installation of a fiber optic cable from Frontier Communications. Valley Electric and QualiTEQ installed a larger enclosure in the secondary treatment building to house the controls for two chemical dosing pumps. University Mechanical continued to assemble and install equipment associated with a biosolids dryer system in the biosolids building, but, similar to Valley Electric, their work in the biosolids building is substantially complete. At the biosolids building, University Mechanical finished installing grating, toe-kicks, and handrails on a platform associated with the dryer; installed seal water drain piping for dryer feed pumps (see Photo #5); installed potable water piping for an emergency shower; installed vent piping for a natural gas pressure regulator (see Photos #13 and #22); installed seismic straps at a water tank that serves polymer blending units; disassembled and modified centrate drain piping under the centrifuges to prevent centrate from backflowing into the wet cake pumps; and finished installing a roll-off bin cover (see Photo #32). University Mechanical installed closure plates at wall openings for course screen washer/compactor and grit washer discharge chutes at the Headworks building. University Mechanical disassembled a temporary PVC bypass piping system in the headworks building (see Photo #41) that was used to facilitate start-up activities. University Mechanical and its subcontractor, Honeywell, worked on controls for air handling units in the administration building and installed a condensate drain line in the maintenance building (see Photo #54). University Mechanical's subcontractor, Delta Technology Corporation, installed a stainless steel duct at a dust collector and a chute between two conveyors at the biosolids building. Delta Technology Corporation installed seismic straps, cables, and bracing on foul air and HVAC fans, ducts, and piping at the aeration-blower (see Photo #59), secondary treatment, headworks (see Photo #42), and biosolids buildings. A carpenter for Hoffman placed grout around conduit stub-ups and under equipment mounting stands and equipment base plates at the secondary treatment building (see Photo #45) and aeration-blower building (see Photo #60).

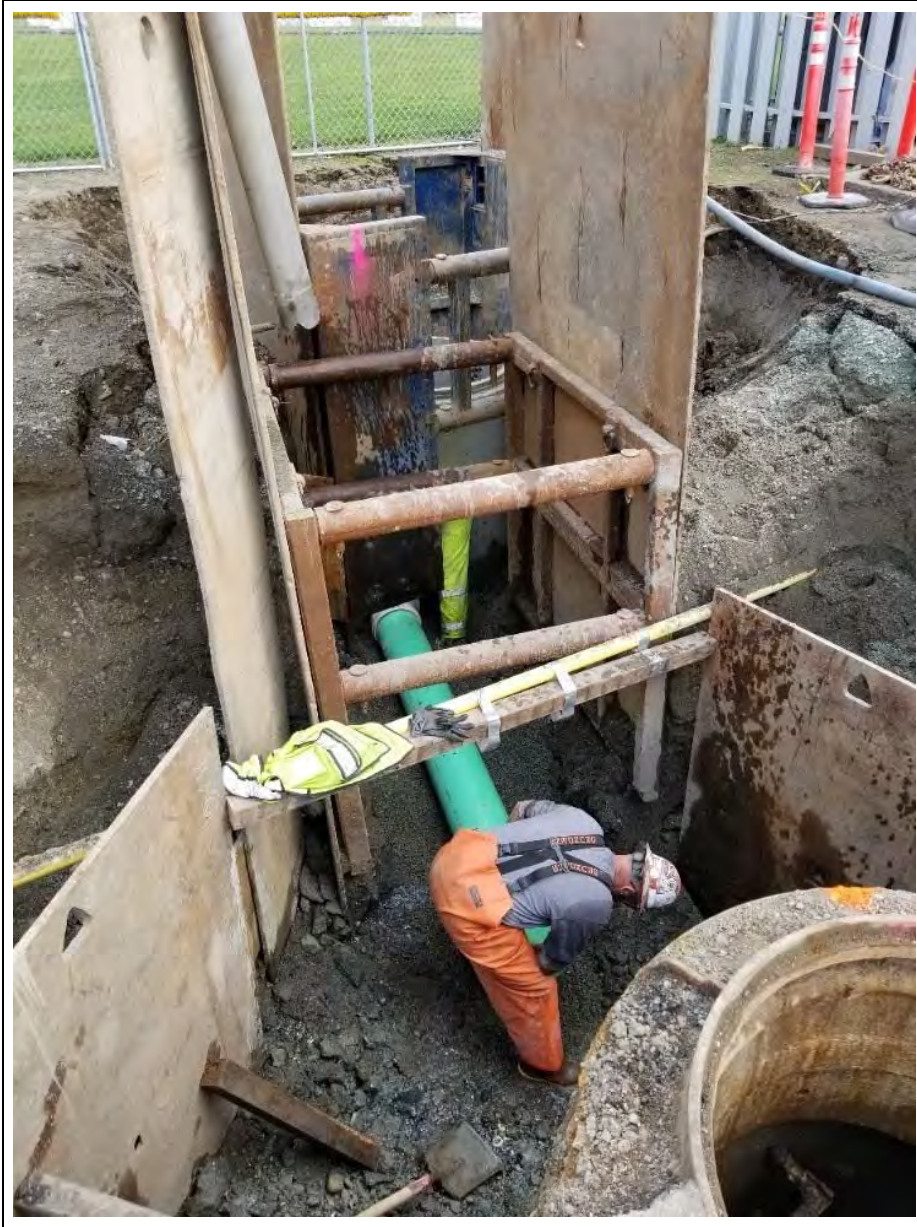
Photo #46

A pipelayer for Interwest Construction is installing a section of 12-inch PVC sanitary sewer pipe between two manholes.

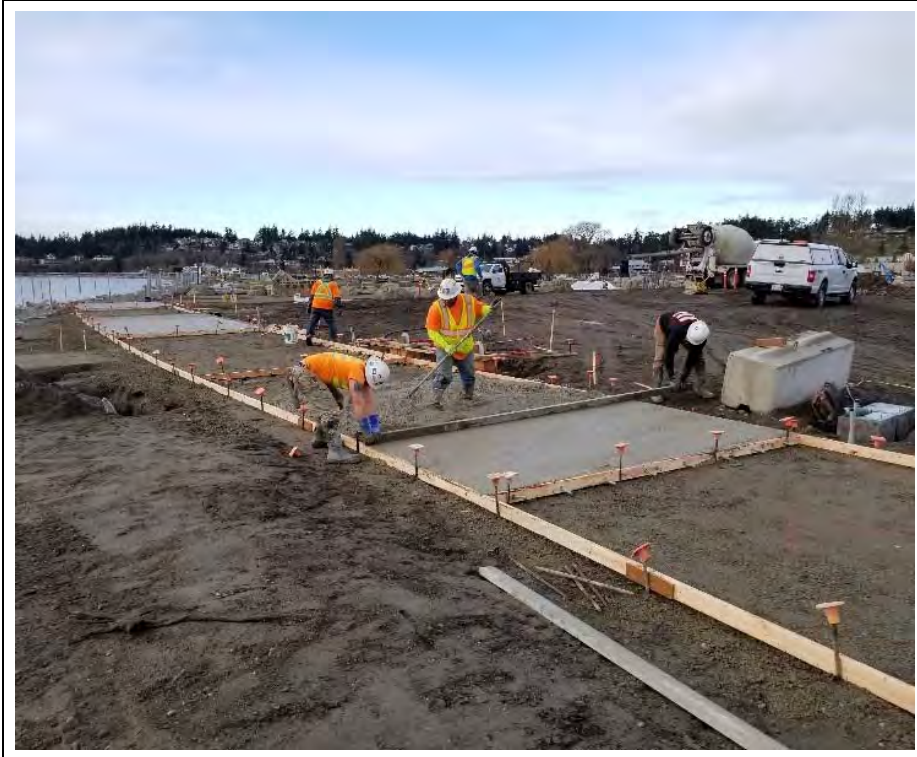
Photo #47

Carpenters and laborers for Interwest Construction are placing concrete for a pedestrian walkway along Oak Harbor Bay.

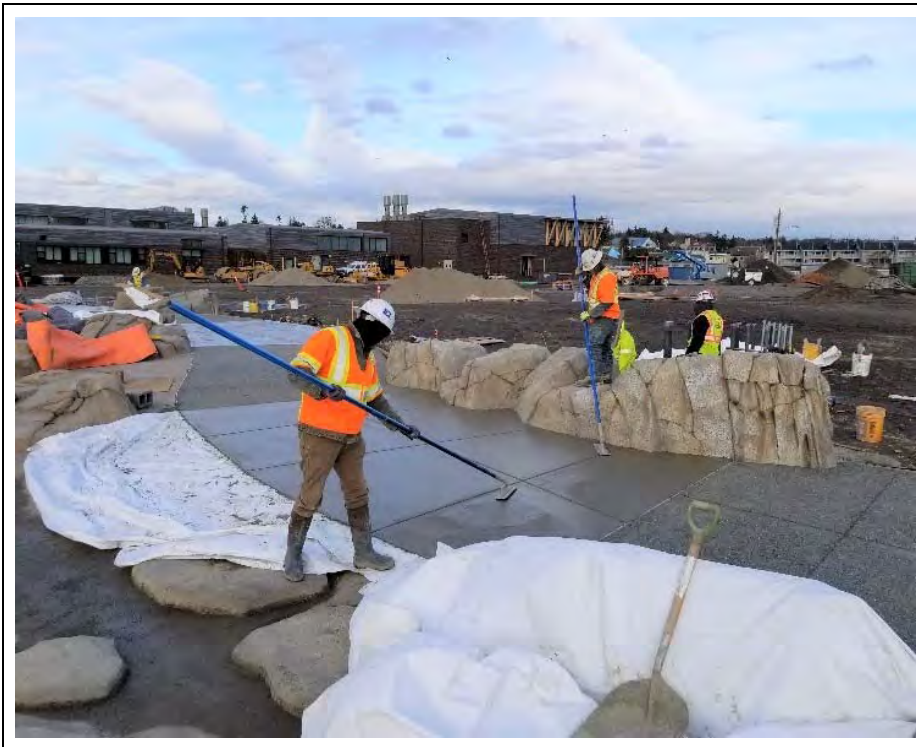
Photo #48

Laborers for Interwest Construction are finishing concrete along the east side of the splash park.

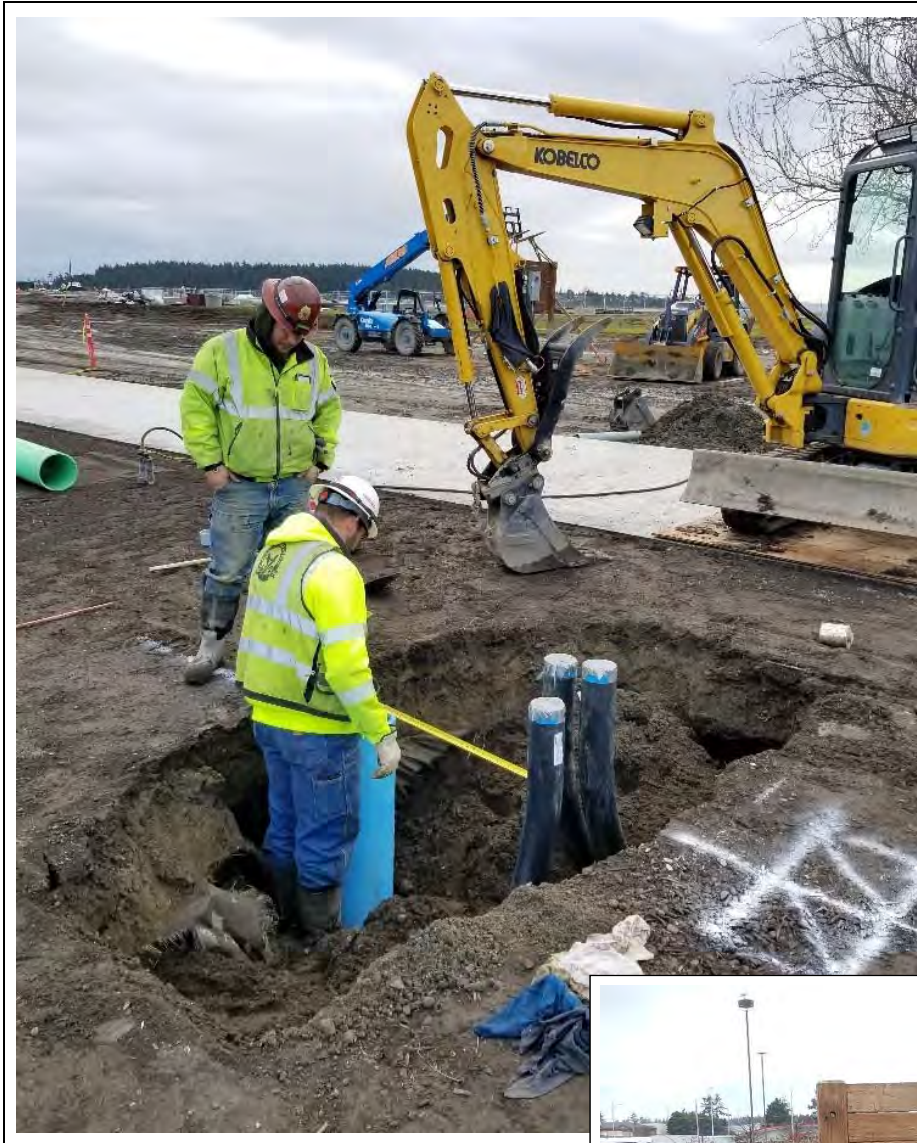
Photo #49

South end of Windjammer Park (looking north) on Thursday, January 17th.

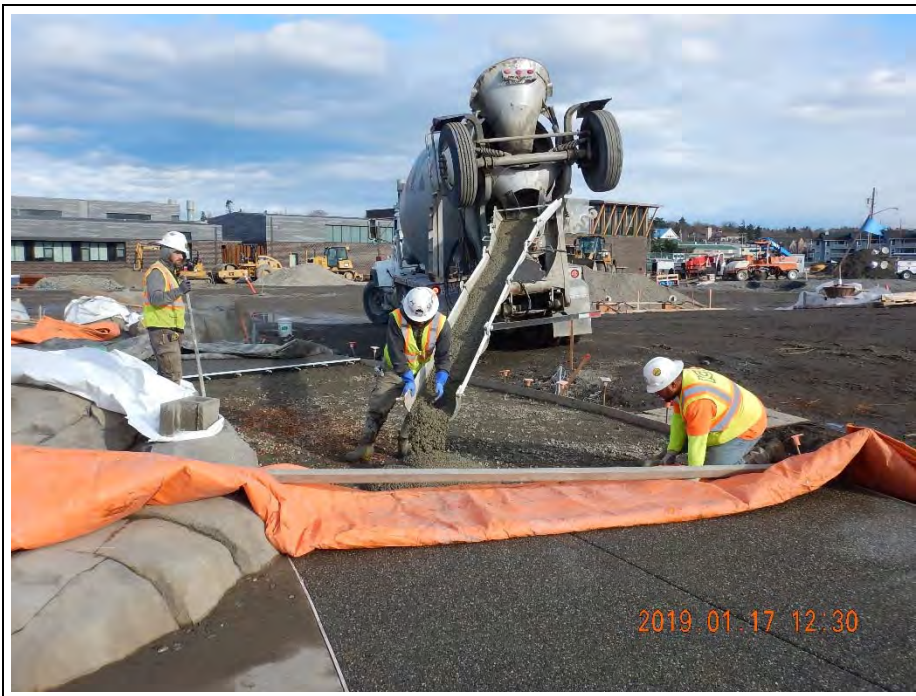
Photo #52

Laborers for Interwest Construction are placing concrete for a pedestrian walkway adjacent to the east side of the splash park (seen at the lower left).

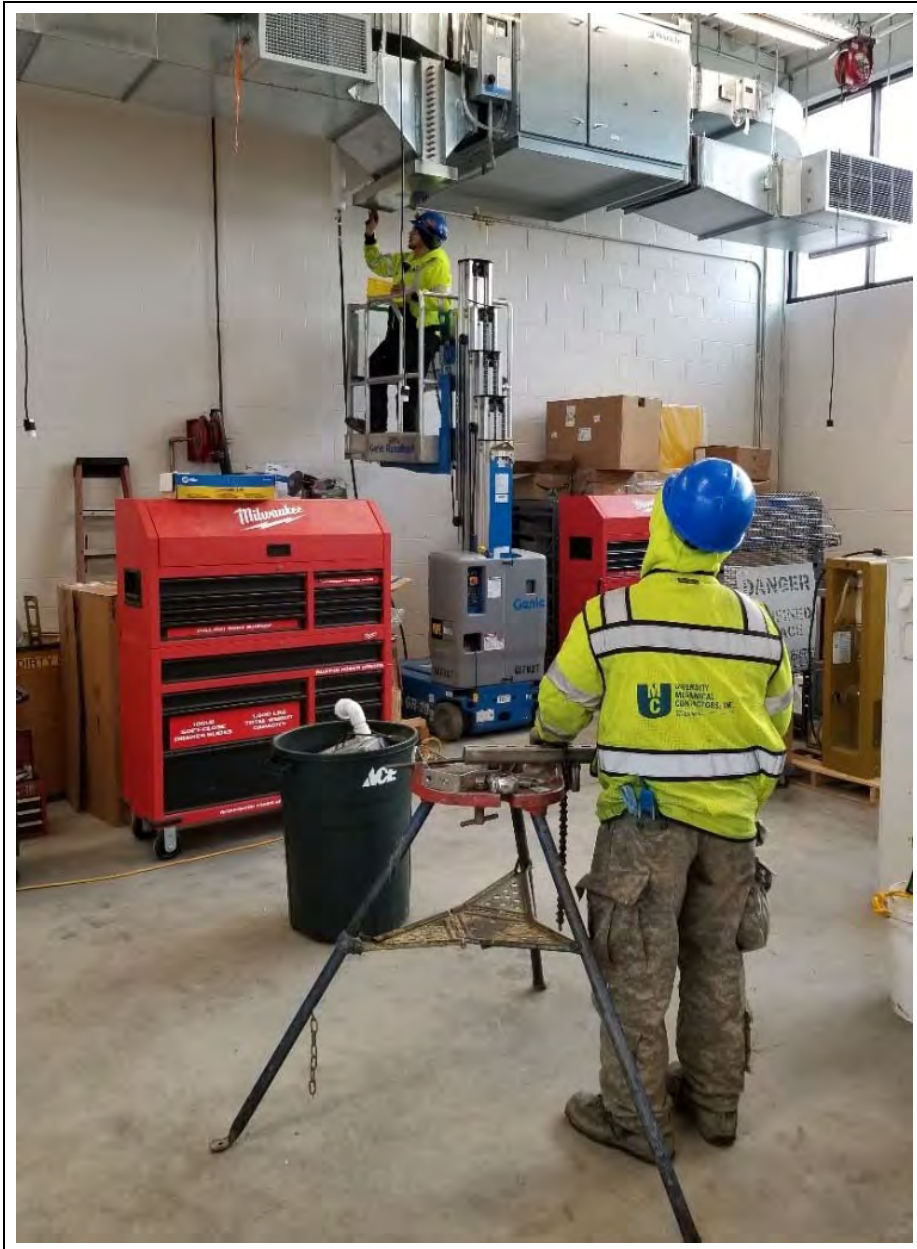
Photo #54

Pipefitters for University Mechanical are beginning to install a condensate drain line from heating and cooling coils.

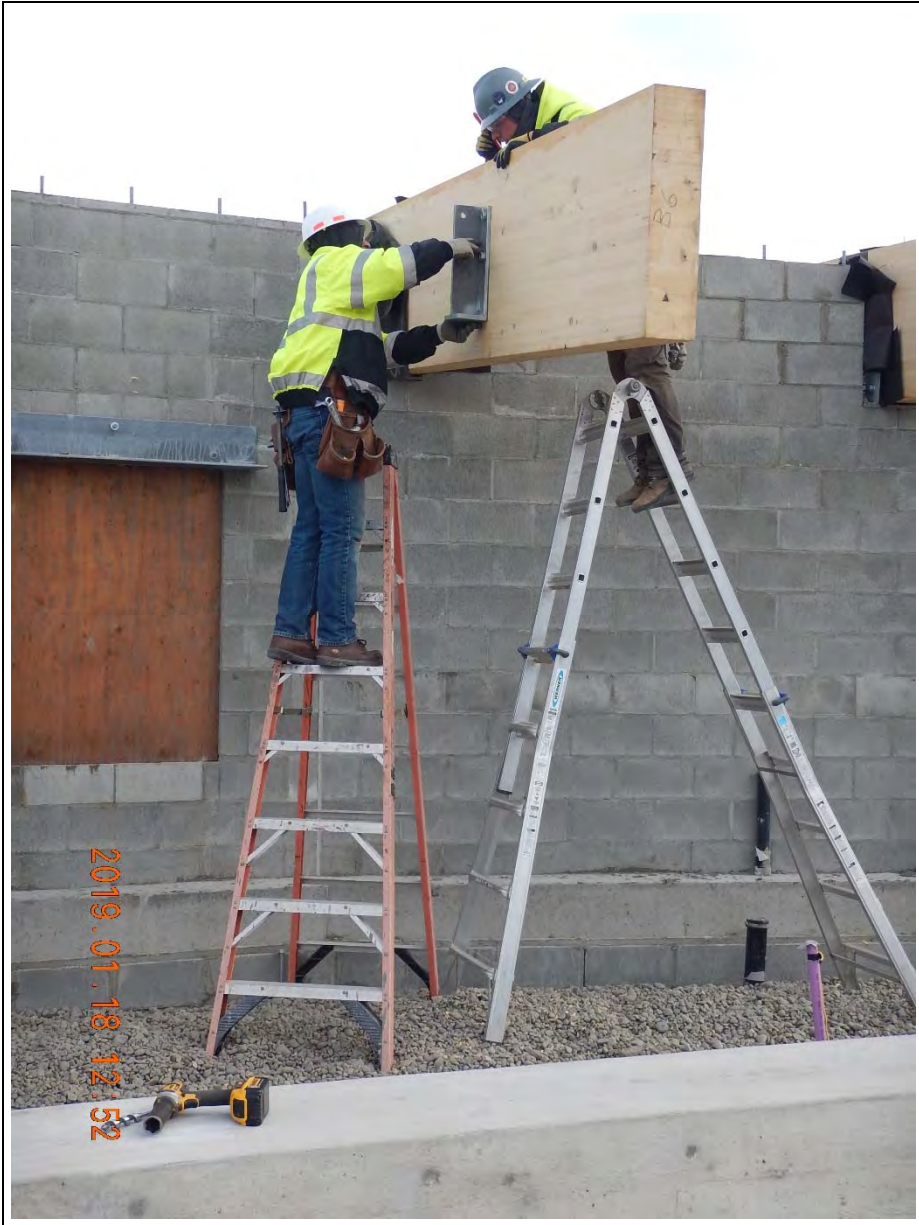
Photo #55

Carpenters for P&L General Contractors are attaching a galvanized steel "knife plate" to a glulam beam.

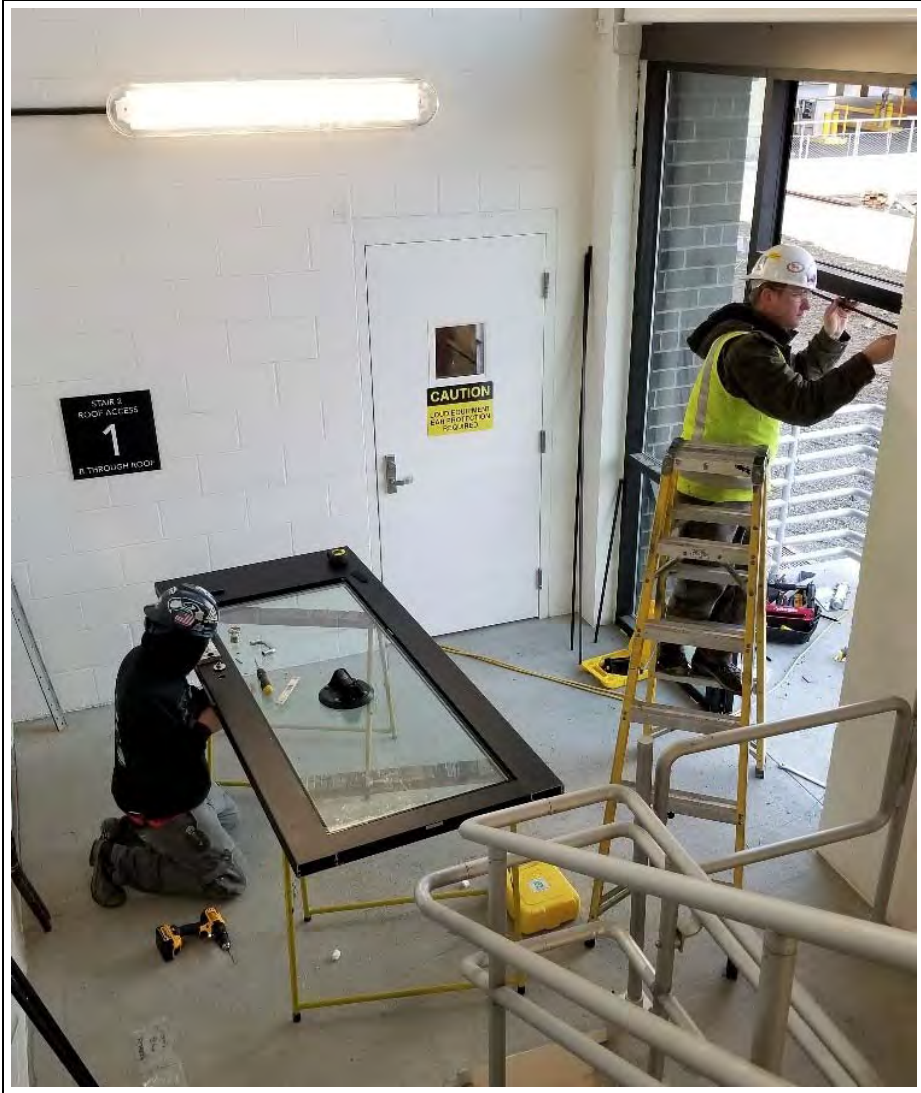
Photo #56

Glaziers for Pacific Glass are re-orienting a doorway.

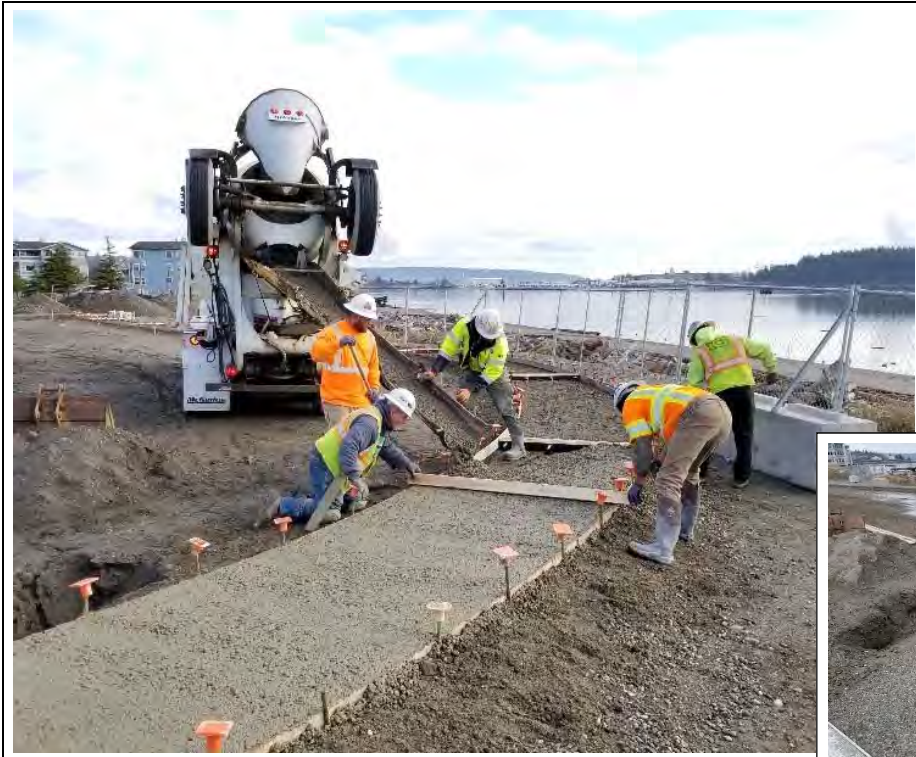
Photo #57

Carpenters and laborers for Interwest Construction are placing concrete for a pedestrian walkway along Oak Harbor Bay.

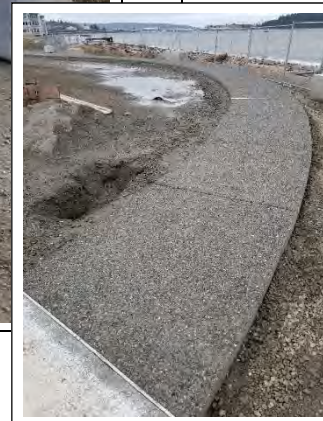
Photo #58

South end of Windjammer Park (looking east) on Monday, January 21st.

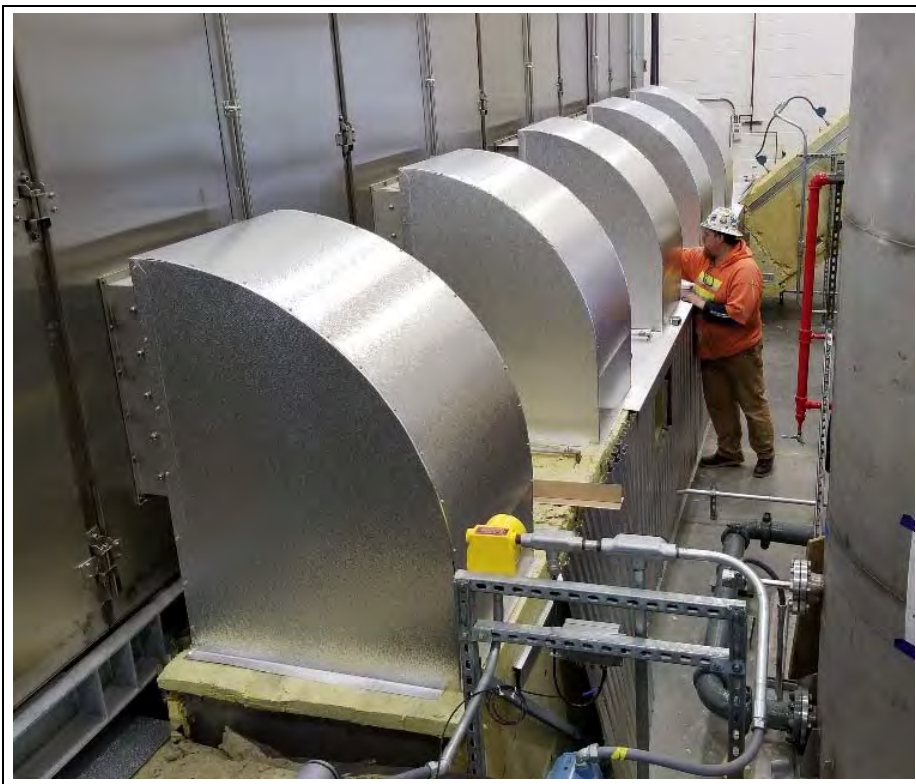
A worker for D&G Mechanical Insulation is installing aluminum jacketing over matt insulation at biosolids dryer ducts.

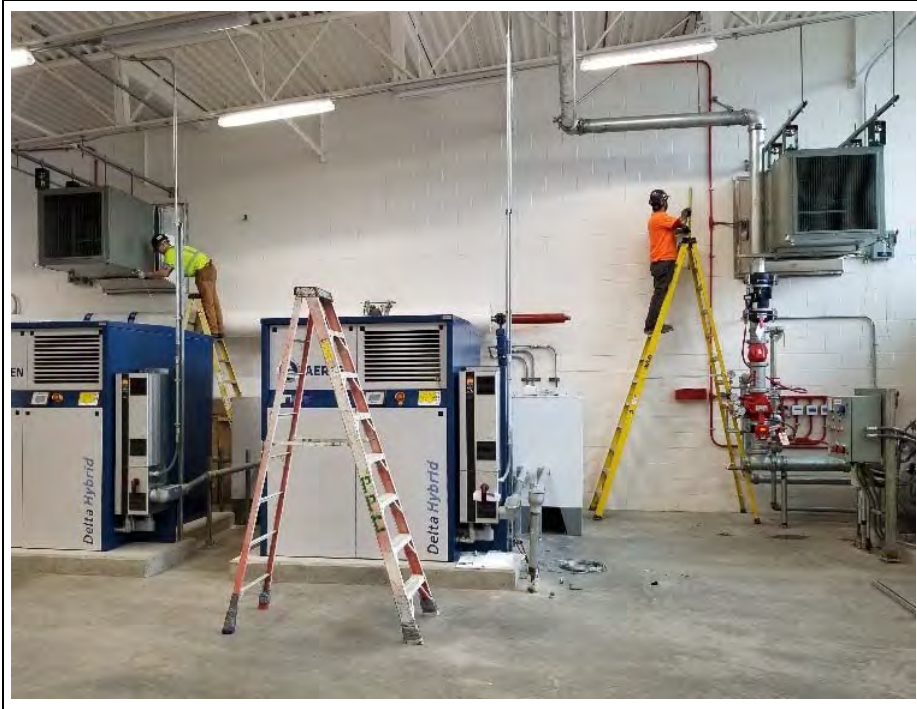
Photo #59

Two sheetmetal workers for Delta Technology Corporation are installing seismic straps and braces on supply fans.

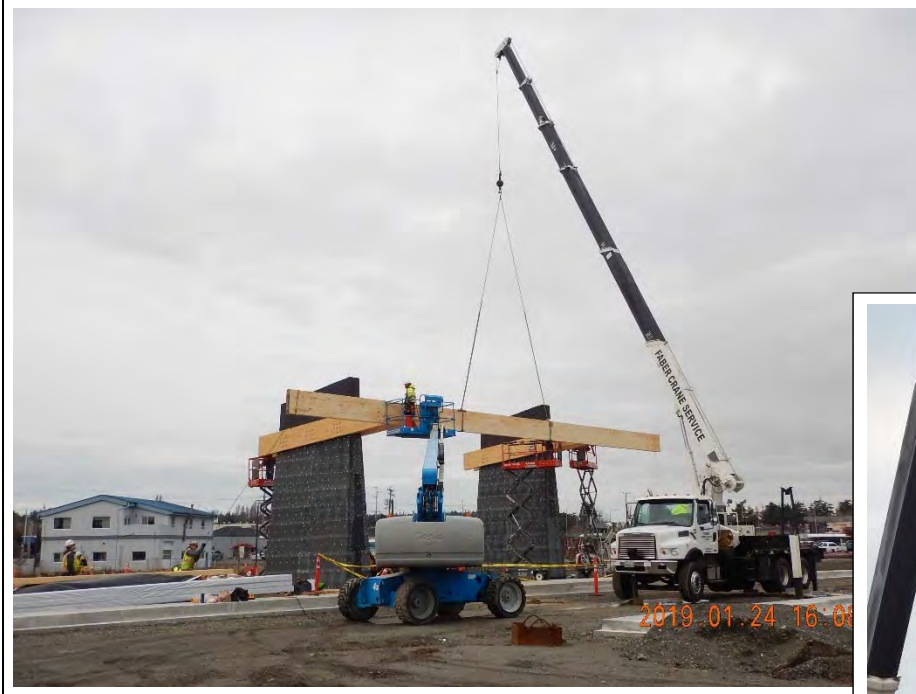
Photo #64

West end of Windjammer Park (looking northwest) on Thursday, January 24th.

Carpenters for P&L General Contractors are utilizing a truck-mounted crane to place glulam beams for the pavilion.

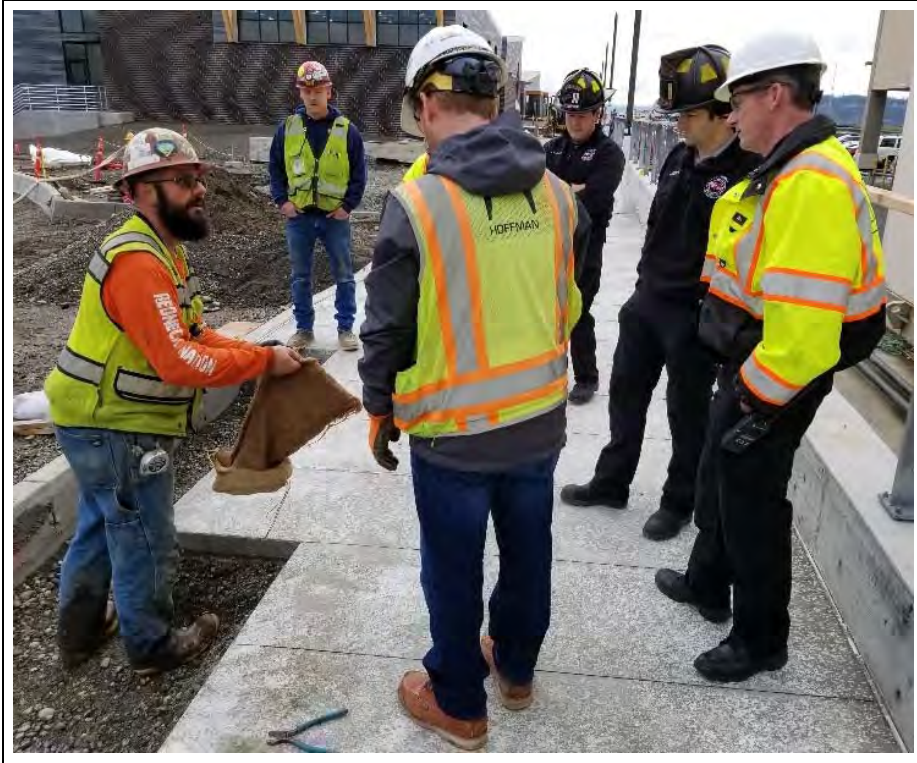
A pipe layer for Interwest Construction (far left) is showing three representatives of the Oak Harbor Fire Department (right) the contents of a burlap bag that was used to catch debris while flushing a fire hydrant.

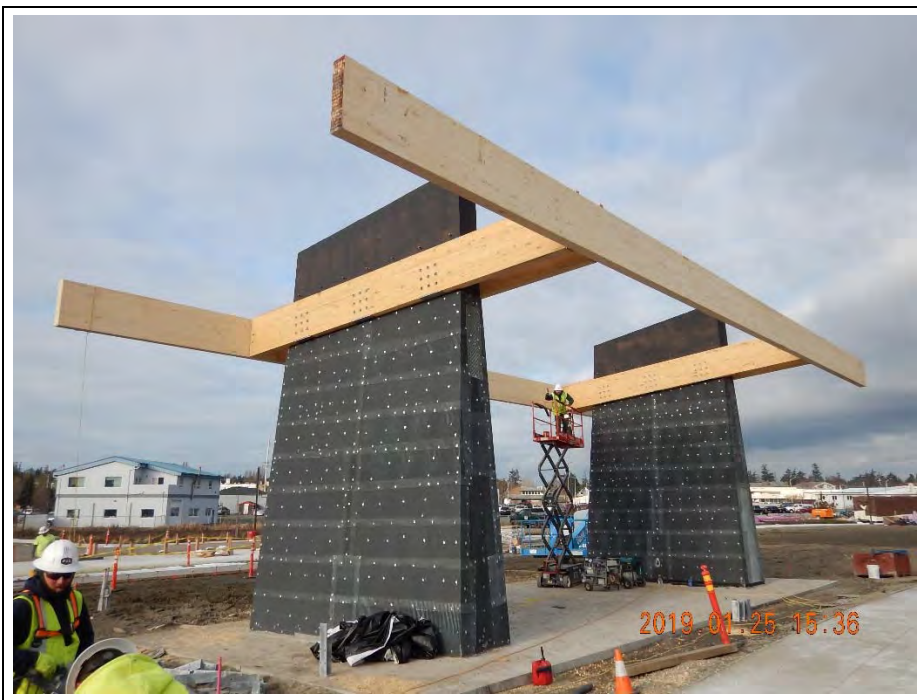
Photo #65

Carpenters for P&L General Contractors continue to place glulam beams for the pavilion.

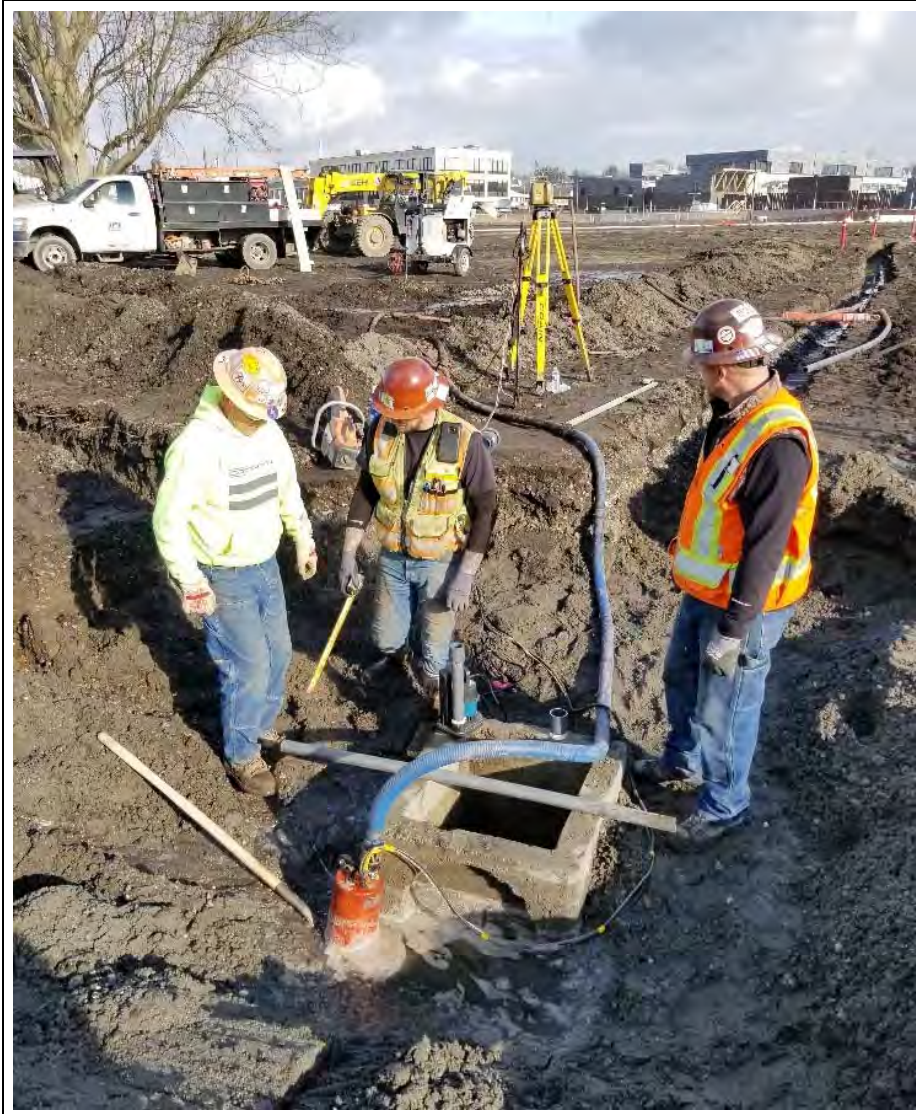
Photo #66

West end of Windjammer Park (looking northwest) on Friday, January 25th.

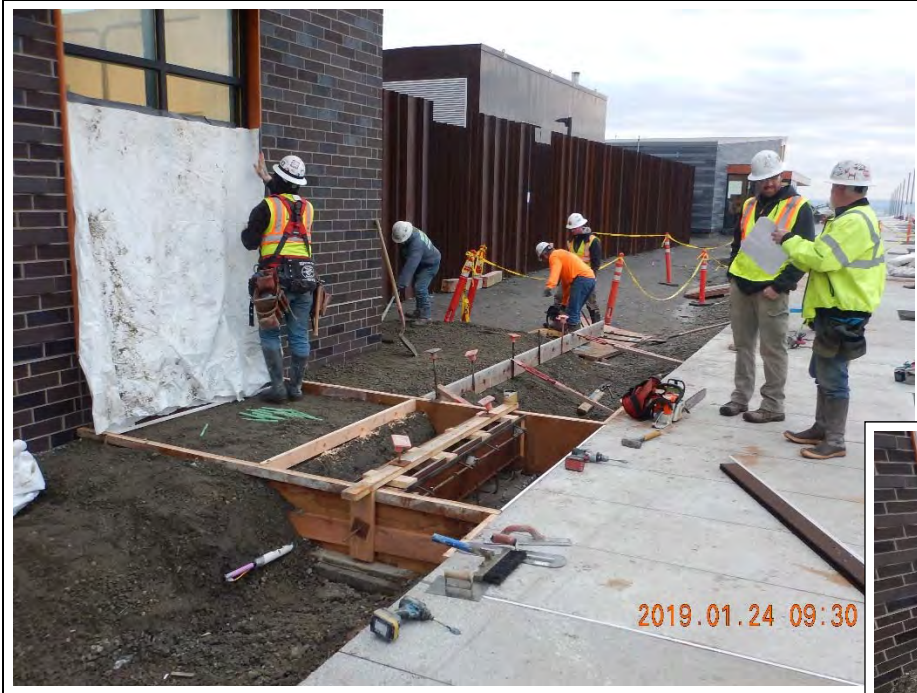
Photo #67

Area north of the lagoon in Windjammer Park (looking west) on Friday, January 25th.

Interwest Construction is installing a catch basin and a sump pump to collect surface water at a low spot and then discharge it to a detention pond next to the administration building.

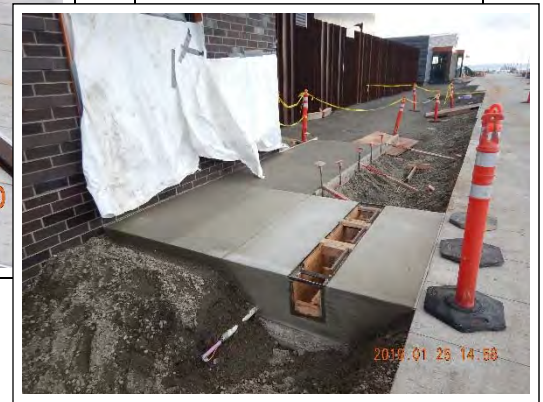
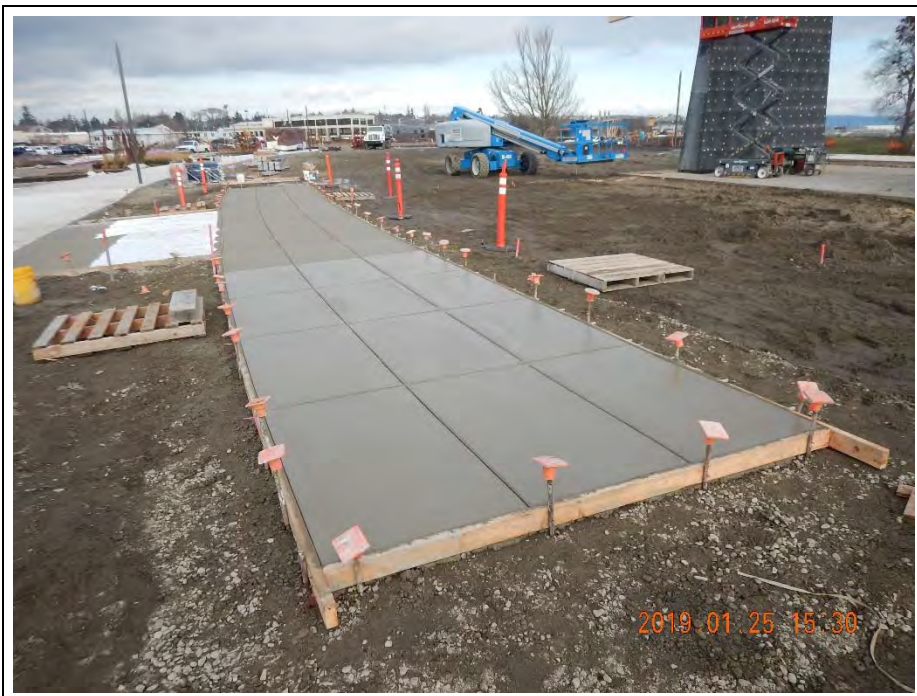
Photo #68

Area 70 Electrical Building (looking southeast) on January 24th and 25th.

Carpenters for Interwest Construction built forms and placed concrete for a walkway next to an interpretive window.

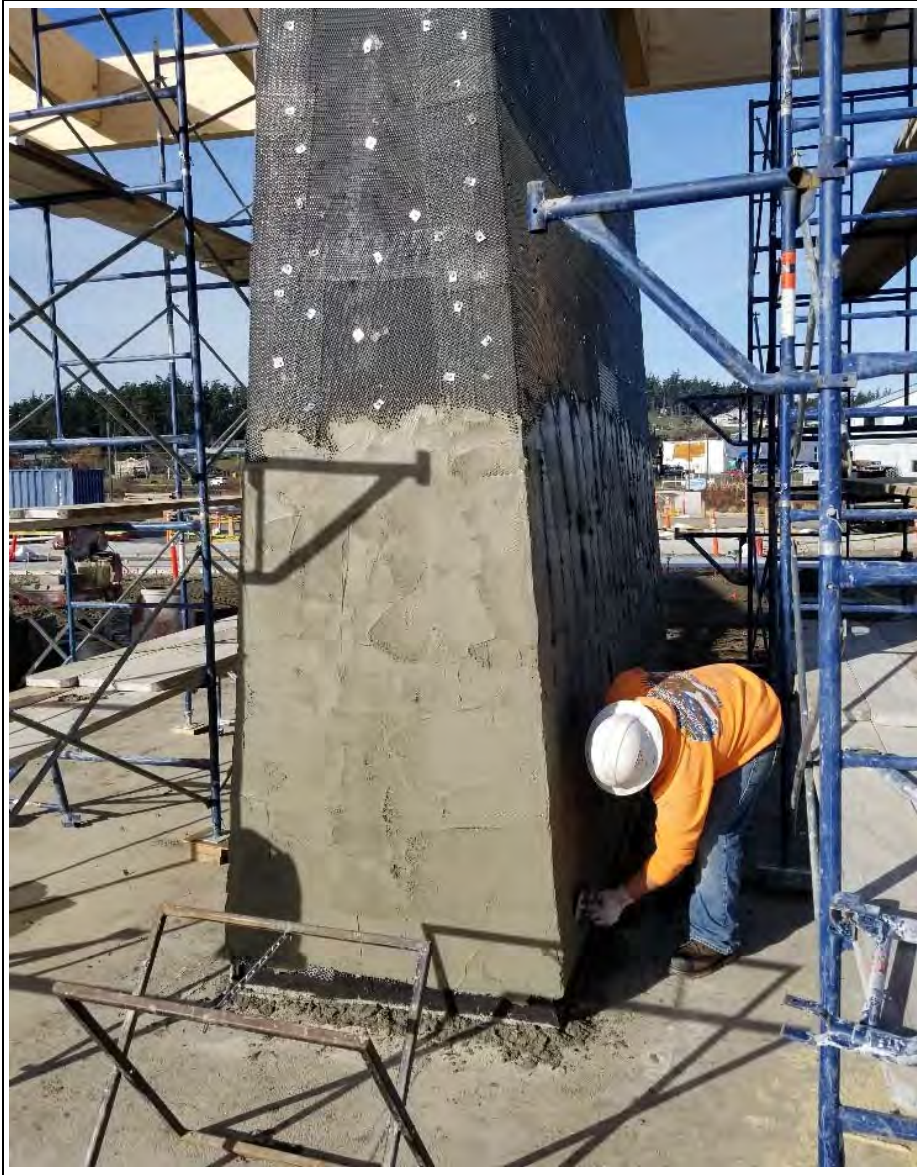
Photo #69

A brick mason for Black Rock Masonry is troweling mortar over metal lath to facilitate installation of a basalt rock façade.

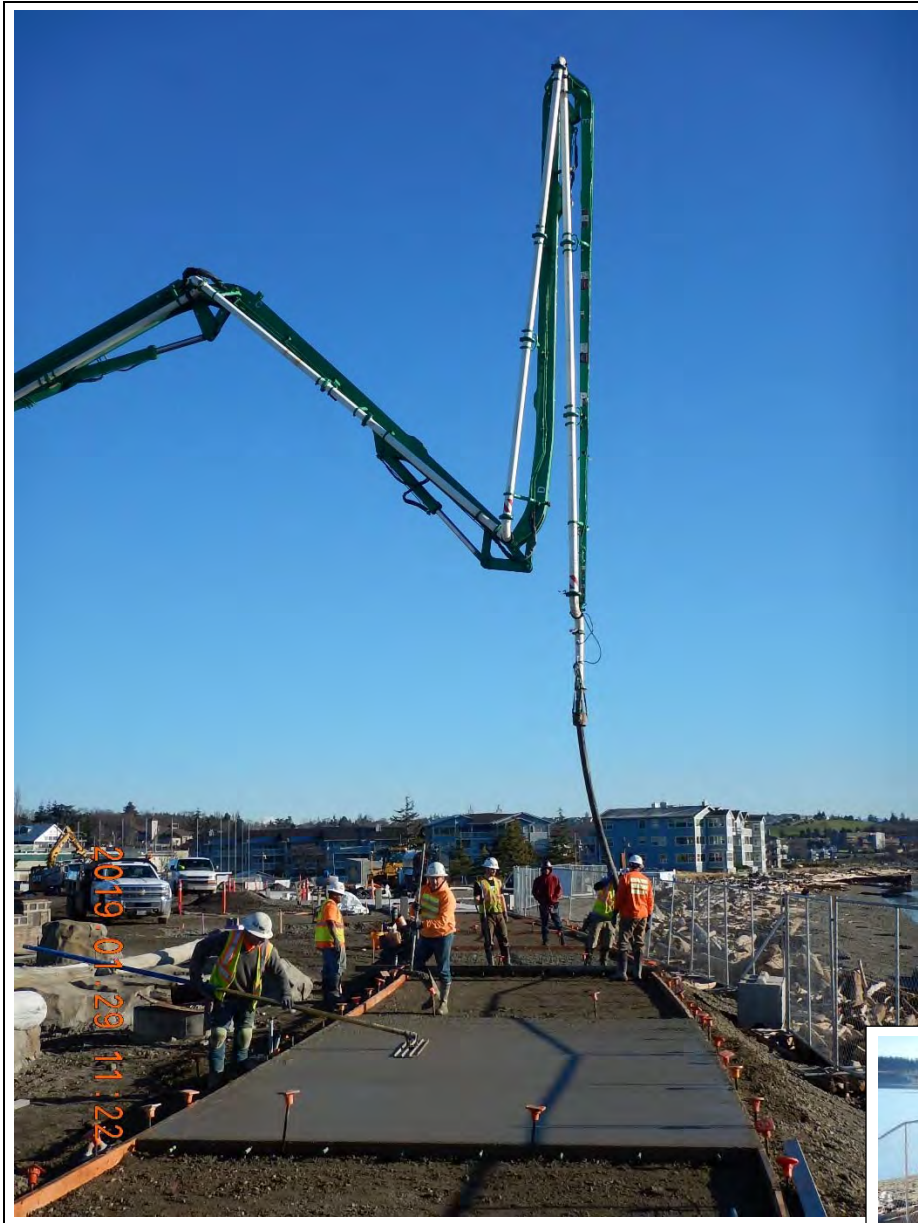
Photo #70

West side of Windjammer Park (looking northwest at the pavilion) on Monday, January 28th.

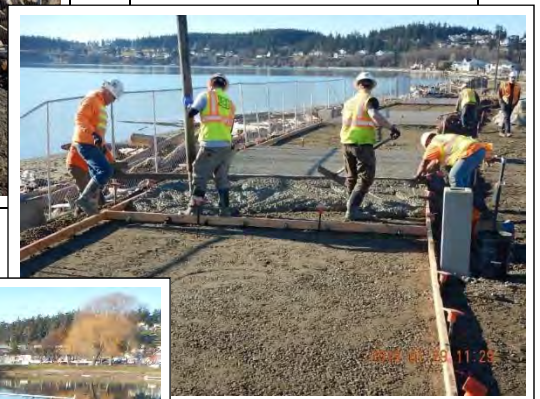
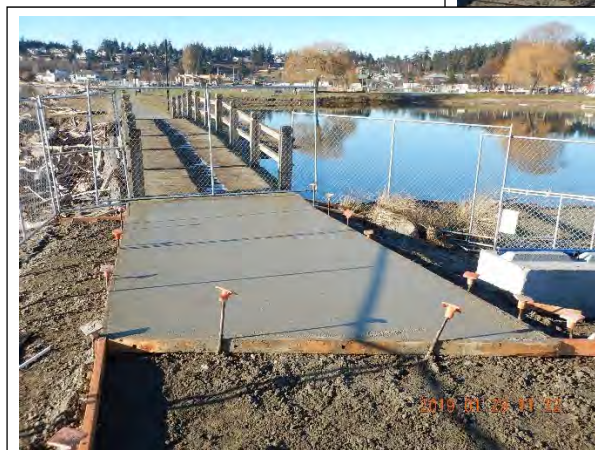
Photo #71

South side of Windjammer Park (looking east and west along the shore of Oak Harbor Bay) on Tuesday, January 29th.

Interwest Construction is utilizing a truck-mounted concrete pump and hydraulic actuated boom to place concrete for a pedestrian walkway along the shoreline of Oak Harbor Bay.
