City of Oak Harbor
City Council Agenda Bill

Bill No. 5. c. i.
Date: February 19, 2019
Subject: Clean Water Facility Update

Clean Water Facility Project

January 2019

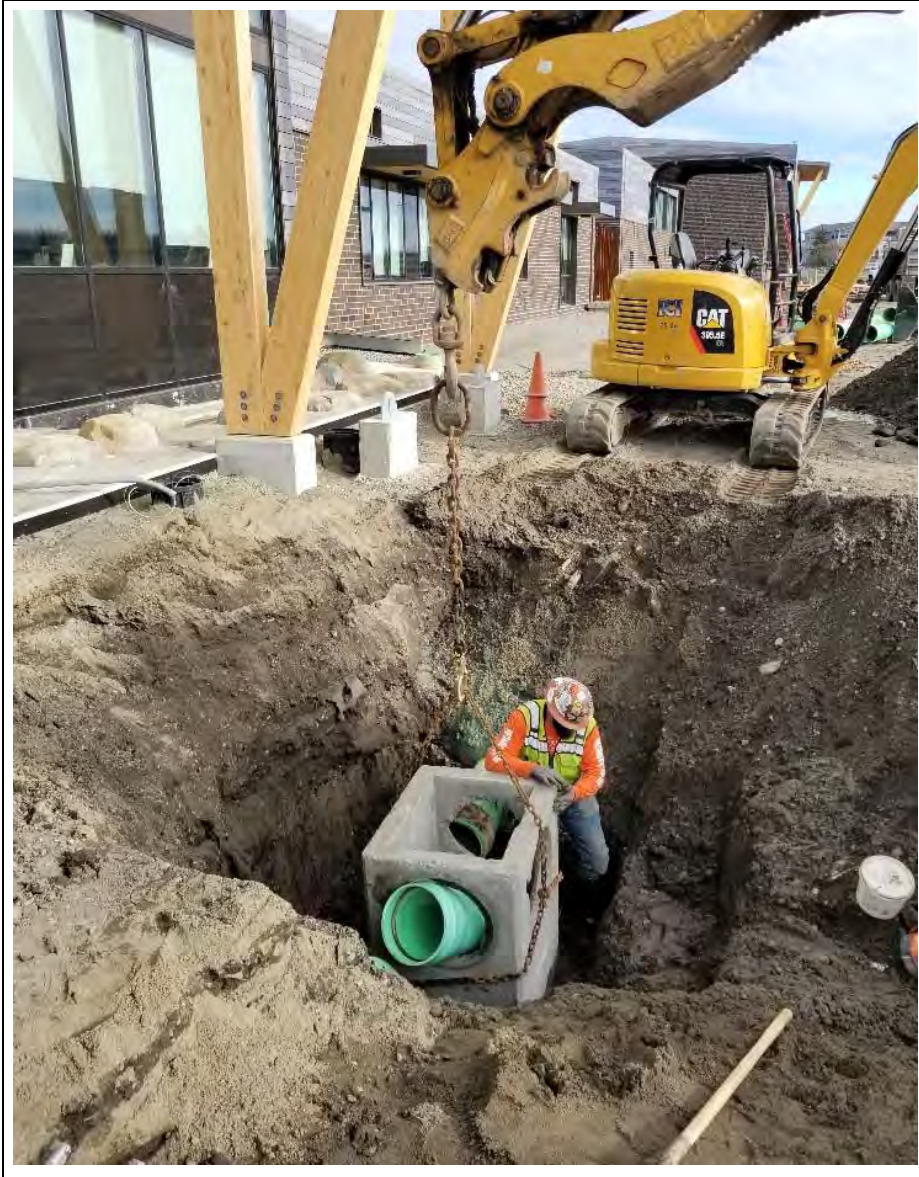
Photo #71

A pipe layer for Interwest Construction, John Pino, is installing a storm water catch basin.

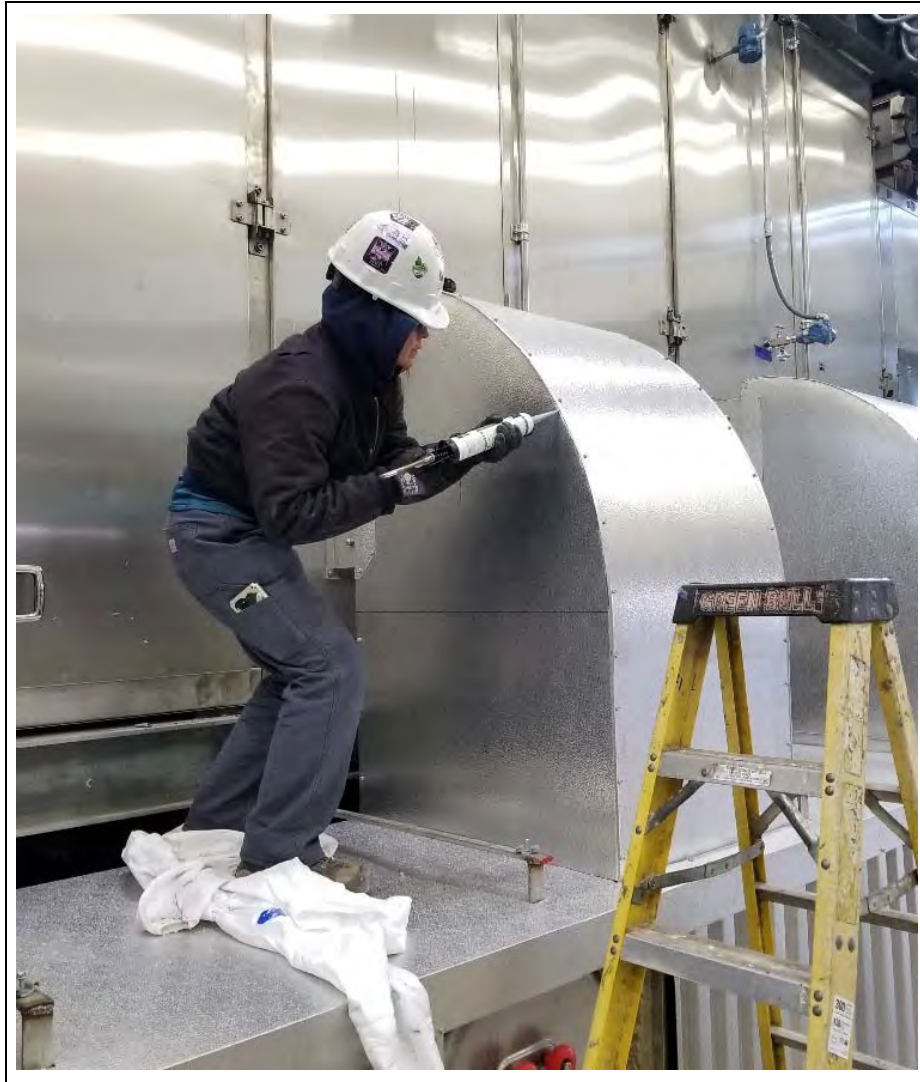
Photo #72

An insulator for D&G
Mechanical Insulation is
caulking joints between
sections of aluminum
jacketing that covers matt
insulation.

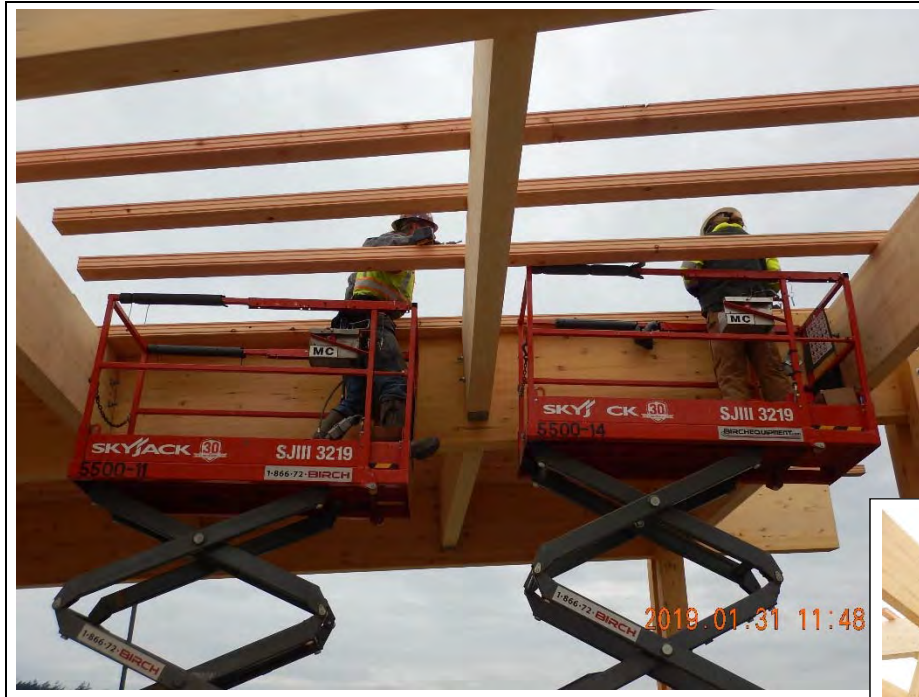
Photo #73

Carpenters for P&L General Contractors are installing tongue-and-groove decking atop glulam beams at the west kitchen.

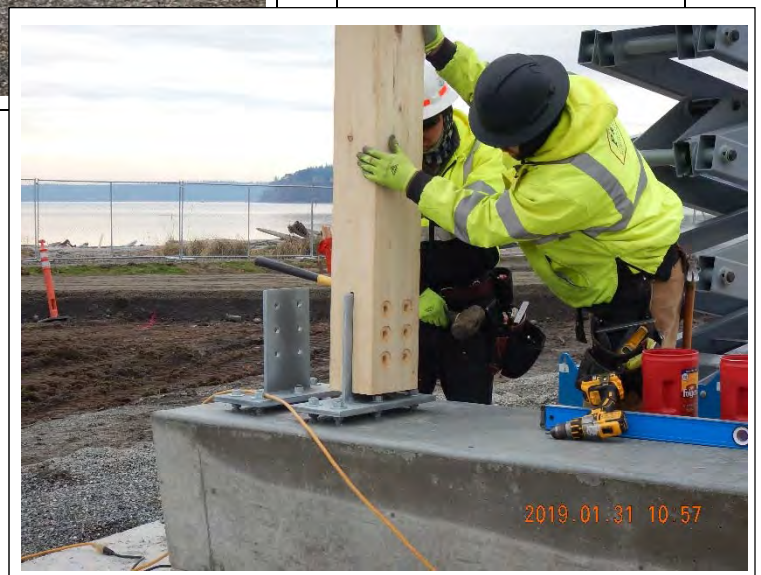
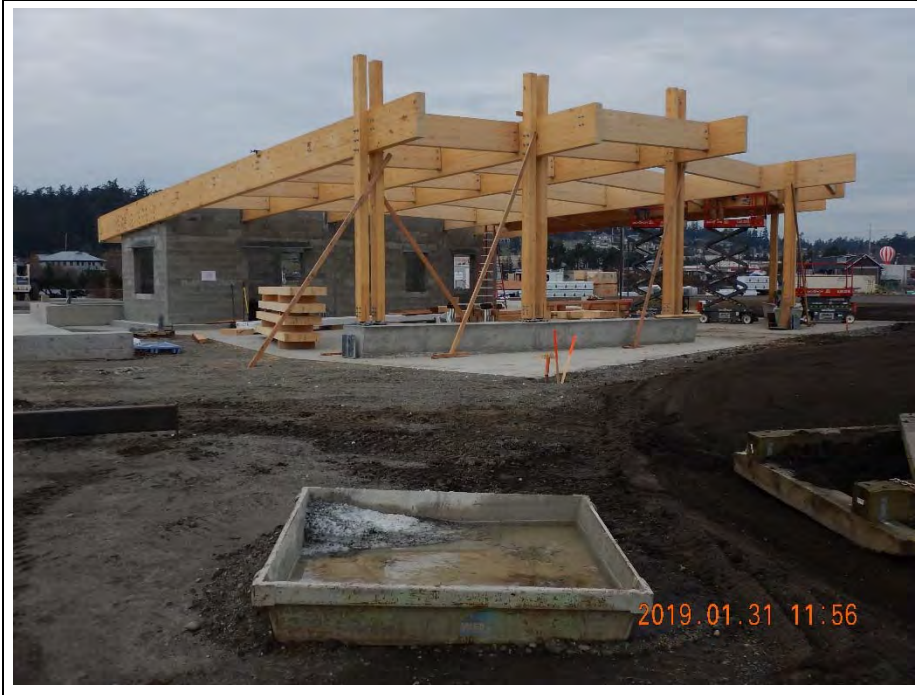
Photo #76

Southeast side of Windjammer Park (looking northwest along the east side of the east kitchen) on Thursday, January 31st.

Carpenters for P&L General Contractors are installing a glulam column.

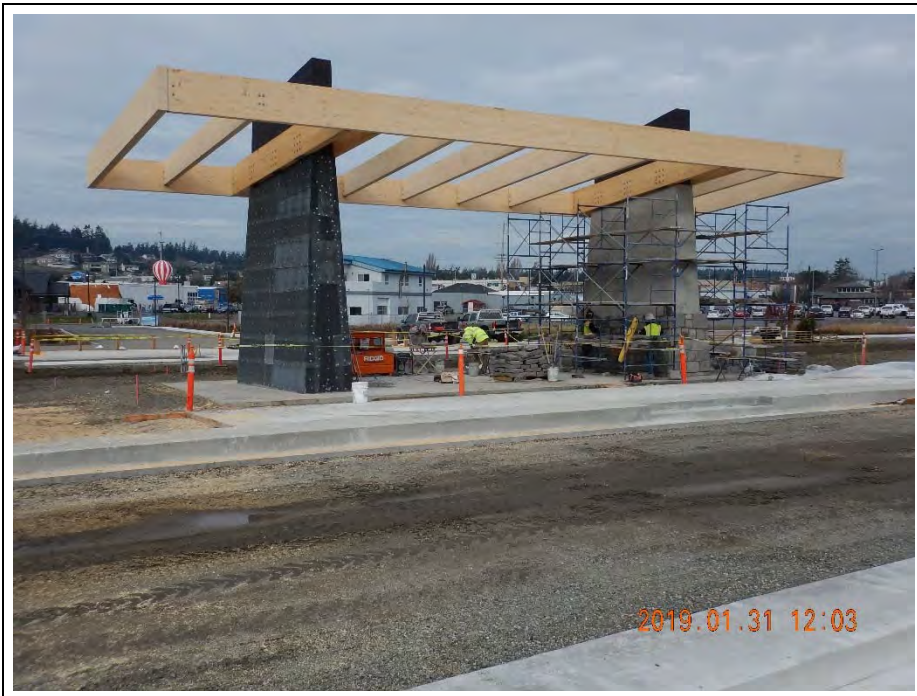
Photo #77

West side of Windjammer Park (looking northwest) on Thursday, January 31st.

This photo depicts the current status of the pavilion.

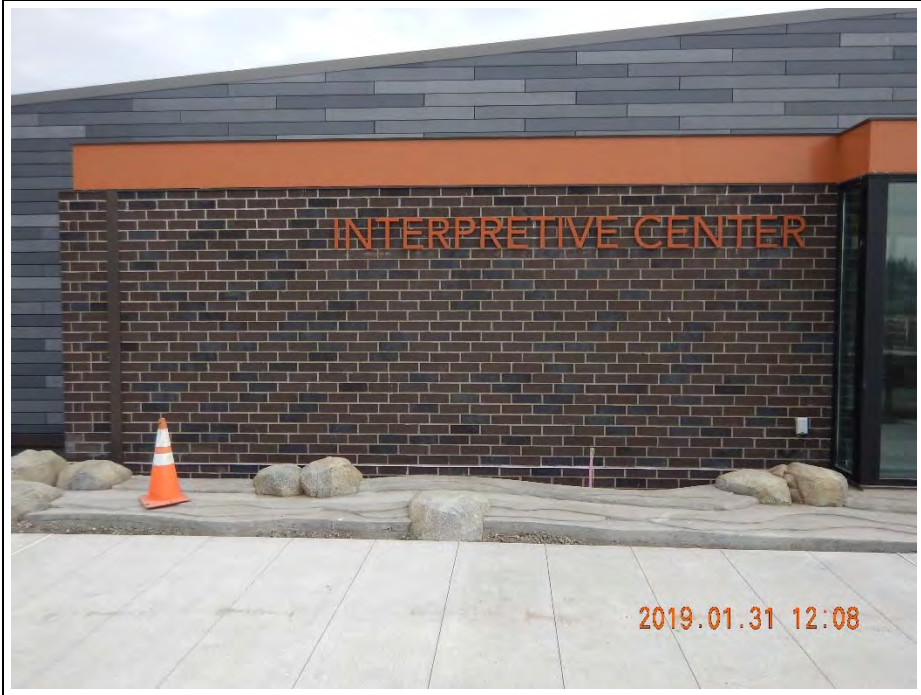
Photo #78

Area 01 Administration Building (looking east) on Thursday, January 31st.

Whidbey Sign Company (a.k.a. Humphrey Sign Co.) placed signage on buildings.

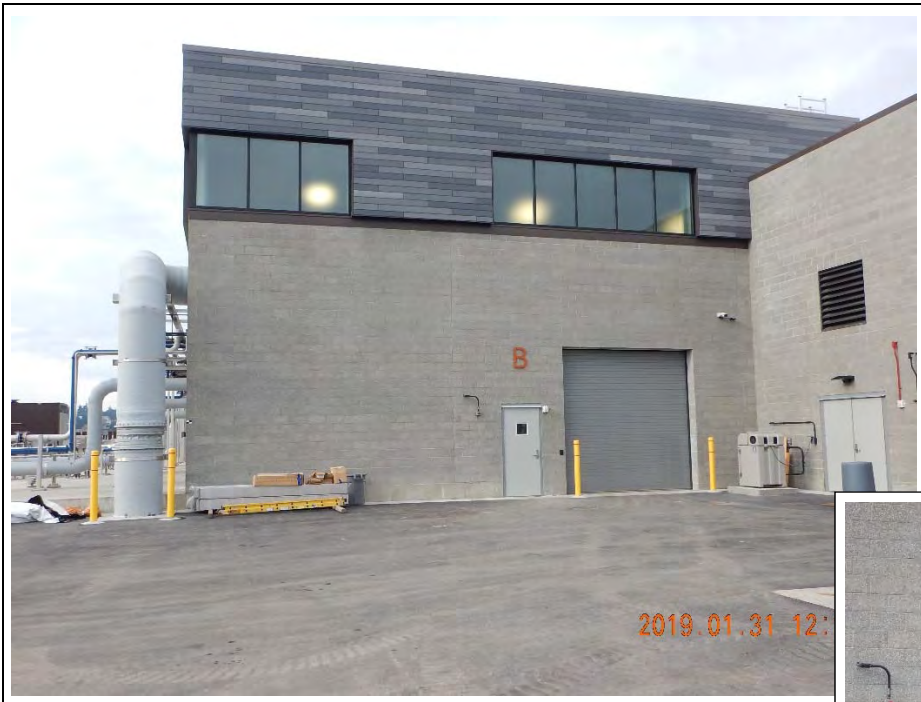
Photo #79

Area 30 Secondary Treatment Building (looking west) on Thursday, January 31st.

Whidbey Sign Company (a.k.a. Humphrey Sign Co.) placed signage on buildings, including letters as requested by Oak Harbor Fire Department.

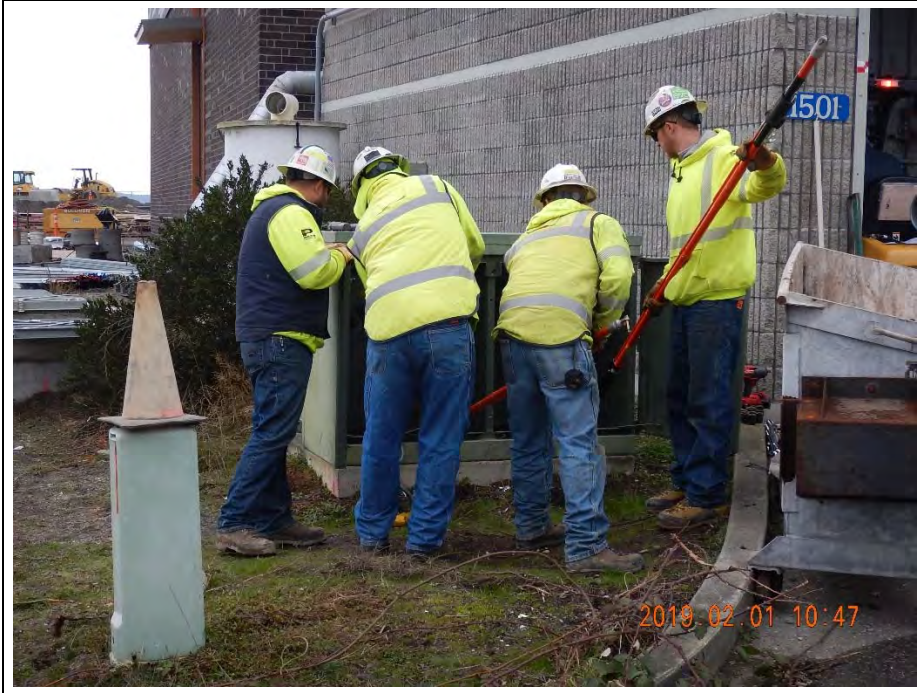
Photo #80

West side of existing City Pump Station (looking south) on Friday, February 1st.

Linemen for Puget Sound Energy's subcontractor, Potelco, are cutting power to the City's existing wastewater pump station so demolition work can begin.

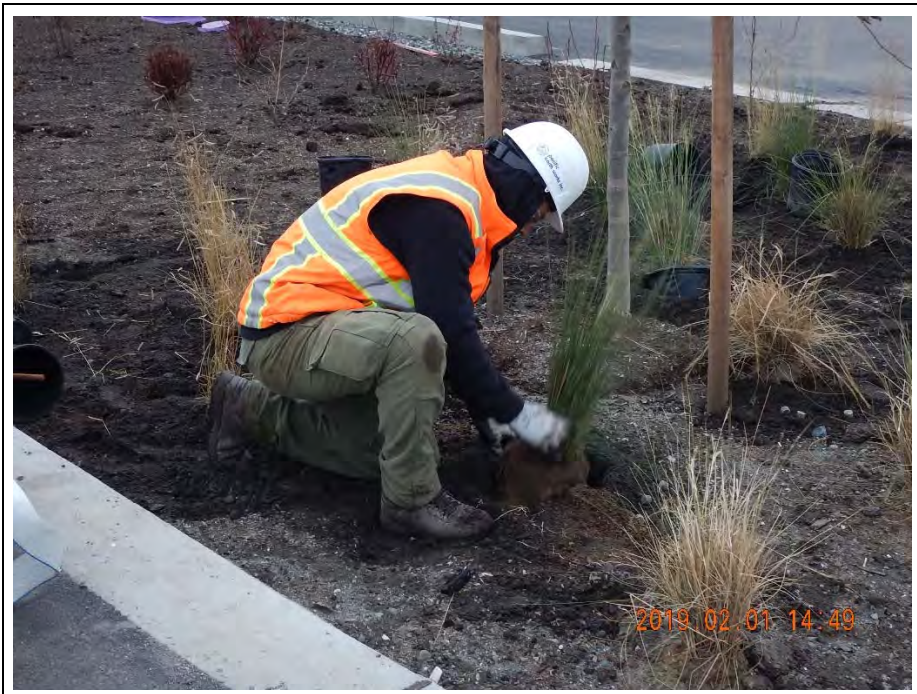
Photo #81

West side of Windjammer Park (looking northwest) on Friday, February 1st.

A landscaper for Pacific Earth Works is planting wetland enhancement plants near the northwest entrance to the park.

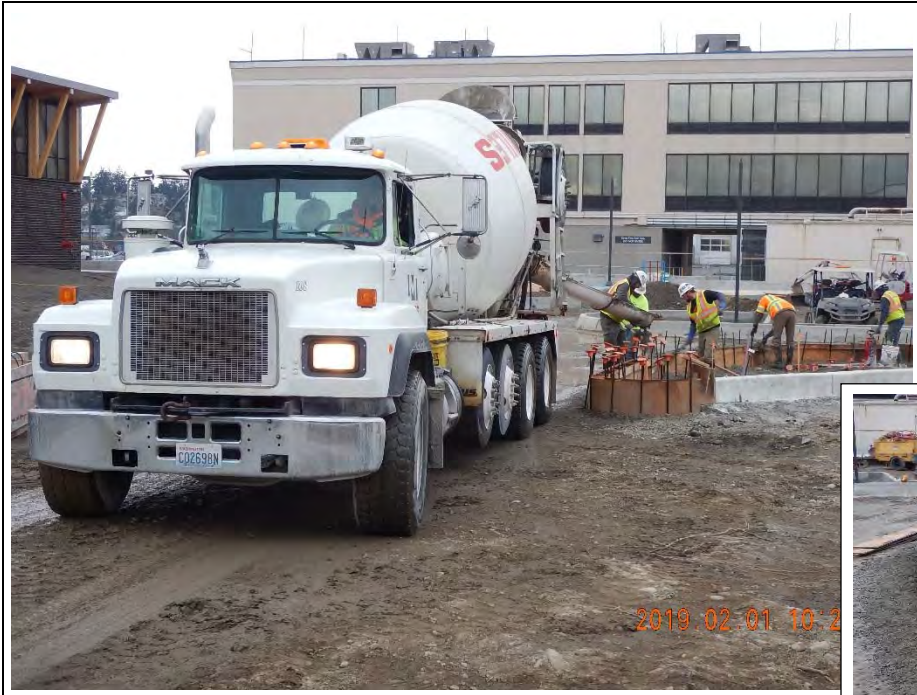
Photo #82

Area north of the Area 30 Secondary Treatment Building (looking west) on Friday, February 1st.

Interwest Construction placed concrete for curbs.

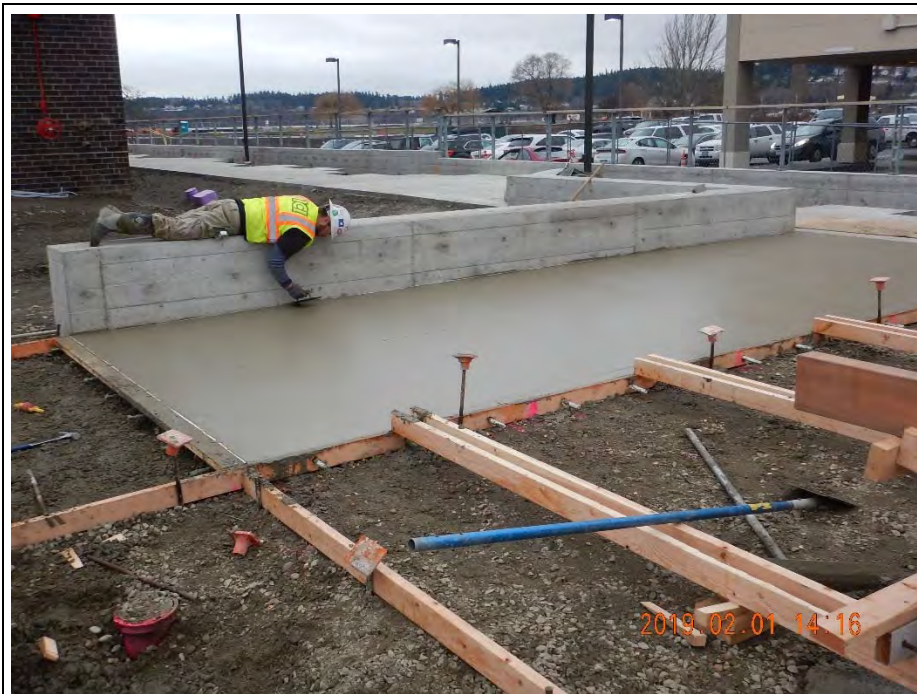
Photo #83

Area north of Area 32 Aeration Blower Building (looking Southwest) on Friday, February 1st.

A carpenter for Interwest Construction is finishing concrete for a section of pedestrian walkway.

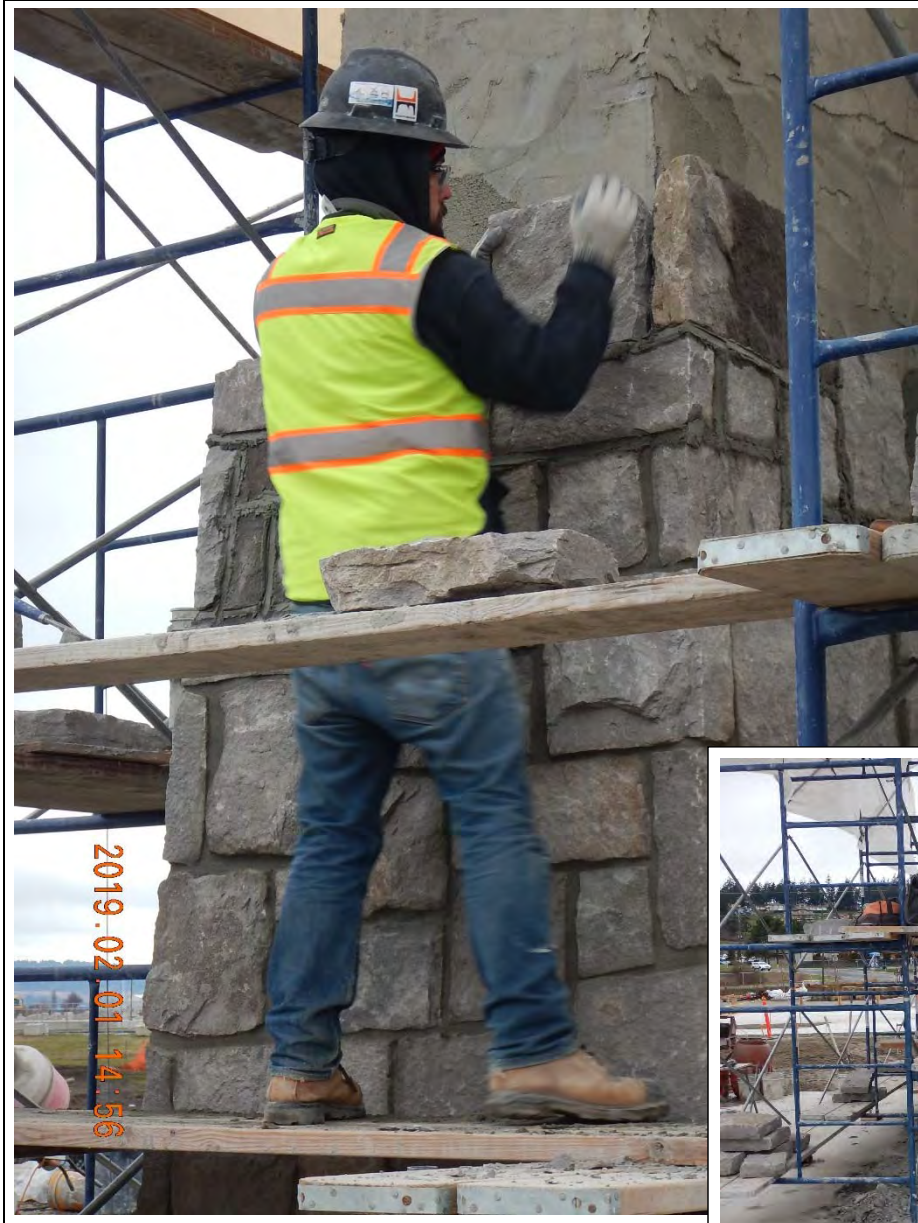
Photo #84

West end of Windjammer Park (looking northeast at the pavilion) on Friday, February 1st.

A brick mason for Black Rock Masonry, Chris Toms, is placing basalt rock at the pavilion.

GMPA No. 13 – Windjammer Park Improvements (continued). Valley Electric attached copper grounding conductors to spray nozzles at the ship-wreck water feature. P&L General Contractors continued to install glulam beams at the west kitchen (see Photos #24, #25, #37, #38, #39, #53, #55, and #76) and began to install tongue-and-groove decking atop the beams (see Photo #73). P&L General Contractors applied damp proofing to shear walls (see Photo #40) and installed glulam beams (see Photos #63, #65, and #77). P&L General Contractors installed glulam columns at the east kitchen (see Photo #75). Black Rock Masonry finished CMU block walls at the west kitchen (see Photo #36). During the last two weeks of January, Black Rock Masonry attached metal lath to shear walls at the pavilion, troweled mortar over the lath (see Photo #69), and then began placing basalt rock against the mortar (see Photo #84).
