City of Oak Harbor
City Council Agenda Bill

Bill No. 5.i
Date: April 16, 2019
Subject: Clean Water Facility Update

City of Oak Harbor
**Clean Water
 Facility Project**

MONTHLY PROGRESS REPORT

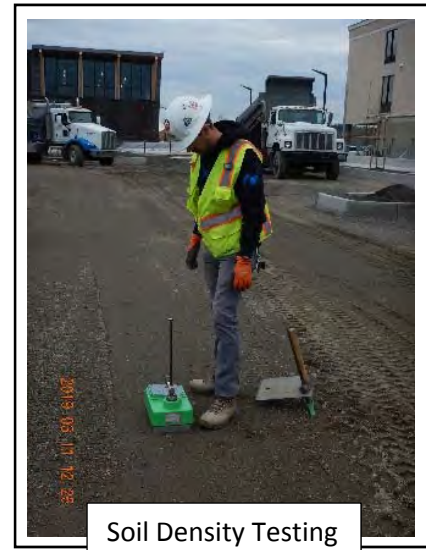
A resident engineer for KBA performed part-time inspection at the clean water facility and at Windjammer Park (mostly at Windjammer Park). Special inspectors for KBA's subconsultant, GeoTest, performed part-time specialty inspection on an as-requested basis (as seen in photo at right). Representatives from Hoffman performed part-time inspection on a daily basis. Hoffman conducted daily quality assurance (QA) coordination meetings with its subcontractors and with KBA. Archaeologists from ERCI were on-site during excavation work at Windjammer Park looking for cultural resources. Inspectors for the State Department of Labor & Industries inspected electrical work on an as-requested basis (see Photo #74). City building official Scott King was on site several times to observe construction work at Windjammer Park and participate in "punch list" walk throughs at the clean water facility. Inspectors produced written daily reports that were filed on the City's server.

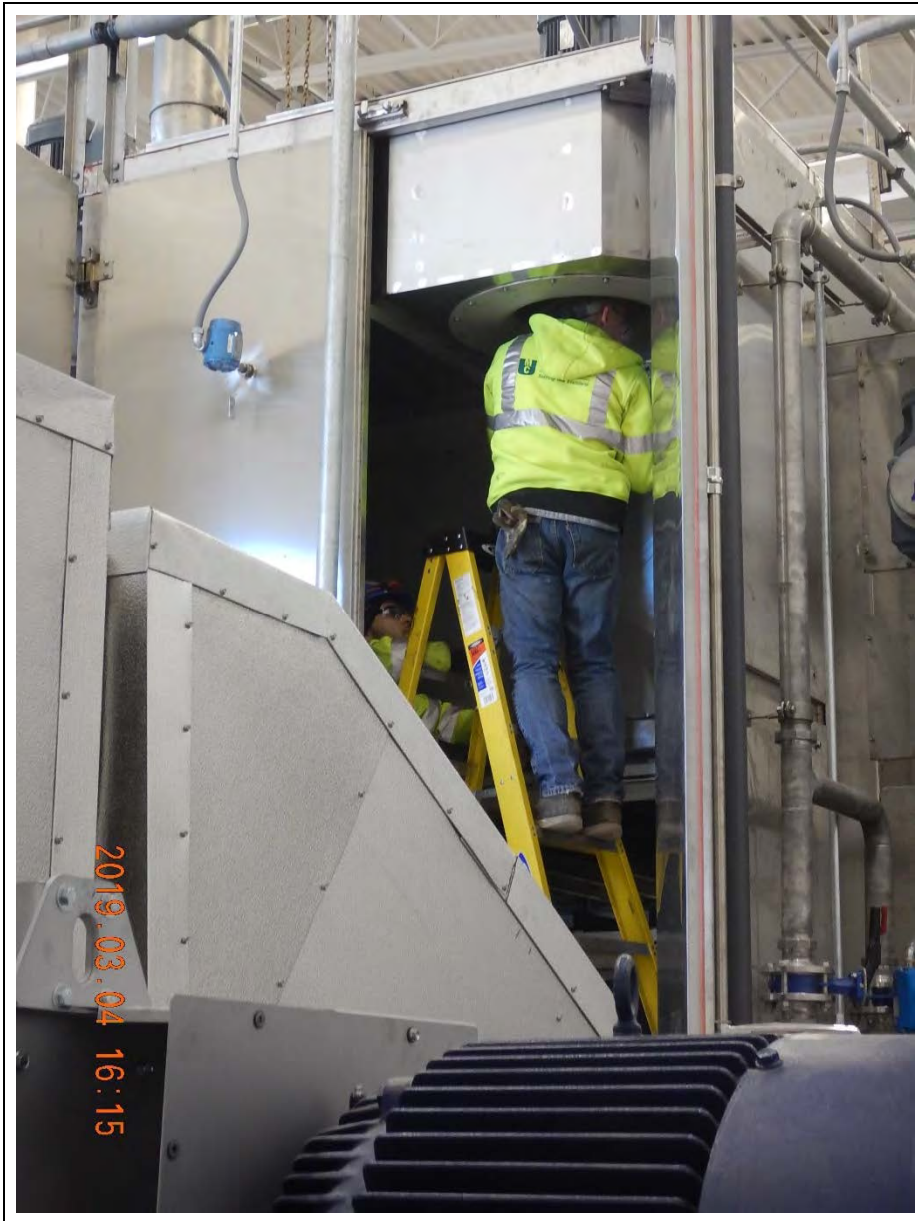
Photo #3

Area 50 Biosolids Building (looking west at the northeast corner of the dryer) on Monday, March 4th.

- A representative of Rockwell was on site on March 6th to address problems with several variable frequency drives.
- Adjustments were made to fans inside the dryer (see Photo #3).
- Adjustments were made to a dryer feed distributor (see Photo #24).
- Adjustments and modifications were made to a transfer conveyor (see Photos #25 and #48).
- Stainless steel unions associated with a deluge water piping system and a condenser cooling water piping system were welded to stop leaks (see Photos #26 and #47).

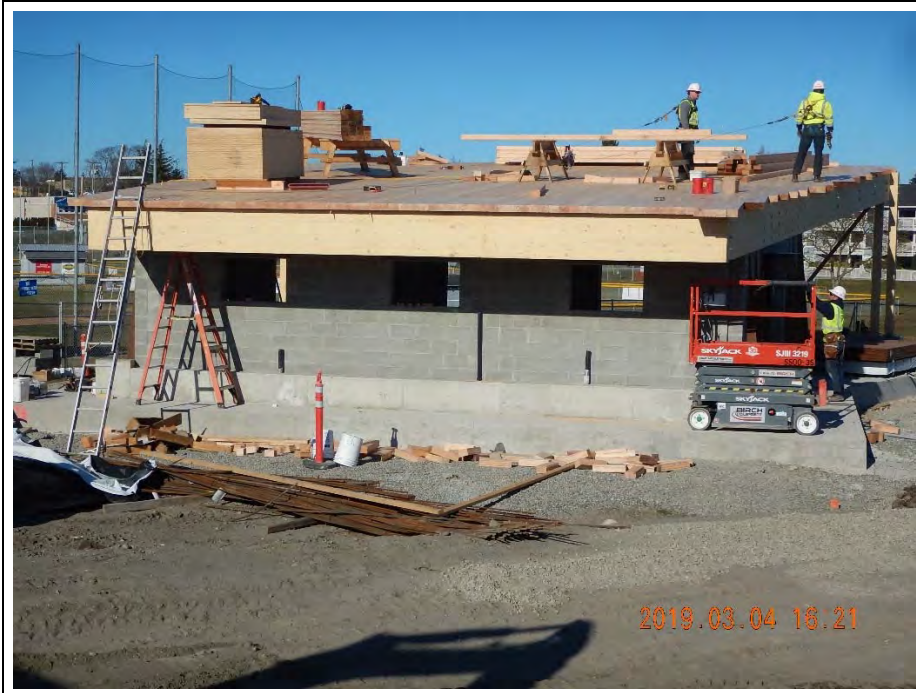
Photo #4

Southeast end of Windjammer Park (looking east at the east kitchen) on Monday, March 4th.

Carpenters for P&L General Contractors are placing tongue-and-groove decking atop glulam beams at the east kitchen.

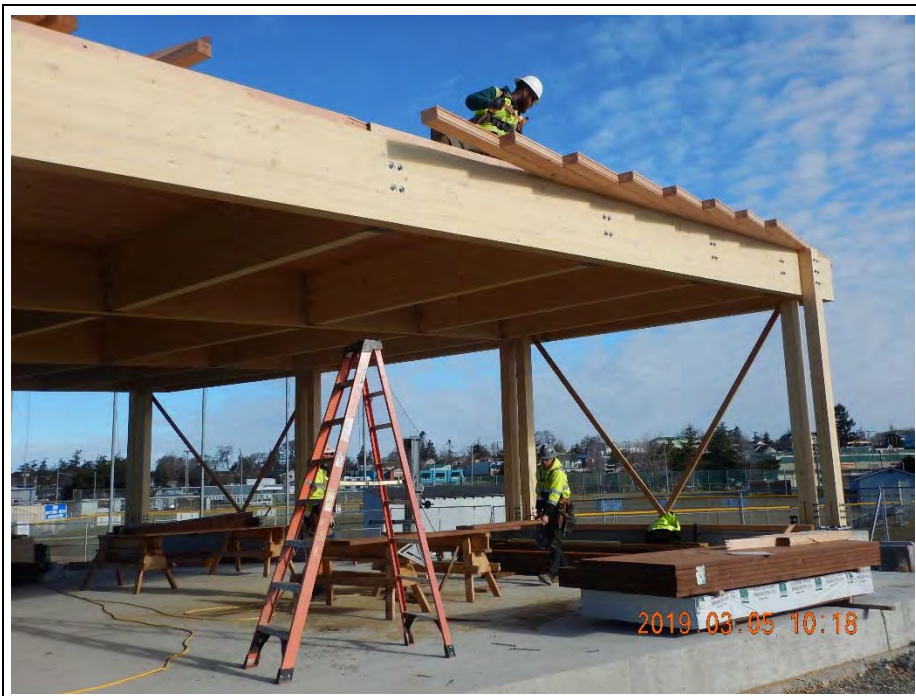
Photo #5

Southeast end of Windjammer Park (looking north at the east kitchen) on Tuesday, March 5th.

A carpenter for P&L General Contractors is placing tongue-and-groove decking atop glulam beams at the east kitchen.

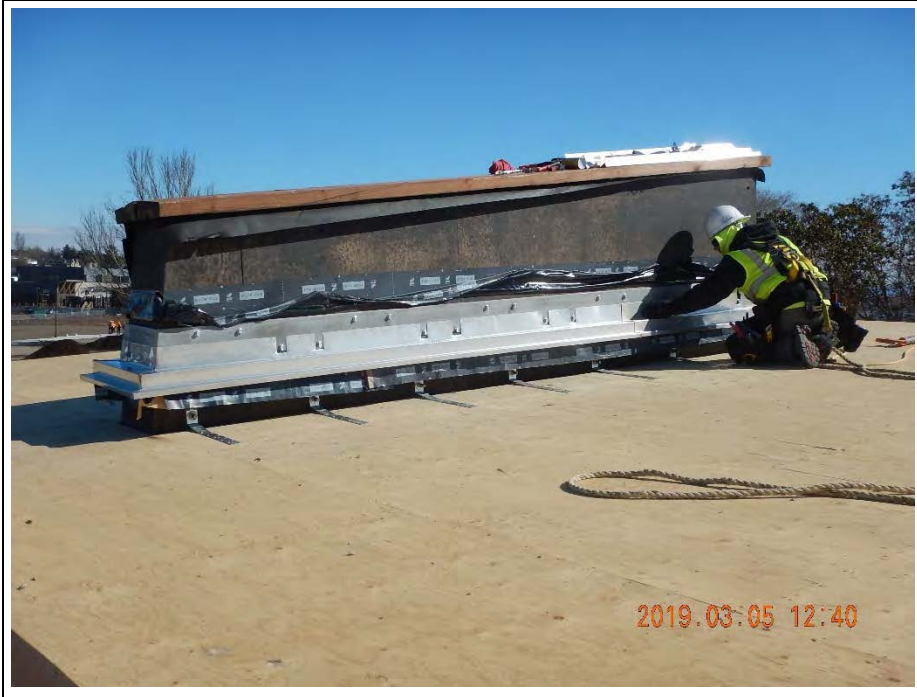
Photo #7

West end of Windjammer Park (looking east at the pavilion) on Tuesday, March 5th.

A sheet metal worker for Axiom is installing stainless steel flashing over a support angle. Basalt stone veneer will be placed atop the flashing/support angle.

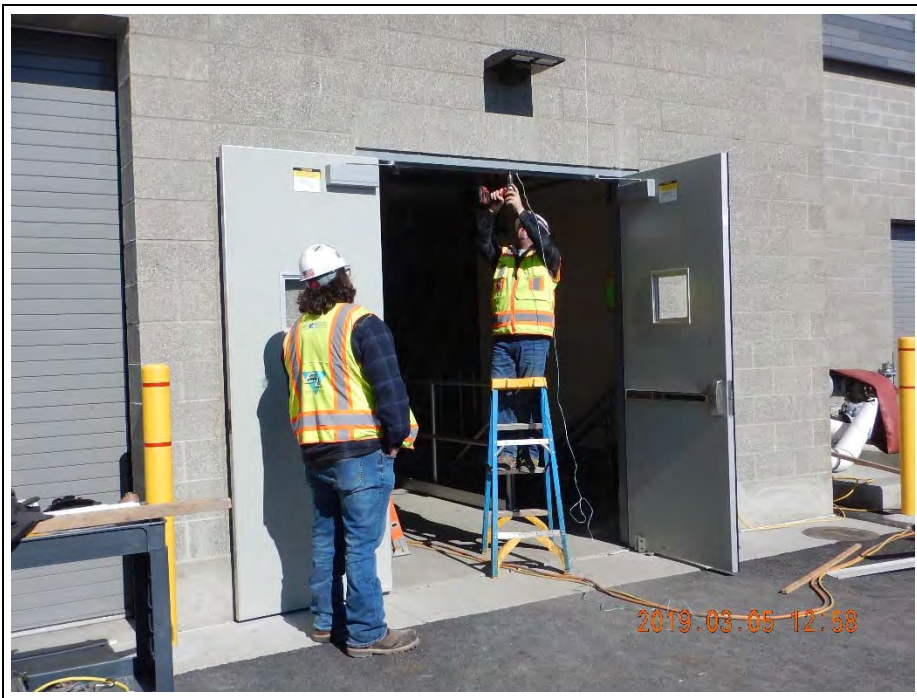
Photo #8

Area 20 Headworks (looking northeast) on Tuesday, March 5th.

Electricians for EZ Interface are installing access control devices.

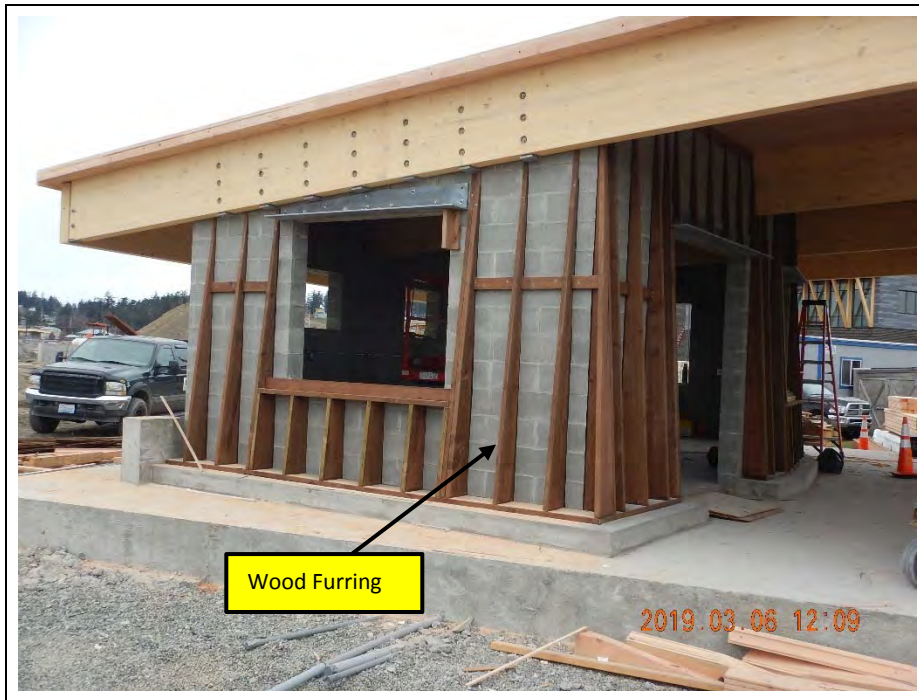
Photo #9

Southeast end of Windjammer Park (looking northwest at the east kitchen) on Wednesday, March 6th.

P&L General Contractors installed pressure-treated wood furring over CMU blocks.

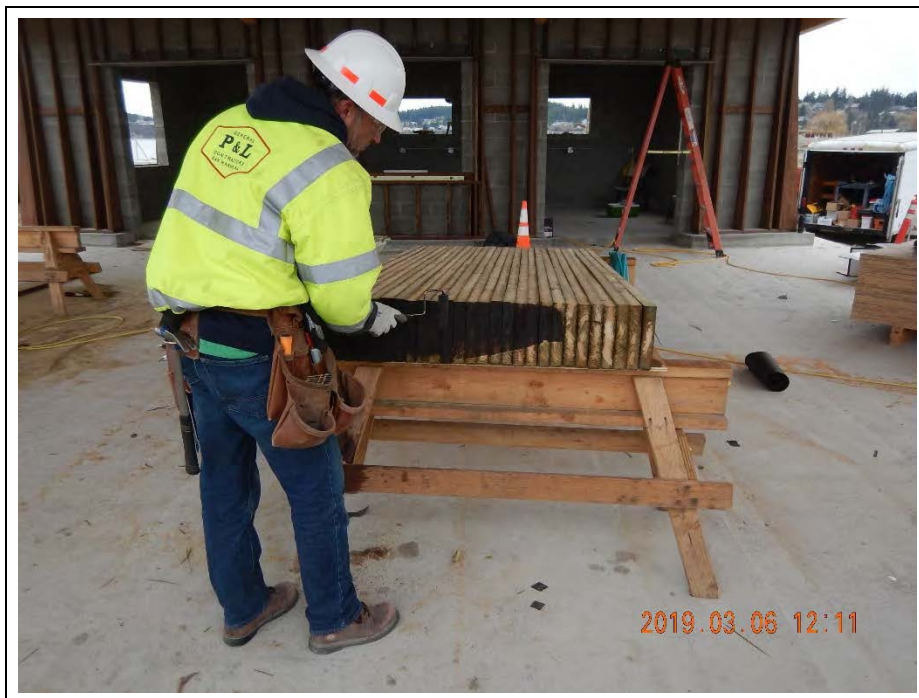
Photo #10

Southeast end of Windjammer Park (looking southwest at the east kitchen) on Wednesday, March 6th.

A carpenter for P&L General Contractors is applying a preservative to the cut ends of pressure-treated wood furring.

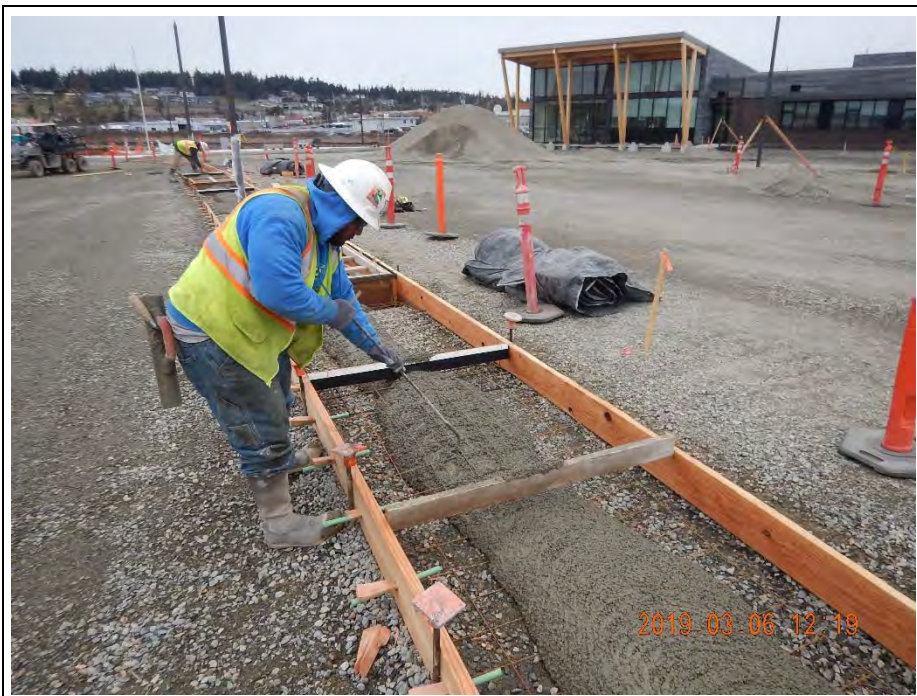
Photo #12

East end of Windjammer Park Building (looking northwest) on Wednesday, March 6th.

A laborer for Interwest Construction is lifting up wire-welded fabric to locate it in the center of the 8-inch thick concrete.

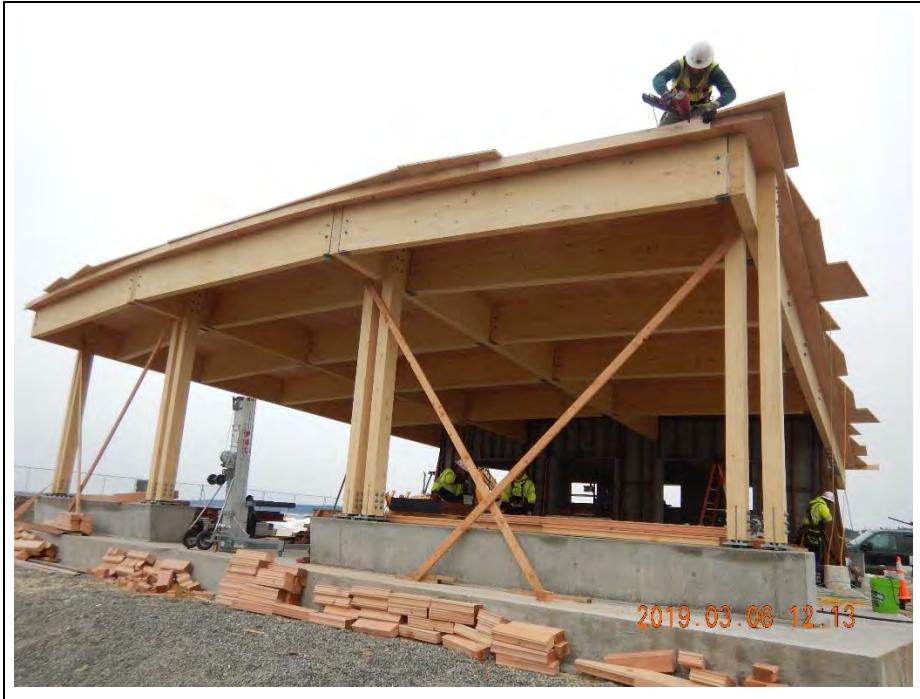
Photo #13

Southeast end of Windjammer Park (looking southwest at the east kitchen) on Wednesday, March 6th.

A carpenter for P&L General Contractors is nailing a strip of plywood sheathing along the perimeter of the roof.

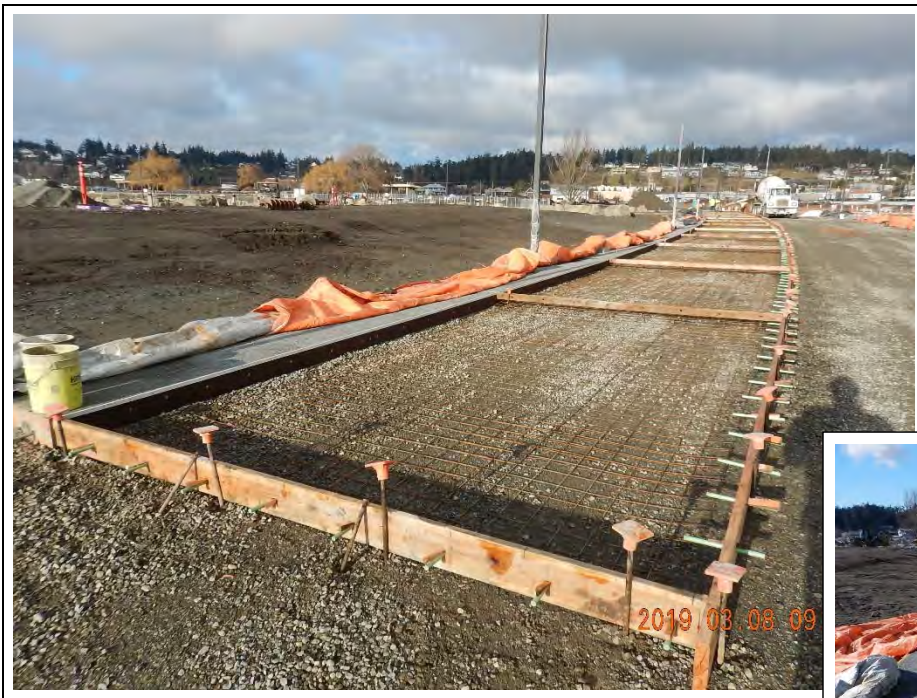
Photo #18

East end of Windjammer Park (looking northwest) on Friday, March 8th.

Interwest Construction placed concrete for vehicular concrete pavement.

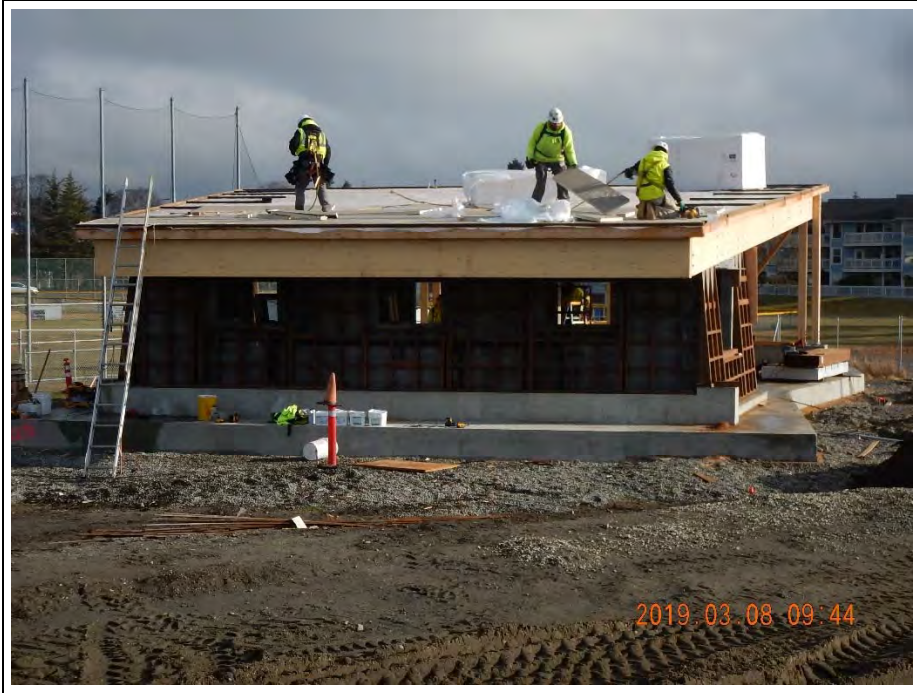
Photo #19

Southeast end of Windjammer Park (looking northeast towards the east kitchen) on Friday, March 8th.

Sheet metal workers for Axiom are installing insulation board atop the east kitchen.

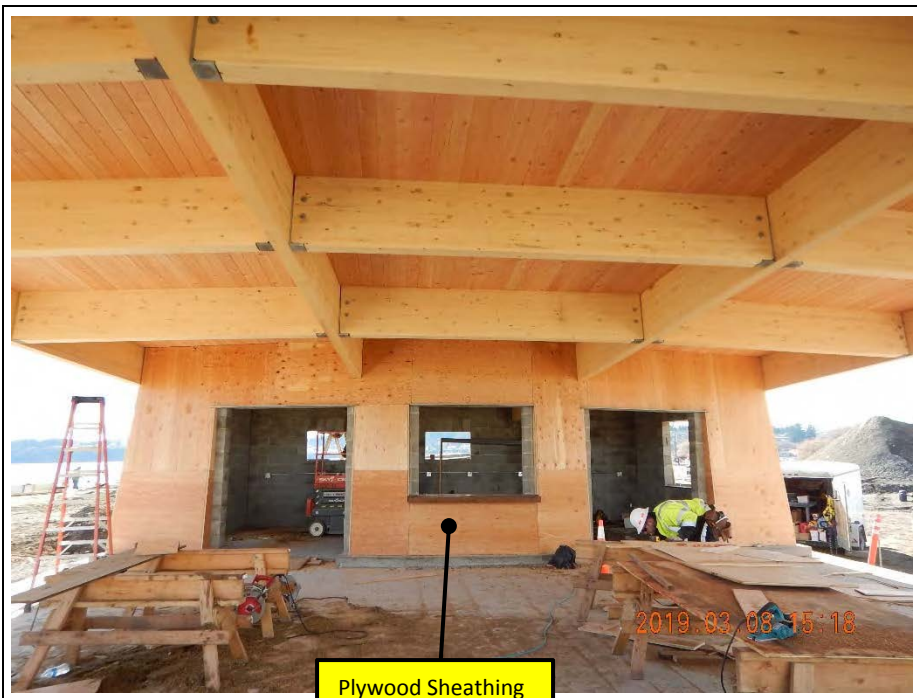
Photo #20

Southeast end of Windjammer Park (looking southwest from the seating area of the east kitchen) on Friday, March 8th.

This photo depicts the status of plywood sheathing over pressure-treated wood furring at the east kitchen.

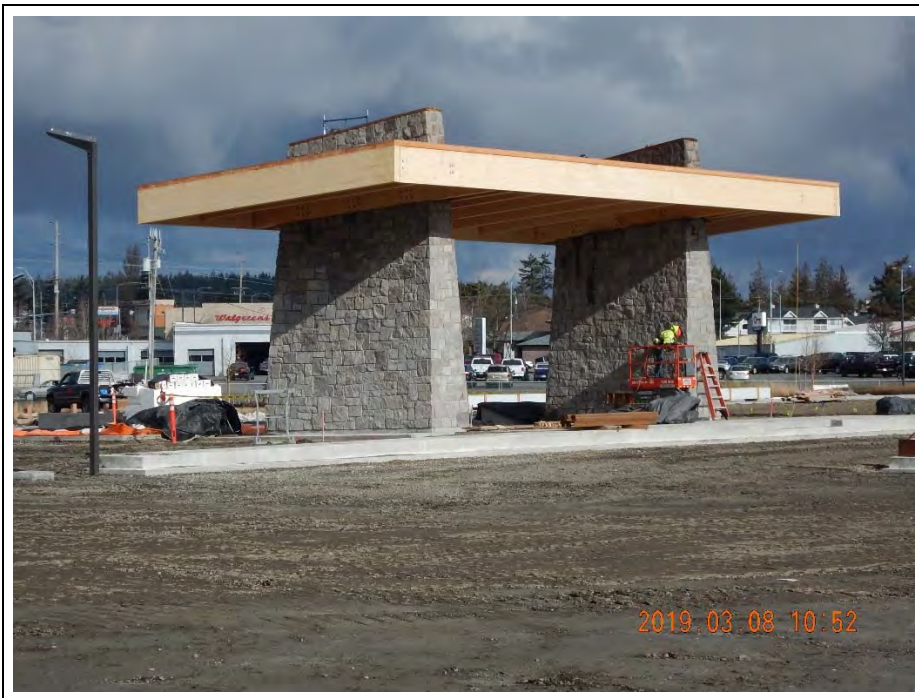
Photo #22

West end of Windjammer Park (looking north at the pavilion) on Friday, March 8th.

This photo depicts the status of the pavilion. Glulam beam, tongue-and-groove decking, plywood sheathing, and basalt stone veneer are complete. A standing seam metal roof has not yet been installed.

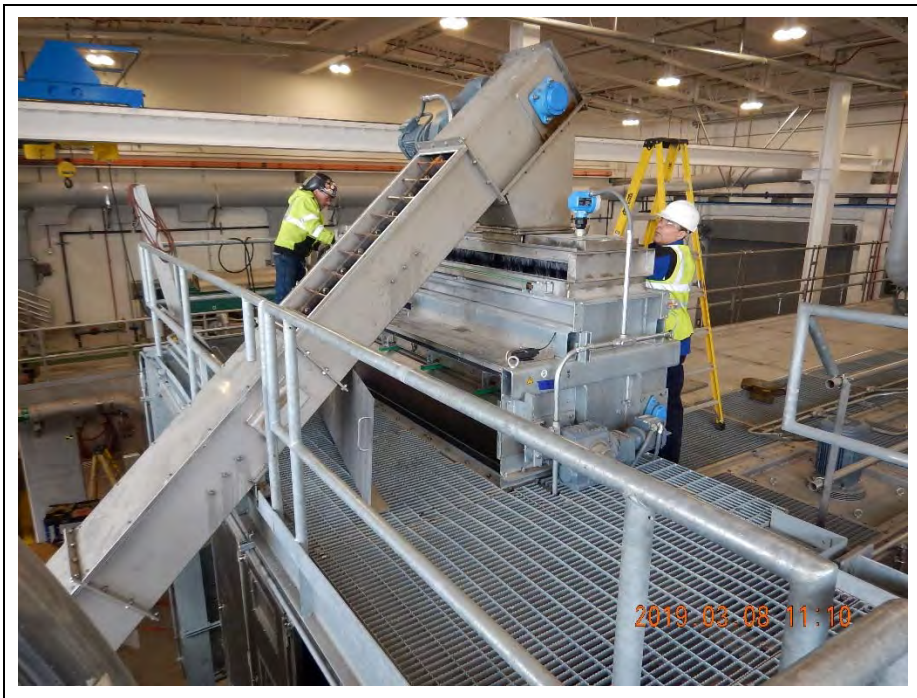
Photo #24

Area 50 Biosolids Building (looking northwest atop the south side of the dryer) on Friday, March 8th.

An ironworker for University Mechanical (left) and a commissioning engineer for Haarslev, Peter Gerweck, are working on a feed distributor. Mr. Gerweck is here from Germany.

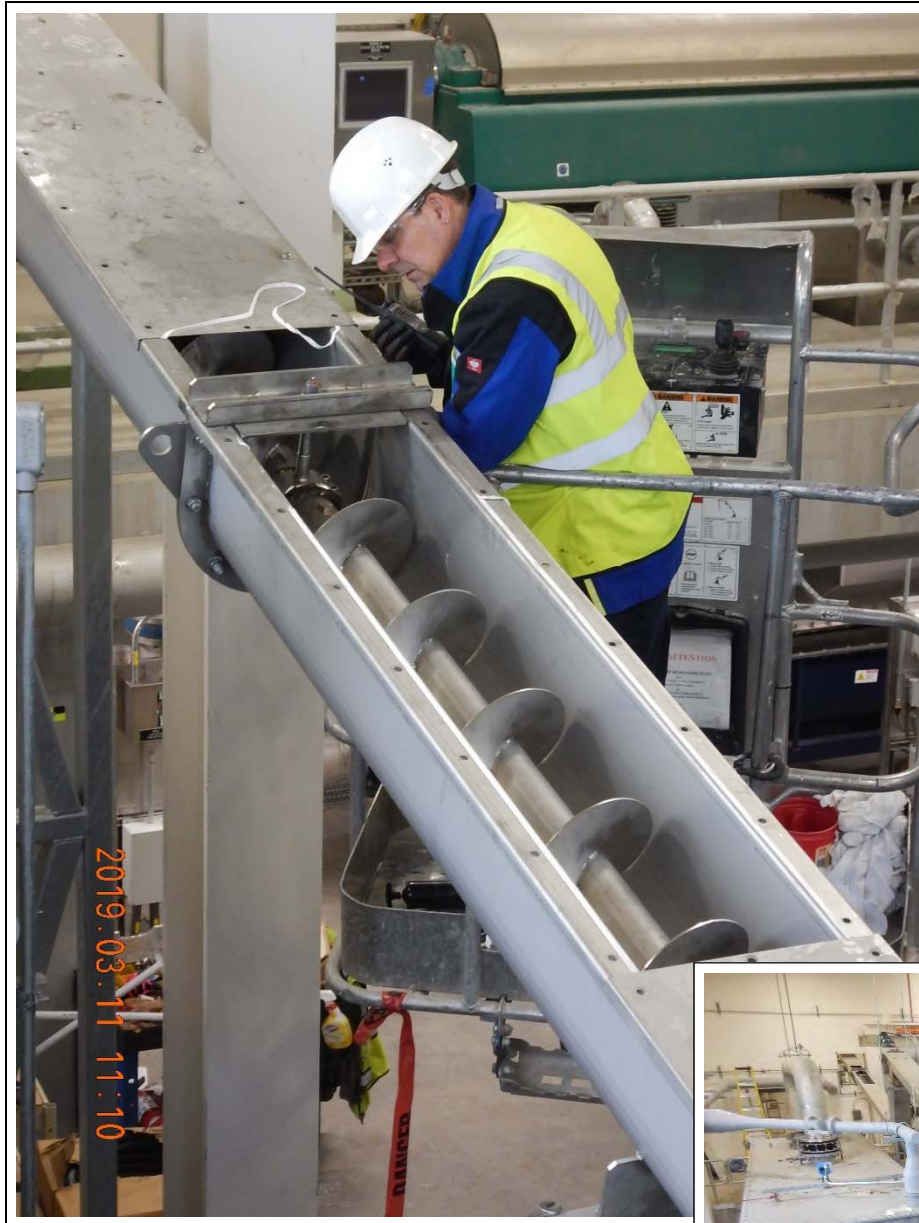
Photo #25

Area 50 Biosolids Building (looking west) on Monday, March 11th.

A commissioning engineer for Haarslev, Peter Gerweck, is adjusting a transfer conveyor. This transfer conveyor is the first of three conveyors in series that will convey dried sludge (i.e., Class A biosolids) from the dryer to a roll-off bin. Mr. Gerweck is here from Germany where the biosolids dryer was designed and manufactured.

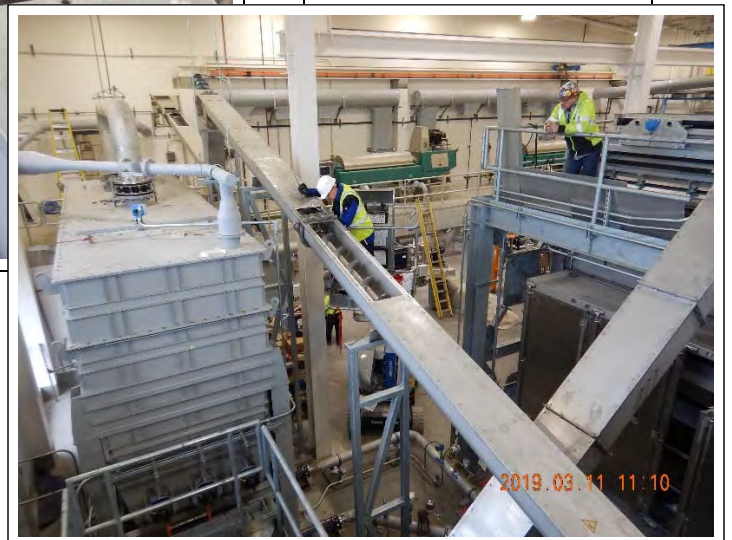
Photo #26

Area 50 Biosolids Building (looking southwest towards the north end of the biosolids dryer) on Monday, March 11th.

A commissioning engineer for Haarslev, Peter Gerweck (left in white hard hat), and two pipefitters for University Mechanical are evaluating 2-inch stainless steel unions that leaked when pressurized with utility water.

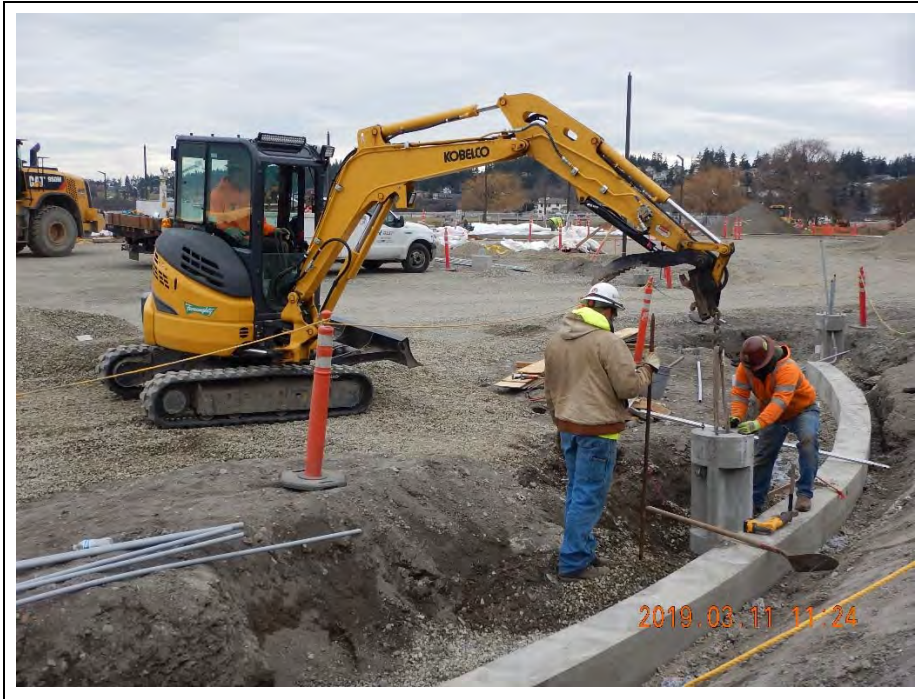
Photo #27

East end of Windjammer Park (looking west) on Monday, March 11th.

Three electricians for Valley Electric are setting a precast lamp base next to a footing for a weathering steel retaining wall.

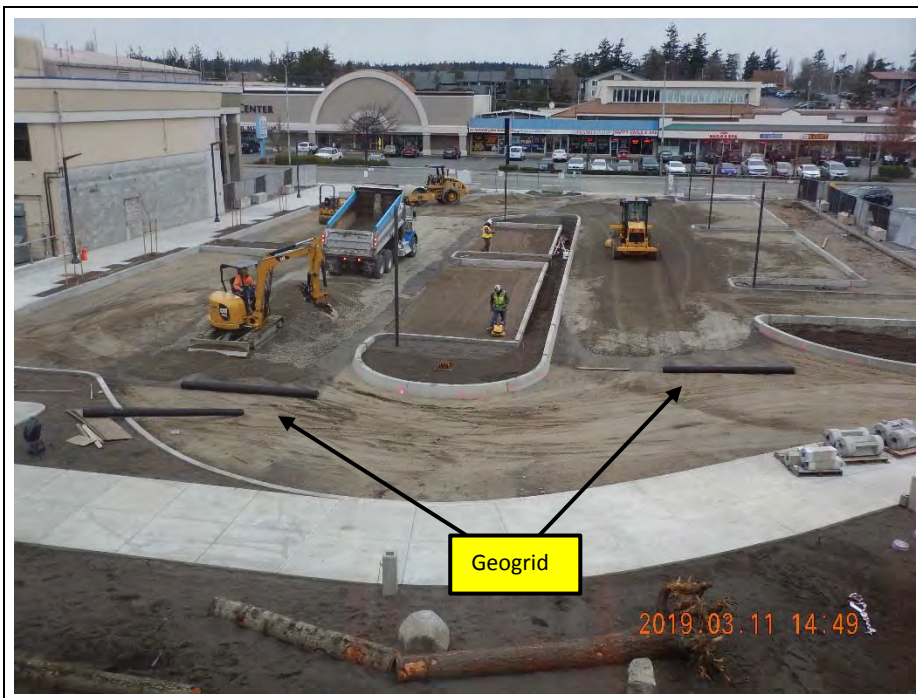
Photo #28

Area north of Area 30 Secondary Treatment Building (looking north) on Monday, March 11th.

Operators and laborers for Interwest Construction are placing geogrid and crushed rock base for a parking lot.

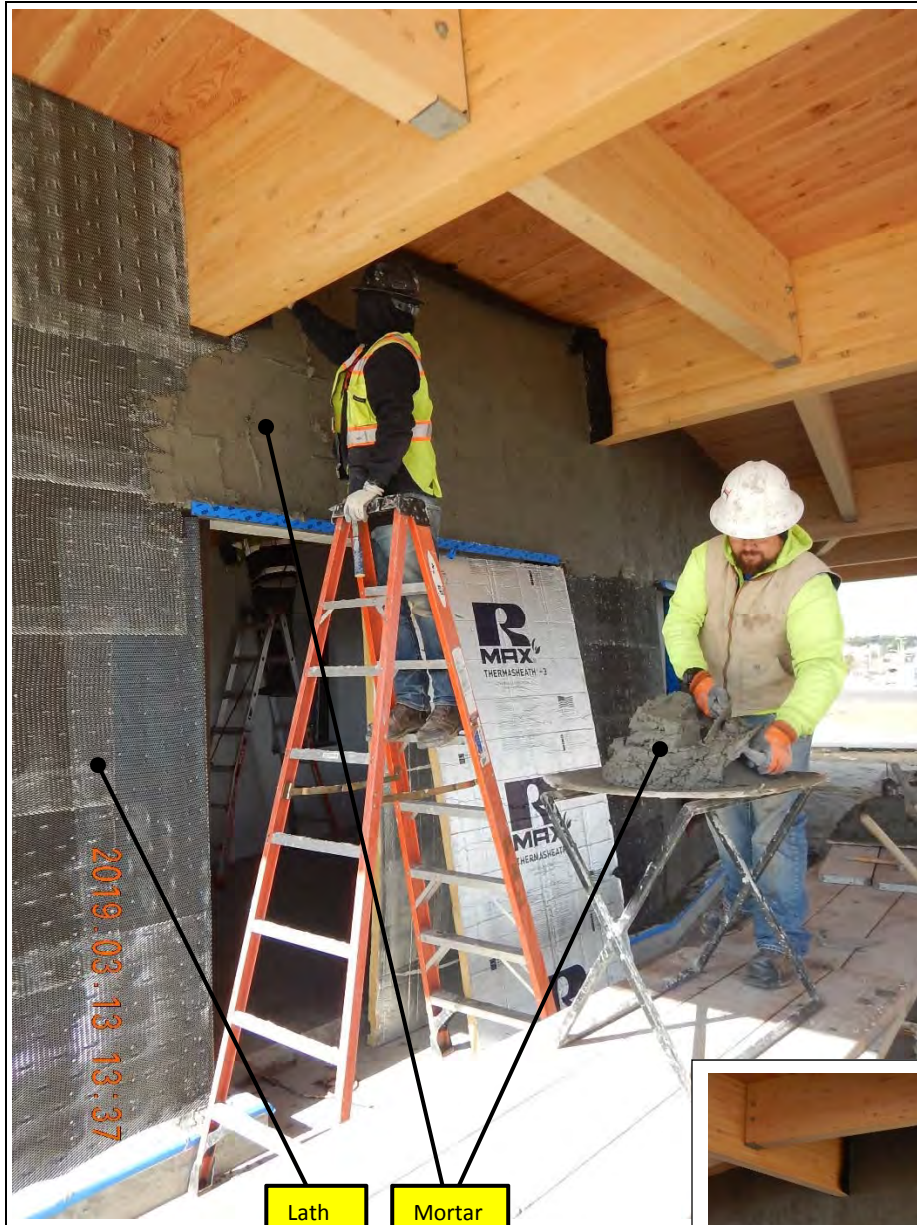
Photo #34

Southwest end of Windjammer Park (looking northwest at the west kitchen) on Wednesday, March 13th.

Masons for Black Rock Masonry are placing mortar over aluminum lath before building basalt stone veneer.

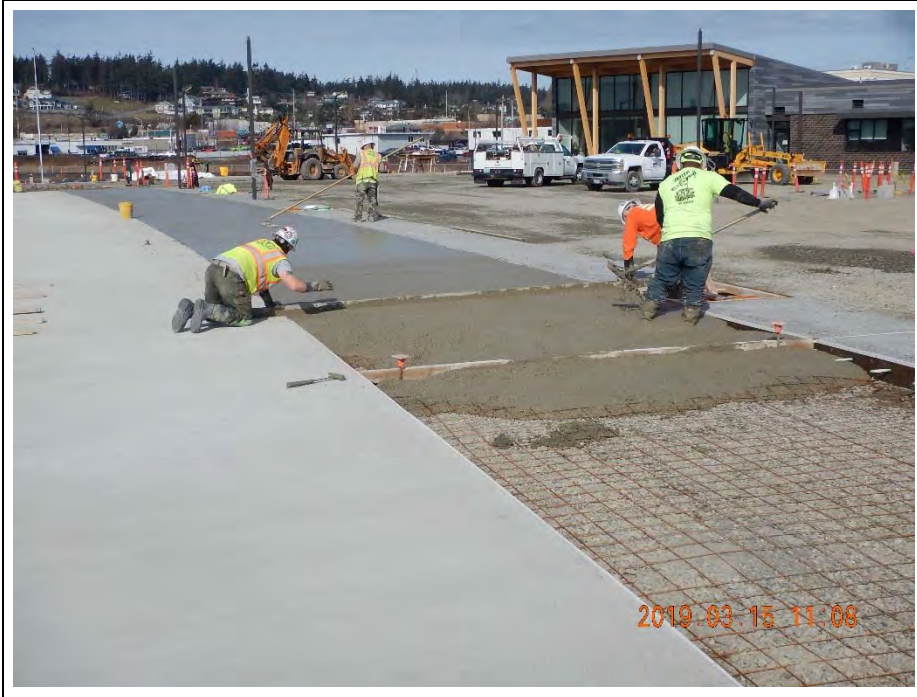
Photo #41

East end of Windjammer Park (looking northwest towards the administration building) on Friday, March 15th.

Carpenters, laborers, and finishers for Interwest Construction are placing concrete for vehicular concrete paving.

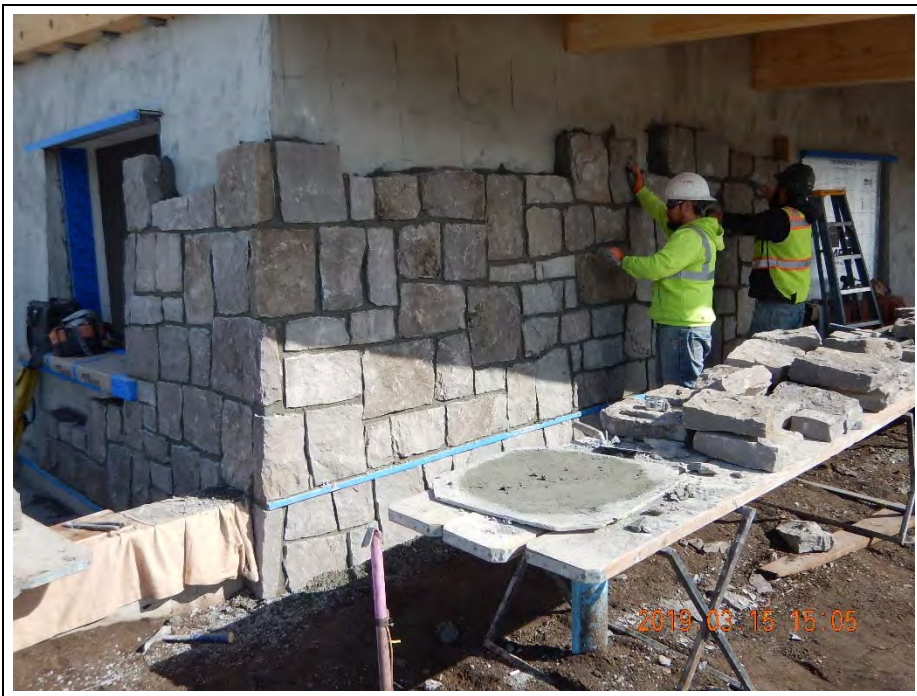
Photo #42

Southwest corner of Windjammer Park (looking southeast at the west kitchen) on Friday, March 15th.

Masons for Black Rock Masonry are building basalt stone veneer.

- Interwest Construction and Lakeside Industries built a new parking lot north of the clean water facility (see Photos #62, #63, and #64).
- Black Rock Masonry finished installing basalt stone veneer at the pavilion and west kitchen and began work at the east kitchen (see Photos #17, #22, #34, #42, and #52).

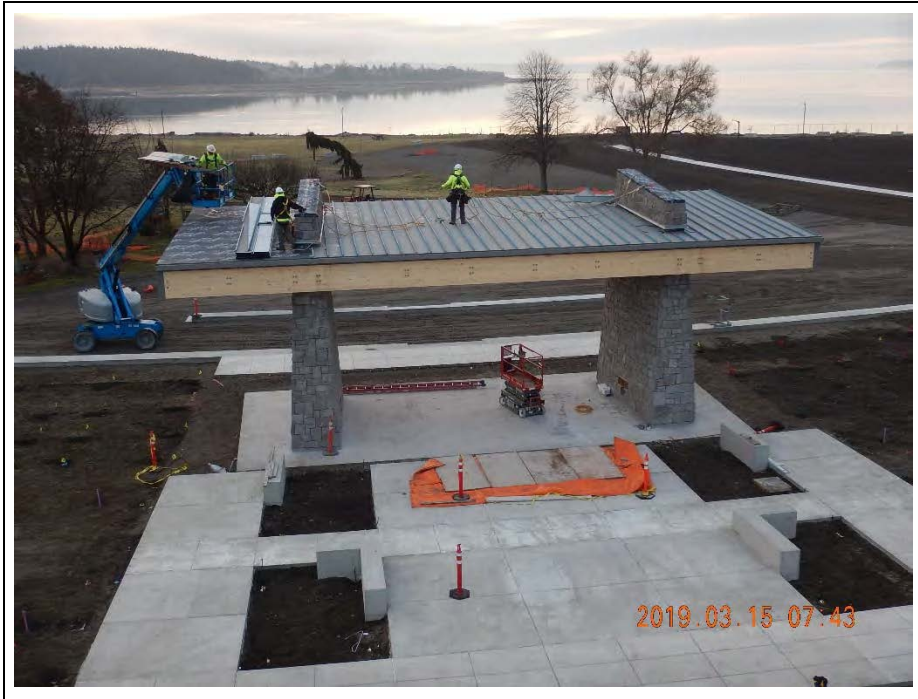
Photo #43

West end of Windjammer Park (looking southeast at the pavilion) on Friday, March 15th.

Sheet metal workers for Axiom are installing a standing seam metal roofing system atop the pavilion.

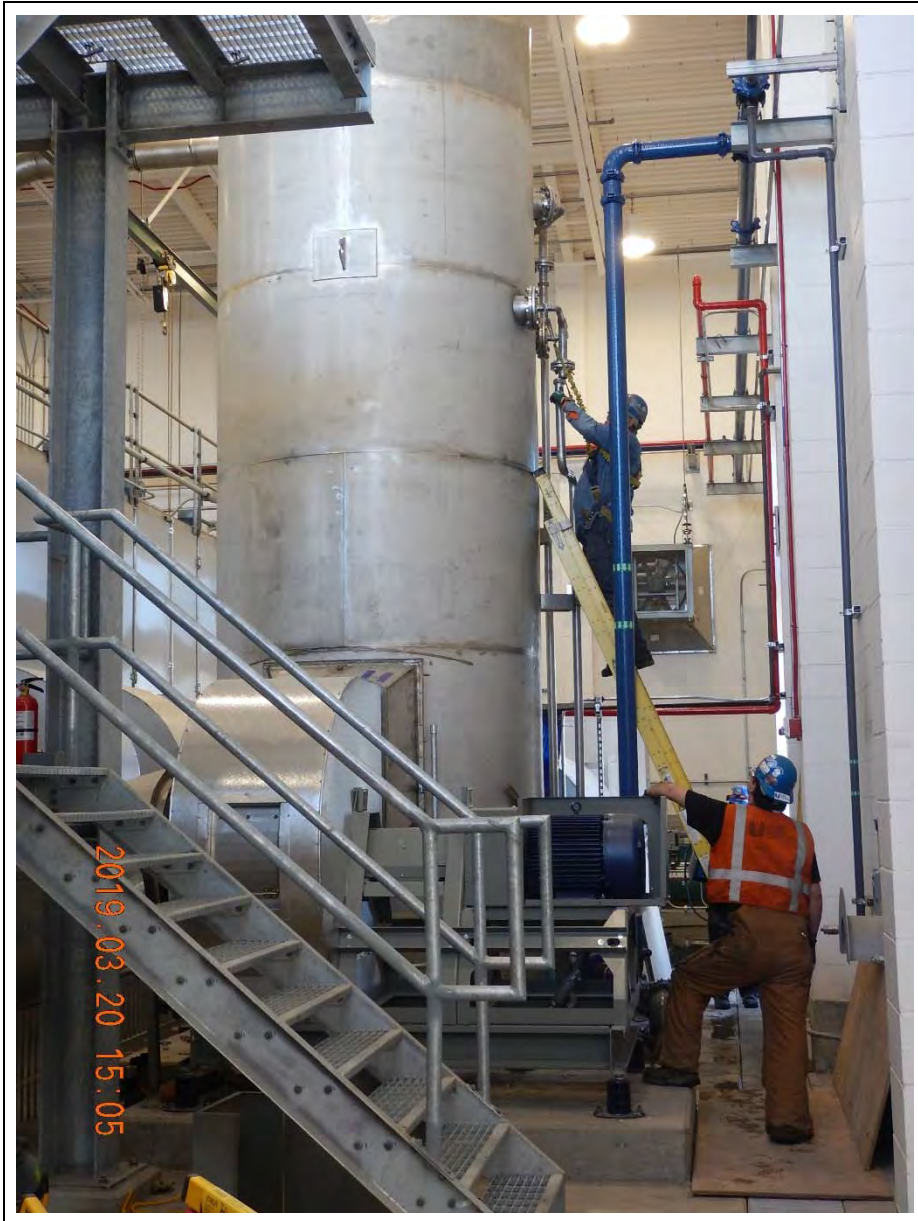
Photo #47

A welder for University
Mechanical (top) is
welding 2-inch stainless
steel piping that makes up
part of a manifold that
conveys utility water into a
condenser.

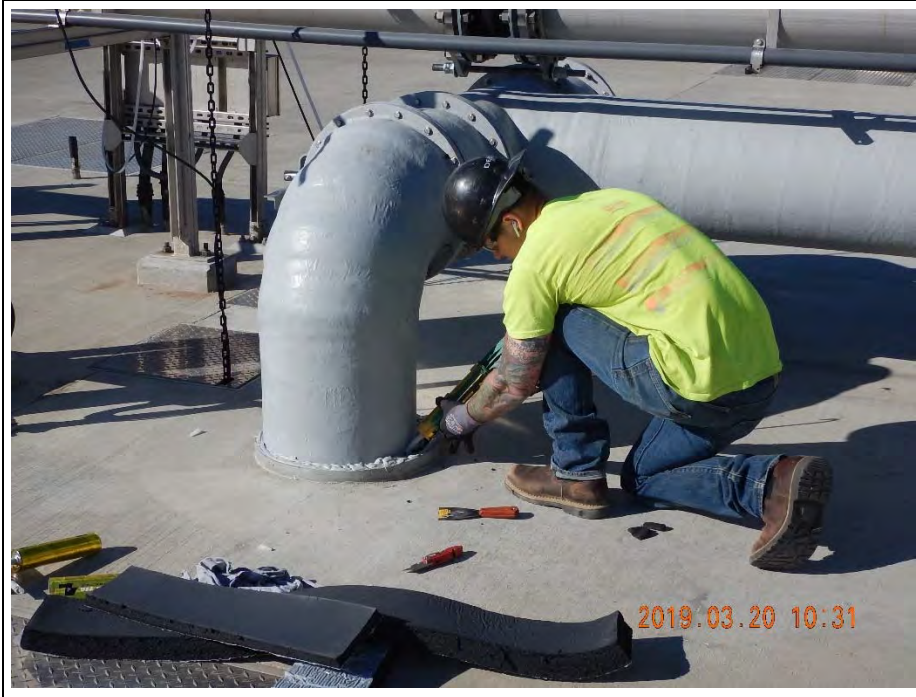
Photo #49

A sheet metal worker for
Delta Technology
Corporation is applying
sealant atop a link seal at
a foul air pipe penetration.

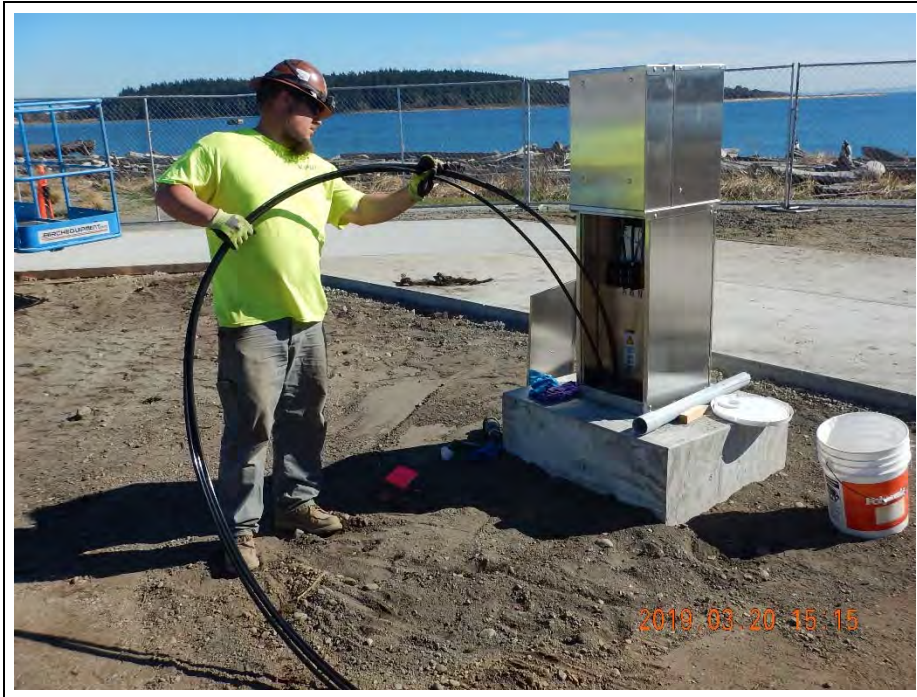
Photo #51

Southeast end of Windjammer Park (looking southeast) on Wednesday, March 20th.

An electrician for Valley Electric is installing conductors between a service pedestal/utility meter (seen in the photo) and a pedestal for a transformer provided by Puget Sound Energy.

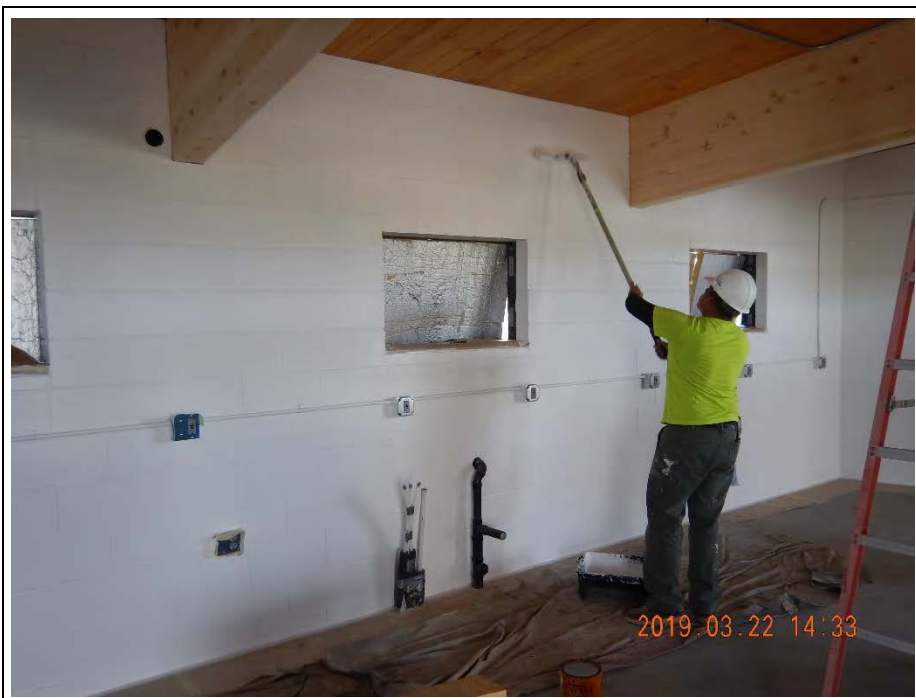
Photo #55

Southeast end of Windjammer Park (looking northwest inside the east kitchen) on Friday, March 22nd.

A painter for Brushworks Northwest is painting CMU block.

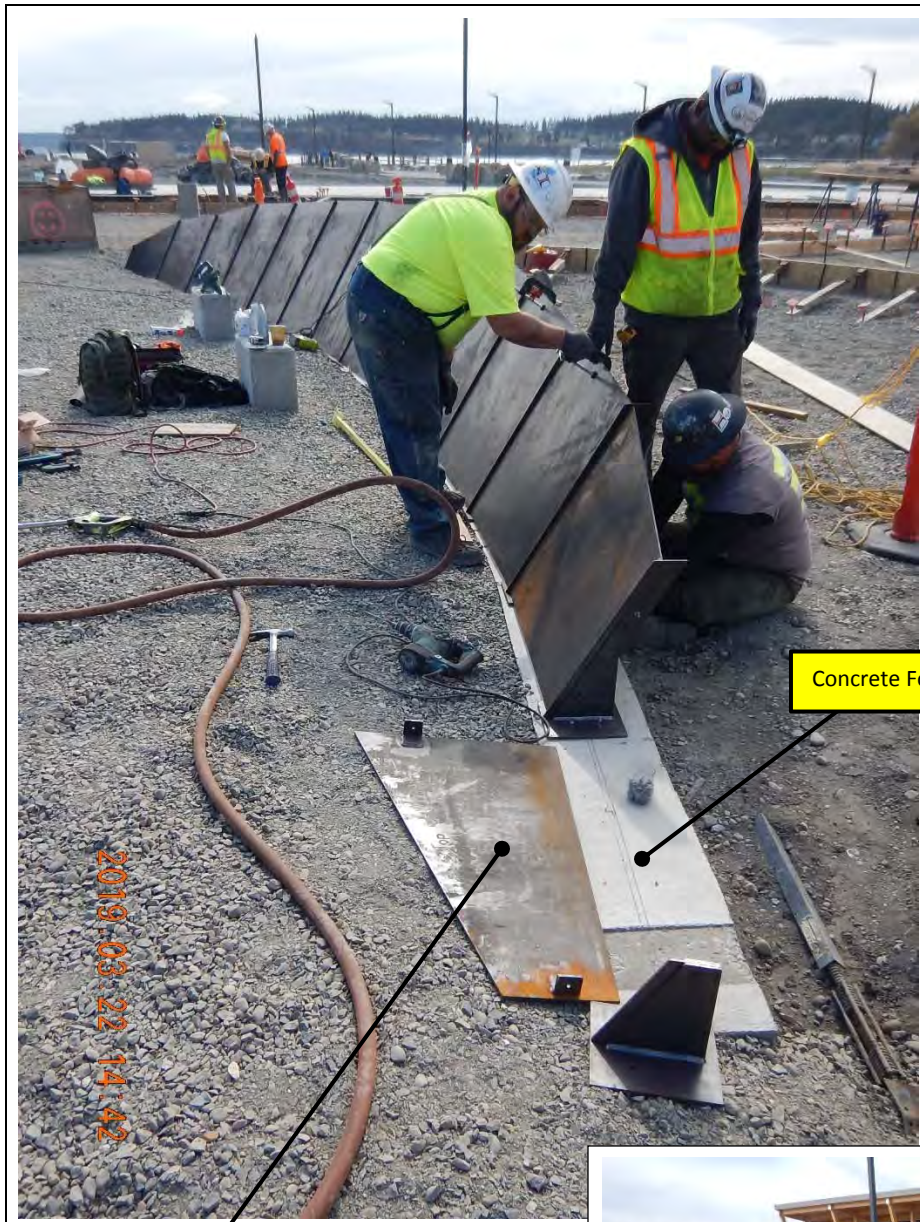
Concrete Footing

Weathering Steel Wall Panel

Area south of Area 01 Administration Building (looking south and north) on Friday, March 22nd.

Laborers for Interwest Construction are assembling a weathering steel retaining wall.

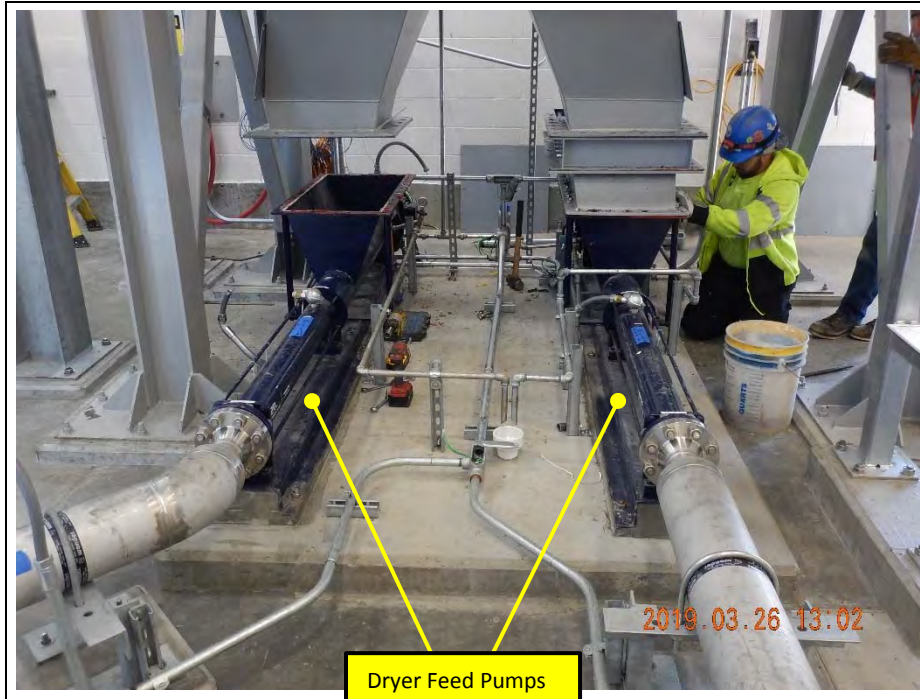
Photo #57

A pipefitter for University Mechanical, Alex Rocha, is removing slide gates and chutes above two dryer feed pumps. The chutes, which are located between a dryer feed hopper (not seen) and the dryer feed pumps, are believed to have caused dewatered sludge to “bridge” at the dryer feed pumps.

- Slide gates and chutes between dryer feed pumps and a dryer feed hopper were removed to keep dewatered sludge from “bridging” at the dryer feed pumps (see Photos #57, #58, and #68).
- A stainless steel plate was welded inside the condenser to keep cooling water from entering a duct between an off gas fan and the condenser.
- A gas pressure regulating valve (supplied by the project) that was located in series with a gas pressure regulating valve supplied by Cascade Natural Gas was removed to prevent gas pressure from oscillating.
