City of Oak Harbor
City Council Agenda Bill

Bill No. 5.i
Date: April 16, 2019
Subject: Clean Water Facility Update

City of Oak Harbor
**Clean Water
 Facility Project**

MONTHLY PROGRESS REPORT

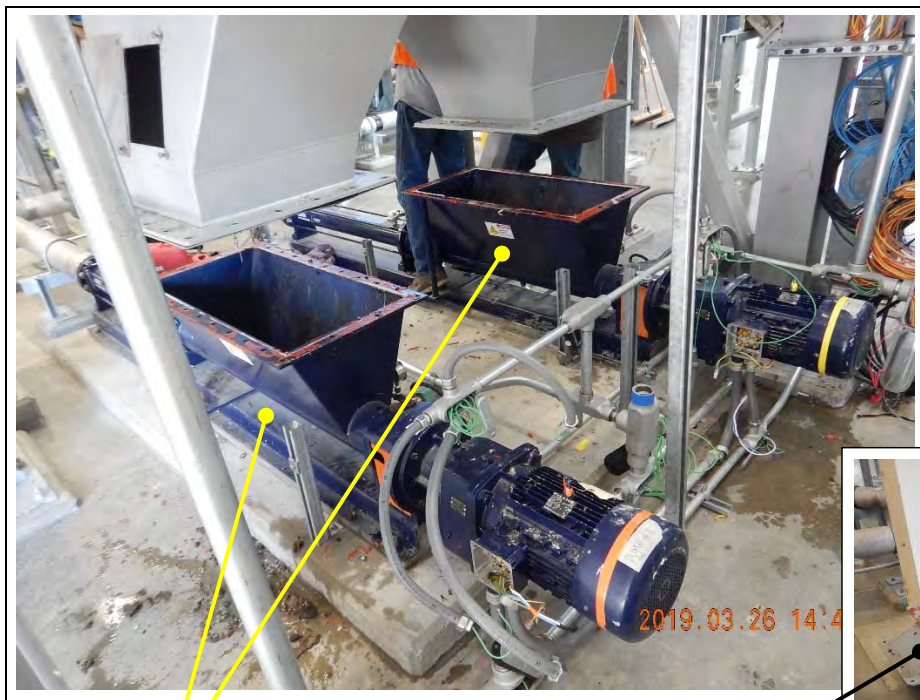
Photo #58

Slide Gates

- Slide gates and chutes between dryer feed pumps and a dryer feed hopper were removed to keep dewatered sludge from “bridging” at the dryer feed pumps (see Photos #57, #58, and #68).
- A stainless steel plate was welded inside the condenser to keep cooling water from entering a duct between an off gas fan and the condenser.
- A gas pressure regulating valve (supplied by the project) that was located in series with a gas pressure regulating valve supplied by Cascade Natural Gas was removed to prevent gas pressure from oscillating.

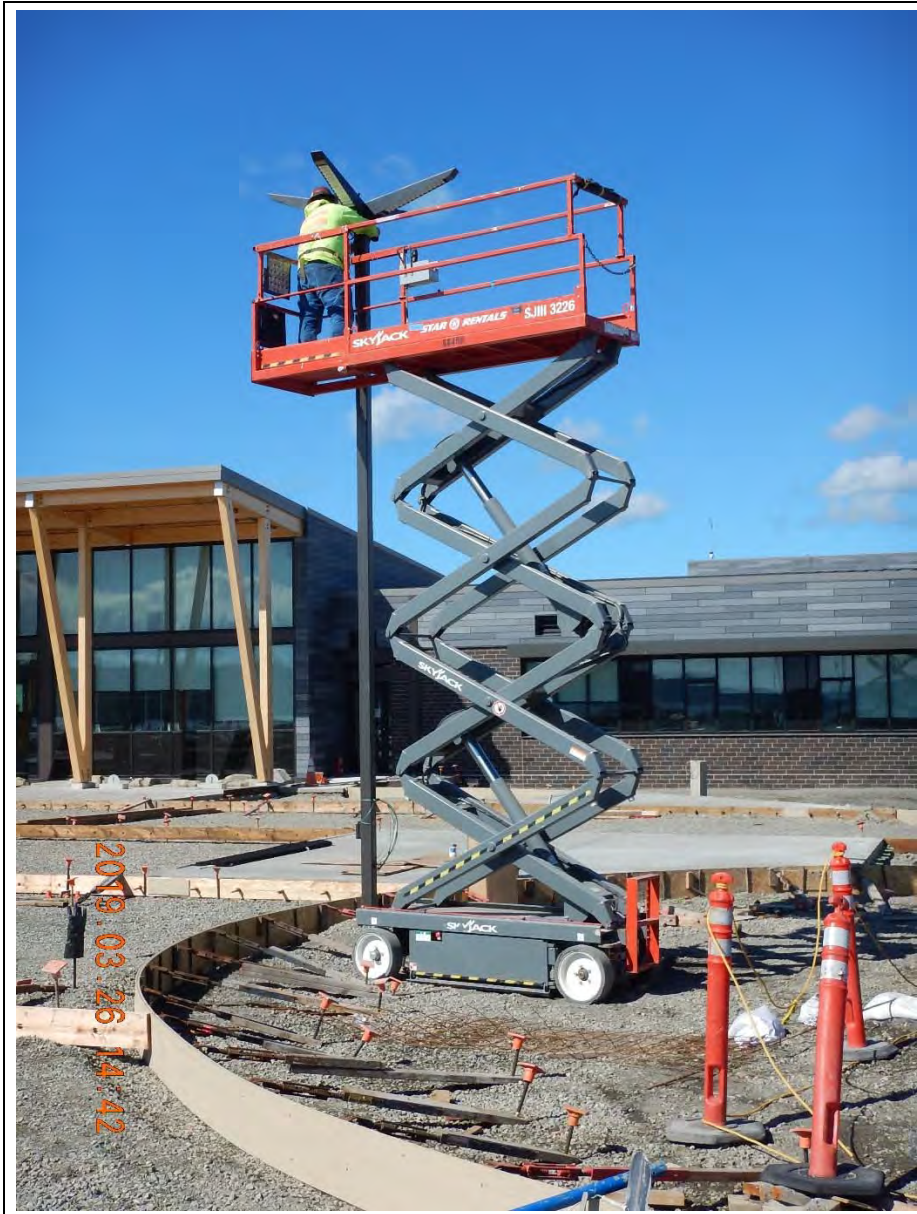
Photo #61

Area south of Area 01
Administration Building
(looking north) on
Tuesday, March 26th.

An electrician for Valley
Electric is installing an LED
light atop a fiberglass
pole.

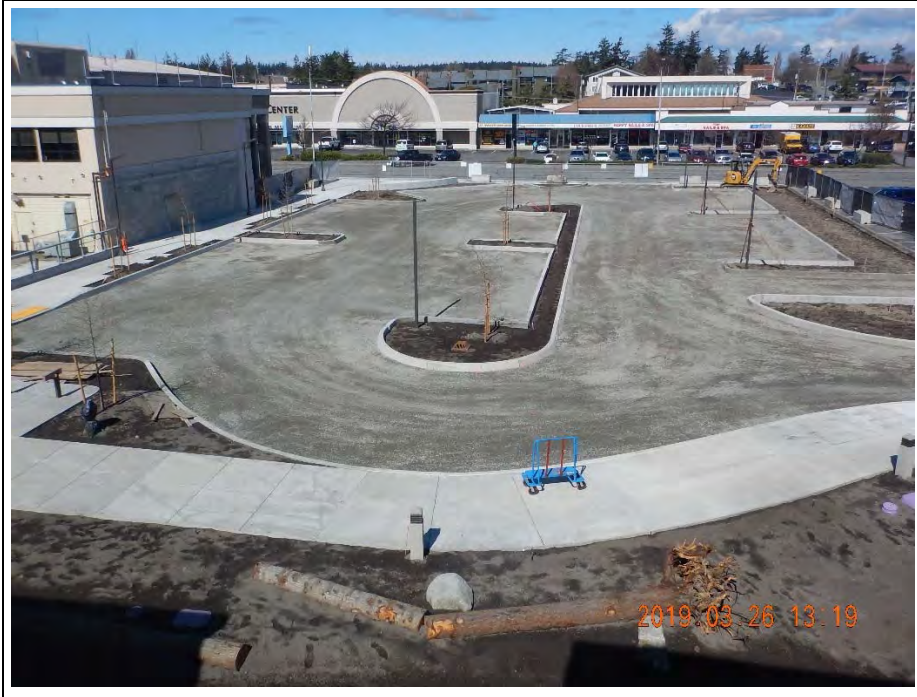
Photo #62

Area north of Area 30 Secondary Treatment Building (looking north) on Tuesday, March 26th.

This photo depicts the status of a new parking lot the day before paving begins.

- Interwest Construction and Lakeside Industries built a new parking lot north of the clean water facility (see Photos #62, #63, and #64).
- Black Rock Masonry finished installing basalt stone veneer at the pavilion and west kitchen and began work at the east kitchen (see Photos #17, #22, #34, #42, and #52).

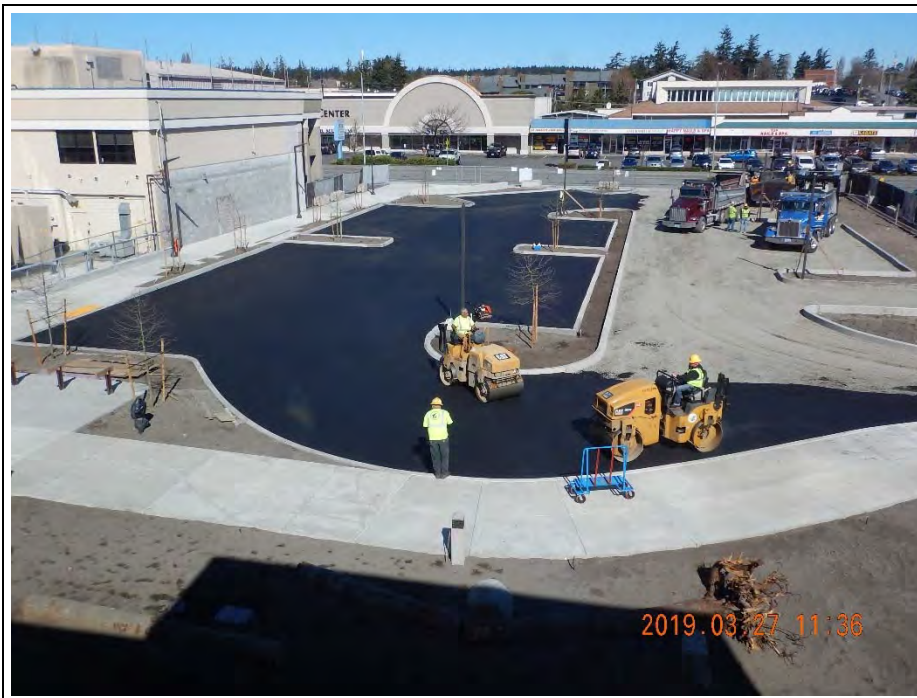
Photo #63

Area north of Area 30 Secondary Treatment Building (looking north) on Wednesday, March 27th.

Lakeside Industries is placing asphalt paving for a new parking lot where the old Whidbey Island Bank Building was located.

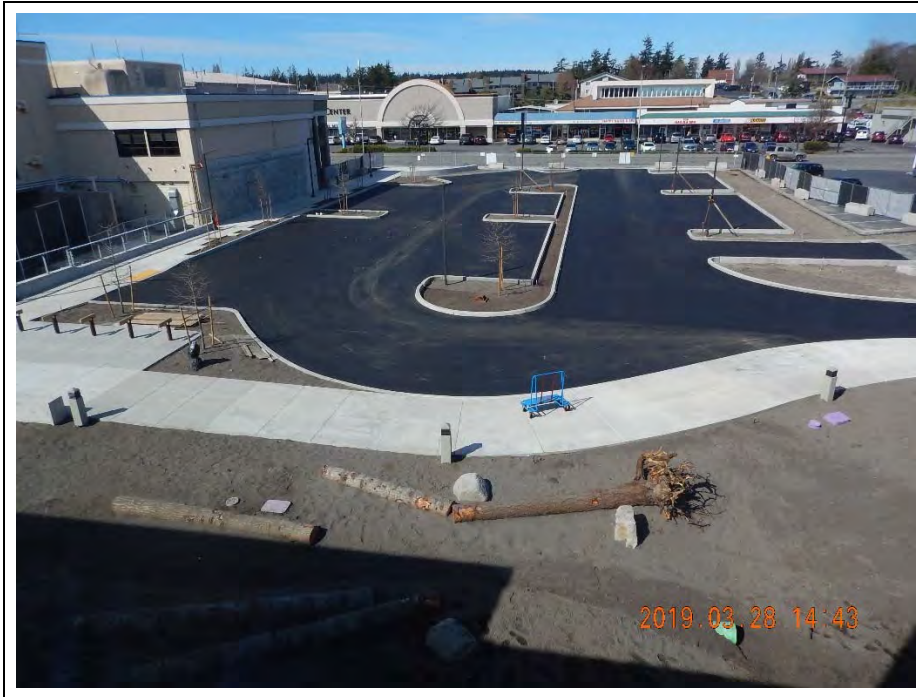
Photo #64

Area north of Area 30 Secondary Treatment Building (looking north) on Thursday, March 28th.

This photo depicts the status of a new parking lot where the old Whidbey Island Bank Building was located.

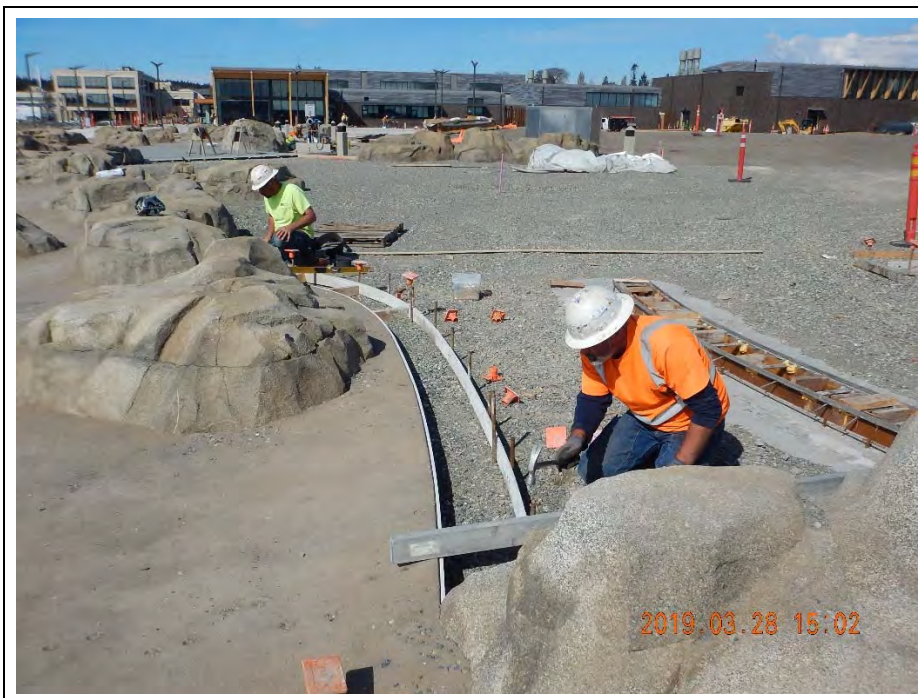
Photo #65

South end of Windjammer Park (looking north along the east side of the splash park) on Thursday, March 28th.

Two carpenters for Interwest Construction are building forms for an accent band.

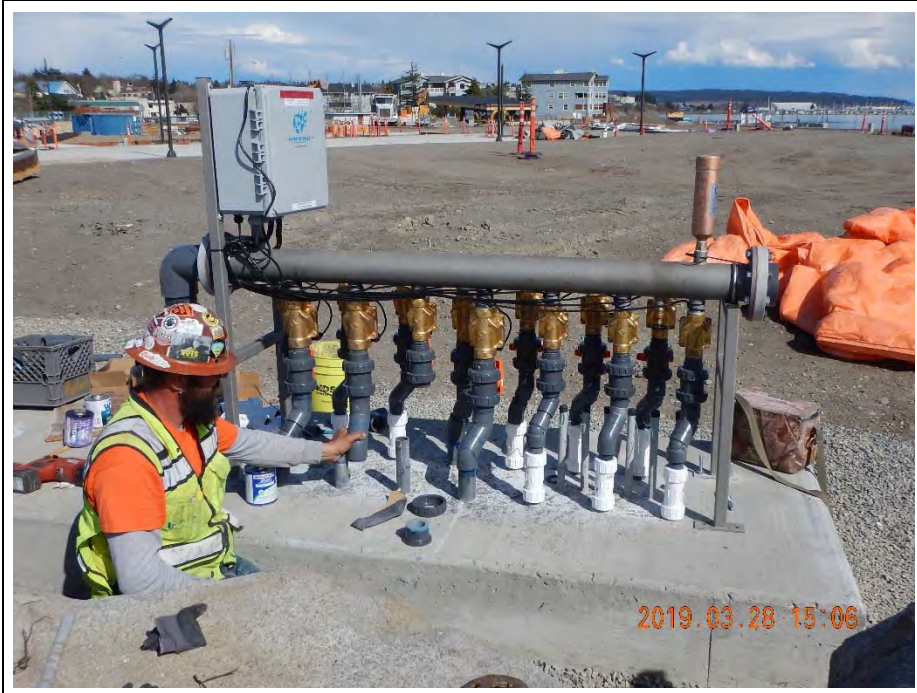
Photo #66

South end of Windjammer Park (looking east from the east side of the splash park) on Thursday, March 28th.

A pipe layer for Interwest Construction, John Pino, is assembling PVC pipe that makes up part of a distribution manifold that serves the splash park and the shipwreck water feature.

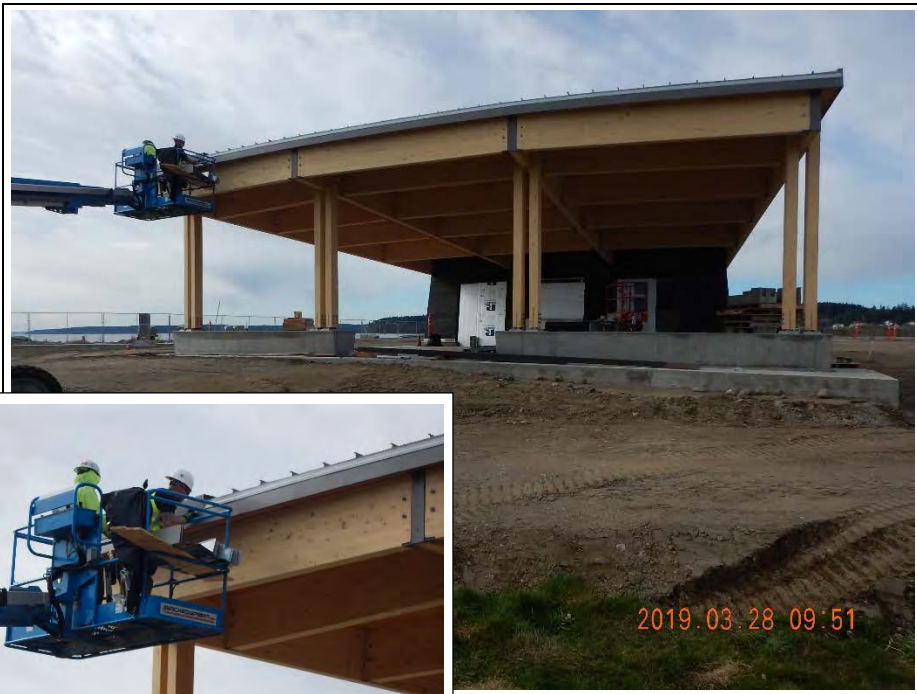
Photo #67

Southeast end of Windjammer Park (looking southwest at the east kitchen) on Thursday, March 28th.

Sheet metal workers for Axiom are installing flashing that makes up part of a standing seam metal roofing system.

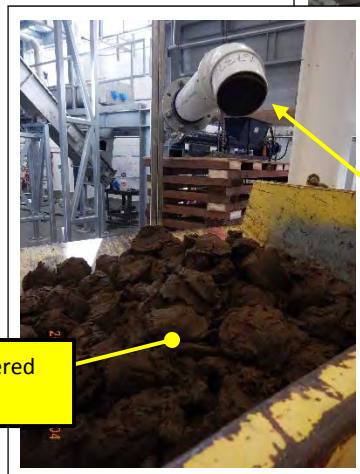
Left: Pipefitters for University Mechanical are modifying temporary discharge piping from an elevated dryer feed pump so the pump can convey dewatered sludge to the dryer.

Bottom: This photo depicts the dryer feed pump after it was elevated atop wood timbers (so it could be bolted directly to the dryer feed hopper) and its discharge piping was temporarily routed to a dumpster.

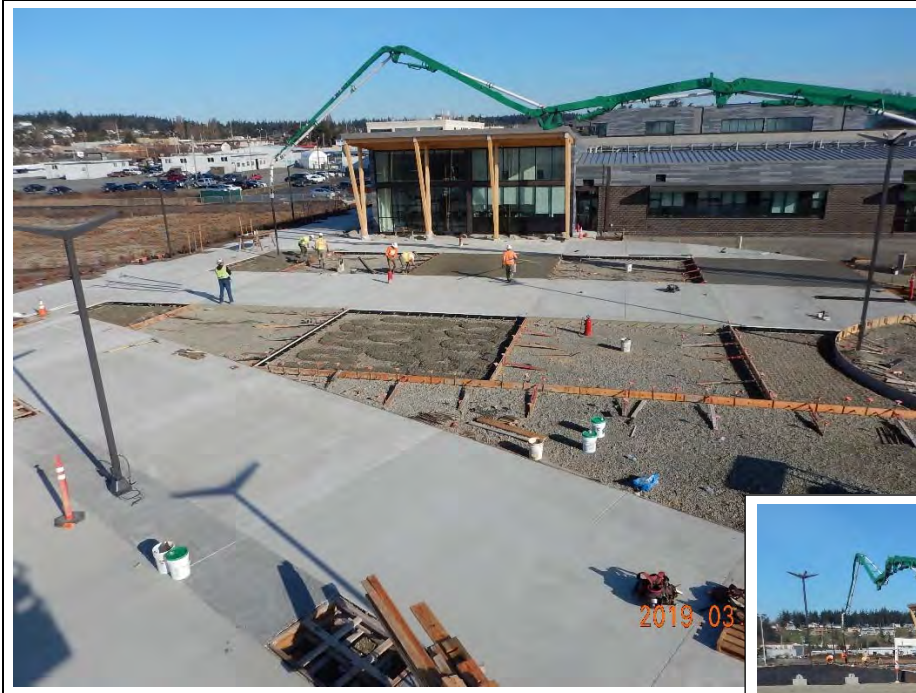
Photo #69

Area south of Area 01 Administration Building (looking north) on Friday, March 29th.

Interwest Construction is utilizing a truck-mounted concrete pump with a hydraulic actuated boom to place vehicular concrete paving.

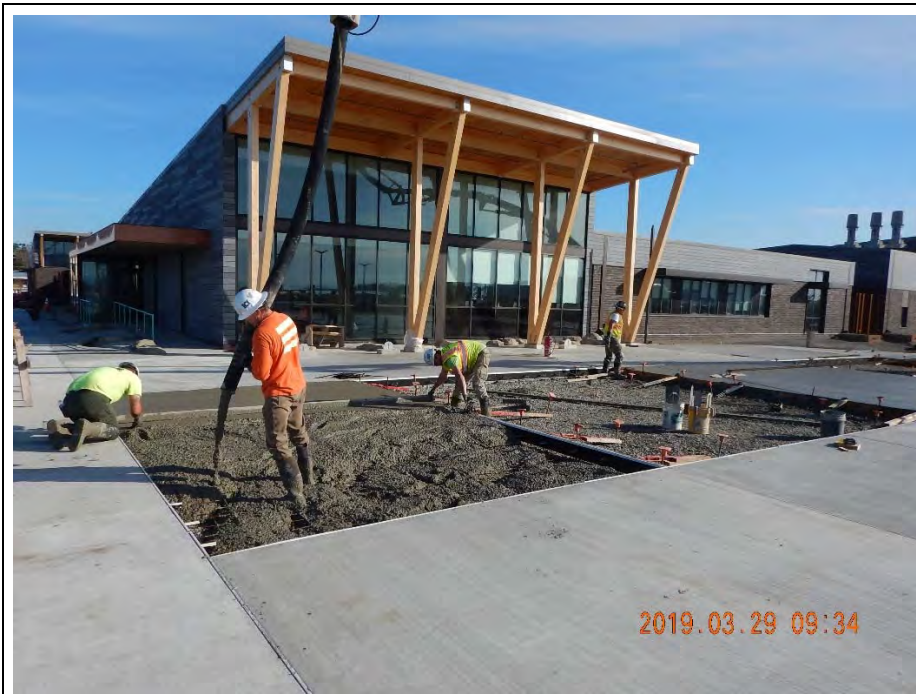
Photo #70

Area south of Area 01 Administration Building (looking northeast) on Friday, March 29th.

Interwest Construction is utilizing a truck-mounted concrete pump with a hydraulic actuated boom to place vehicular concrete paving.

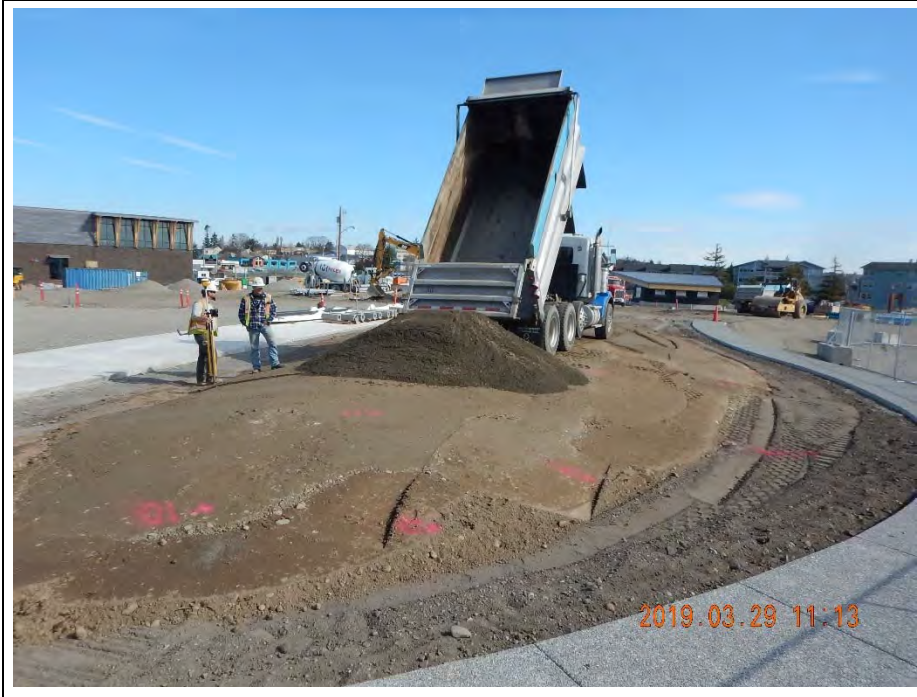
Photo #71

South end of Windjammer Park (looking east) on Friday, March 29th.

Interwest Construction is placing imported earthen material for a berm.
