City of Oak Harbor
City Council Agenda Bill

Bill No. 5. c. i.
Date: August 8, 2018
Subject: Clean Water Facility Update

Clean Water Facility Project

MONTHLY PROGRESS REPORT

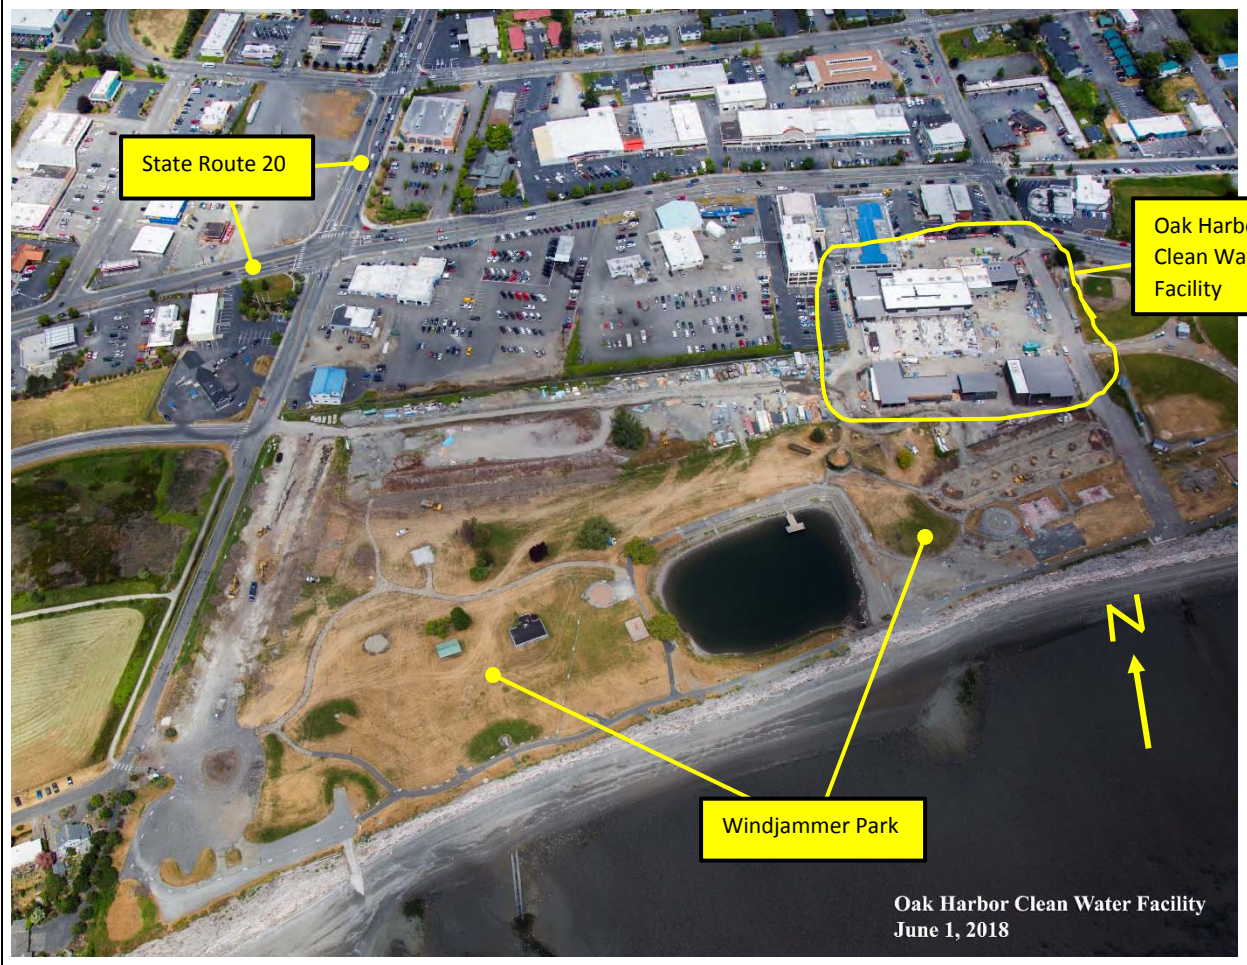
Photo #1

Aerial photo of Windjammer Park and the Clean Water Facility job site (looking north) on June 1, 2018, two weeks after demolition work at Windjammer Park began.

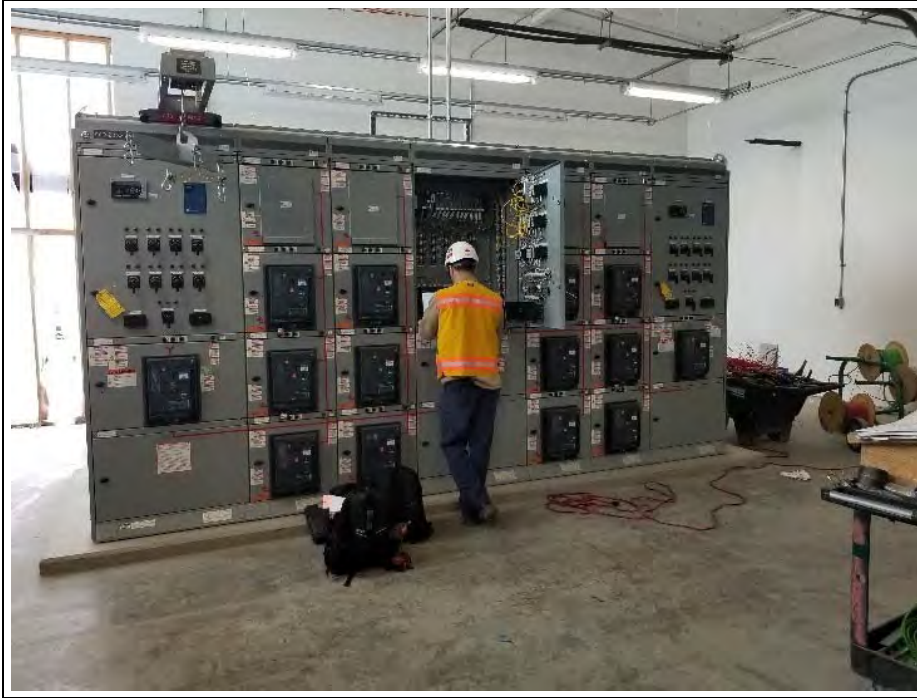
Photo #5

Area 70 Electrical Building (looking west) on Monday, June 4th.

An engineer for General Electric is programming switchgear so the switchgear can communicate with the Clean Water Facility SCADA system.

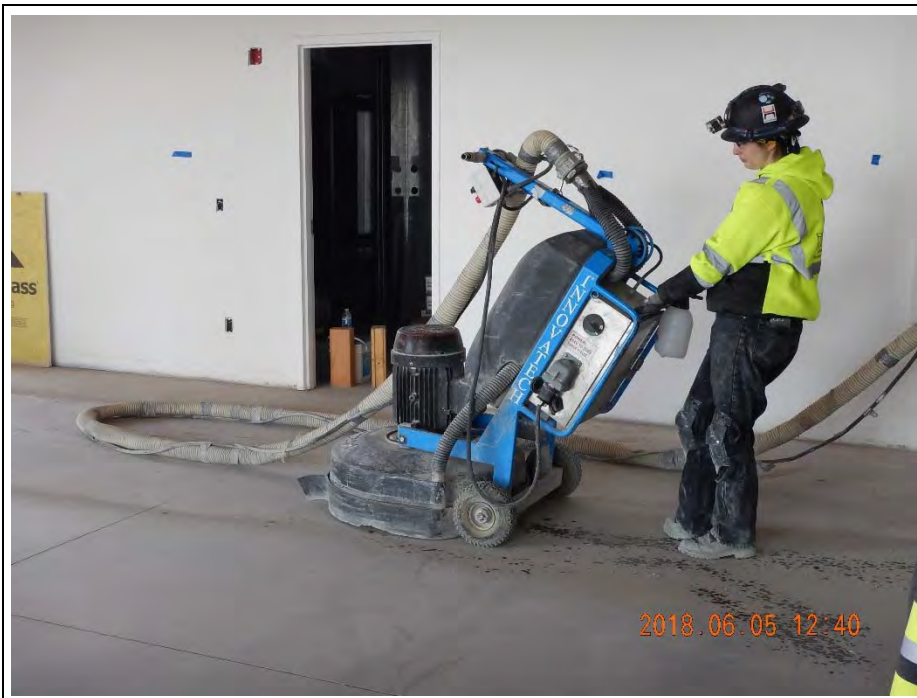
Photo #6

Area 01 Administration Building (looking northwest) on Tuesday, June 5th.

A cement mason for Flooring Solutions is grinding a concrete floor in the interpretive center.

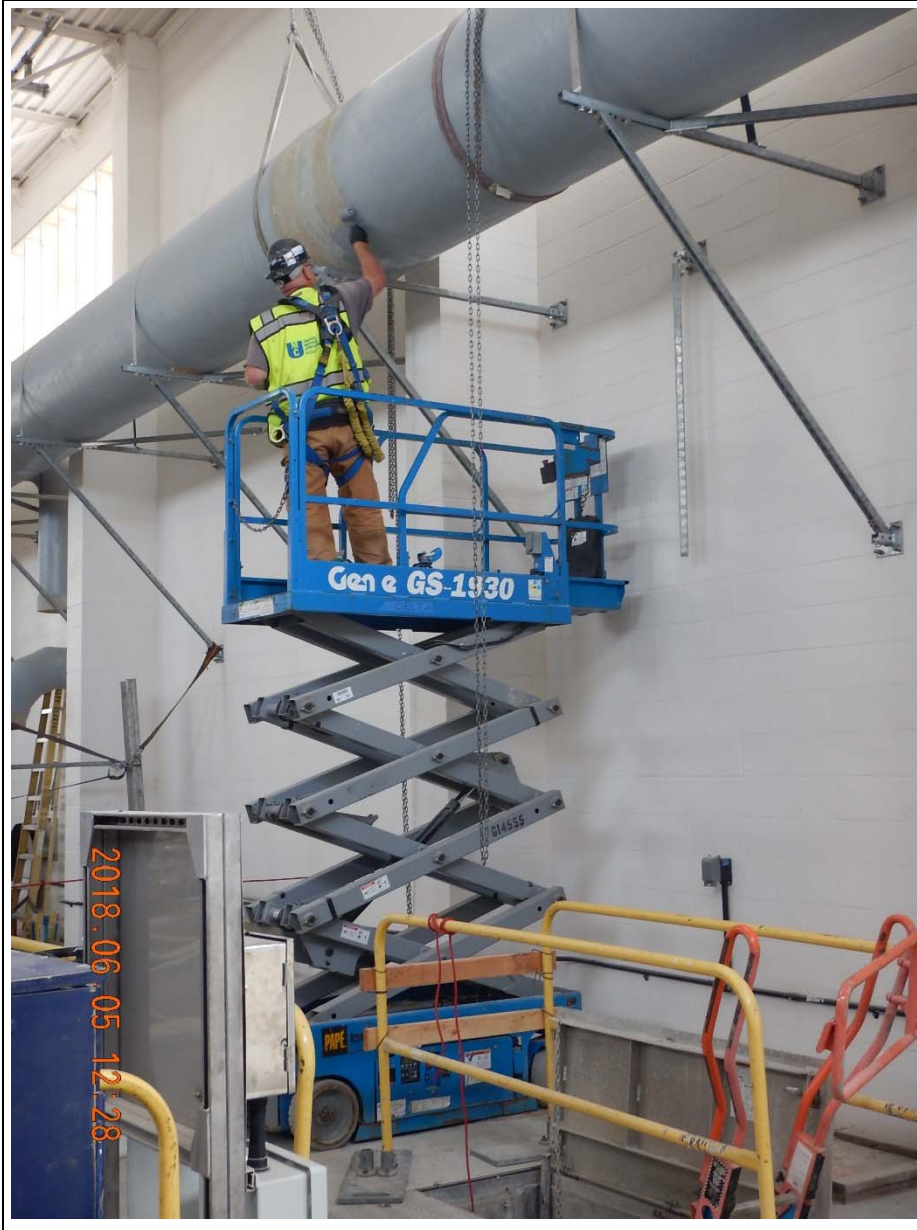
Photo #7

Secondary Treatment Building (looking southeast) on Tuesday, June 5th.

A sheet metal worker for Delta Corporation is painting over a splice between two sections of 36-inch fiber reinforced plastic (FRP) foul air piping.

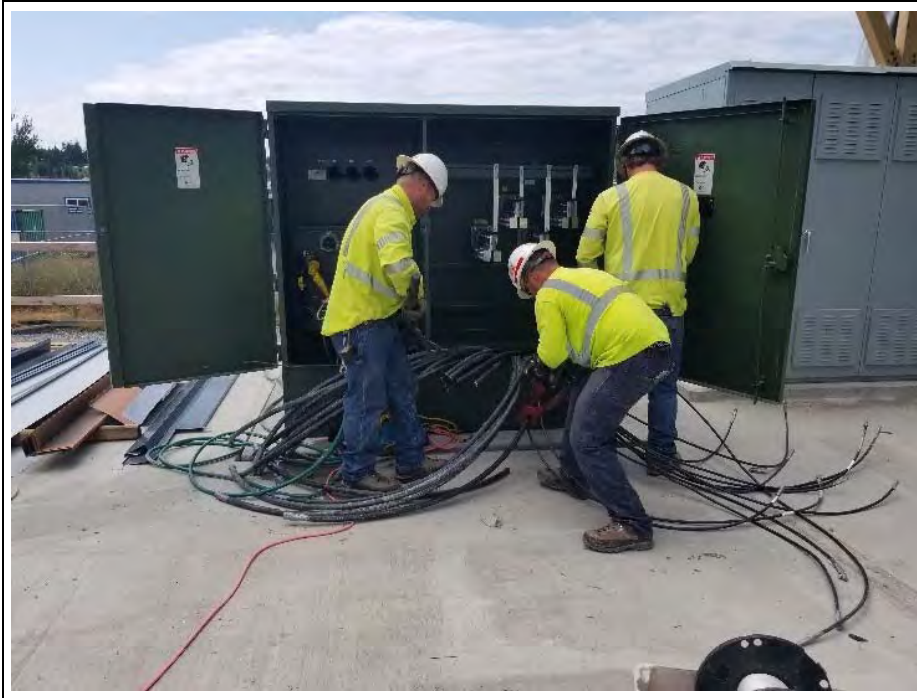
Photo #8

Area 70 Generator Yard (looking west) on Tuesday, June 5th.

Linemen for Puget Sound Energy are preparing to terminate conductors at a transformer.

Start-up Activities. On June 5th, linemen for Puget Sound Energy (PSE) terminated conductors and energized PSE's transformer at the generator yard (see Photo #8). On June 11th, Valley Electric energized switchgear in the electrical building (see Photo #11). On June 20th and 21st, a representative from APSCO operated two plant drain pumps and conducted operator training (see Photo #16). On June 28th, representatives from Golden Harvest (slide gates) and Rotork (motor-driven actuators) operated ten slide gates by means of motor-driven actuators at the membrane tanks and aeration basins (see Photo #31). Carollo Engineers prepared a startup plan and submitted it to Department of Ecology. Hoffman continued to conduct weekly start-up coordination meetings with its subcontractors and Carollo Engineers.

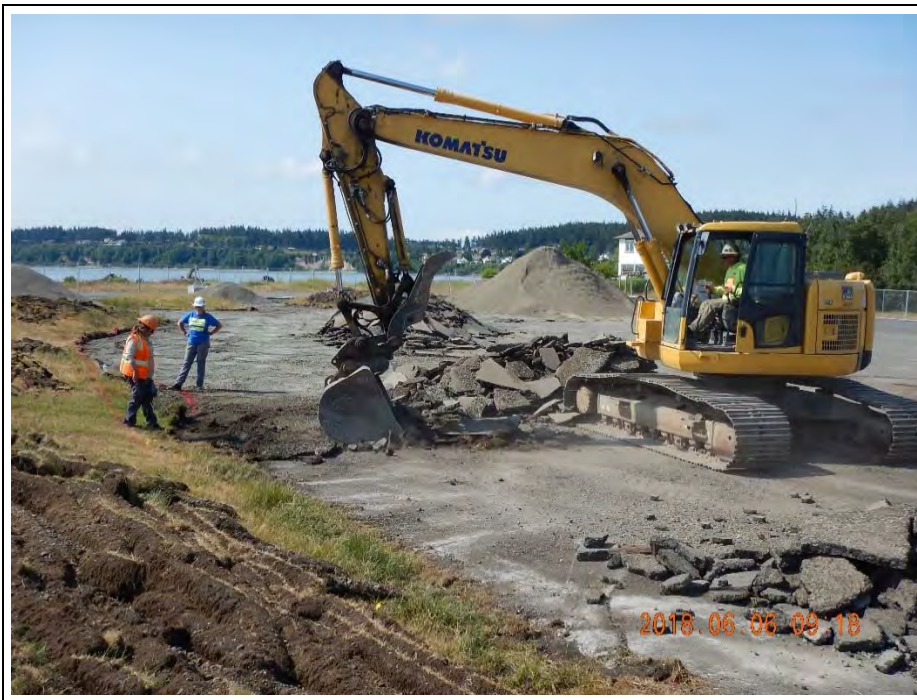
Photo #9

Windjammer Park (looking south) on Wednesday, June 6th.

Interwest Construction is utilizing an excavator to demolish existing pavement that made up a parking lot at the southwest corner of Windjammer Park. An archaeologist for ERCI (left, in orange vest) is observing the work.

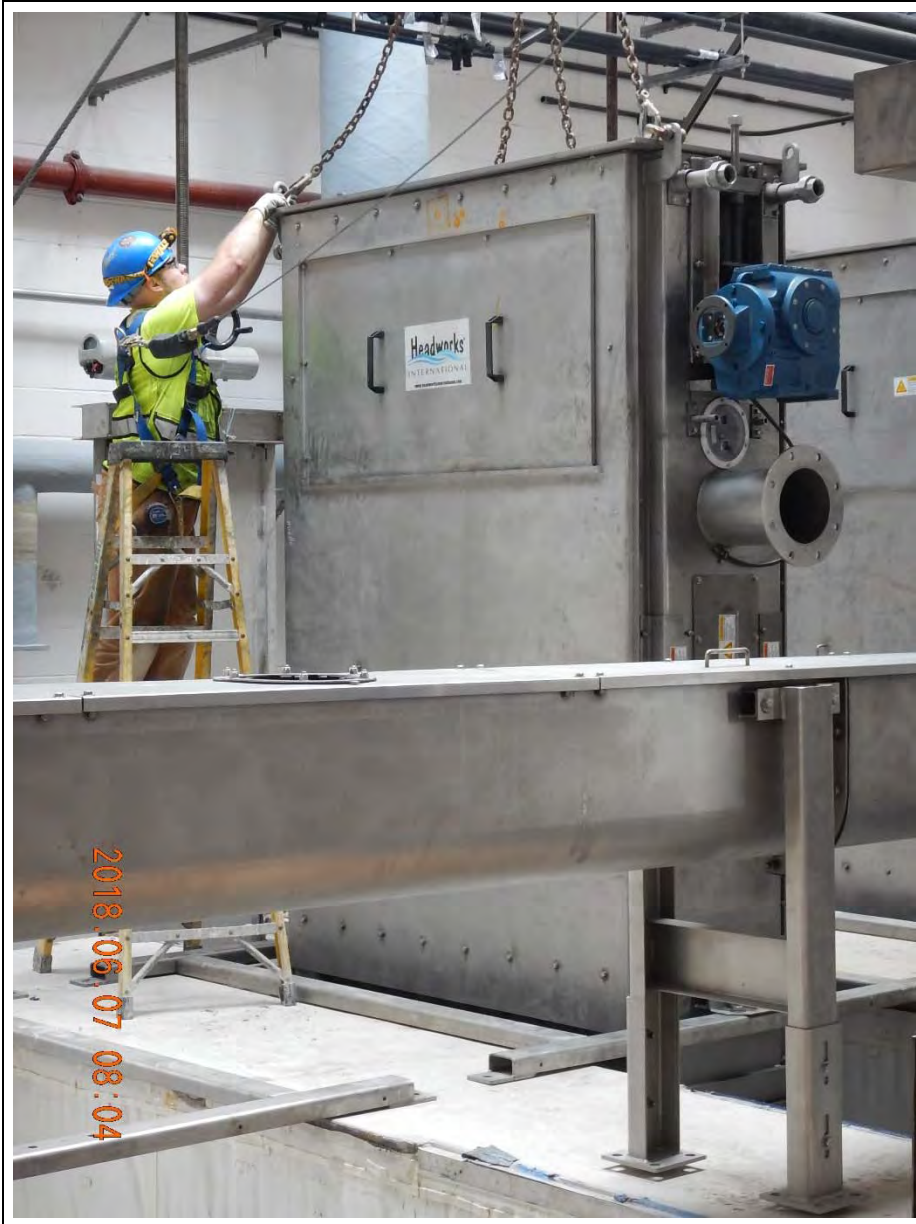
Photo #10

Area 20 Headworks (looking northeast) on Thursday, June 7th.

A pipefitter for University Mechanical is removing rigging from a fine screen that was just lowered into place (through a skylight) by an all-terrain crane into a fine screen channel.

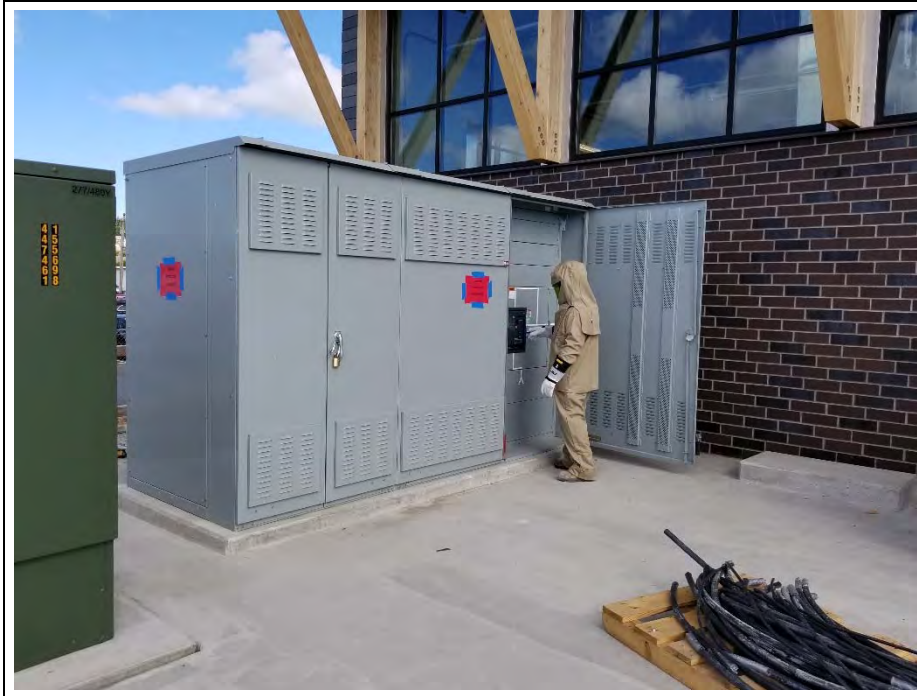
Photo #11

Area 70 Generator Yard (looking northwest) on Monday, June 11th.

An electrician for Valley Electric is wearing an arc flash protection suit when operating the main circuit breaker serving the new Clean Water Facility.

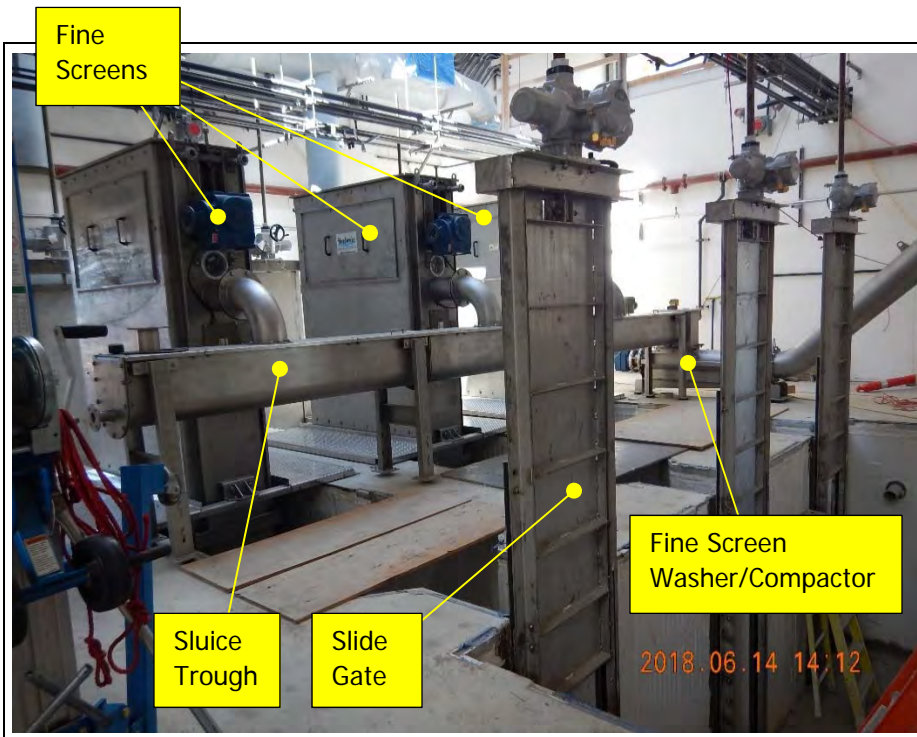
Photo #12

Area 20 Headworks (looking northeast) on Thursday, June 14th.

This photo depicts the fine screens, slide gates, and other components installed at the fine screen channels.

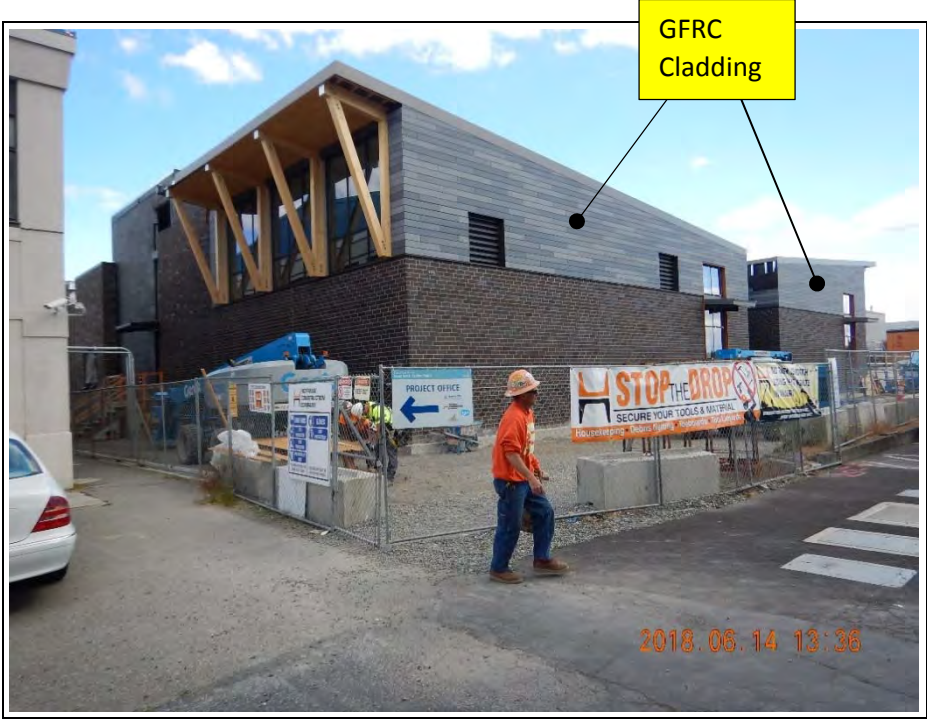
Photo #13

Area 32 Aeration Blower Building and Area 70 Electrical Building (looking southeast) on Thursday, June 14th.

This photo depicts glass fiber reinforced concrete (GFRC) cladding that was recently installed.

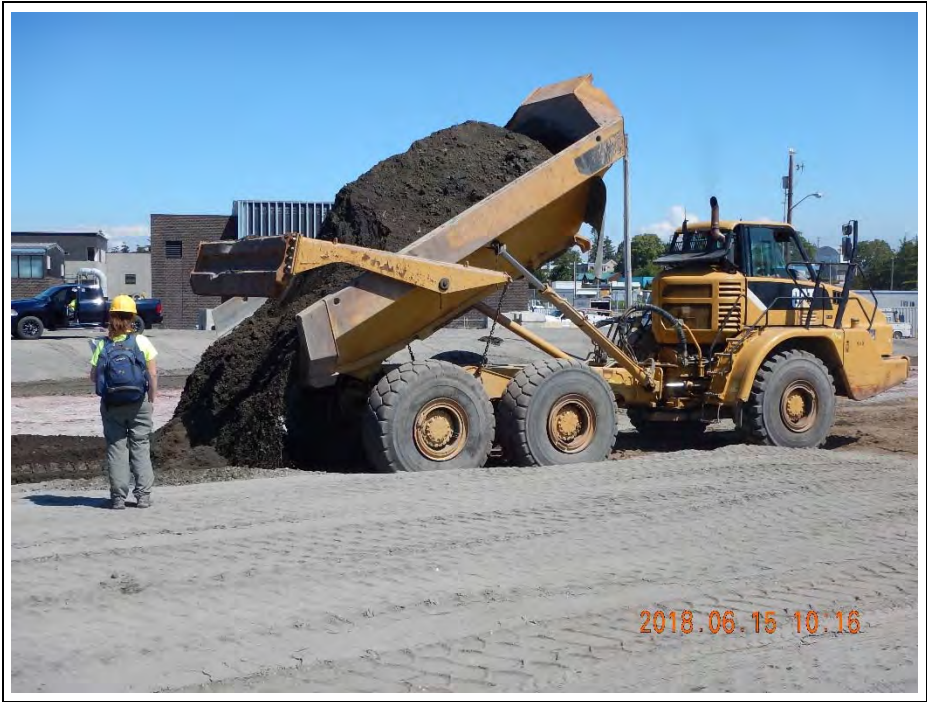
Photo #14

Windjammer Park south of the new clean water facility maintenance building (looking north) on Thursday, June 14th.

Interwest Construction is utilizing articulated dump trucks to haul on-site material from a stockpile. These trucks weigh approximately 50K lbs unloaded and over 110K lbs loaded. An archaeologist for ERCI (left) is observing the work.

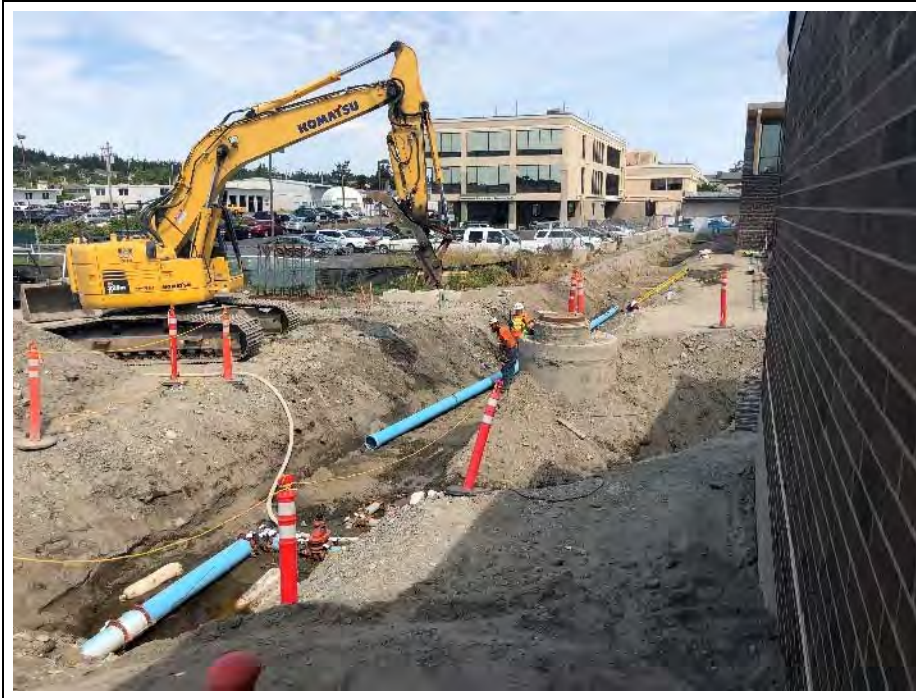
Photo #15

Area 01 Administration Building (looking north) on Wednesday, June 20th.

Interwest Construction is installing an 8-inch PVC water pipeline near the west sides of the administration, electrical, and aeration blower buildings.

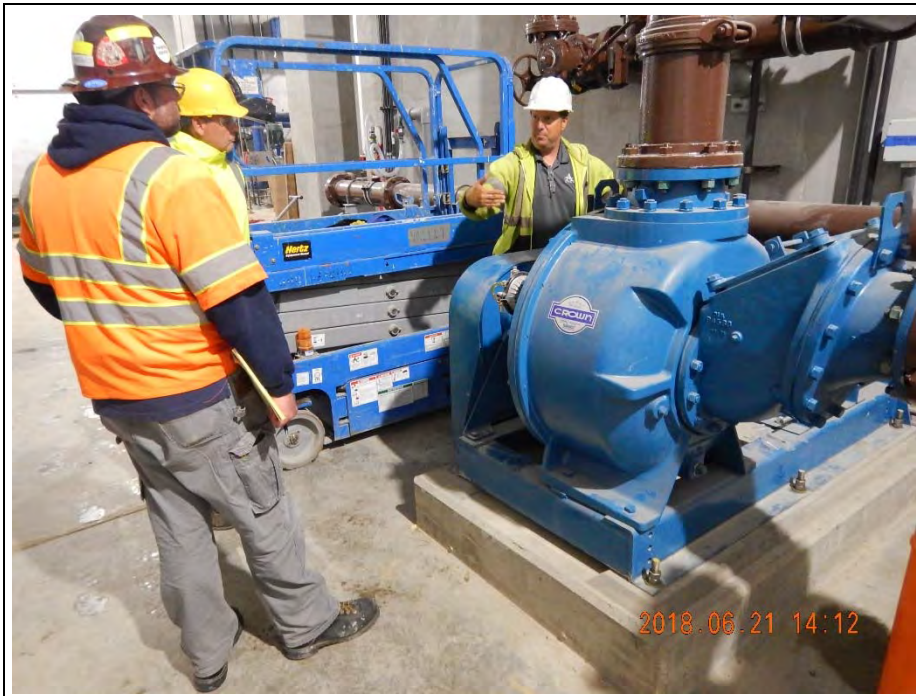
Photo #16

Area 39 Drain Pump Station (looking northeast) on Thursday, June 21st.

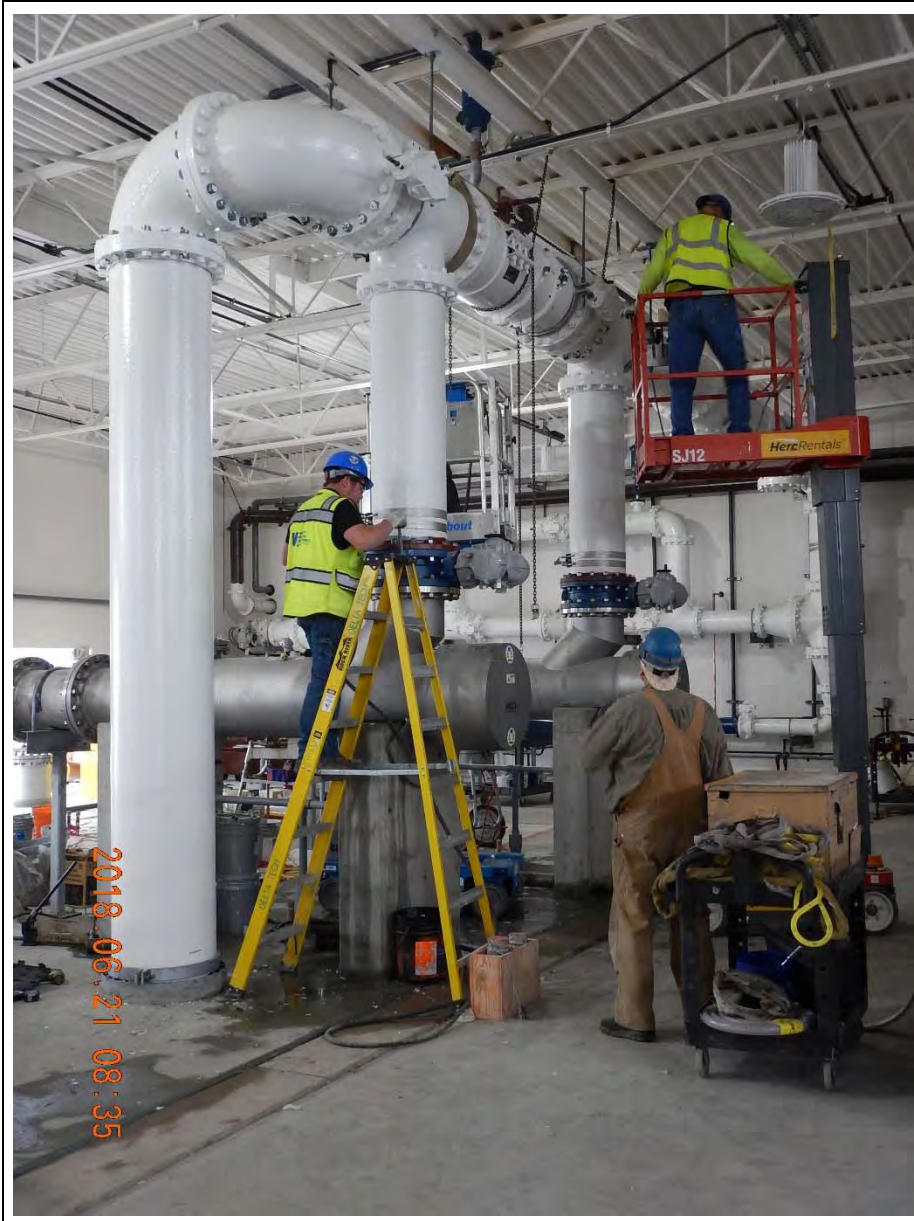
Photo #17

Area 30 Secondary Treatment Building (looking northeast) on Thursday, June 21st.

Pipefitters for University Mechanical are tightening bolts at flanged connections. This work is occurring after an initial hydrotest of plant effluent piping on the discharge side of ultraviolet reactors.

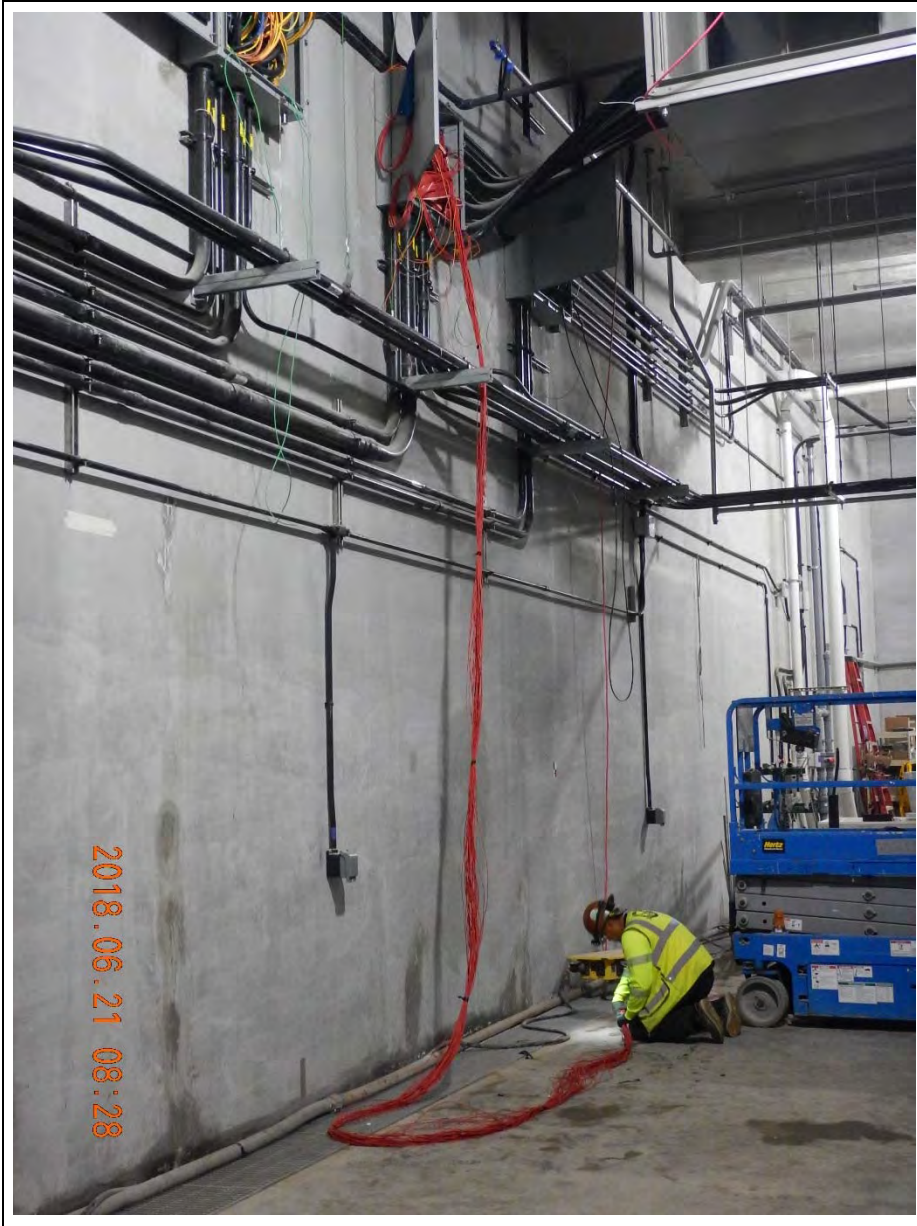
Photo #18

Area 39 Drain Pump Station (looking north) on Thursday, June 21st.

An electrician for Valley Electric is sorting conductors from a junction box.

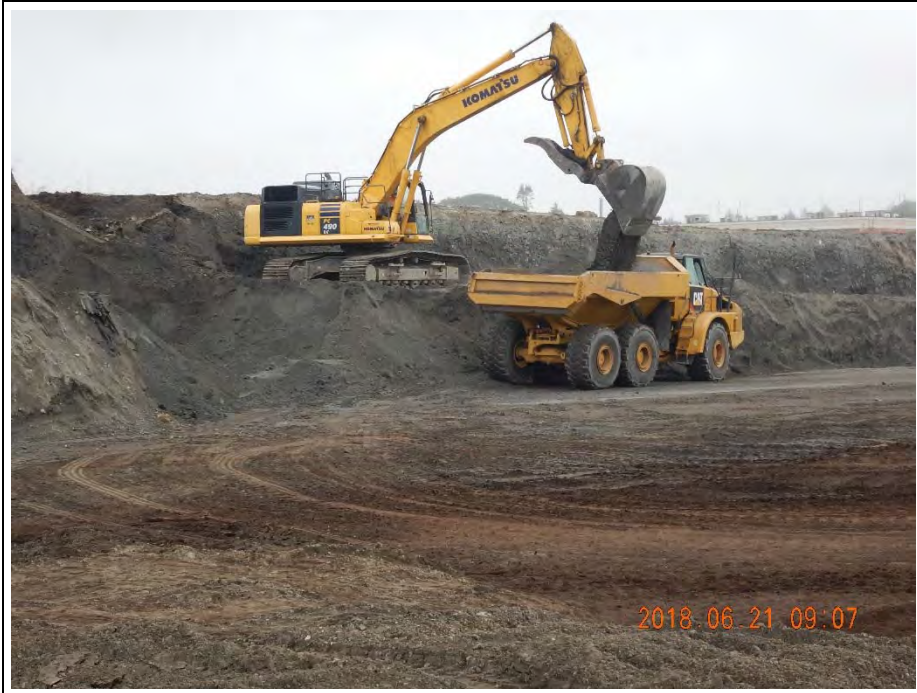
Photo #19

North end of Windjammer Park (looking northeast) on Thursday, June 21st.

- Interwest Construction filled and graded on-site earthen material at Windjammer Park (see Photos #1, #9, #14, #19, #20, and #36).
- Puget Sound Energy energized its transformer at the generator yard (see Photo #8) and Valley Electric energized switchgear in the electrical building (see Photo #11).
- Start-up activities began in earnest. Equipment suppliers operated plant drain pumps (see Photo #16) and motor-driven slide gate actuators (see Photo #31).
- University Mechanical installed a grit basin mixer, fine screens, and a sluice trough and fine screen washer/compactor in the headworks building (see Photos #10 and #12) and dryer parts in the biosolids building (see Photo #21 and #34).
- Axiom began installing GFRC cladding on the exteriors of buildings (see Photos #13 and #25).
- Delta Corporation installed sound enclosures for fans at the odor control structure (see Photo #32).

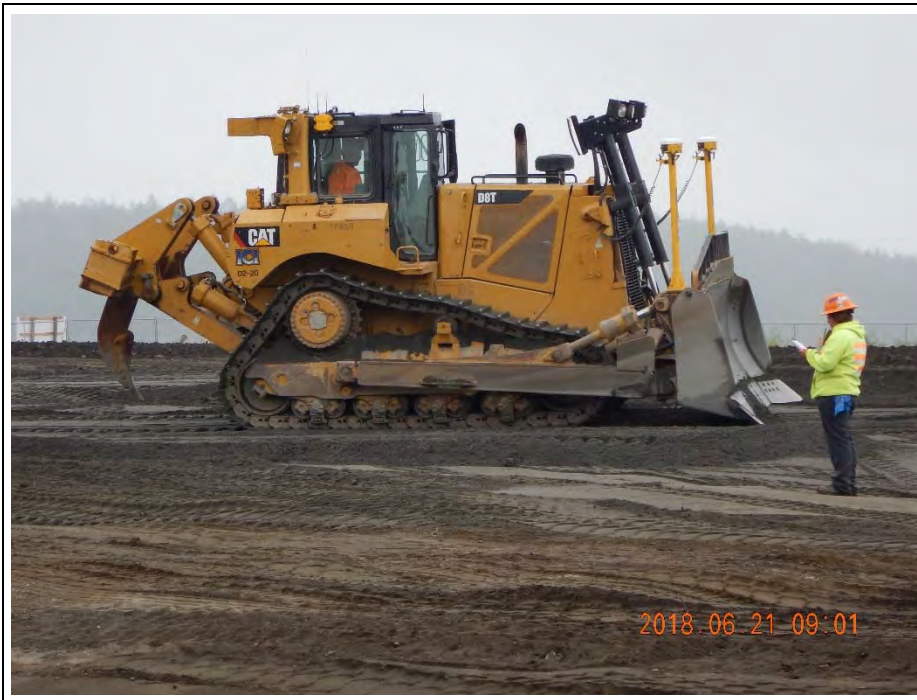
Photo #20

West end of Windjammer Park (looking south) on Thursday, June 21st.

The Caterpillar D8 dozer that Interwest Construction uses to spread earthen material is almost 12 feet tall and weighs approximately 87,000 lbs (equivalent to 17 Ford F150 pickup trucks).

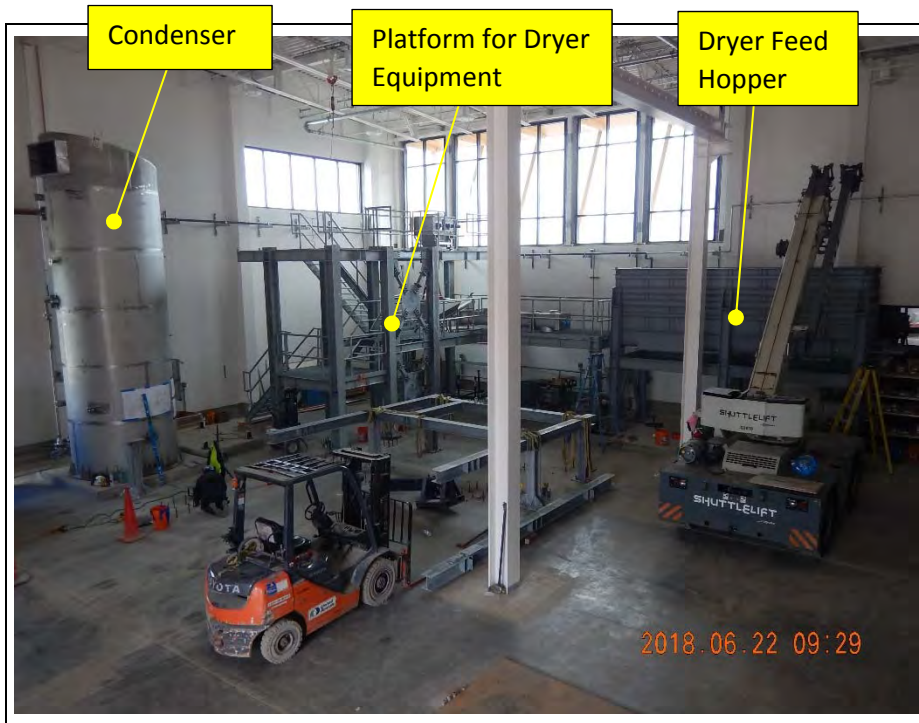
Photo #21

Area 50 Biosolids Building (looking southeast) on Friday, June 22nd.

This photo depicts the current status of the biosolids dryer installation.

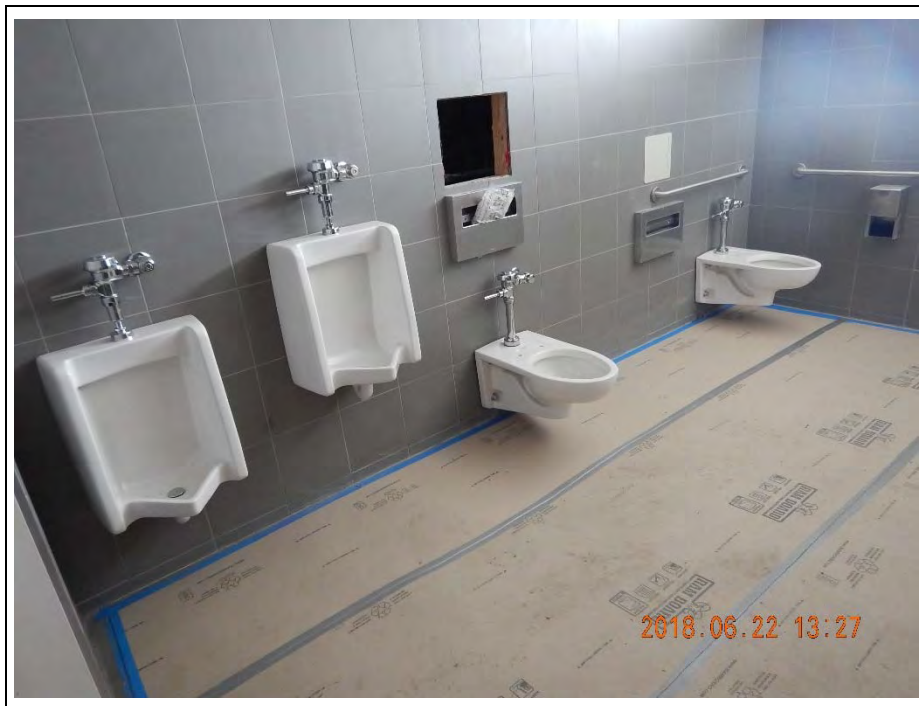
Photo #22

Area 01 Administration Building (looking northwest) on Friday, June 22nd.

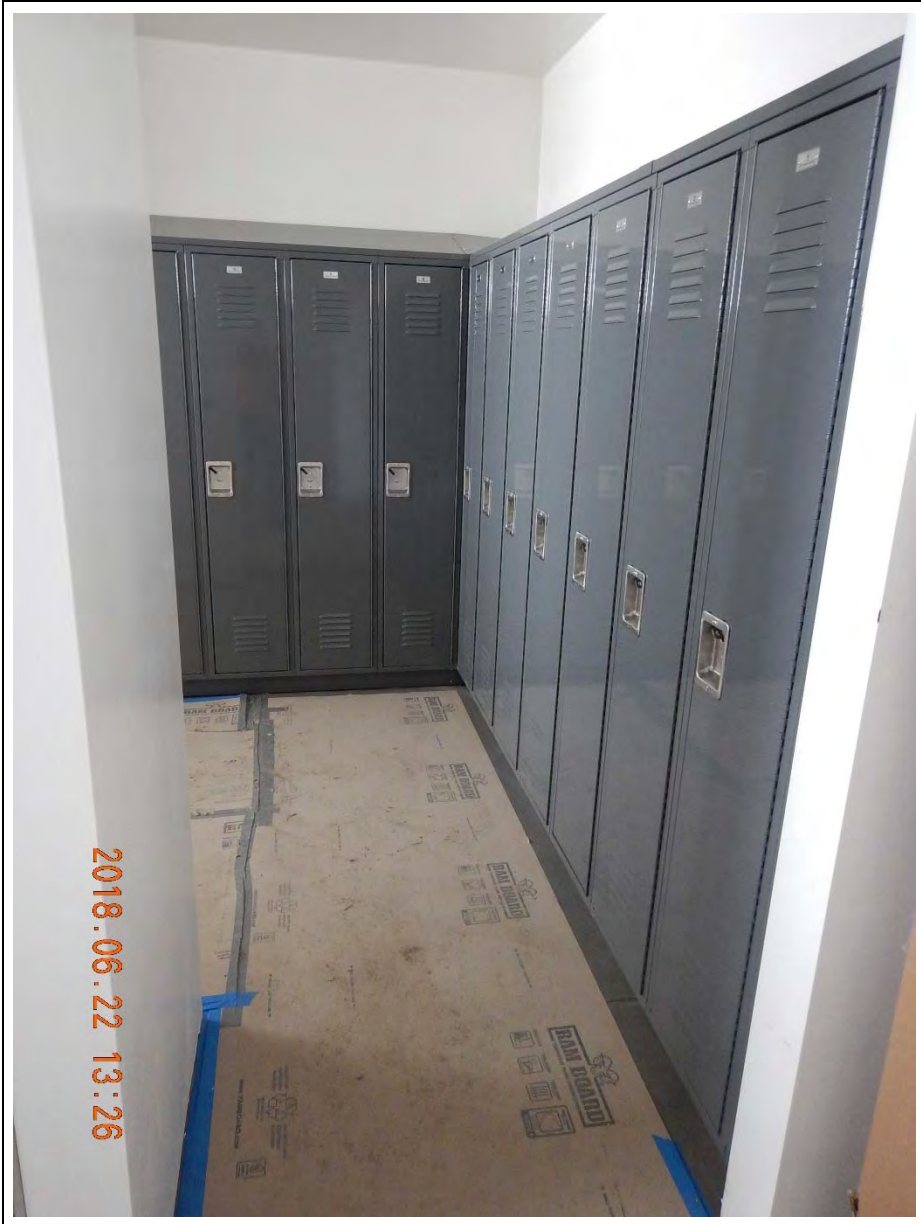
Photo #23

Area 01 Administration Building (looking east) on Friday, June 22nd.

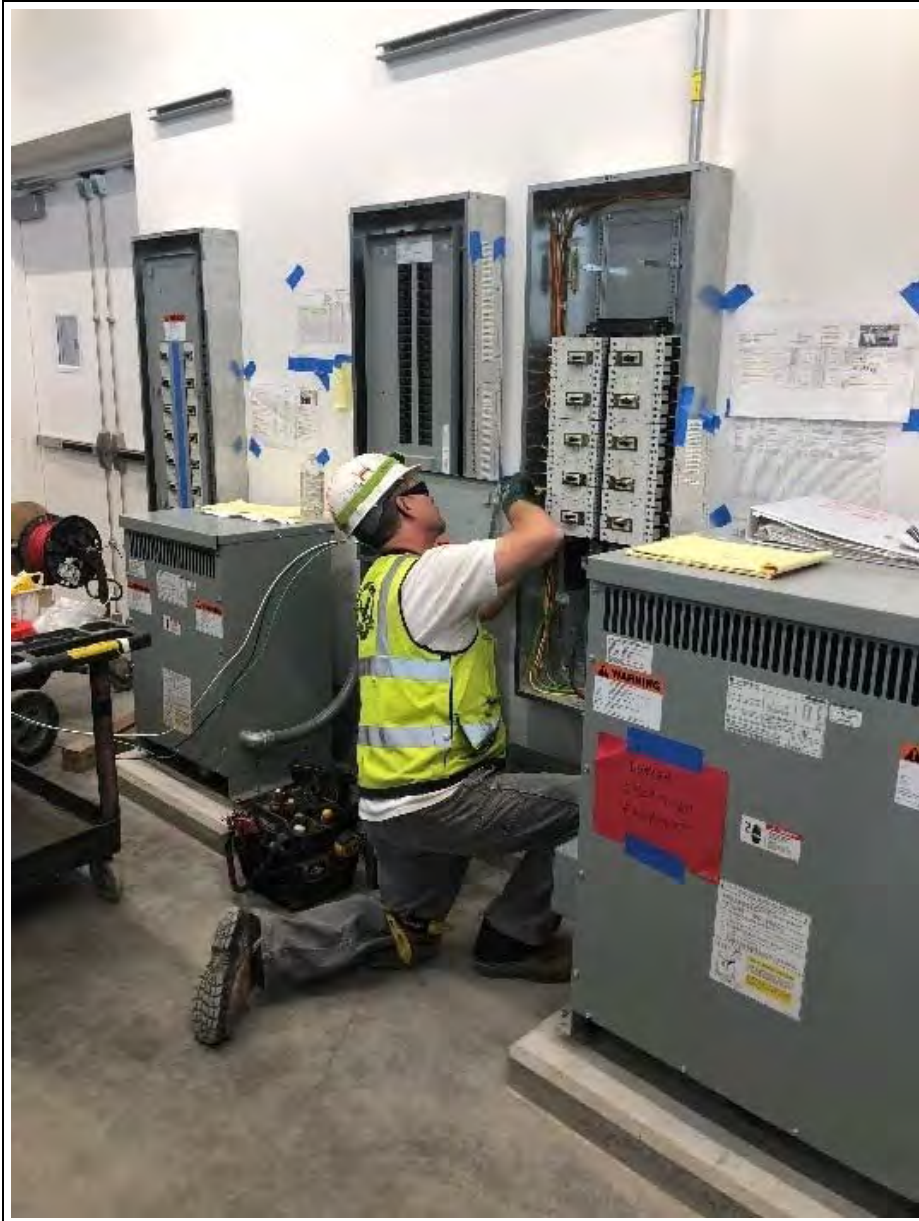
Photo #24

Area 70 Electrical Building
(looking northeast) on
Friday, June 22nd.

An electrician for Valley
Electric is terminating
conductors at a lighting
panel.

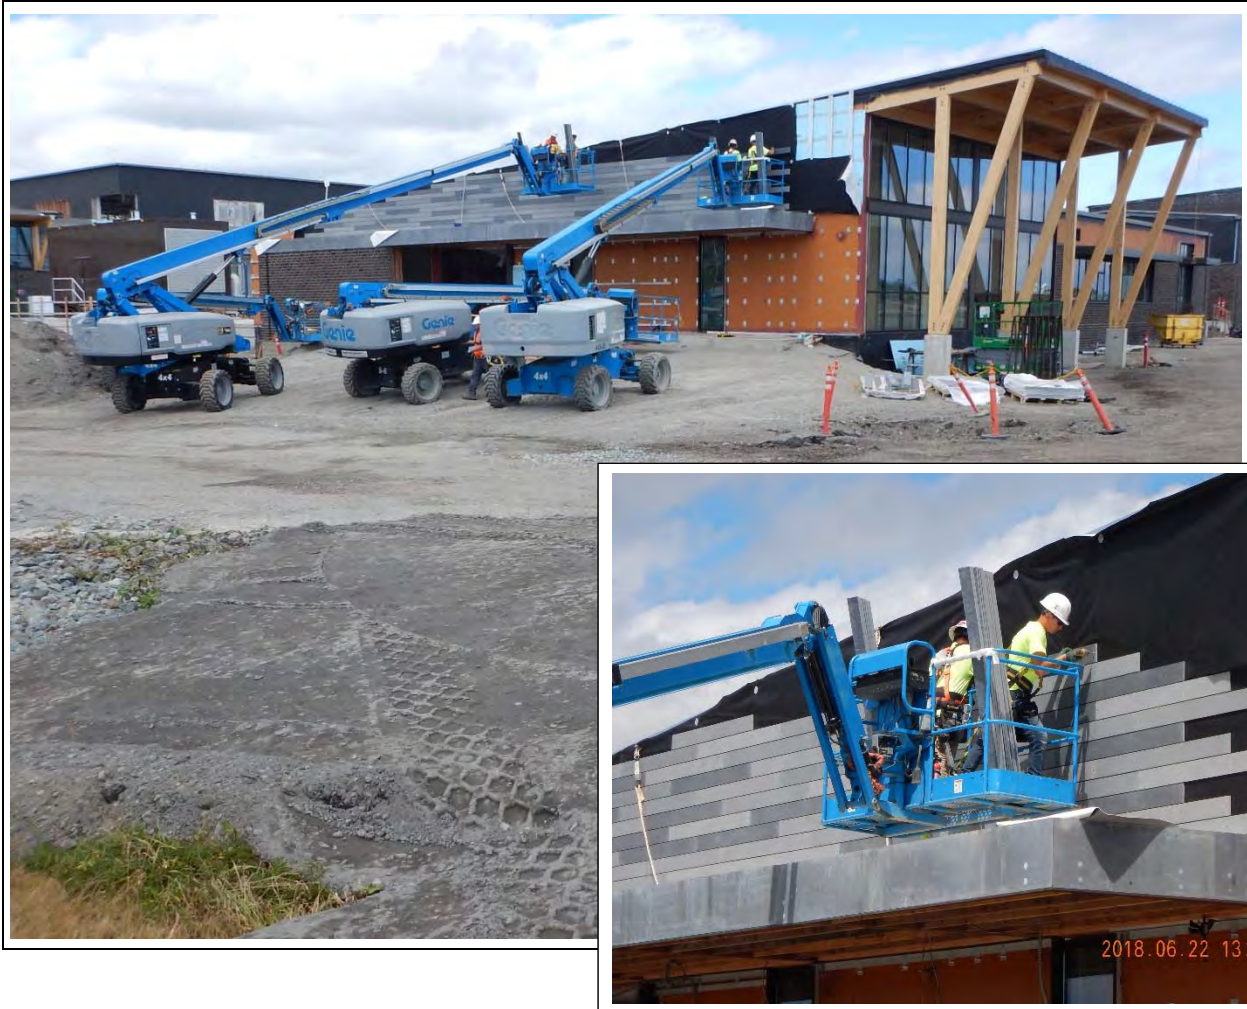
Photo #25

Area 01 Administration Building (looking northeast) on Friday, June 22nd. Axiom is installing glass-fiber reinforced concrete (GFRC) cladding.

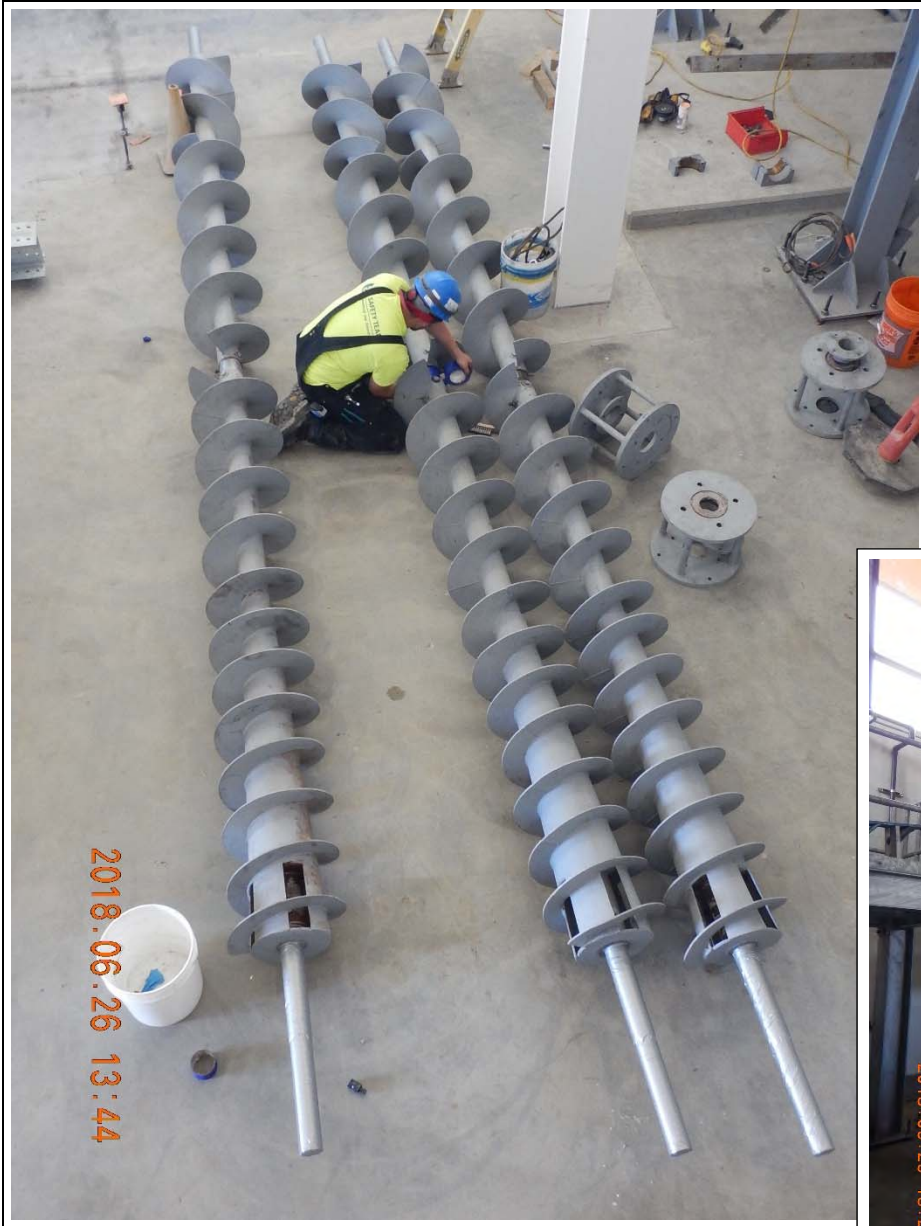
Photo #26

Area 50 Biosolids Building (looking east) on Tuesday, June 26th.

A pipefitter for University Mechanical is disassembling augers (left) for a biosolids dryer hopper (lower right) so the augers can be sandblasted and painted.

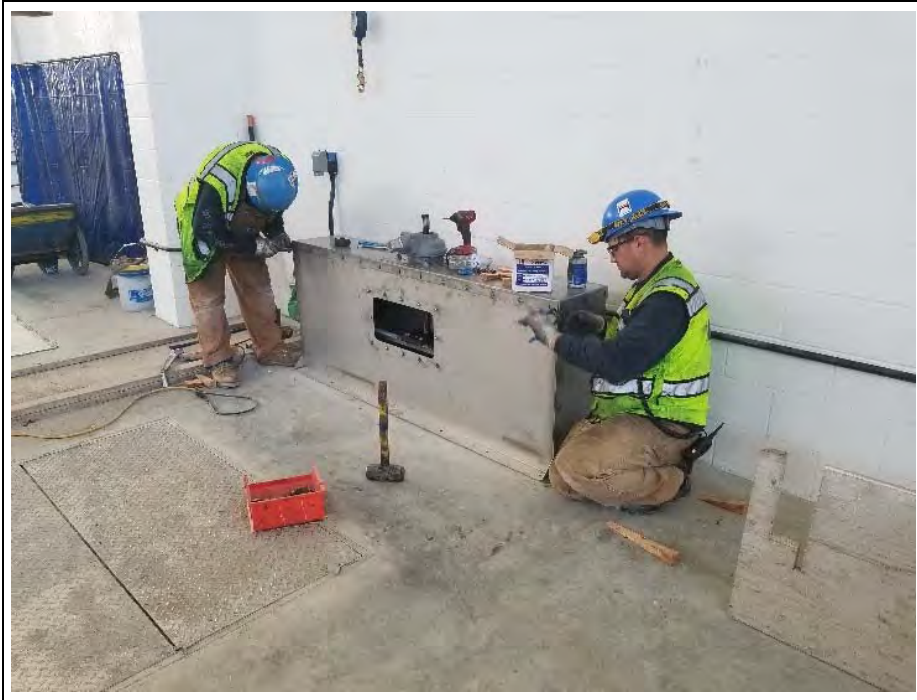
Photo #27

Area 30 Secondary Treatment Building (looking southeast) on Tuesday, June 26th.

Pipefitters for University Mechanical are assembling a cover over the top of a slide gate for Aeration Basin No. 1.

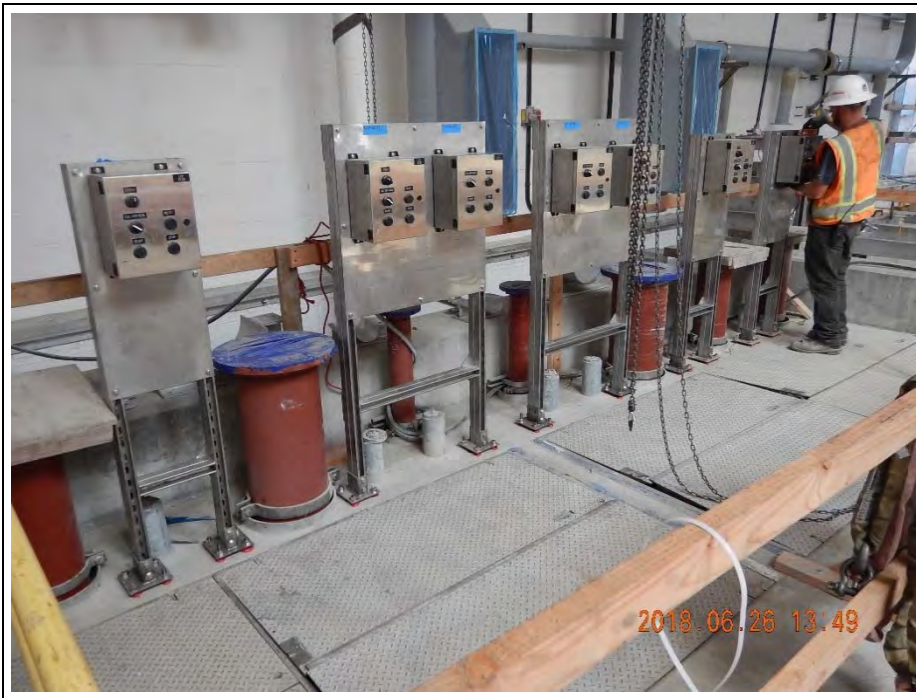
Photo #28

Area 20 Headworks (looking northeast) on Tuesday, June 26th.

An electrician for Valley Electric is installing local control panels for influent pumps.
