City of Oak Harbor
City Council Agenda Bill

Bill No. 5. c. i.
Date: August 8, 2018
Subject: Clean Water Facility Update

Clean Water Facility Project

MONTHLY PROGRESS REPORT

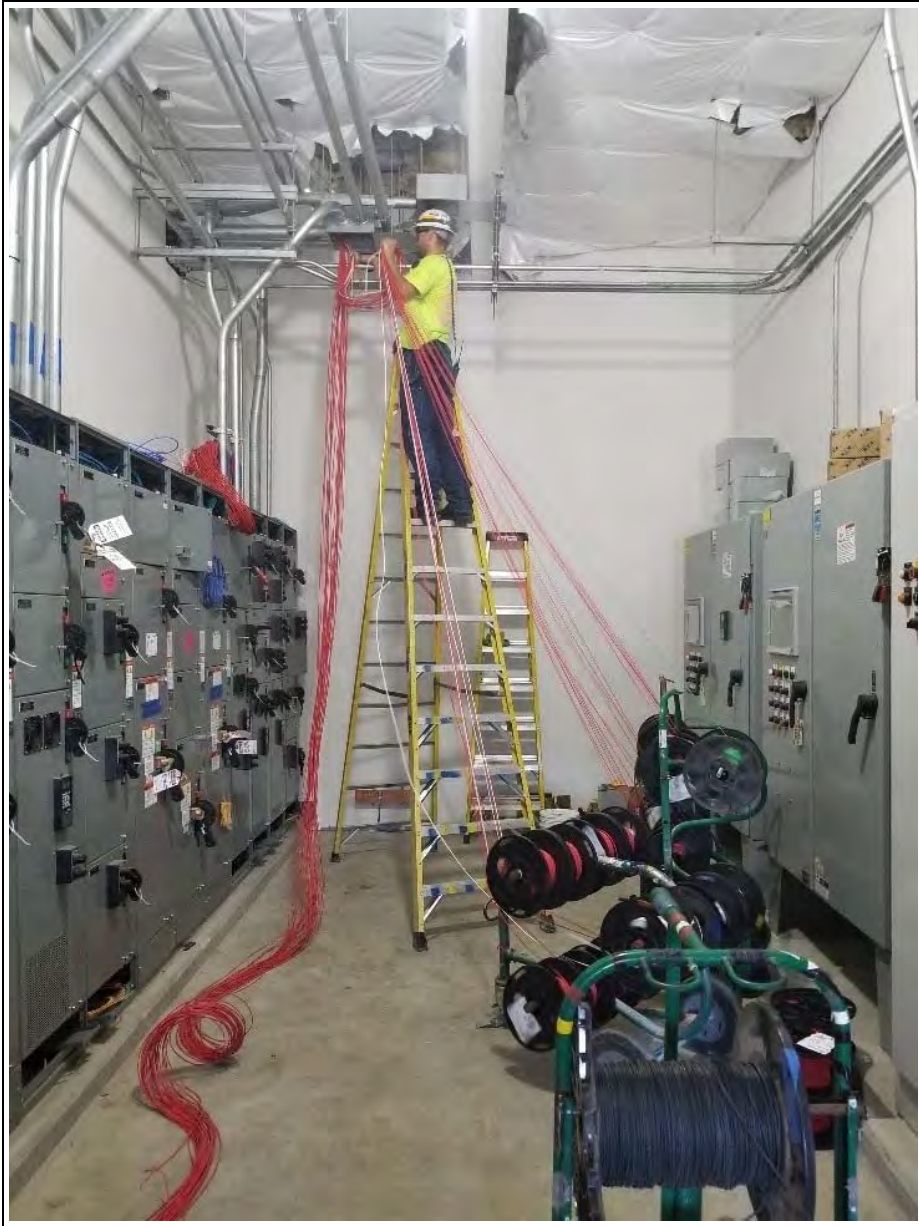
Photo #29

Area 20 Headworks
(looking north) on
Tuesday, June 26th.

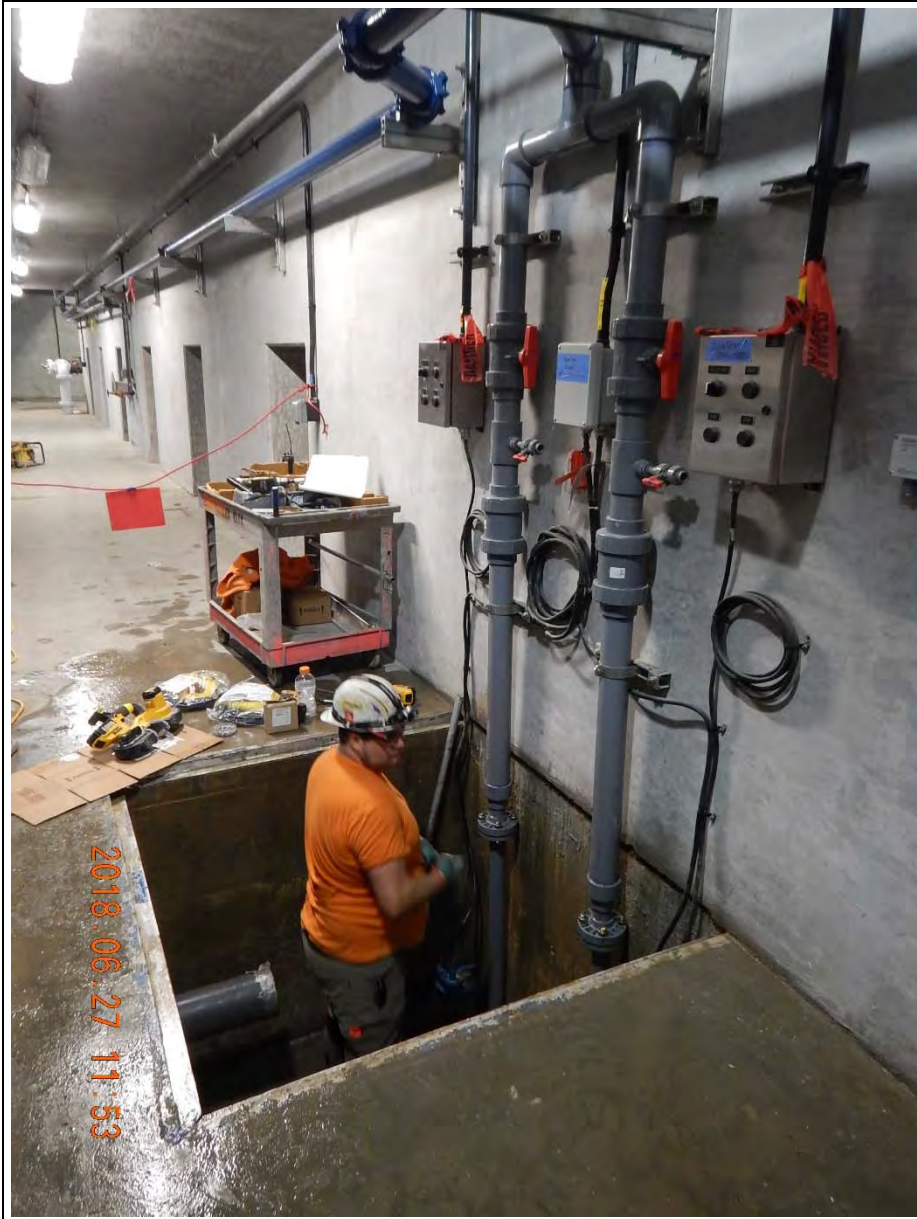
Photo #30

Area 34 Membrane Bio-reactor under a mixed liquor channel (looking west) on Wednesday, June 27th.

An electrician for Valley Electric is installing floats for sump pumps.

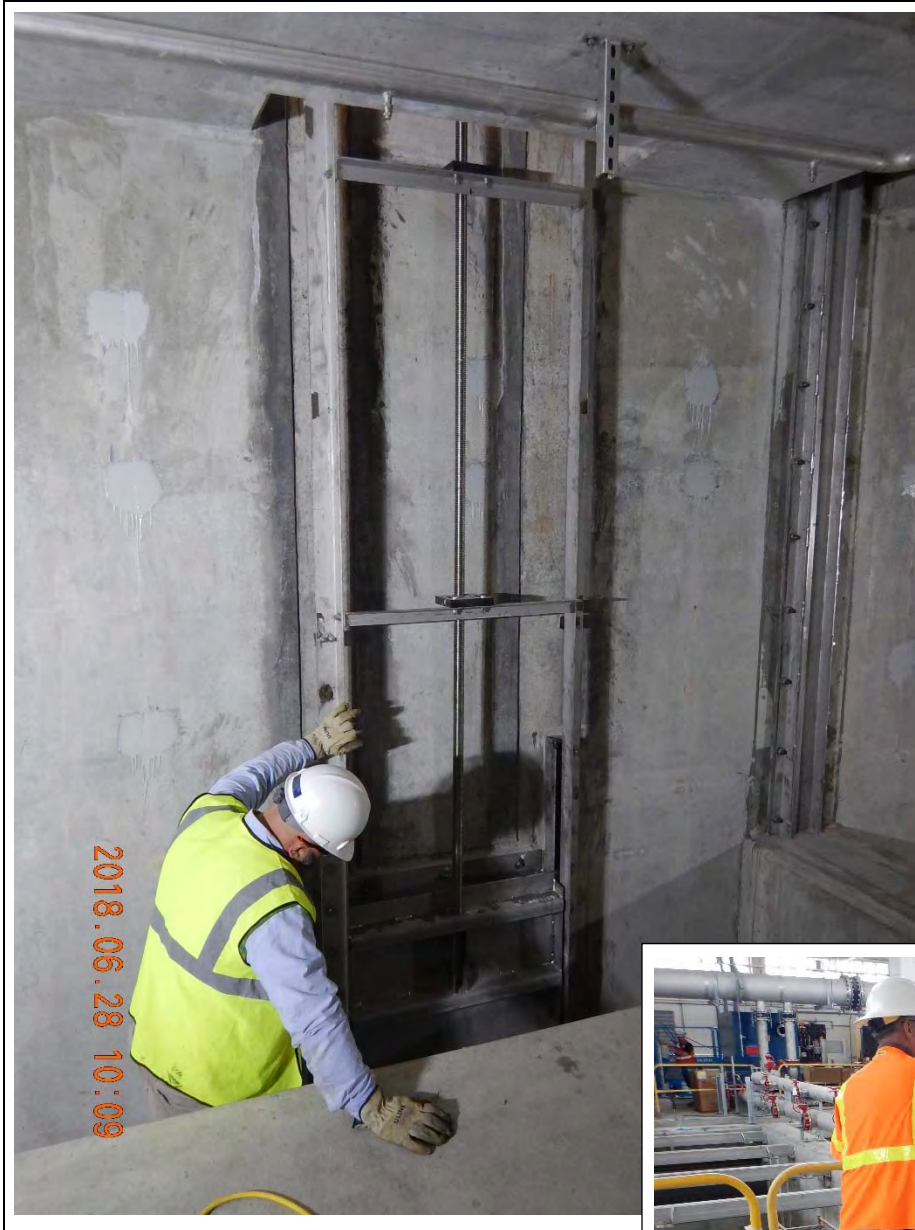
Photo #31

Area 34 Membrane Bio-reactor (looking northeast) on Thursday, June 28th.

Lower Right: Representatives from Rotork (left) and Golden Harvest (right) are raising and lowering a slide gate by means of a motor-driven actuator to verify that the actuator and the slide gate are operating correctly.

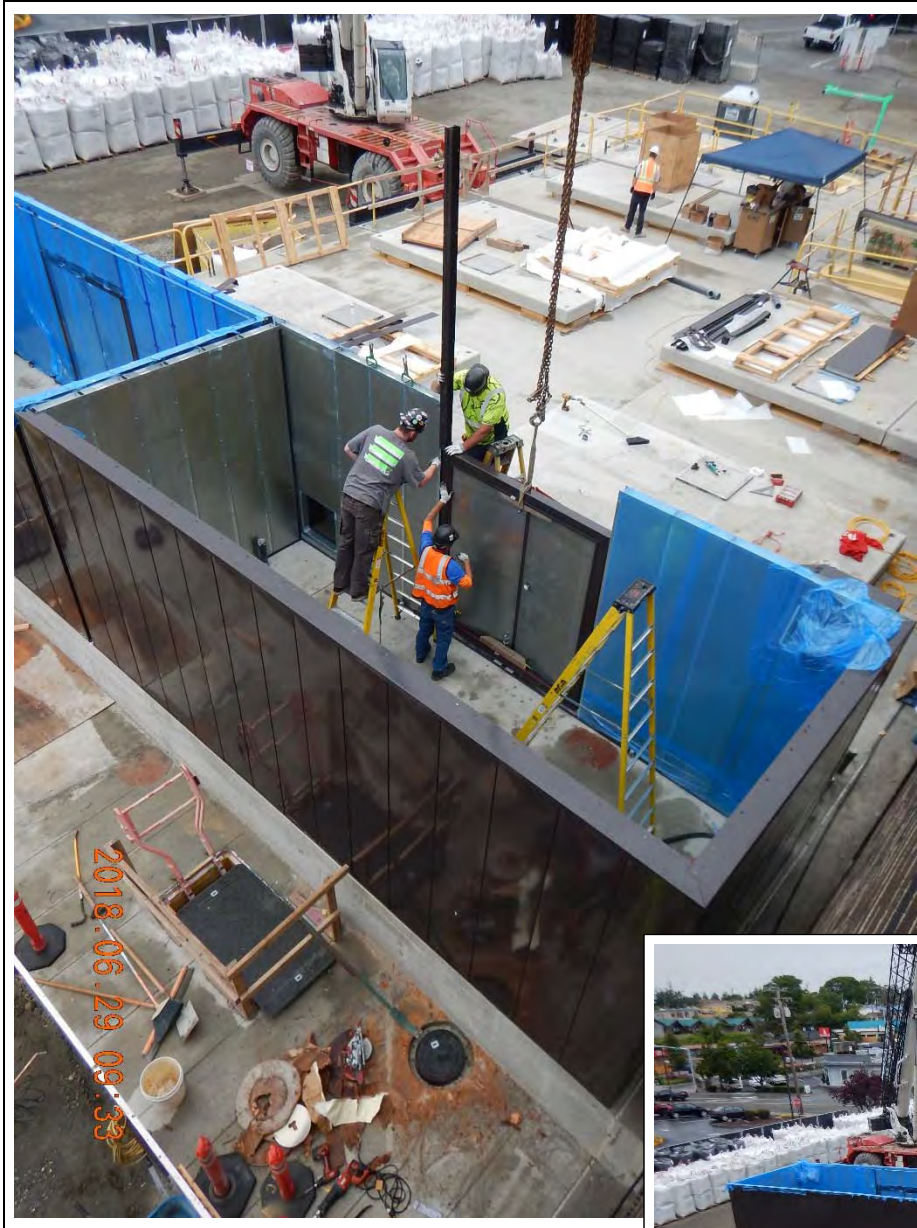
Photo #32

Area 60 Odor Control
(looking northeast) on
Friday, June 29th.

Hoffman is utilizing an
all-terrain crane to help
sheet metal workers for
Delta Corporation install a
section of sound enclosure
atop the west side of the
odor control structure.

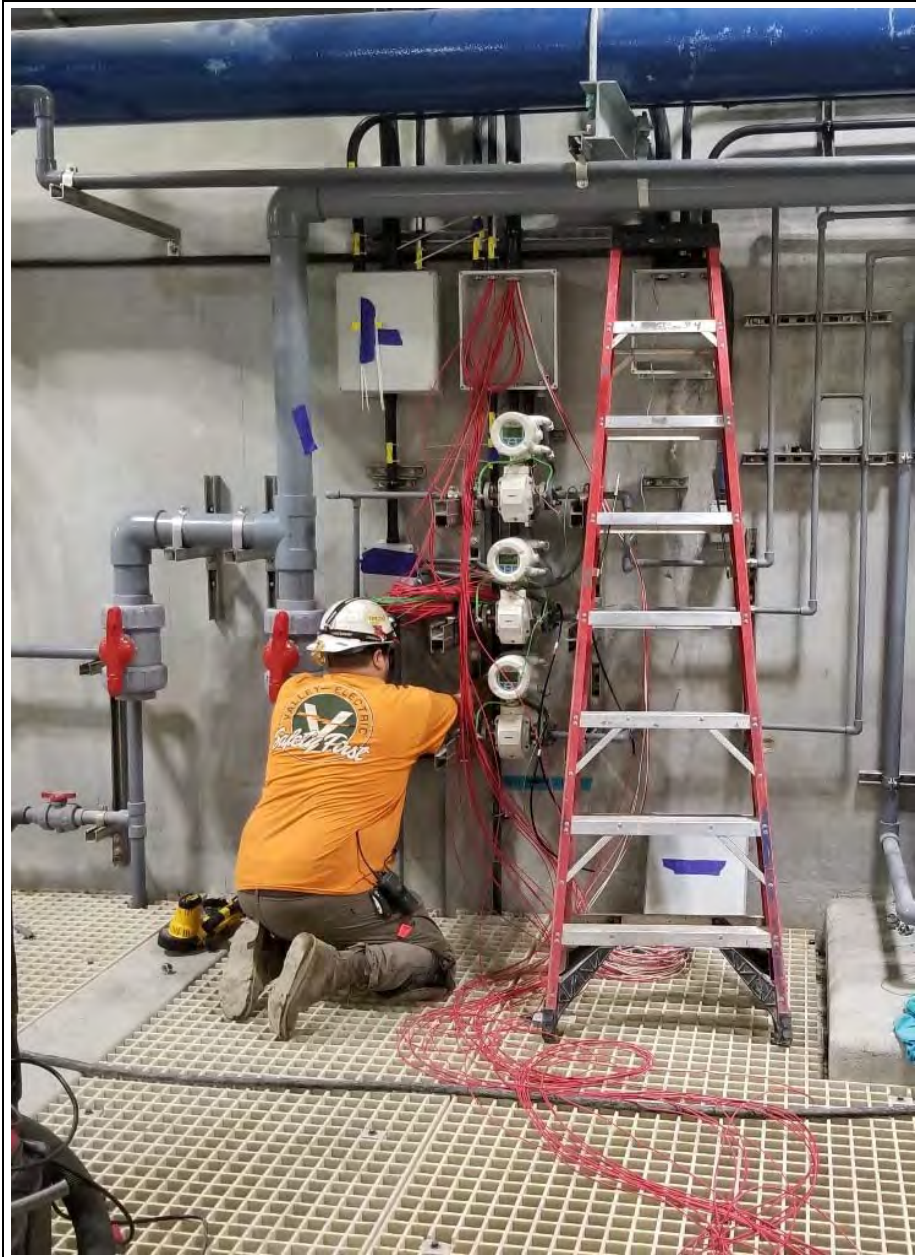
Photo #33

Area 37 Chemical Facilities
(looking north) on Friday,
June 29th.

An electrician for Valley
Electric is installing flexible
conduit for flow meters.

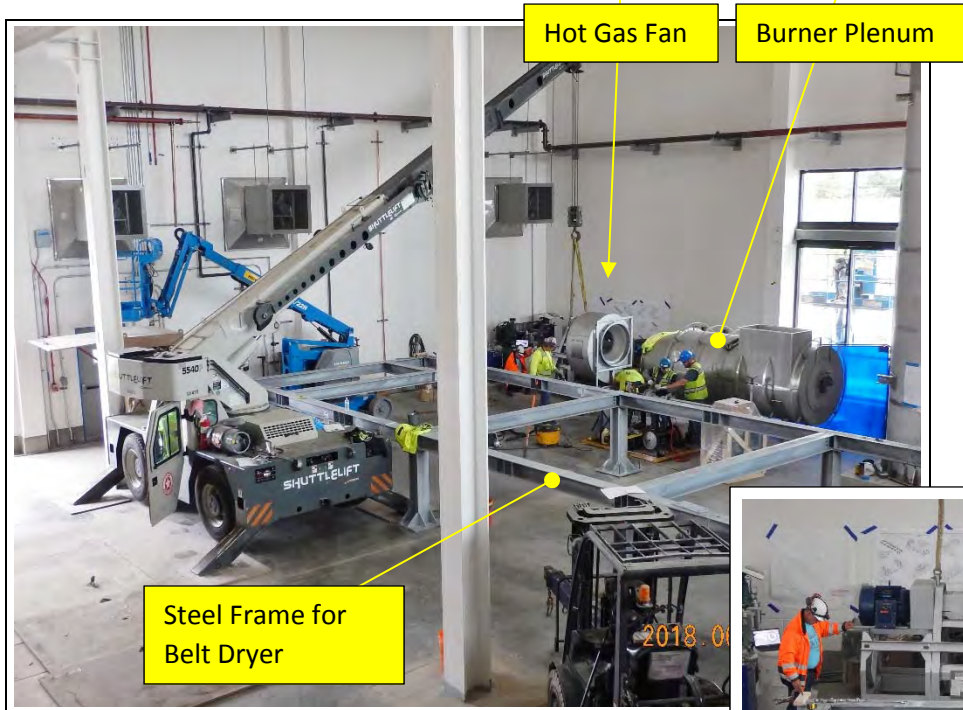
Photo #34

Area 50 Biosolids (looking northeast) on Friday, June 29th.

Hoffman is utilizing a mobile crane to help pipefitters for University Mechanical install a hot gas fan.

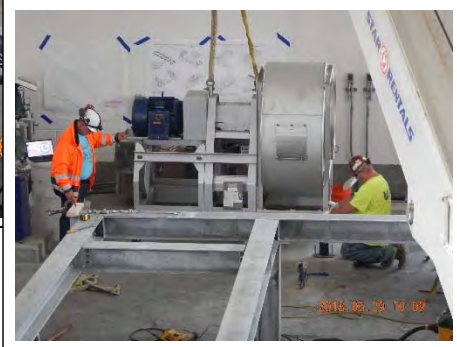
Photo #35

Area 60 Carbon Vessels (looking south) on Friday, June 29th.

GMPA No. 12 – Odor Control System. Work on this GMPA is approximately 69% complete. Penington Painting's subcontractor, Hunnicutt's, Inc., finished applying an elastomeric polyurethane coating system to the interior walls of the odor control structure. Steelkorr finished installing fiber reinforced plastic (FRP) grating in the odor control structure. Delta Corporation began installing sound enclosures for fans at the west side of the odor control structure (see Photo #32). Delta Corporation attached pre-filters and 10-foot-tall stacks to the carbon adsorption vessels (see Photo #35).

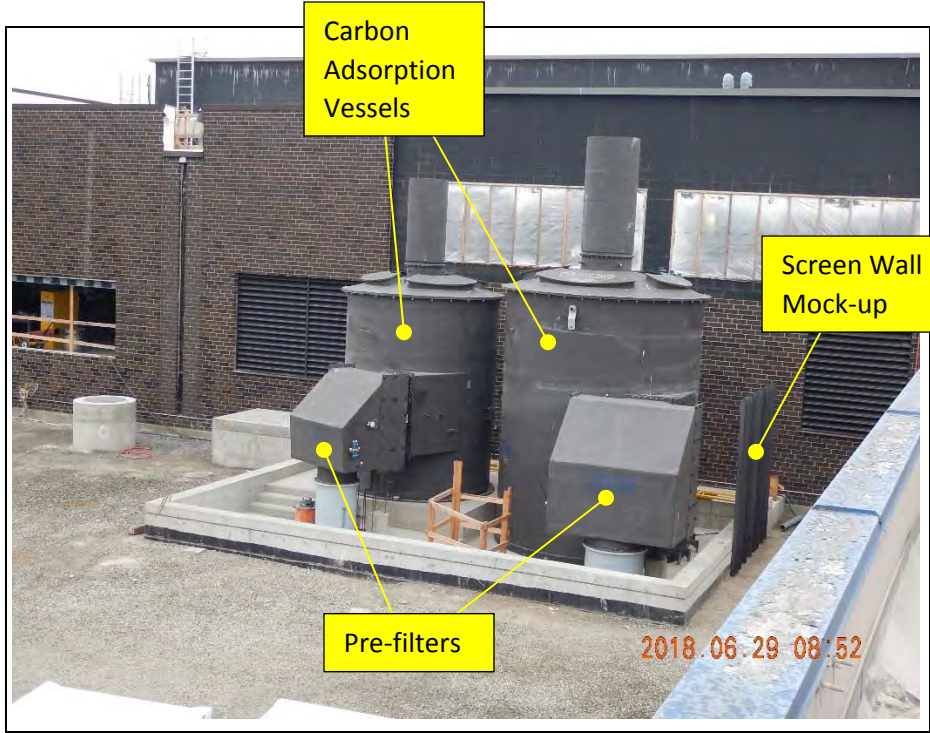
This picture depicts the current status of the carbon adsorption vessels.

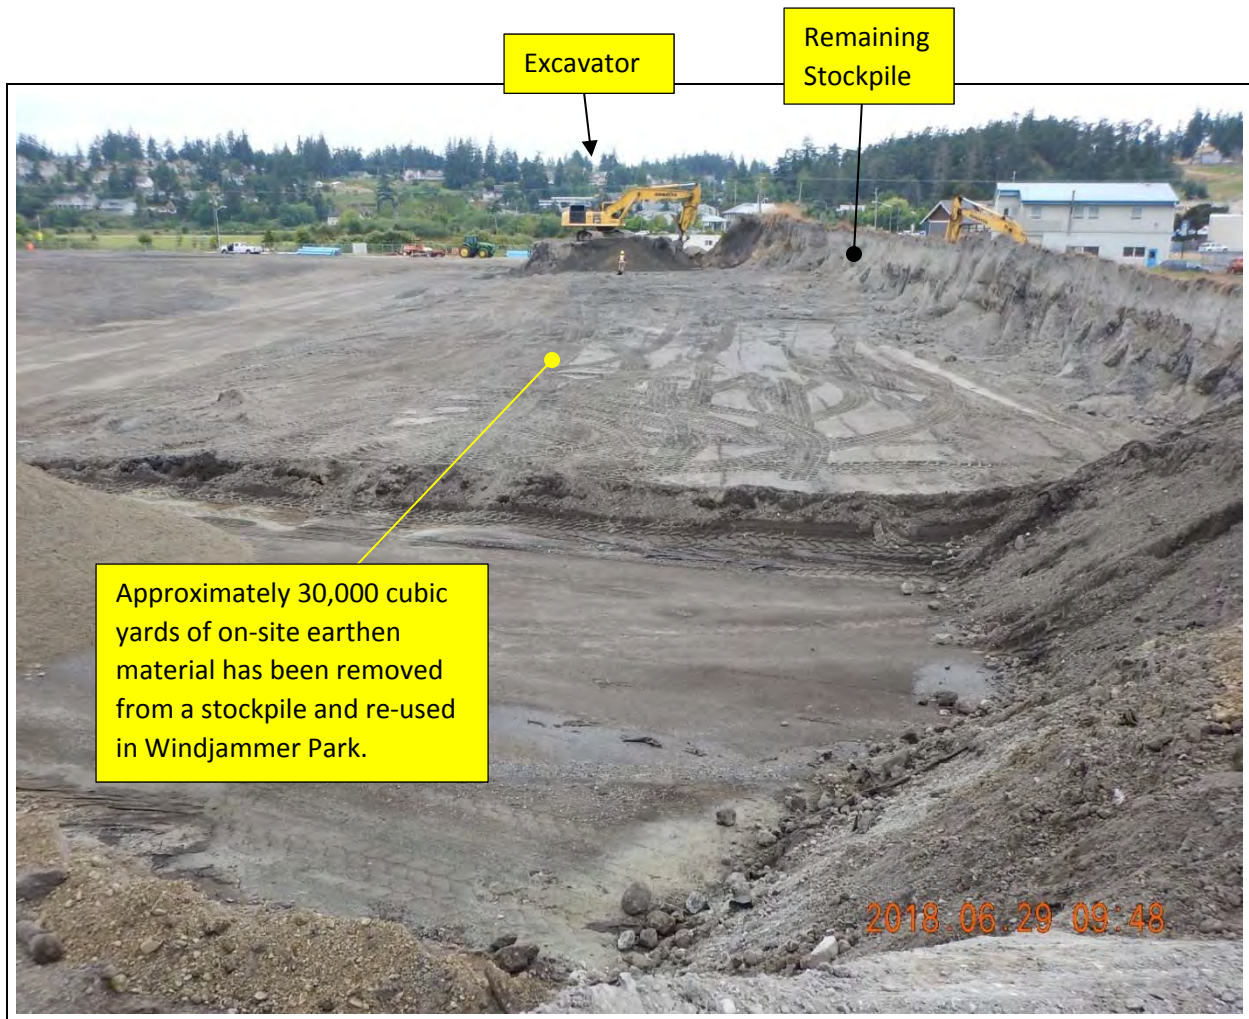
Photo #36

Windjammer Park (looking west) on Friday, June 29th. Interwest Construction is utilizing earthen material from a soil stockpile to implement a grading plan for Windjammer Park improvements. The earthen material in the stockpile was the result of excavation work that occurred in the spring of 2016 for the Clean Water Facility. The soil stockpile is located at the former location of the northeast portion of Staysail RV Park.

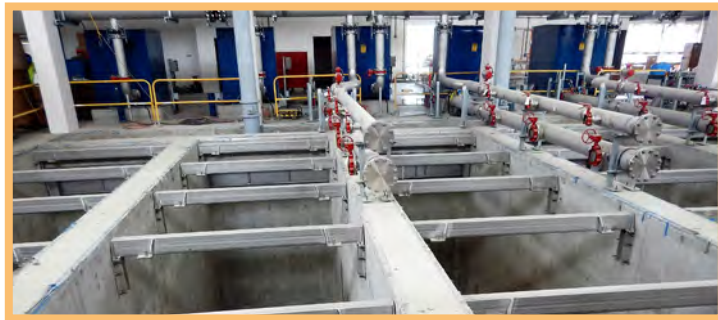
In the secondary treatment building, wastewater passes through the membrane bioreactor (MBR) tanks which stand almost two stories high.

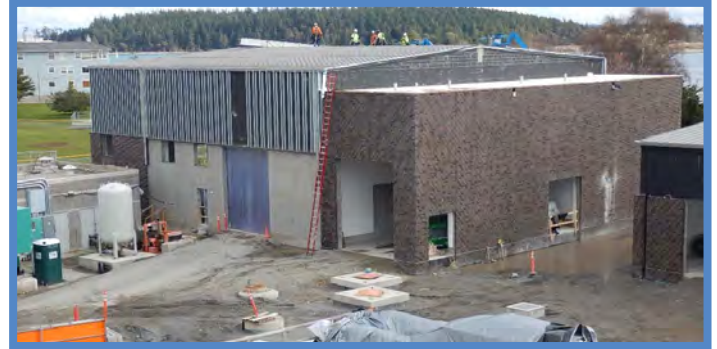
Solids dried in this building will be trucked off site to use as fertilizer for golf courses, farms, community gardens, and more!

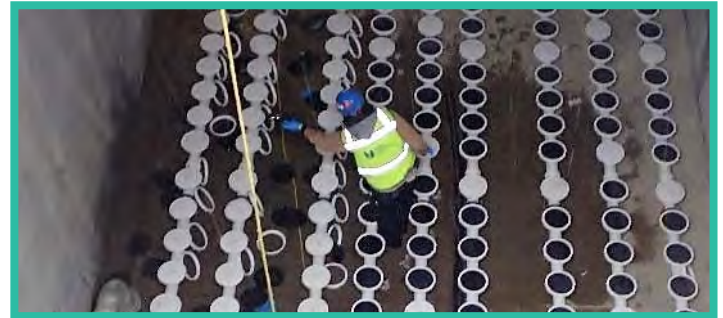
Bubbler pipes in the aeration blower building feed microorganisms that chow down on waste during a three- to six-hour bath.
