City of Oak Harbor  
City Council Agenda Bill

Bill No. 5. c. i.  
Date: September 18, 2018  
Subject: Clean Water Facility Update

# Clean Water Facility Project

# Report *August 2018*

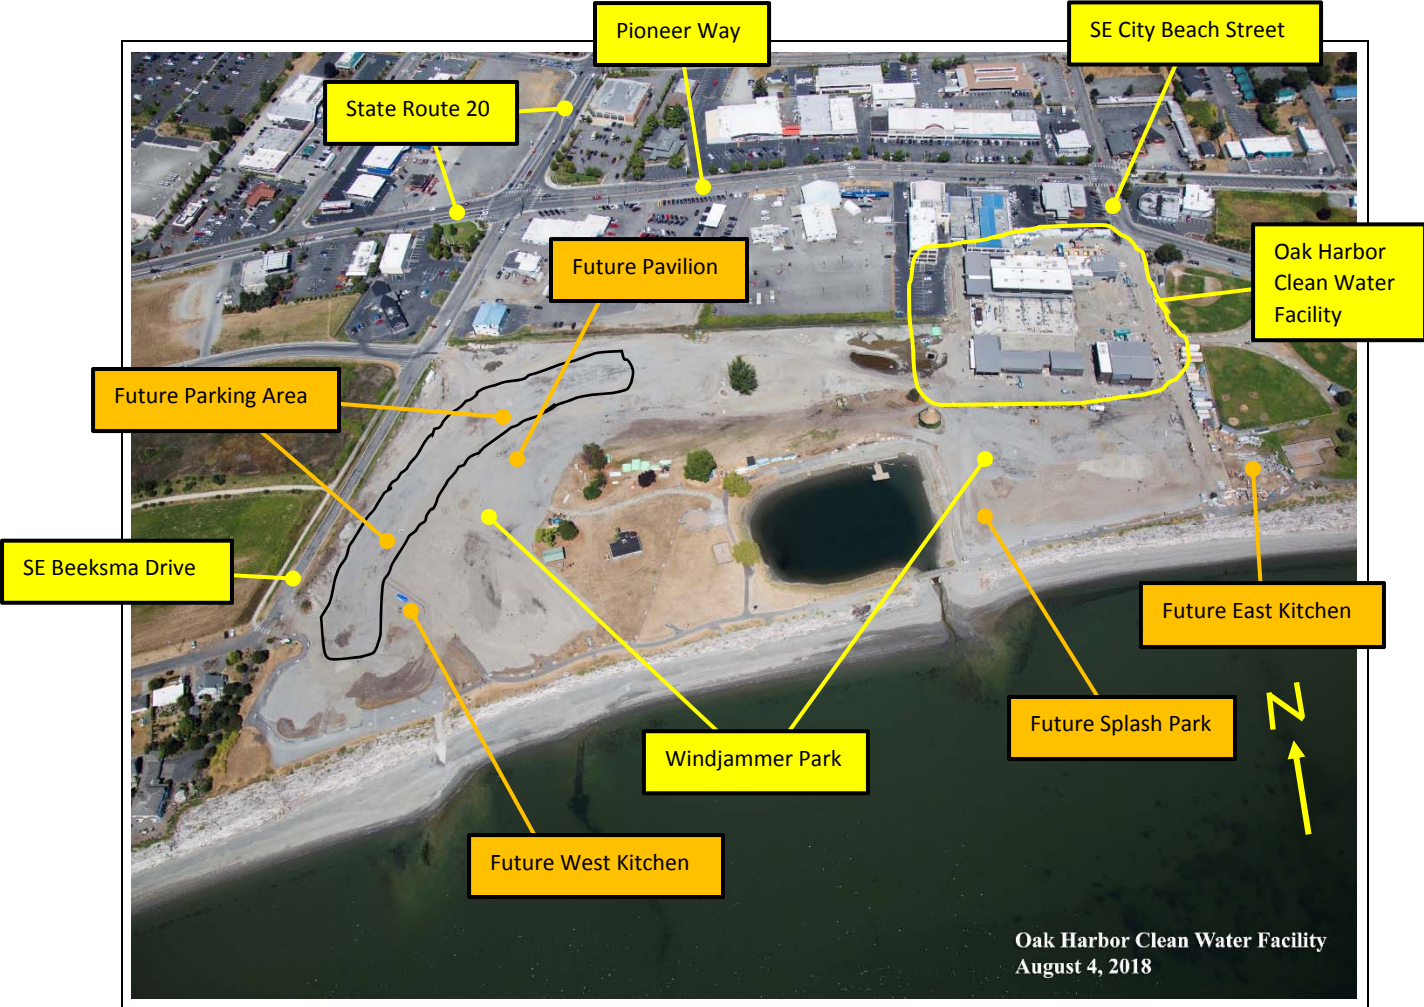
Photo #1

Aerial photo of Windjammer Park and the Clean Water Facility job site (looking north) on August 4<sup>th</sup>, 2018, ten weeks after demolition work at Windjammer Park began.

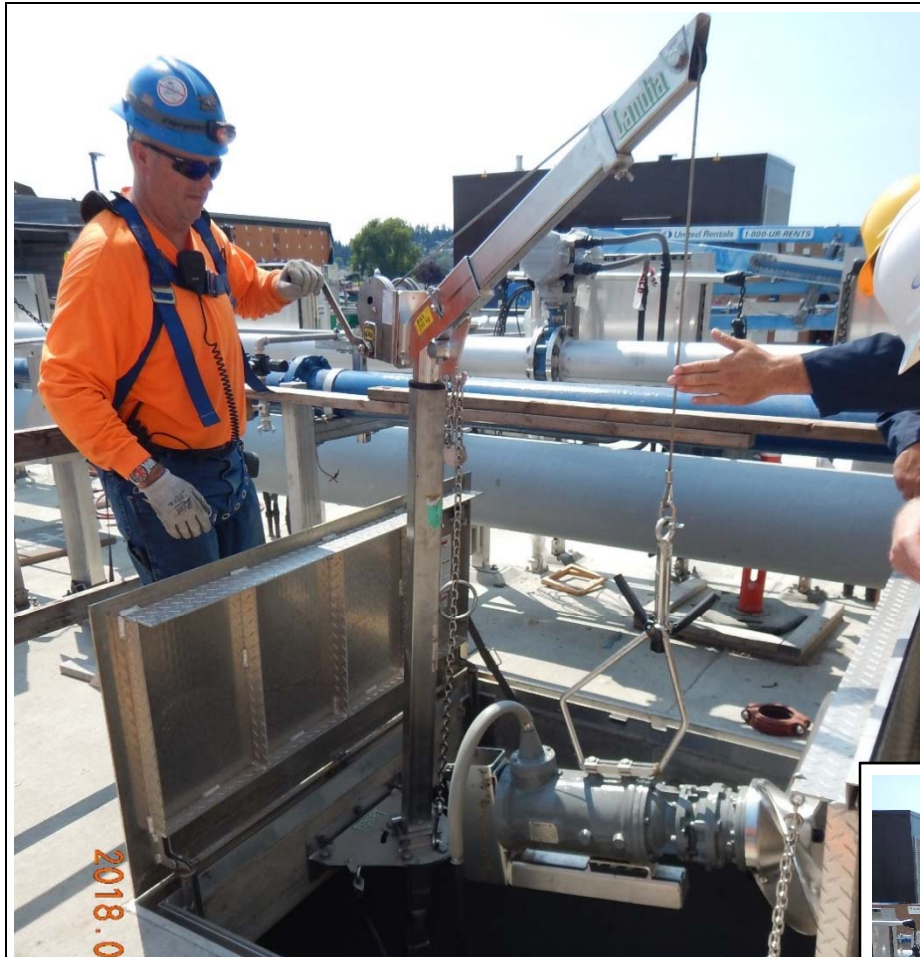
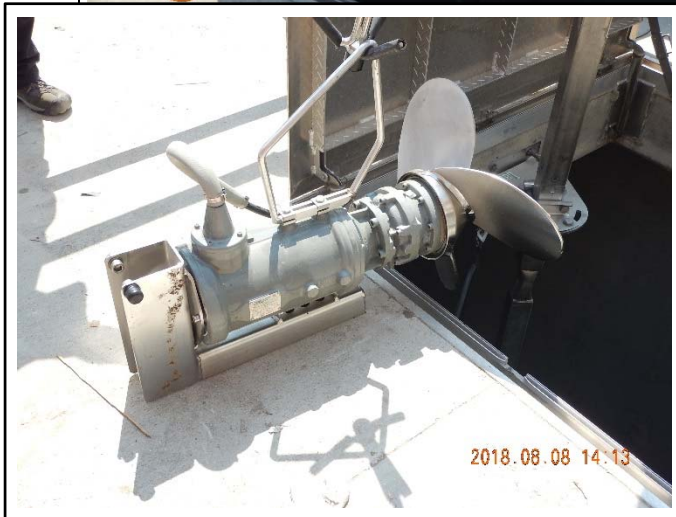
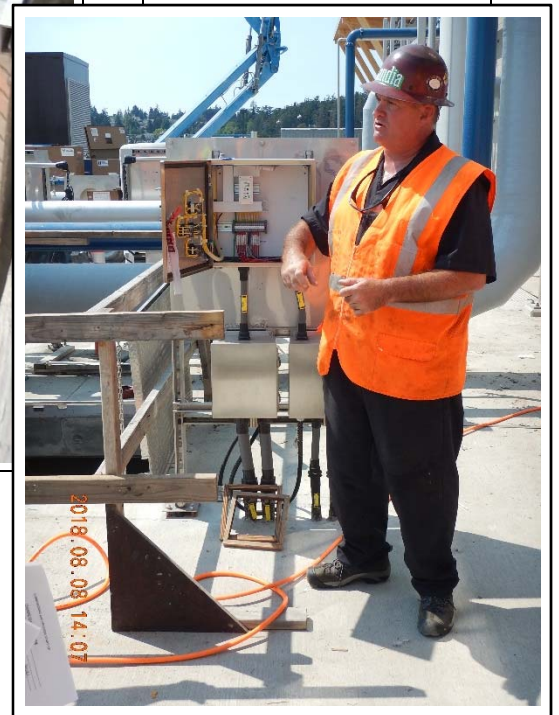
Photo #3

Area 31 Aeration Basins (looking west) on Wednesday, August 8<sup>th</sup>.

Bottom right: Landia representative Ken Jacobs is conducting operator training.

**Start-up Activities.** On August 8<sup>th</sup>, a representative from Landia operated mixers in aeration basins and conducted operator training (see Photo #3). On August 9<sup>th</sup>, representatives from N.E. Controls and Aerzen operated aeration air blowers and conducted operator training (see Photo #4). On August 15<sup>th</sup>, Valley Electric and its subcontractor, Red Hawk Fire Protection, operated a fire alarm system in the administration building for representatives of the Oak Harbor Fire Department (see Photo #13). On August 16<sup>th</sup>, a representative of Beaver Equipment Company operated a bubbler system in the WAS storage tanks and aeration basins and conducted operator training (see Photos #15 and #43). On August 21<sup>st</sup>, a technician for QualiTech calibrated gas sensors (see Photo #27). On August 23<sup>rd</sup>, a representative of Cummins Corporation performed a load test on an engine generator and conducted operator training (see Photo #32). During the last week of August, representatives for Apsco and Whitney Equipment Company inspected WAS transfer pumps (see Photo #35) and influent pumps (see Photo #40), respectively, and verified that the pumps are ready to operate. Two engineers for Suez Water Technologies and Solutions were on site full-time to prepare membrane equipment for start-up (see Photo #37). Hoffman continued to conduct weekly start-up coordination meetings with its subcontractors and Carollo Engineers.

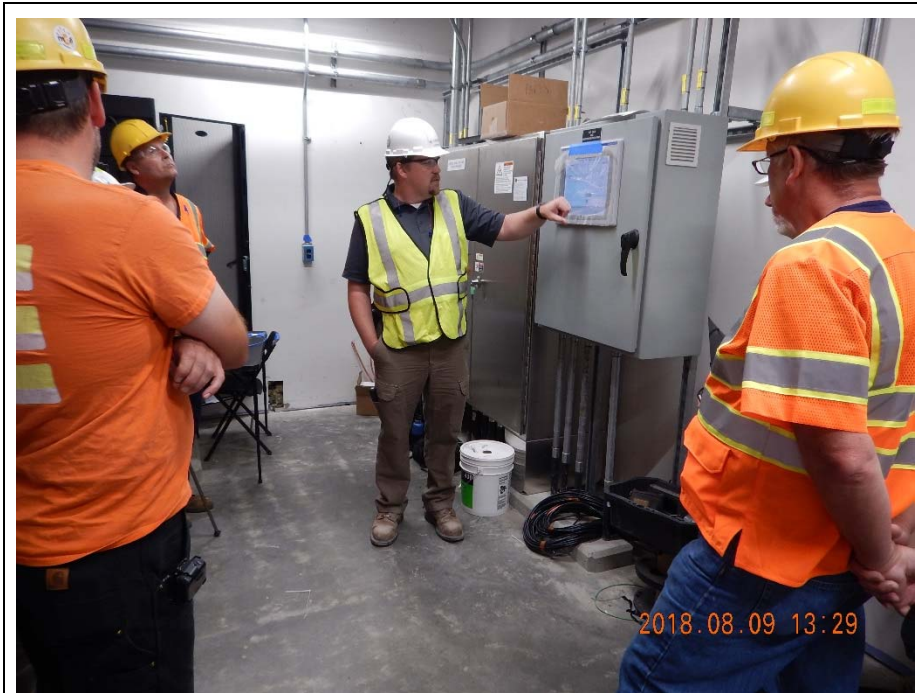
Photo #4

Top: Area 70 Electrical Building (looking west) on Thursday, August 9<sup>th</sup>.

Bottom: Area 32 Aeration Blower Building (looking west) on Thursday, August 9<sup>th</sup>.

An engineer from N.E. Controls, Nick Radley (top), and a field service technician from Aerzen, Donna Conrad (bottom), are conducting operator training pertaining to aeration blowers.

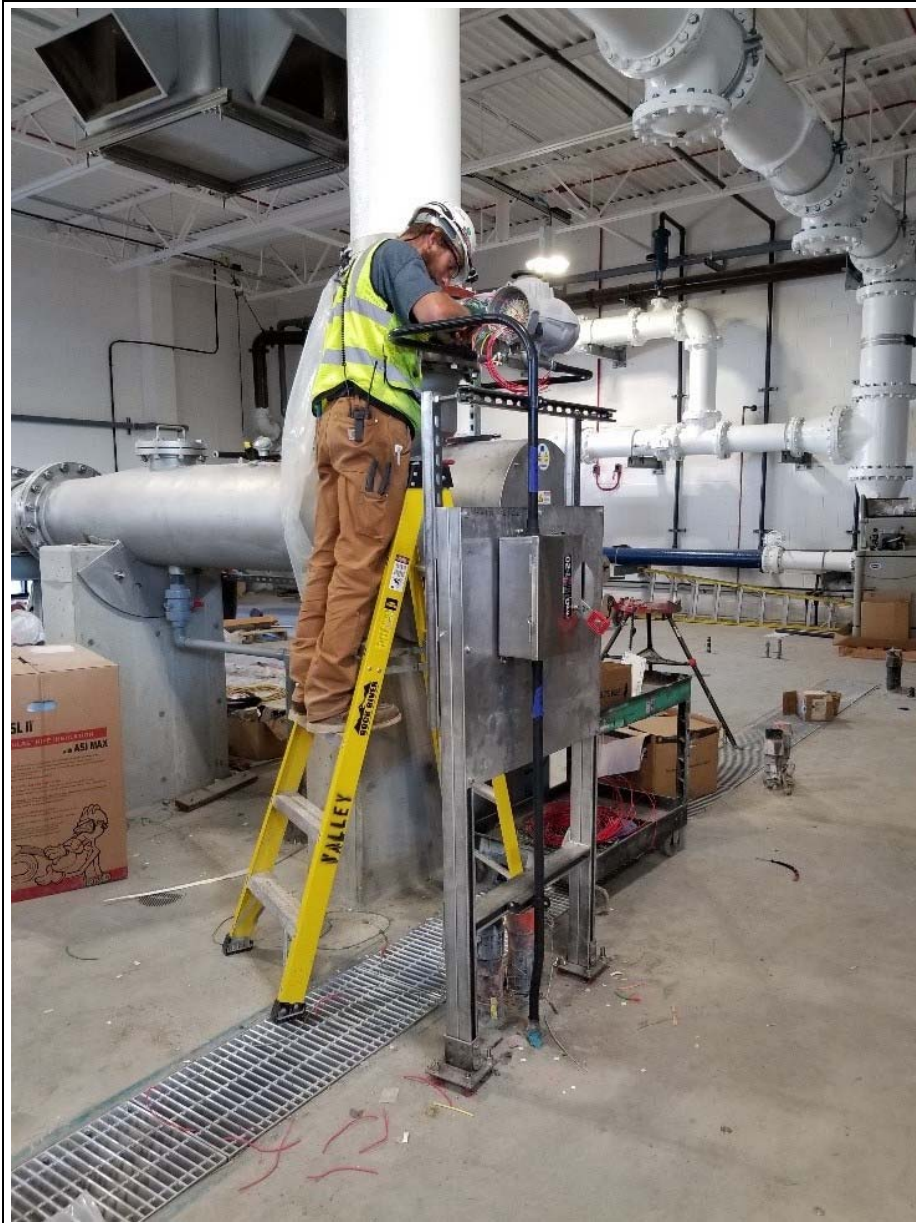
Photo #5

Area 36 UV Disinfection  
(looking northeast) on  
Thursday, August 9<sup>th</sup>.

An electrician for Valley  
Electric is terminating  
conductors at a  
motor-operated valve  
actuator.

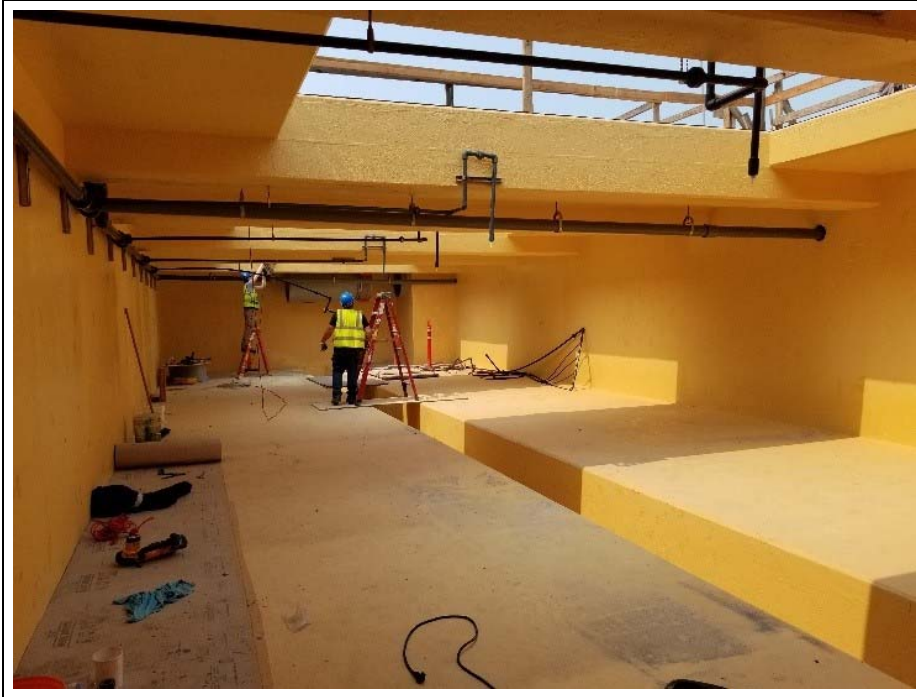
Photo #6

Area 60 Odor Control  
(looking west) on Friday,  
August 10<sup>th</sup>.

Pipefitters are installing  
PVC process piping in the  
odor control structure.

**GMPA No. 12 – Odor Control System.** Work on this GMPA is approximately 80% complete. University Mechanical installed PVC process piping and air distribution plates inside the odor control structure (see Photos #6 and #11). University Mechanical installed recirculation pumps (see Photo #38). Painters for Honeycutt's, Inc., repaired the coating system at pipe penetrations (see Photo #45).

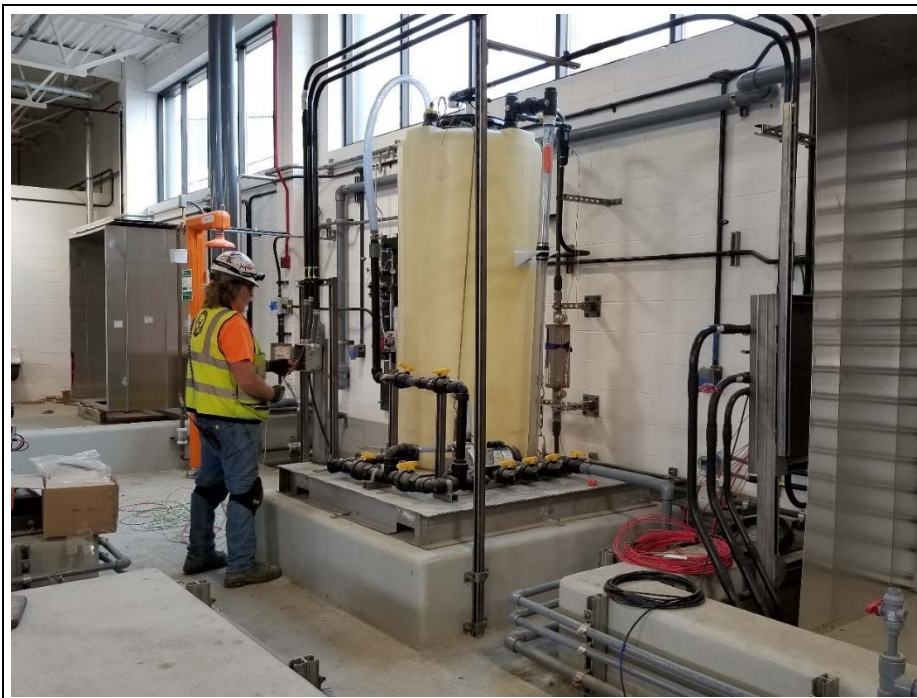
Photo #7

Area 37 Chemical Facilities  
(looking northwest) on  
Monday, August 13<sup>th</sup>.

An electrician for Valley  
Electric is pulling  
conductors to a junction  
box next to a citrus acid  
tank.

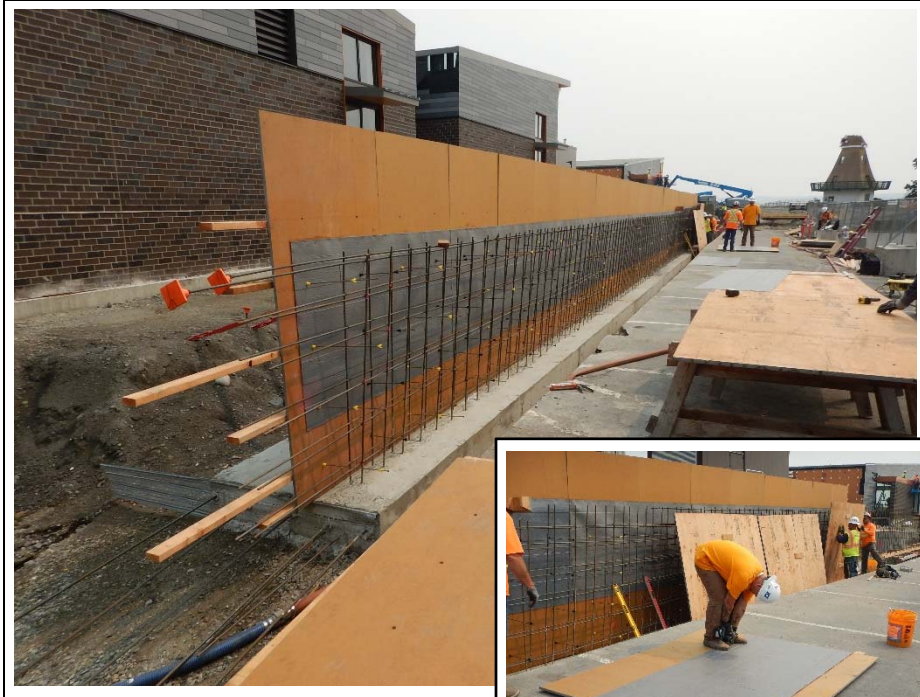
Photo #8

Area adjacent to west side of Aeration Blower and Electrical Buildings (looking south) on Monday, August 13<sup>th</sup>.

**GMPA No. 13 – Civil Site Work.** Work on this portion of GMPA No. 13 is approximately 20% complete. Interwest Construction finished grading an "inner yard" area between the process buildings and the administration and maintenance building. Interwest's subcontractor, Lakeside Industries, paved the inner yard (see Photos #18, #19, and #20). Interwest Construction built formwork and placed reinforcing steel and concrete for a retaining wall next to the west sides of the aeration blower and electrical buildings and the generator yard (see Photos #8, #9, #14, and #36).

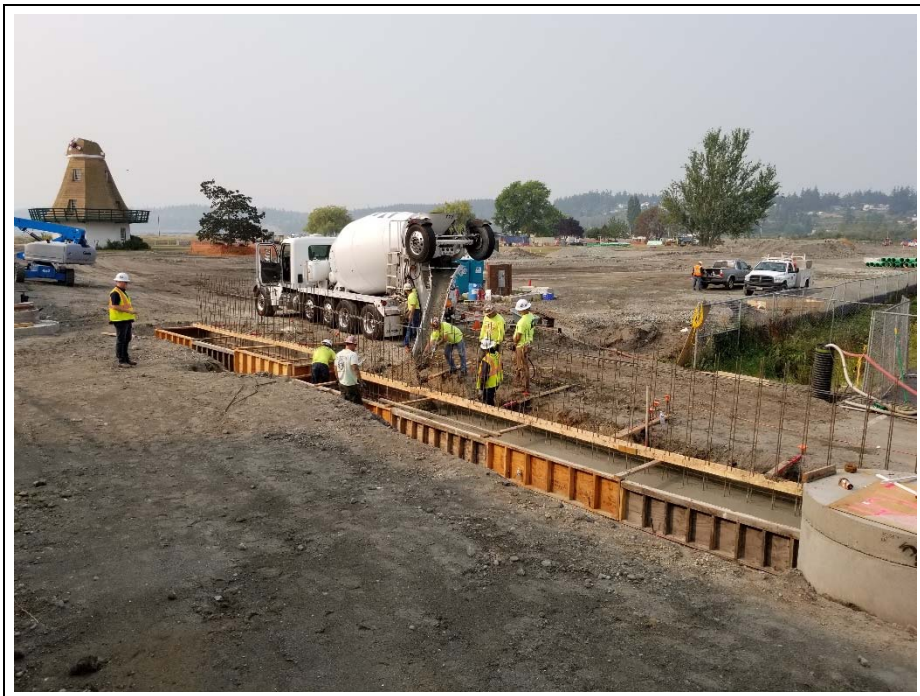
Photo #9

Area adjacent to west side of Area 70 Generator Yard (looking southwest) on Tuesday, August 14<sup>th</sup>.

Carpenters for Interwest Construction are placing concrete for a footing for a retaining wall.

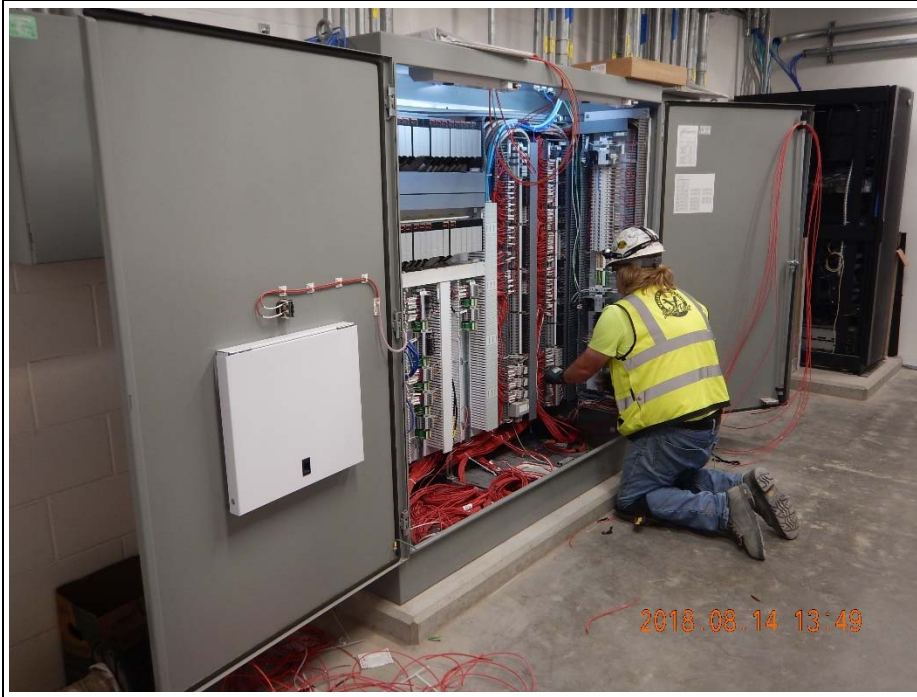
Photo #10

Area 70 Electrical Building  
(looking southwest in the  
control room) Tuesday,  
August 14<sup>th</sup>.

An electrician for Valley  
Electric is terminating  
conductors at a process  
control module (PCM).

motor starters, process control modules (PCMs), and control panels in the electrical building (see Photo #10). Valley Electric continued to install conduits, conductors, and electrical equipment in the administration building including luminaires and emergency lighting fixtures. Valley Electric installed exterior light fixtures at the administration building (see Photo #33). Rockwell Automation continued to program motor starters in motor control centers in the electrical and headworks buildings. EC Electric installed conduits and conductors for HVAC equipment in the administration building. University Mechanical installed influent pumps and associated discharge piping, coarse and fine screen conveyors and washer/compactors, a grit basin mixer, and grit pumps in the headworks building. University Mechanical began labeling piping systems in the headworks and secondary treatment buildings (see Photo #28). University Mechanical continued to install dryer equipment in the biosolids building. Delta Corporation continued to install fiber reinforced plastic (FRP) foul air piping and HVAC ductwork and equipment in the secondary treatment building and in the headworks building.

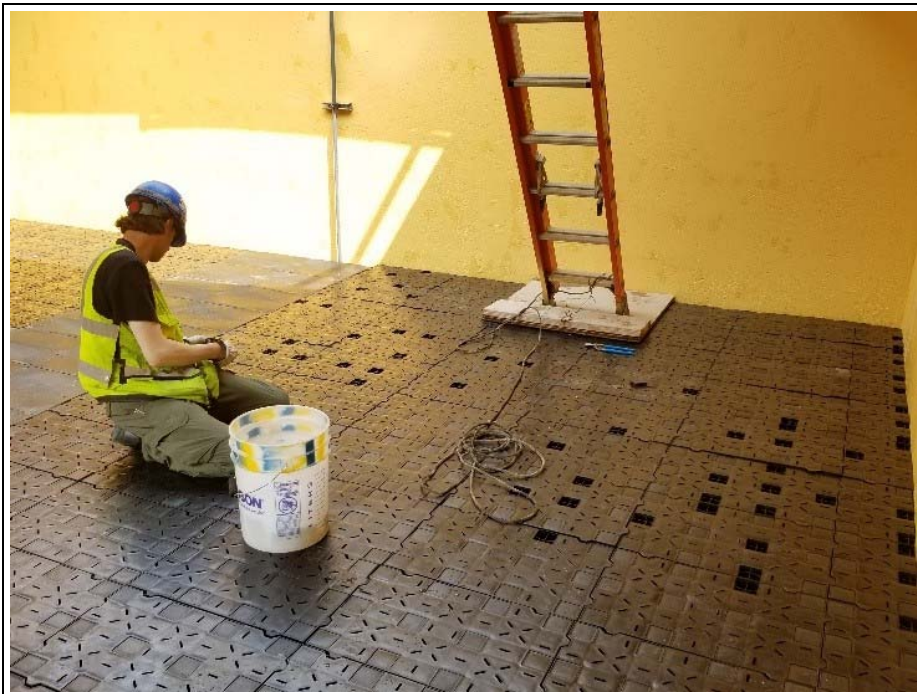
Photo #11

Area 60 Odor Control  
(looking east) on Tuesday,  
August 14<sup>th</sup>.

A pipefitter for University  
Mechanical is installing air  
distribution plates in the  
odor control structure.

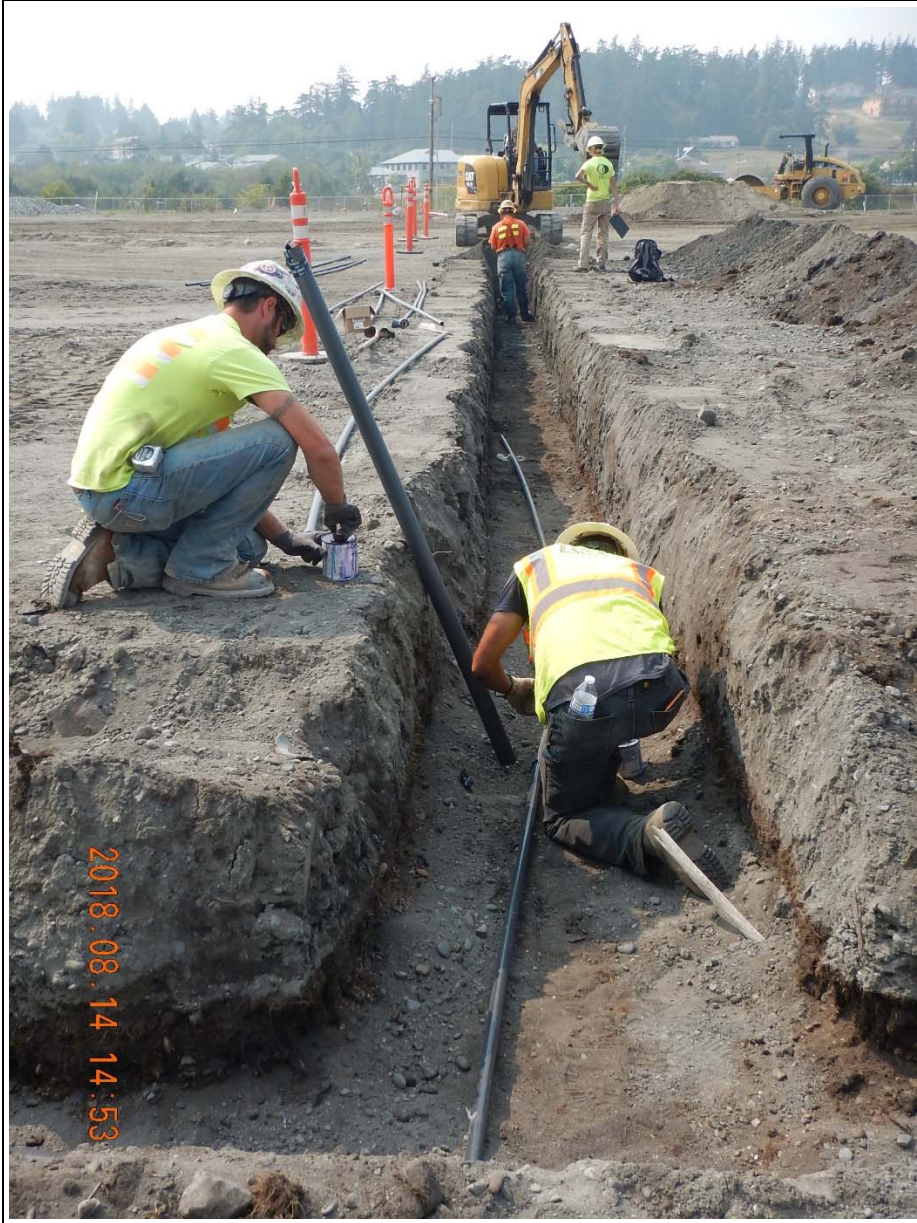
Photo #12

Southwest end of Windjammer Park (looking west) on Tuesday, August 14<sup>th</sup>.

Laborers and pipelayers for Interwest Construction are installing 2-inch PVC water piping in a trench.

- Interwest Construction installed water utilities, performed earthwork, and built curbs at Windjammer Park (see Photos #12, #21, #22, and #24 through #26), and Valley Electric and Pacific Earth Work installed buried electrical conduits (see Photo #34) and irrigation piping, (see Photos #23 and #46), respectively.
- Start-up activities continued. Vendors operated equipment and conducted operator training (see Photos #3, #4, #15, #32, #37, #40, and #43).
- University Mechanical continued to assemble a dryer in the biosolids building.
- Axiom installed GFRC cladding on the secondary treatment building (see Photos #16 and #44).

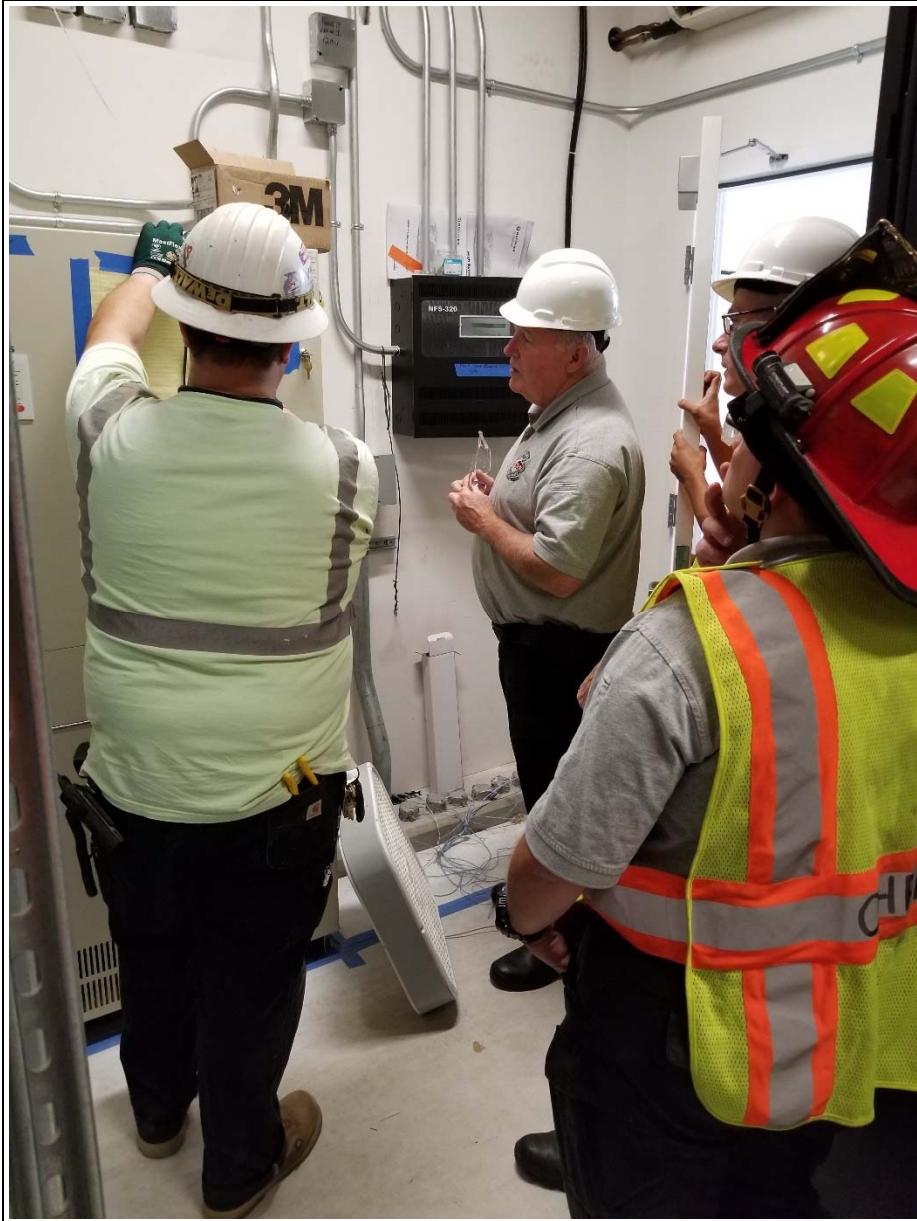
Photo #13

Area 01 Administration Building (looking east in the SCADA room) on Wednesday, August 15<sup>th</sup>.

An electrician for Valley Electric (left) and Oak Harbor Fire Marshall Ray Merrill inspecting an inverter that “inverts” direct current to alternating current (AC) to power emergency lighting systems during failure of normal AC power.

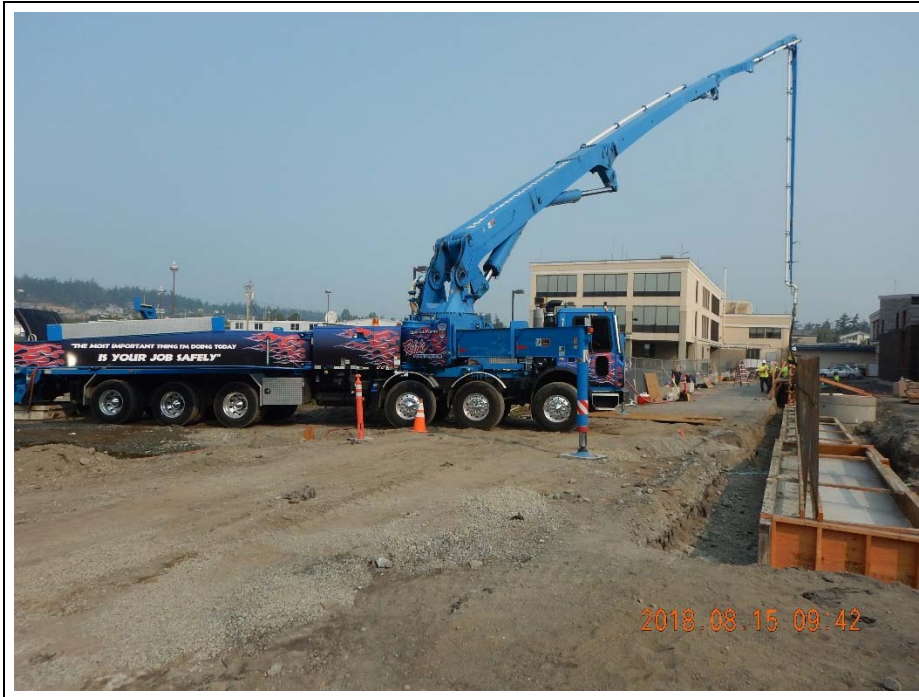
Photo #14

Area adjacent to the west side of Area 70 Generator Yard (looking north) on Wednesday, August 15<sup>th</sup>.

Carpenters for Interwest Construction are utilizing a truck-mounted concrete pump and hydraulic actuated boom to place concrete for a retaining wall.

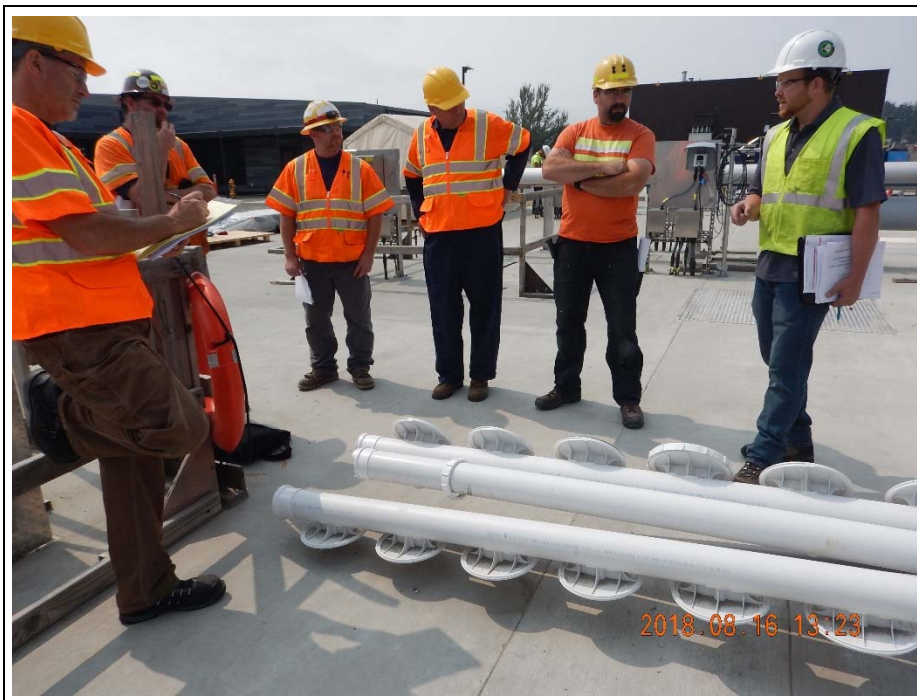
Photo #15

Area 31 Aeration Basins (looking west) on Thursday, August 16<sup>th</sup>.

An engineer for Beaver Equipment Company, Jared Van Putten (right, in yellow vest), is conducting operator training pertaining to the bubbler system (seen in foreground) for the City's operations staff (left).

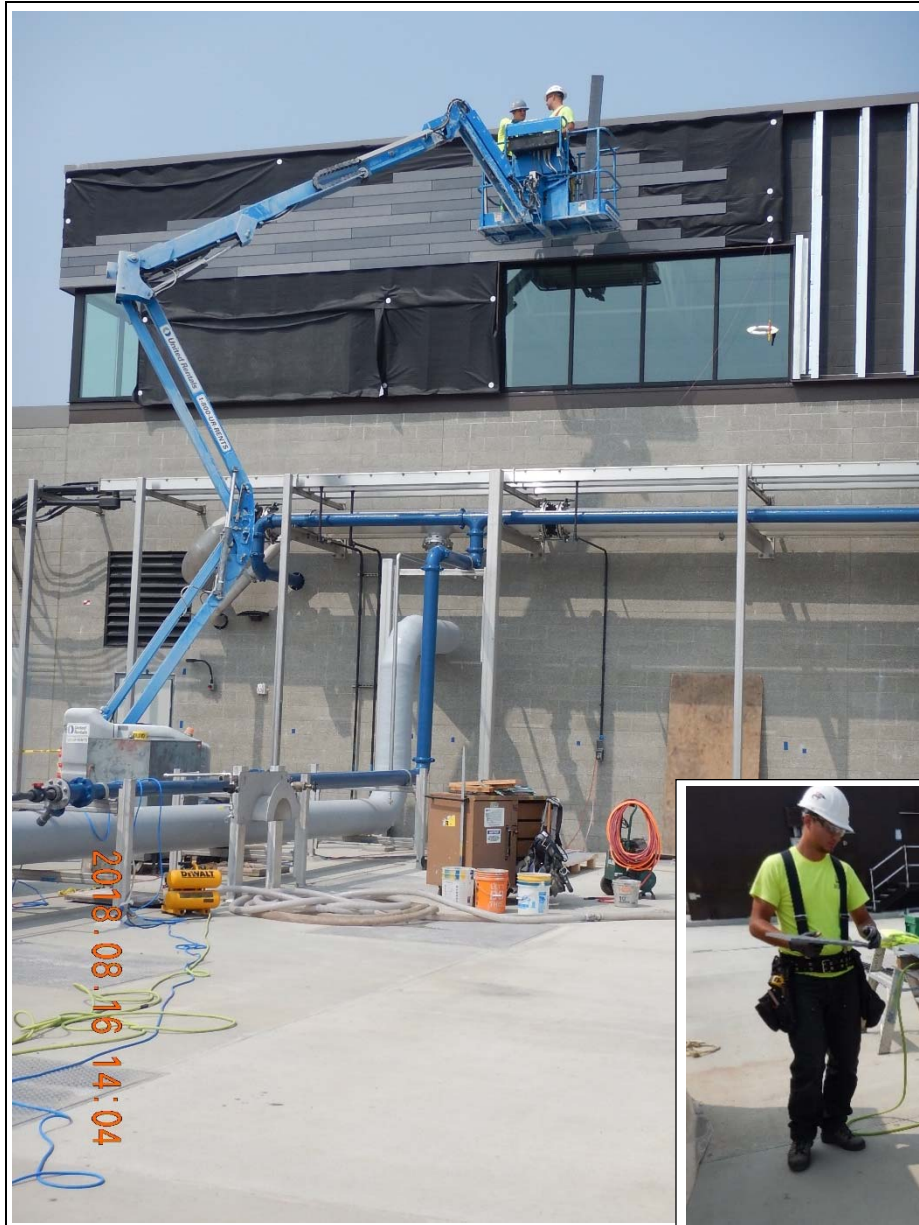
Photo #16

Area 30 Secondary Treatment Building (looking north) on Thursday, August 16<sup>th</sup>.

Bottom: A sheet metal worker for Axiom is cutting sections of GFRC cladding.

**GMPA No. 11 – Superstructure Construction.** Work on this GMPA is approximately 94% complete. University Mechanical modified piping between an air-to-water heat pump in the generator yard and hot and cold water storage tanks in the mechanical room in the administration building. University Mechanical installed appliances in the administration building. Steelkorr installed aluminum tread plates in the headworks building and in the secondary treatment building (see Photo #29). Steelkorr installed handrails in the headworks building (see Photo #41). Pacific Glass installed “etched” glass windows at the biosolids, electrical, aeration blower, and secondary treatment buildings. A small crew for Penington Painting performed miscellaneous painting work in the administration and maintenance buildings and several process buildings. Axiom installed metal furring, rain screen, and glass-fiber reinforced concrete (GFRC) cladding on the upper exterior of the secondary treatment building (see Photos #16 and #44).

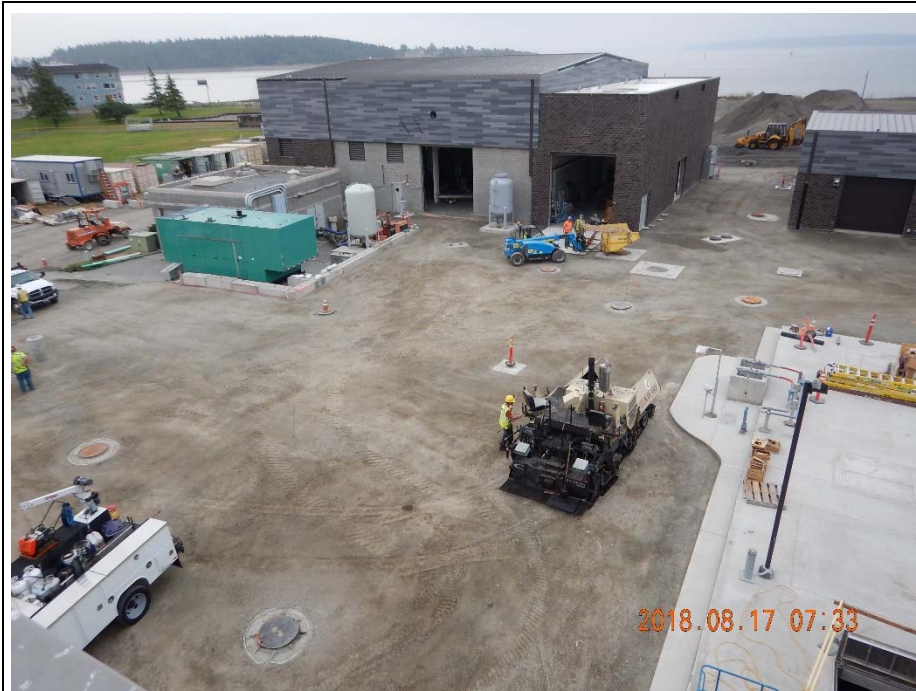
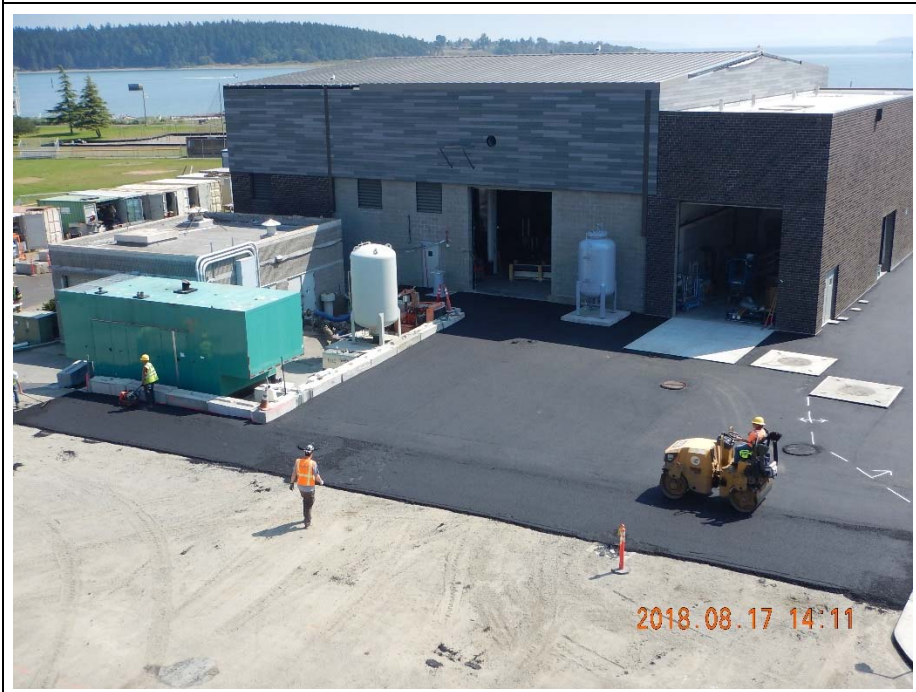
Photo #18

Area 50 Biosolids Building (looking southeast from the roof of Headworks) on Friday, August 17<sup>th</sup>.

Top Photo: Before asphalt paving begins at the north side of the biosolids building.

Bottom Photo: After Lakeside Industries places an initial lift of asphalt pavement at the north side of the biosolids building.

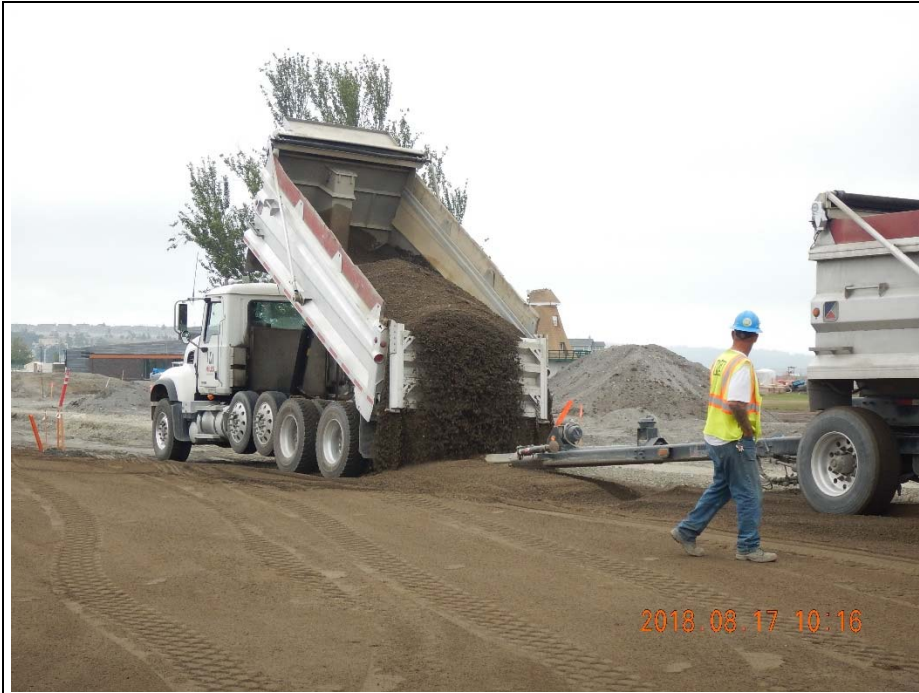
Photo #21

Northwest corner of Windjammer Park (looking east) on Friday, August 17<sup>th</sup>.

Miles Sand and Gravel is delivering base material for a new parking lot.

**GMPA No. 13 – Windjammer Park Improvements.** Work on this portion of GMPA No. 13 is approximately 20% complete. Interwest Construction graded and compacted imported base material at the west end of the park where new curbs and a parking lot are located (see Photos #21, #22, #24, and #25). Interwest's subcontractor, S&S Construction, utilized a slip-form paver to build concrete curbs around the perimeter of the parking lot (see Photo #26). Interwest Construction installed small diameter PVC water piping at the west end of the park (see Photo #12). Pacific Earth Works continued to install 6-inch PVC irrigation system piping (see Photos #23 and #46), and Valley Electric continued to install buried PVC electrical conduits (see Photo #34). P&L General Contractors, Inc., and their subcontractor, Valdez Construction, placed imported base material for the east and west kitchens and the pavillion.

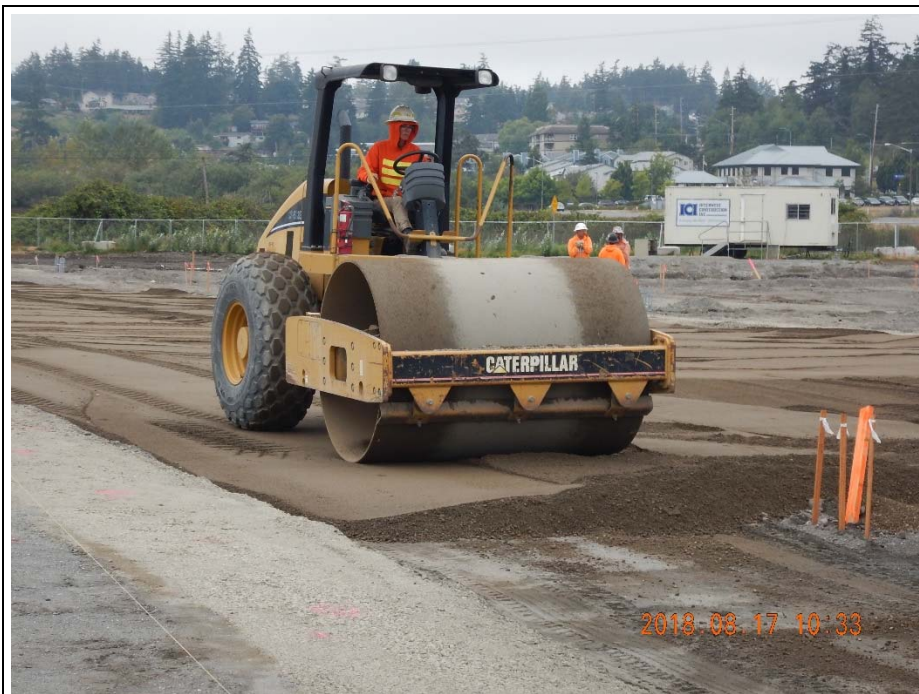
Photo #22

Northwest corner of Windjammer Park (looking west) on Friday, August 17<sup>th</sup>.

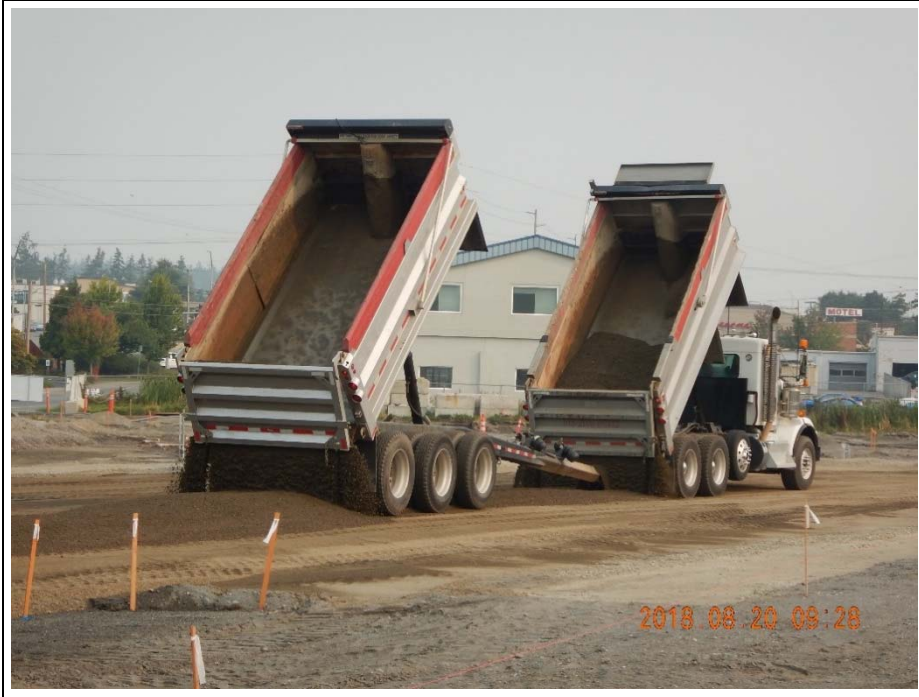
Photo #24

West end of Windjammer Park (looking north) on Monday, August 20<sup>th</sup>.

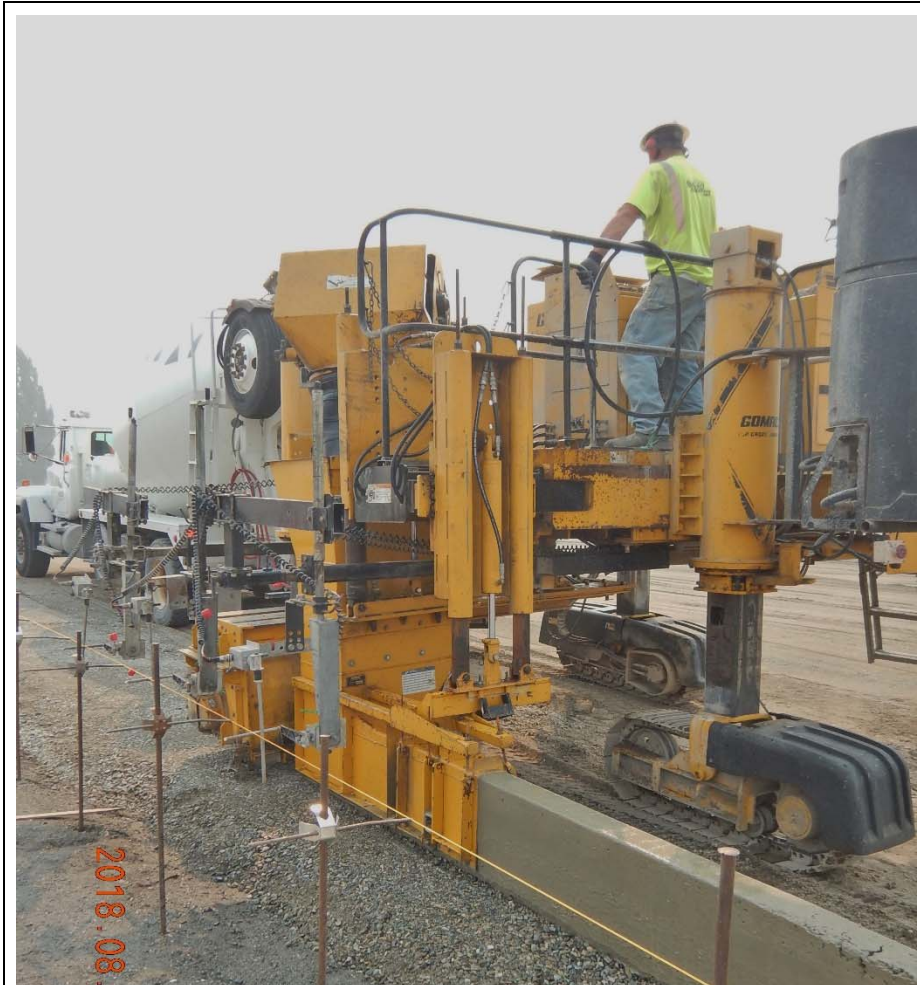
Photo #26

West end of Windjammer Park (looking southwest and south) on Monday, August 20<sup>th</sup>.

S & S Concrete Construction is utilizing a slip-form paver to build curbs around the perimeter of a not-yet-constructed parking lot. Miles Sand and Gravel is providing the concrete.

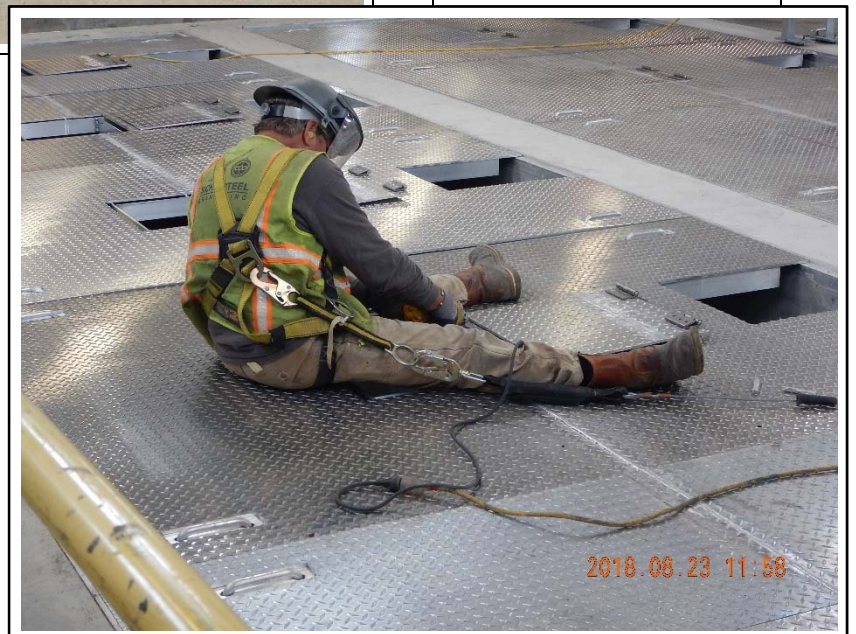
Photo #30

Area 20 Headworks  
(looking northwest) on  
Thursday, August 23<sup>rd</sup>.

Electricians for Valley  
Electric are installing  
conduits and conductors  
associated with control  
panels for influent pumps.

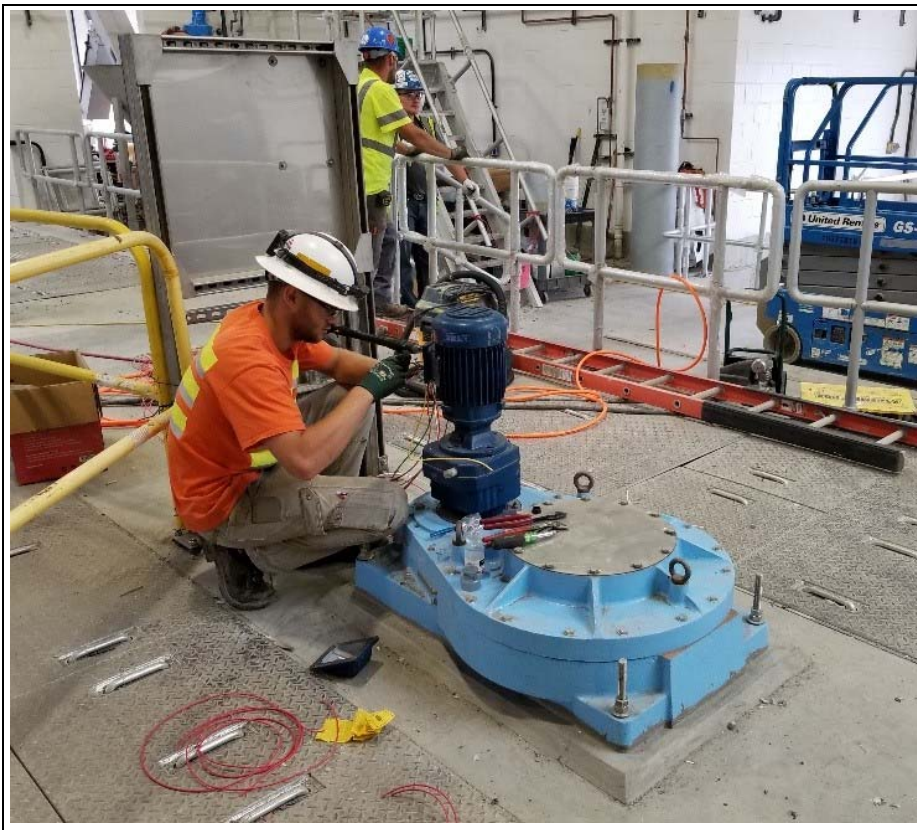
Photo #31

Area 20 – Headworks  
(looking southeast) on  
Thursday, August 23<sup>rd</sup>.

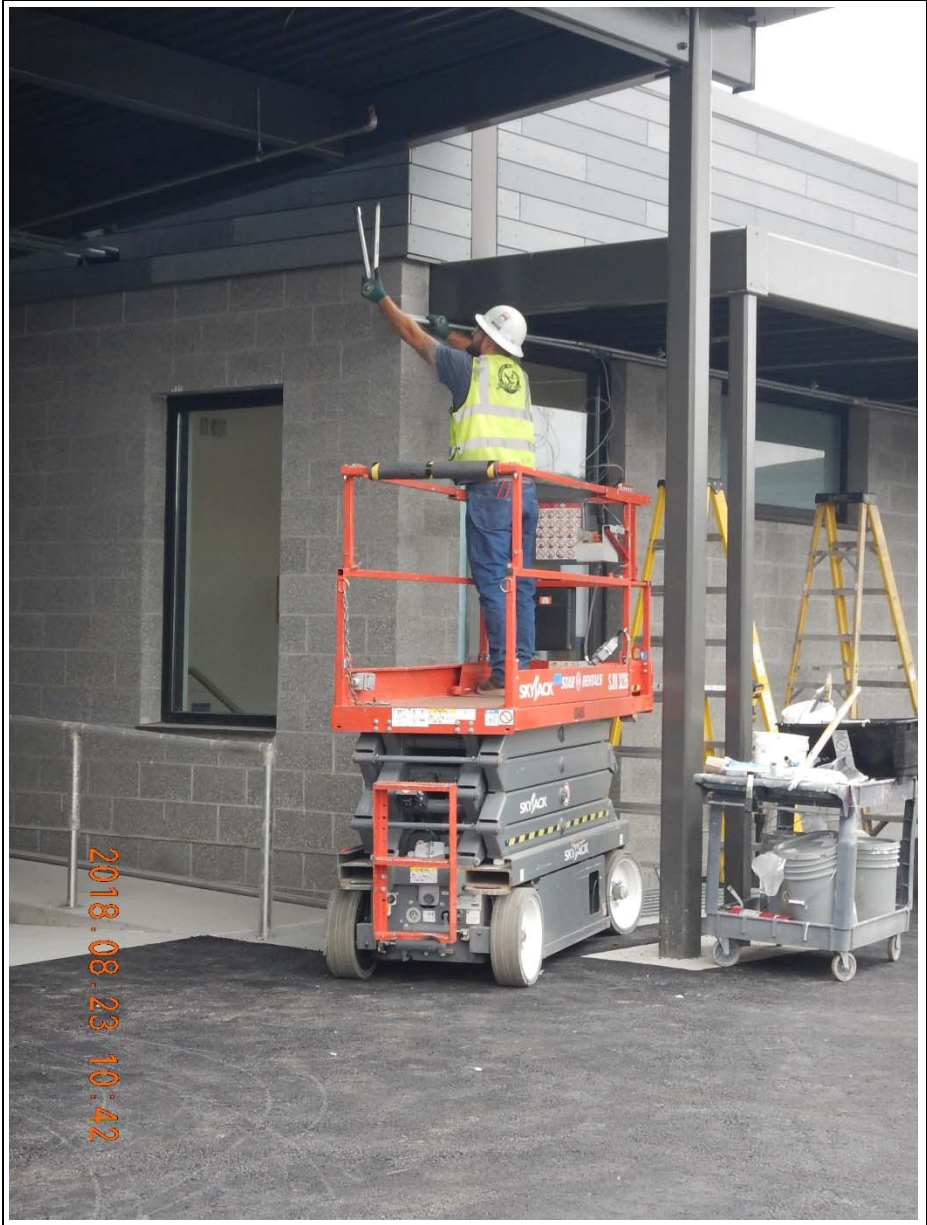
Photo #33

Area 01 Administration Building (looking southwest) on Thursday, August 23<sup>rd</sup>.

An electrician for Valley Electric is installing conduits for lighting under a covered storage area.
