City of Oak Harbor  
City Council Agenda Bill

Bill No. 5. c. i.  
Date: September 18, 2018  
Subject: Clean Water Facility Update

# Clean Water Facility Project

# Report *August 2018*

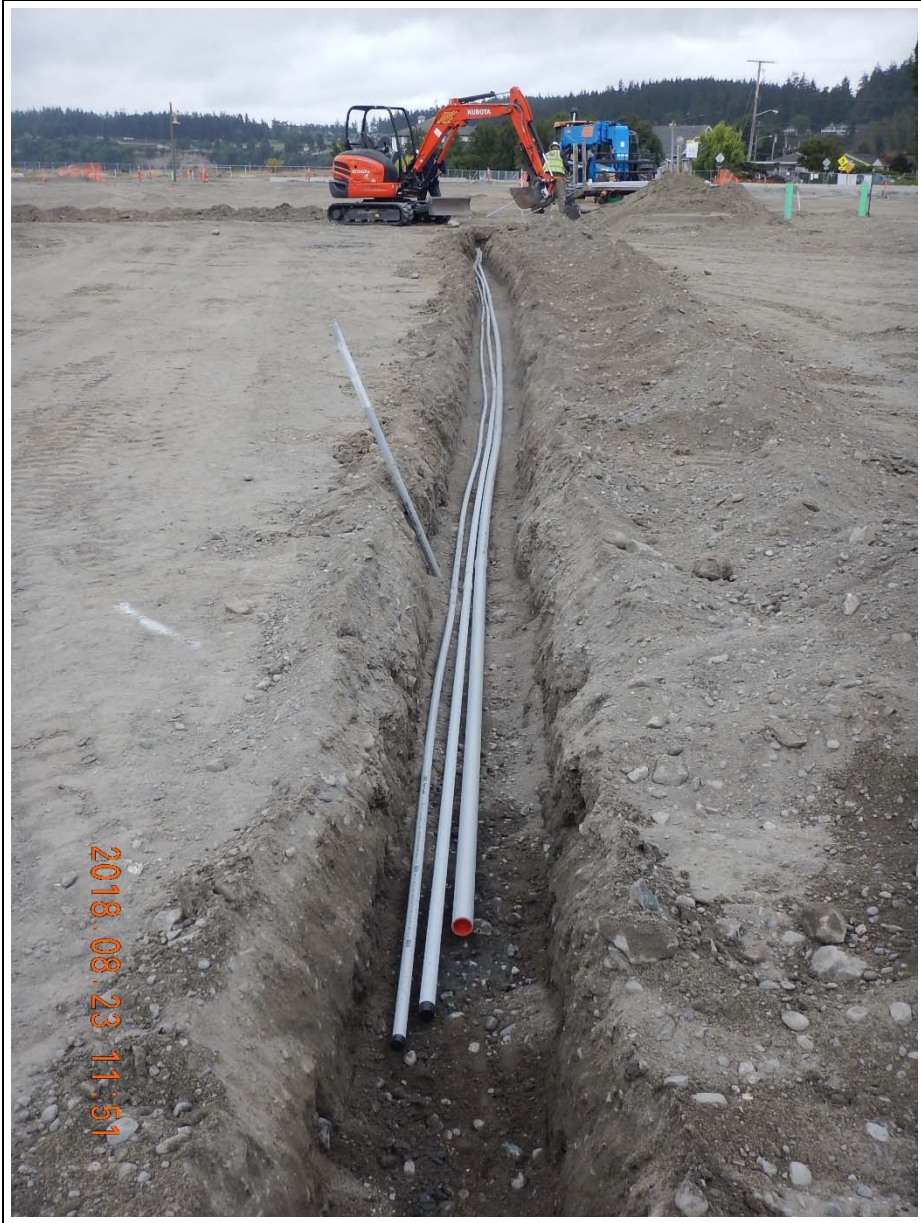
Photo #34

Southwest end of Windjammer Park (looking southwest) on Thursday, August 23<sup>rd</sup>.

Electricians for Valley Electric are installing buried electrical conduits.

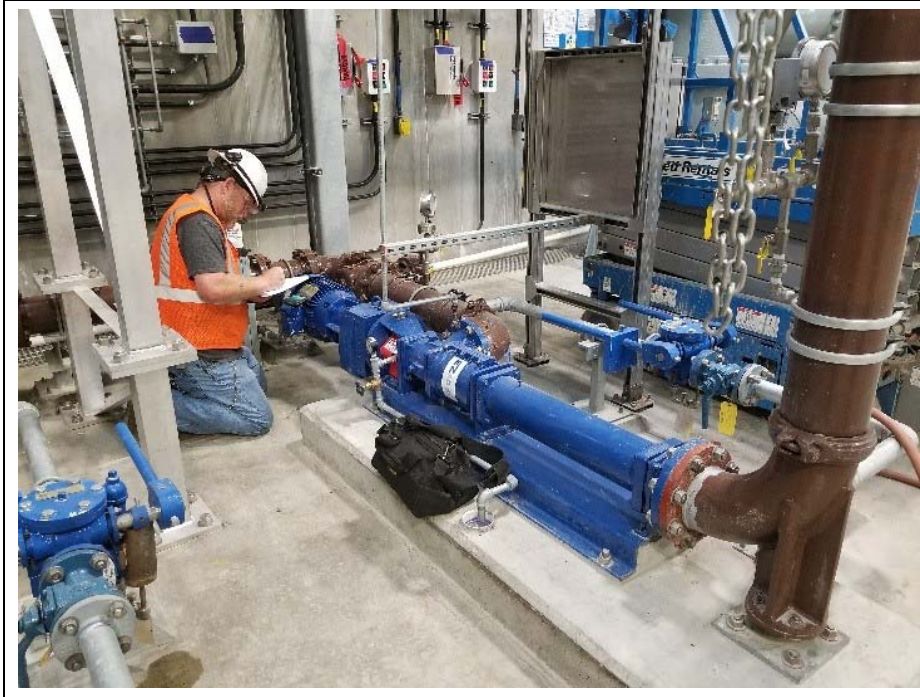
Photo #35

Area 35 RAS/WAS Pumping (looking southwest) on Monday, August 27<sup>th</sup>.

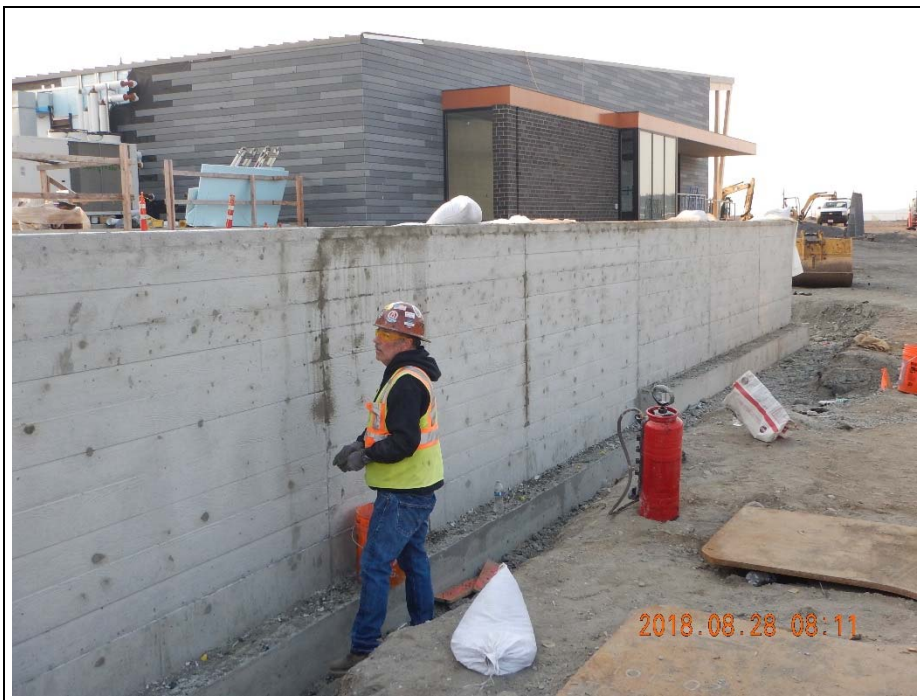
Photo #36

Area adjacent to the west side of Area 70 Generator Yard (looking southeast) on Tuesday, August 28<sup>th</sup>.

A carpenter for Interwest Construction is applying grout to form-tie holes and other imperfections in a newly constructed concrete retaining wall.

**GMPA No. 13 – Civil Site Work.** Work on this portion of GMPA No. 13 is approximately 20% complete. Interwest Construction finished grading an "inner yard" area between the process buildings and the administration and maintenance building. Interwest's subcontractor, Lakeside Industries, paved the inner yard (see Photos #18, #19, and #20). Interwest Construction built formwork and placed reinforcing steel and concrete for a retaining wall next to the west sides of the aeration blower and electrical buildings and the generator yard (see Photos #8, #9, #14, and #36).

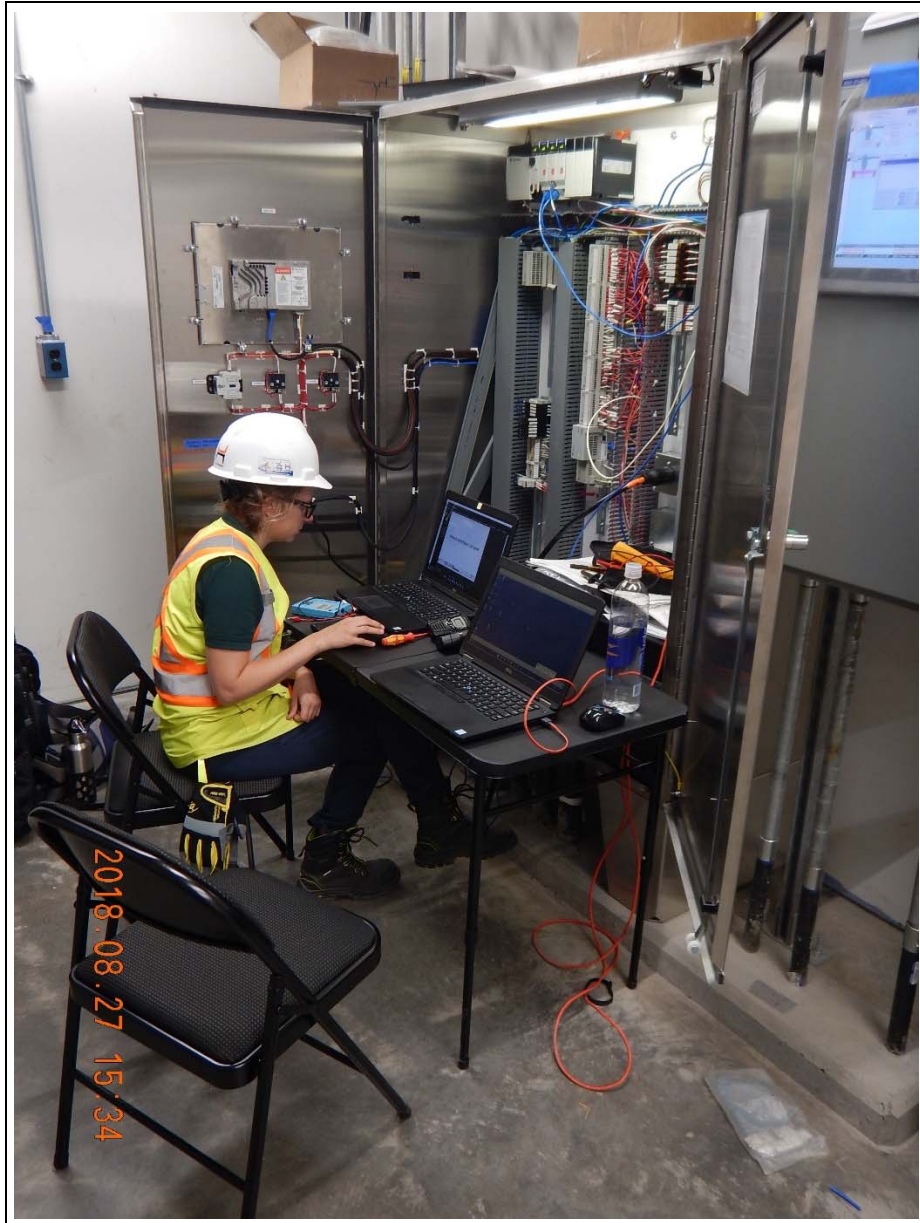
Photo #37

Area 70 Electrical Buiding (looking northwest in the control room) on Monday, August 27th.

An engineer for Suez Water Technologies and Solutions, Kathleen McAllister, is verifying that a control panel is communicating properly with equipment associated with a membrane filtration system.

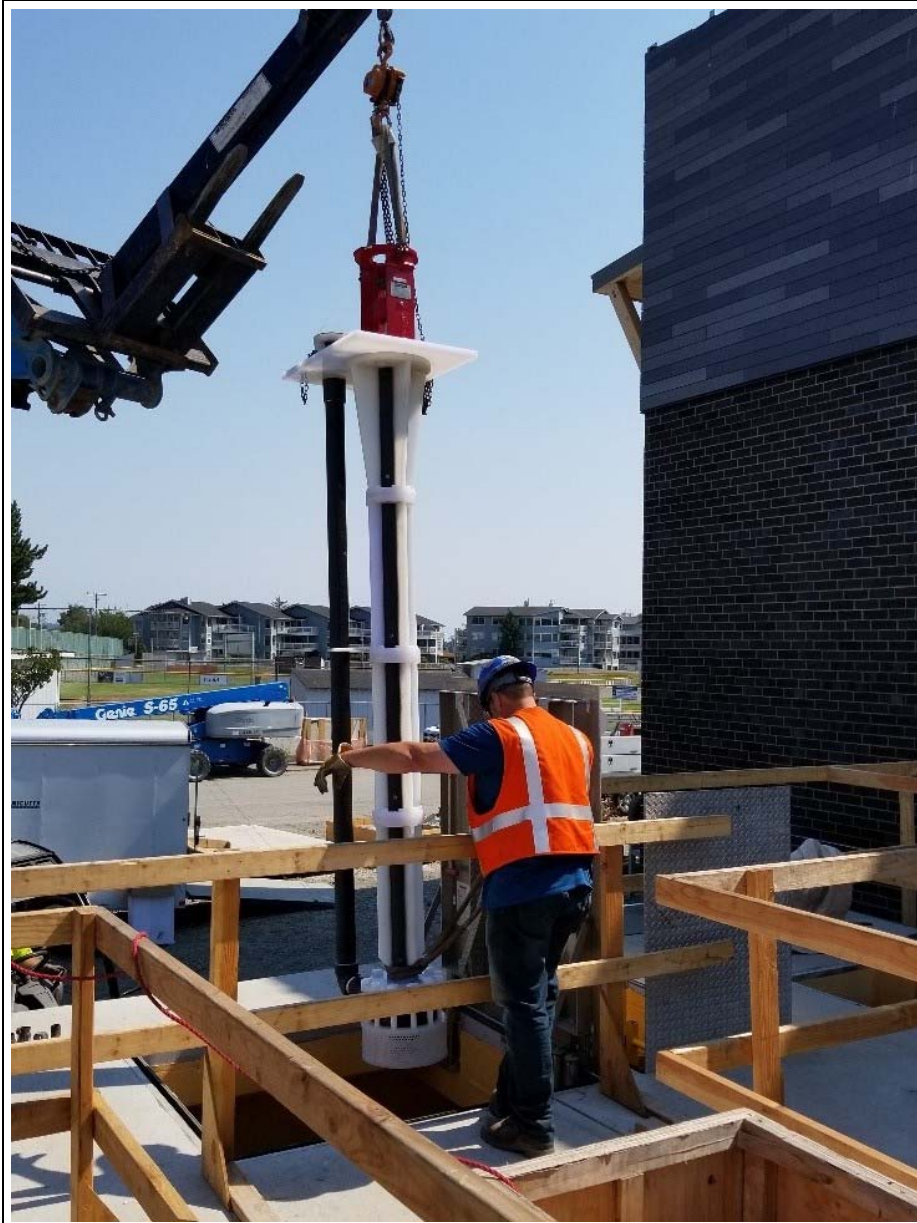
Photo #38

Area 60 Odor Control  
(looking east) on Tuesday,  
August 28<sup>th</sup>.

**GMPA No. 12 – Odor Control System.** Work on this GMPA is approximately 80% complete. University Mechanical installed PVC process piping and air distribution plates inside the odor control structure (see Photos #6 and #11). University Mechanical installed recirculation pumps (see Photo #38). Painters for Honeycutt's, Inc., repaired the coating system at pipe penetrations (see Photo #45).

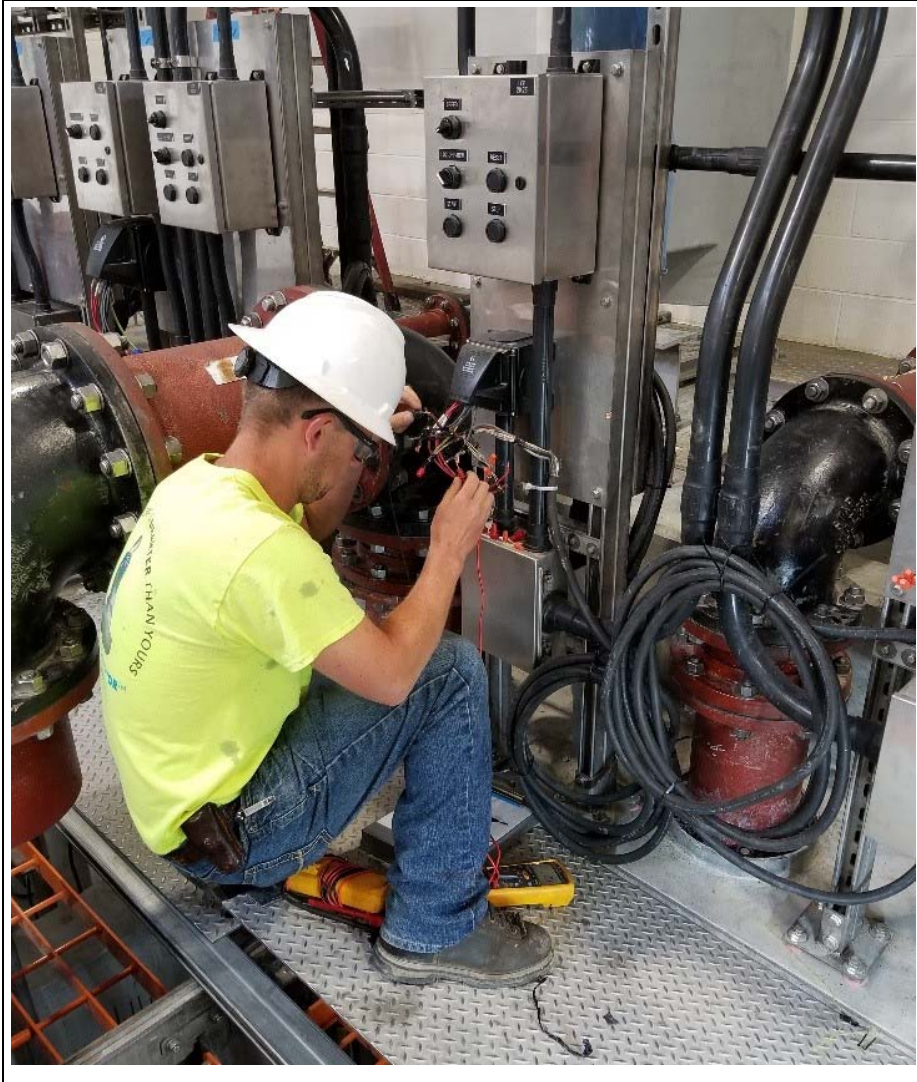
Photo #40

Area 20 Secondary Treatment (looking northwest) on Wednesday, August 29<sup>th</sup>.

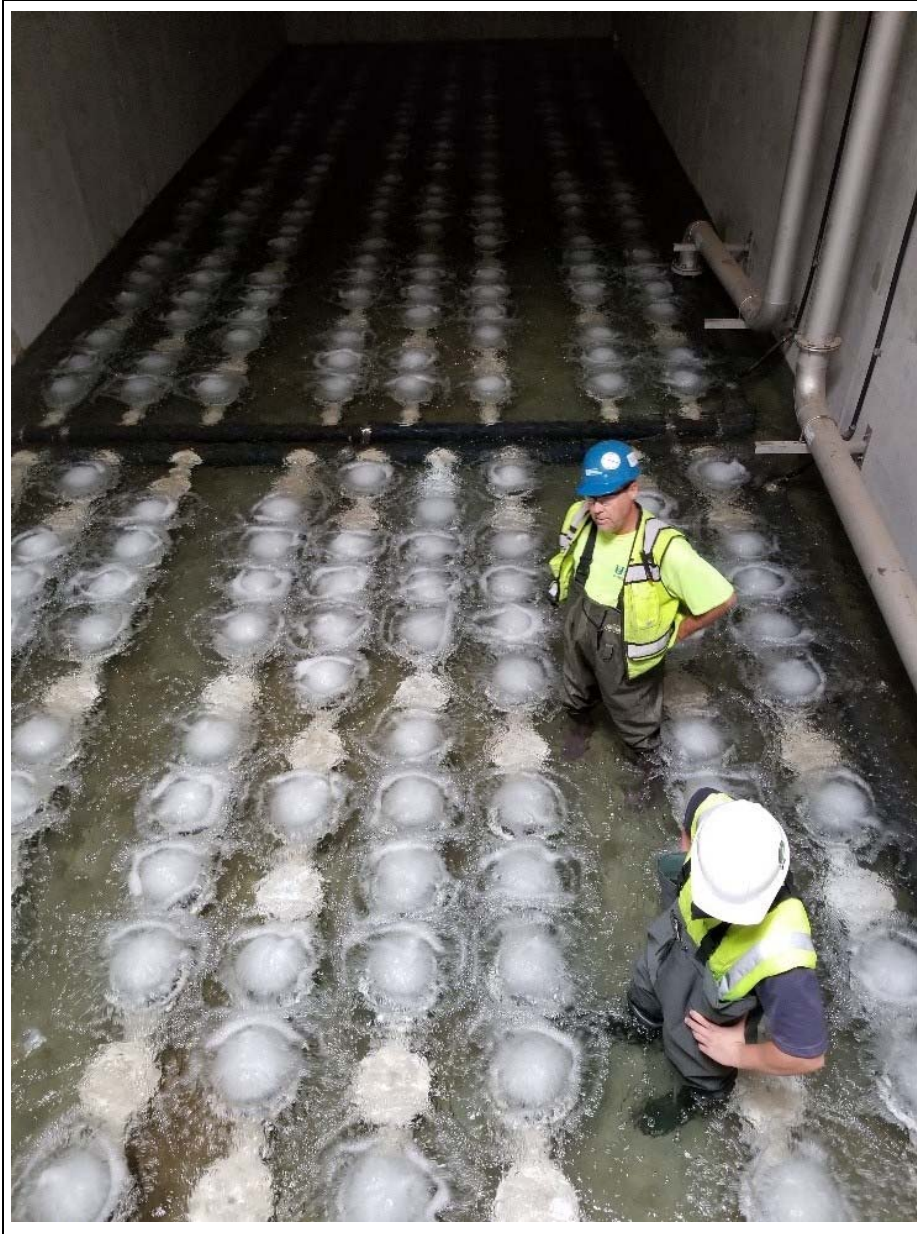
Photo #43

Area 31 Aeration Basins (looking north) on Thursday, August 30<sup>th</sup>.

A pipefitter for University Mechanical (top) and a technician for Beaver Equipment Company, Jared Van Putten (bottom), are inspecting a bubbler system in operation at the bottom of an aeration basin.

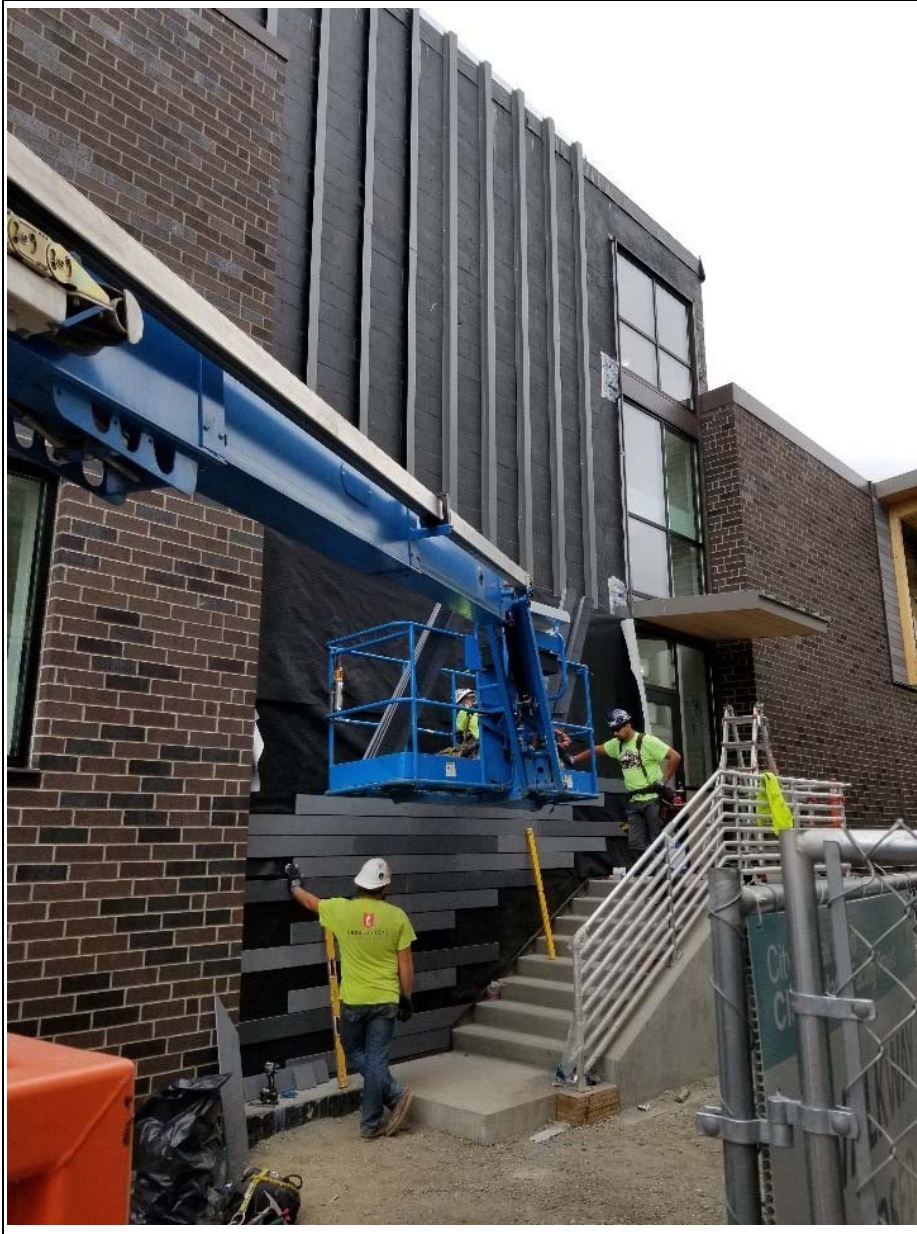
Photo #44

Area 30 – Secondary Treatment Building (looking southwest) on Thursday, August 30<sup>th</sup>.

Sheet metal workers for Axiom are installing metal furring, rain screen, and glass-fiber reinforced concrete (GFRC) cladding to the exterior of the north side of the secondary treatment building.

**GMPA No. 11 – Superstructure Construction.** Work on this GMPA is approximately 94% complete. University Mechanical modified piping between an air-to-water heat pump in the generator yard and hot and cold water storage tanks in the mechanical room in the administration building. University Mechanical installed appliances in the administration building. Steelkorr installed aluminum tread plates in the headworks building and in the secondary treatment building (see Photo #29). Steelkorr installed handrails in the headworks building (see Photo #41). Pacific Glass installed “etched” glass windows at the biosolids, electrical, aeration blower, and secondary treatment buildings. A small crew for Penington Painting performed miscellaneous painting work in the administration and maintenance buildings and several process buildings. Axiom installed metal furring, rain screen, and glass-fiber reinforced concrete (GFRC) cladding on the upper exterior of the secondary treatment building (see Photos #16 and #44).

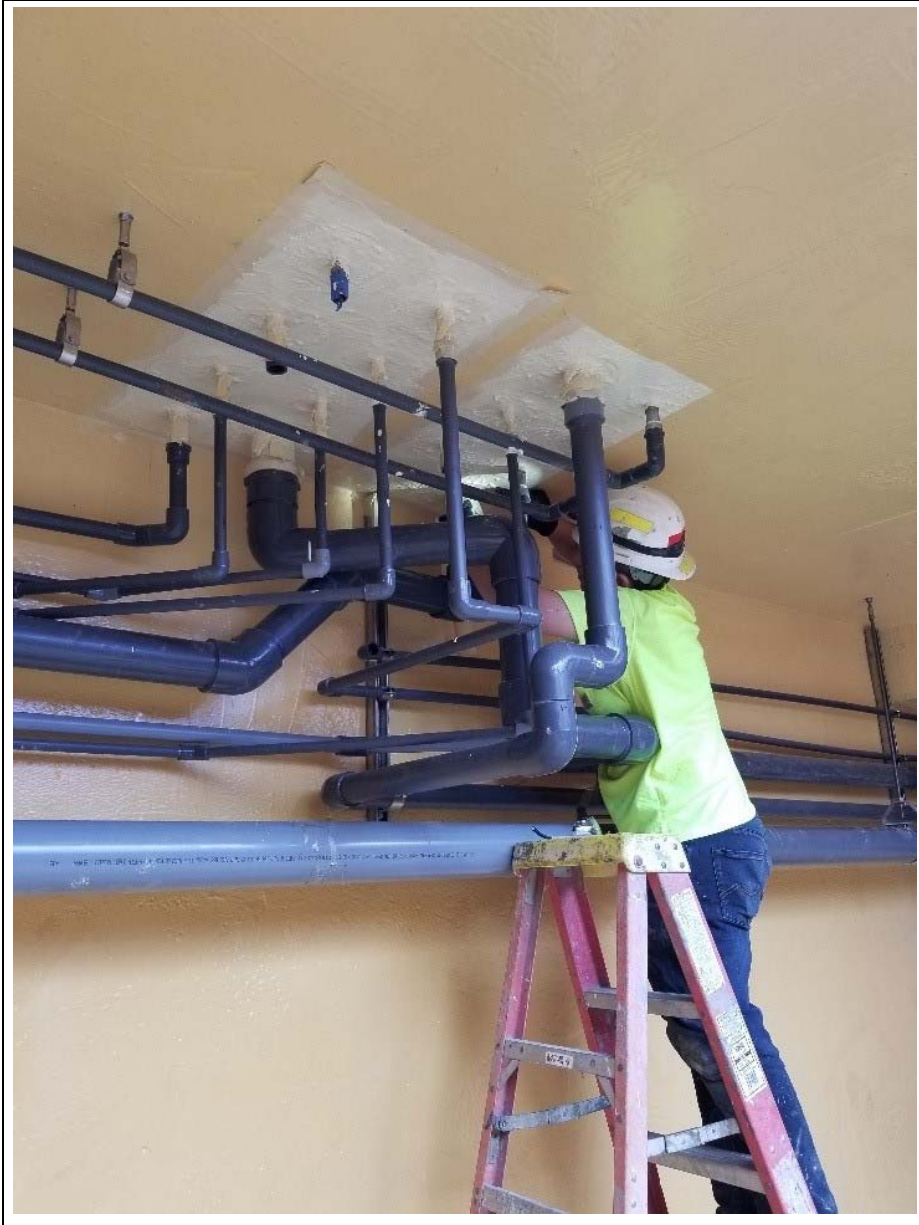
Photo #45

Area 20 Odor Control  
(looking southwest) on  
Thursday, August 30<sup>th</sup>.

A painter for Honeycutt's,  
Inc., is repairing a coating  
system at pipe  
penetrations.

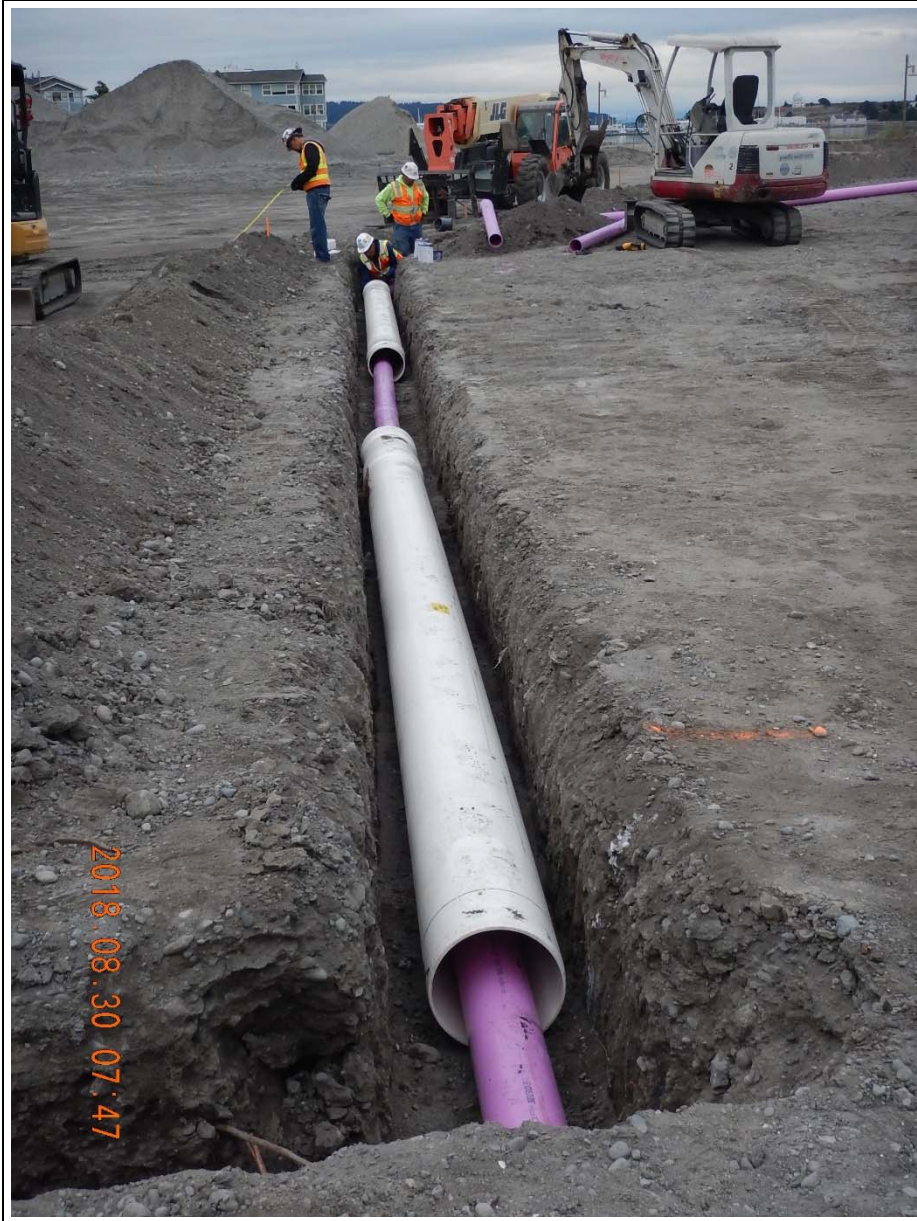
Photo #46

East end of Windjammer Park (looking east) on Thursday, August 30<sup>th</sup>.
